ASBESTOS SURVEY REPORT FOR HARRATON AND DISTRICT COMMUNITY ASSOCIATION, BONEMILL LANE, WASHINGTON, NE38 8BQ.

Asbestos Register for

Harraton and District CA, Bonemill Lane, Washington

Date: 23 April 2025

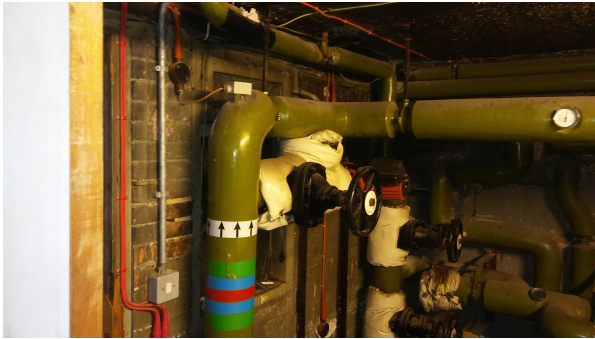
Item 1 Ref: 374621-16

The pipe lagging in the plant room (Rm 0/01) does not contain asbestos.

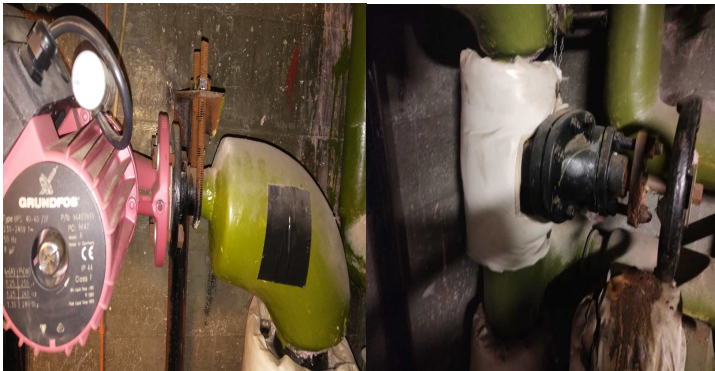
Item 2 Ref: 374621-17

The pipework flange gasket in the plant room (Rm 0/01) does contain asbestos.

Any change in appearance should be reported to Property Services.

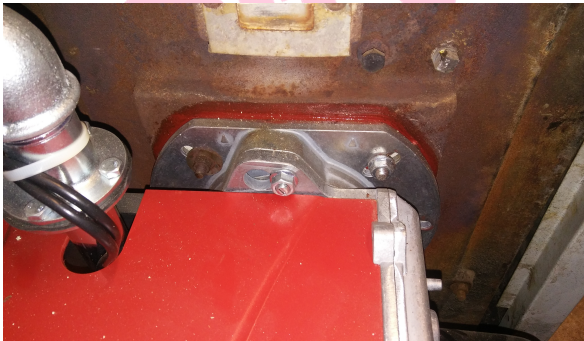
Item 3 Ref: 374621-18

The gasket to the boiler in the plant room (Rm 0/01) does not contain asbestos.

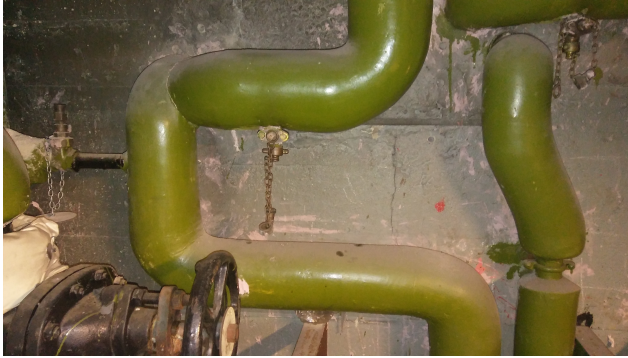
Item 4 Ref: 374621-19

The debris to walls in the plant room (Rm 0/01) does not contain asbestos.

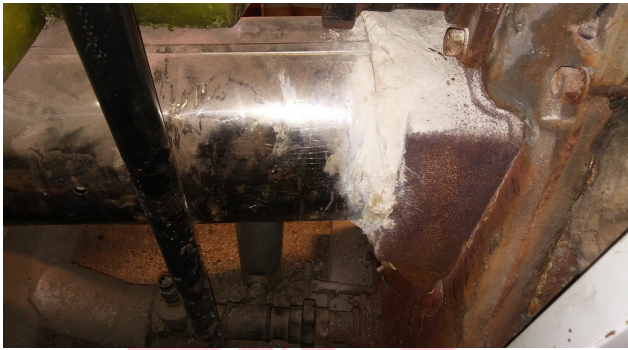
Item 5 Ref: 374621-20

The seal to metal boiler flue in the plant room (Rm 0/01) does not contain asbestos.

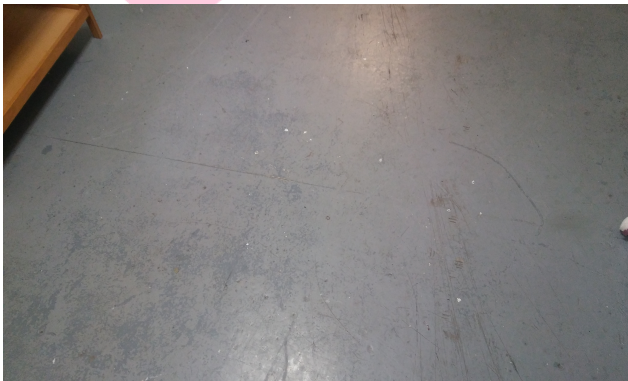
Item 6 Ref: 374621-1

The floor covering in the store (Rm 0/03) does not contain asbestos.

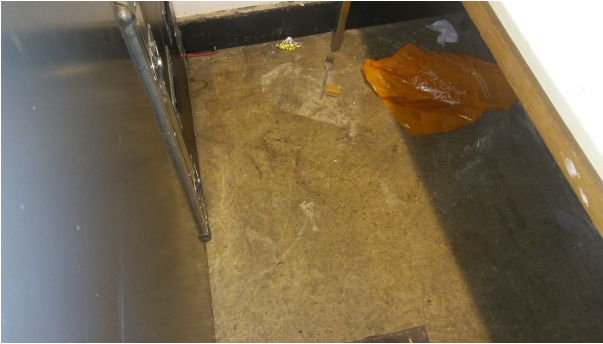
Item 7 Ref: As 374621-1

The floor covering in the Store (Rm 0/03a) does not contain asbestos.

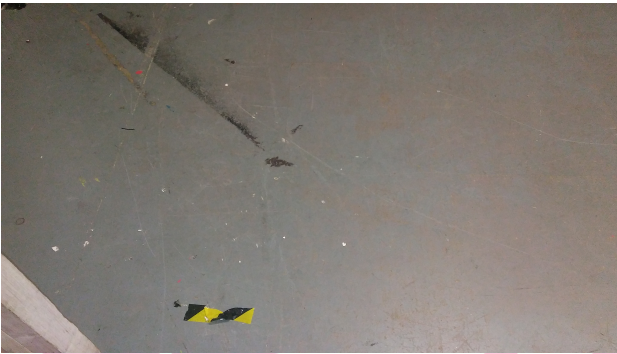
Item 8 Ref: As 374621-1

The floor covering the stage (Rm 0/08a) does not contain asbestos.

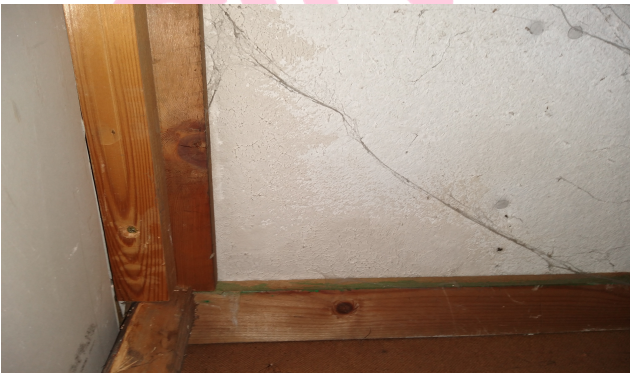
Item 9 Ref: 374621-15

The textured coating to the fibreboard ceiling in the boiler cupboard (Rm 0/09a) does contain asbestos.

Any change in appearance should be reported to Property Services.

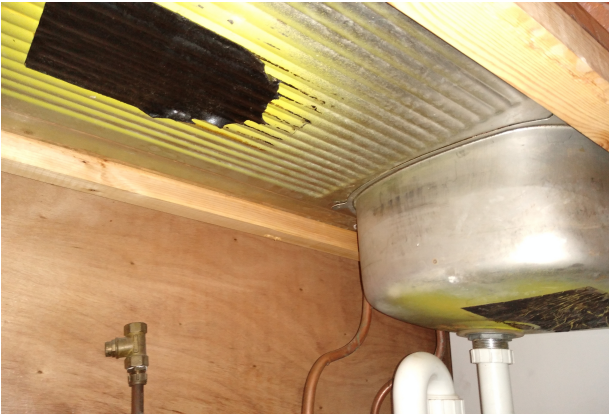
Item 10 Ref: 374621-11

The sink pad in the bar (Rm 0/10) does contain asbestos.

Any change in appearance should be reported to Property Services.

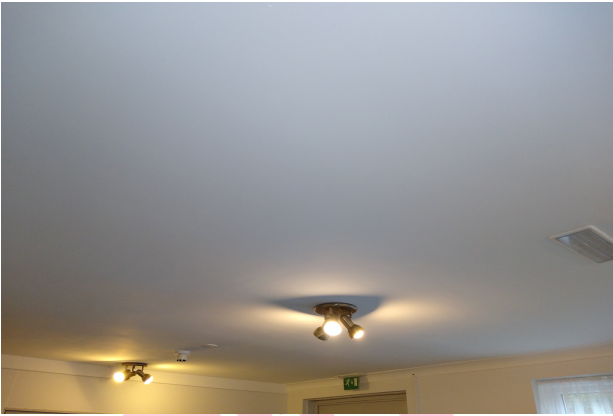
Item 11 Ref: As 374621-14

The textured coating behind the plaster skim in the lounge (Rm 0/12) does contain asbestos.

Any change in appearance should be reported to Property Services.

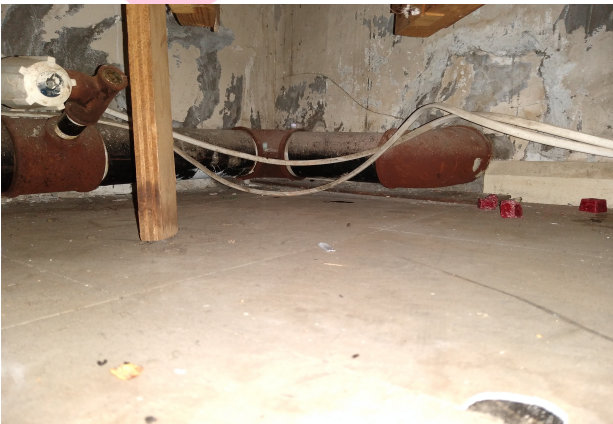
Item 12 Ref: 374621-12

The floor covering under the seating in the lounge (Rm 0/12) does contain asbestos.

Any change in appearance should be reported to Property Services.

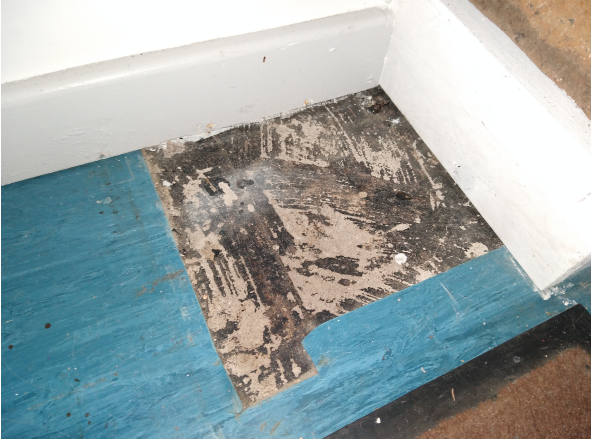
Item 13 Ref: 374621-13

The bitumen to concrete floor under blue modern flooring in the lounge (Rm 0/12) does contain asbestos.

Any change in appearance should be reported to Property Services.

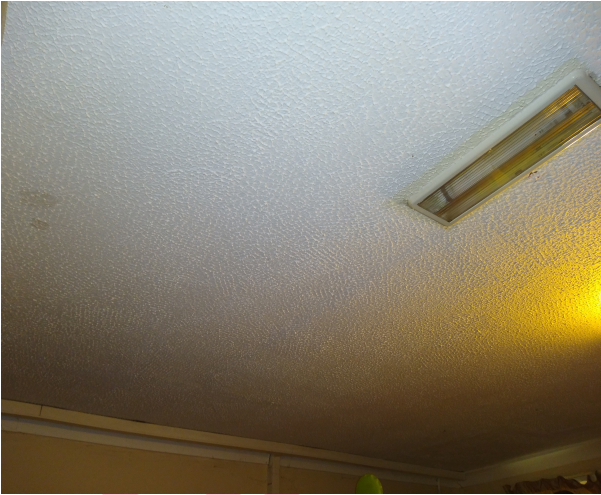
Item 14 Ref: 374621-14

The textured coating to the plasterboard ceiling in the store (Rm 0/12a) does contain asbestos.

Any change in appearance should be reported to Property Services.

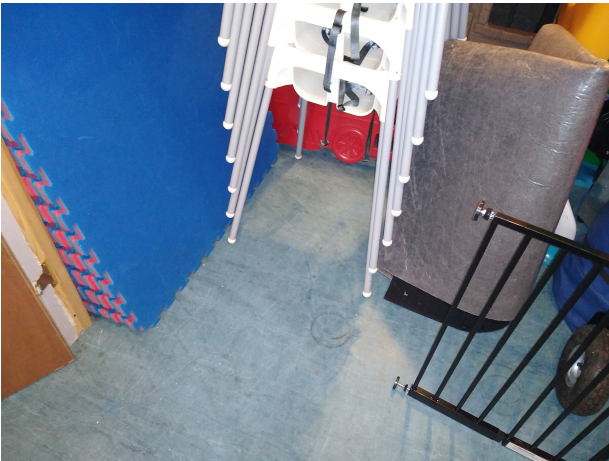
Item 15 Ref: As 374621-13

The bitumen to concrete floor under blue modern flooring in the store (Rm 0/12a) does contain asbestos.

Any change in appearance should be reported to Property Services.

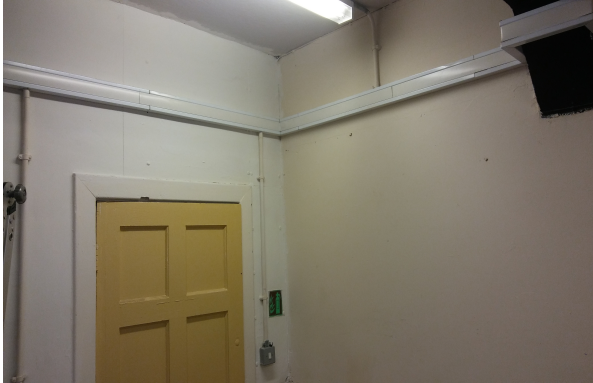
Item 16 Ref: 374621-6

The panels around door to 0/020 in the common room (Rm 0/16) does contain asbestos.

Any change in appearance should be reported to Property Services.

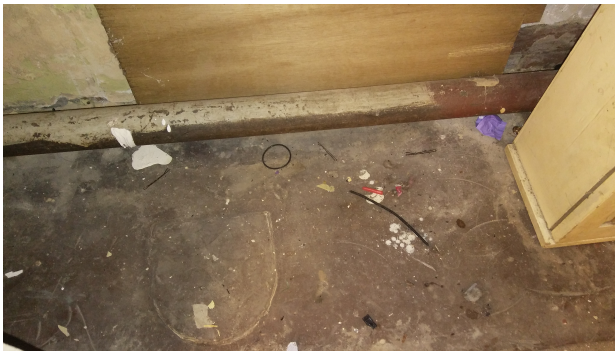
Item 17 Ref: 374621-5

The floor covering in the store (Rm 0/16a) does not contain asbestos.

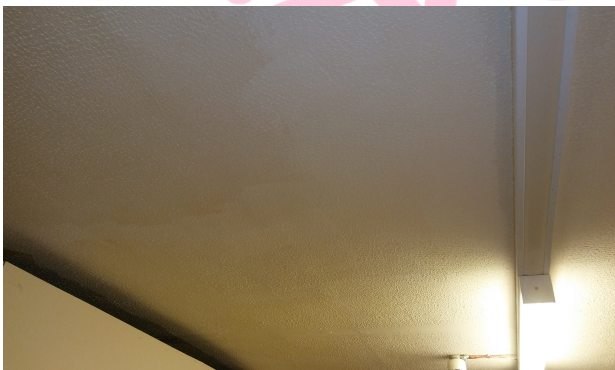
Item 18 Ref: As 374621-13

The textured coating onto plasterboard ceiling in the common room lobby (Rm 0/17) does contain asbestos.

Any change in appearance should be reported to Property Services.

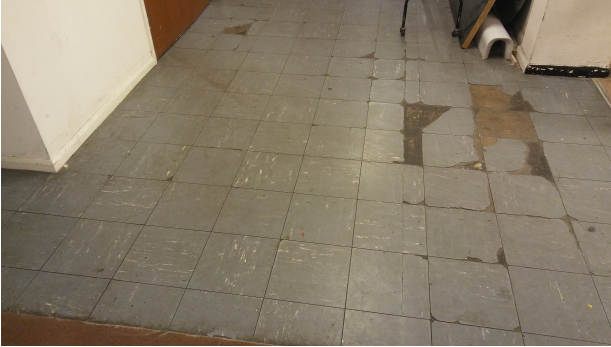
Item 19 Ref: 374621-8

The floor covering in the common room lobby (Rm 0/17) does not contain asbestos.

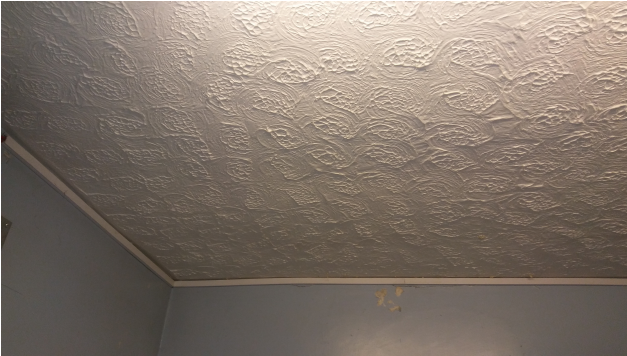
Item 20 Ref: 374621-10

The ceiling in the WC (Rm 0/18) does not contain asbestos.

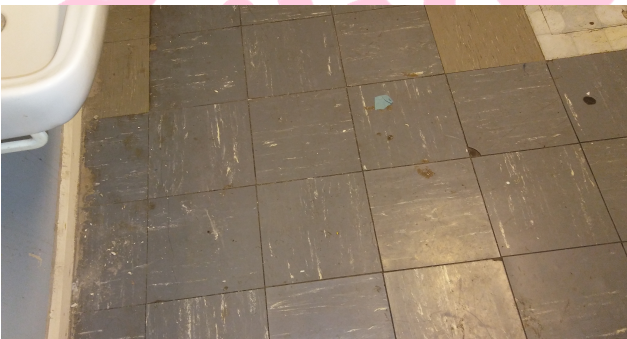
Item 21 Ref: As 374621-8

The floor covering in the WC (Rm 0/18) does not contain asbestos.

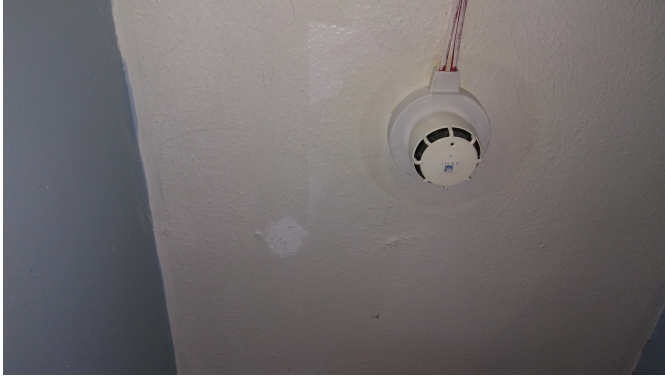
Item 22 Ref: 374621-9

The ceiling in the WC lobby (Rm 0/18a) does contain asbestos.

Any change in appearance should be reported to Property Services.

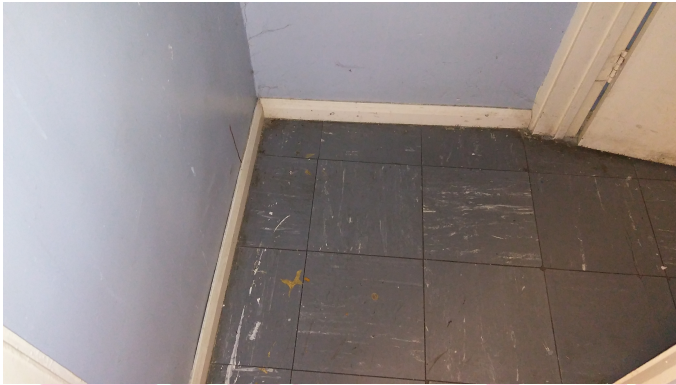
Item 23 Ref: As 374621-8

The floor covering in the WC lobby (Rm 0/18a) does not contain asbestos.

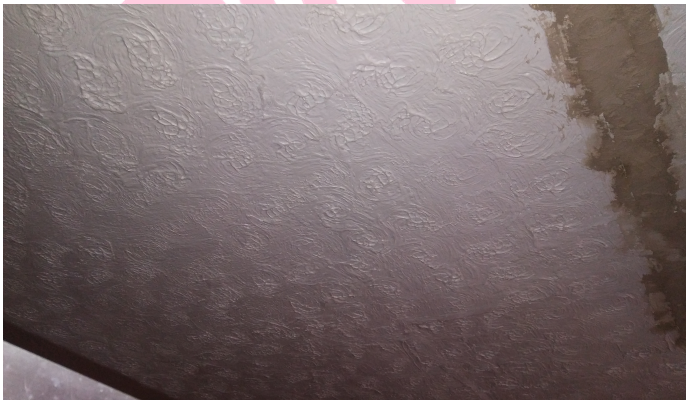
Item 24 Ref: As 374621-10

The ceiling in the WC (Rm 0/19) does not contain asbestos.

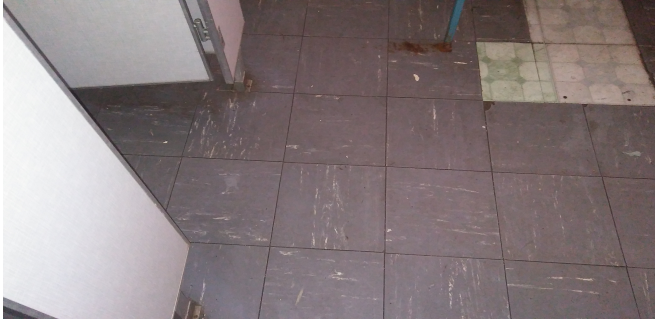
Item 25 Ref: As 374621-8

The floor covering in the WC lobby (Rm 0/19) does not contain asbestos.

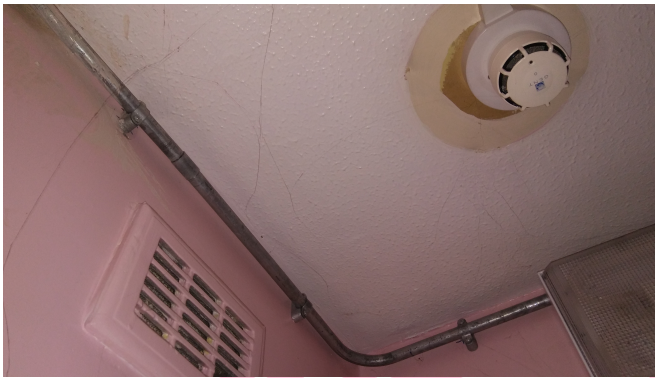
Item 26 Ref: As 374621-9

The ceiling in the WC lobby (Rm 0/19a) does contain asbestos.

Any change in appearance should be reported to Property Services.

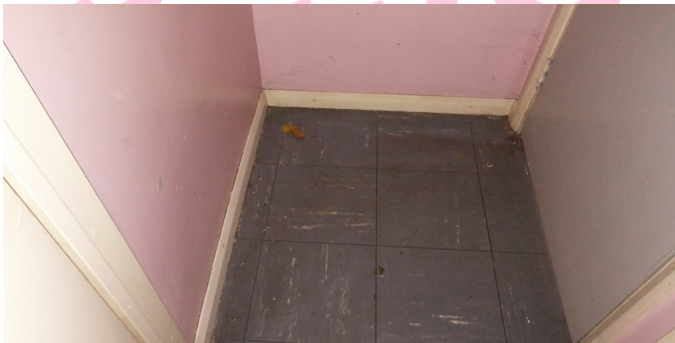
Item 27 Ref: As 374621-8

The floor covering in the WC lobby (Rm 0/19a) does not contain asbestos.

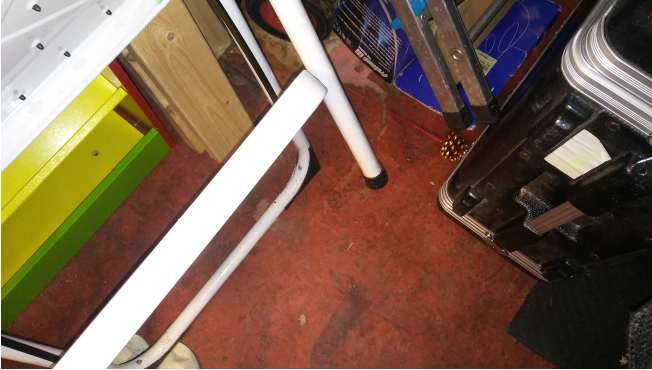
Item 28 Ref: As 374621-3

The floor covering in the Store (Rm 0/20) does not contain asbestos.

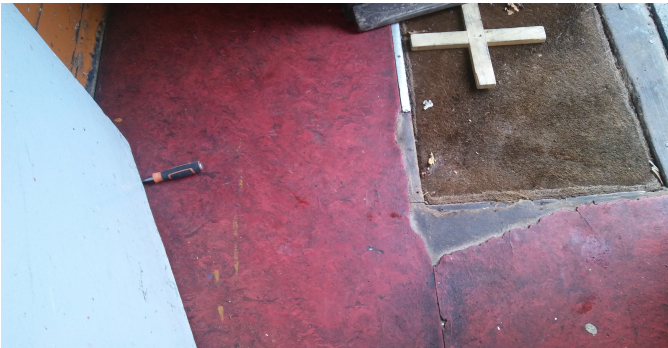
Item 29 Ref: As 374621-3

The floor covering in the lobby (Rm 0/22) does not contain asbestos.

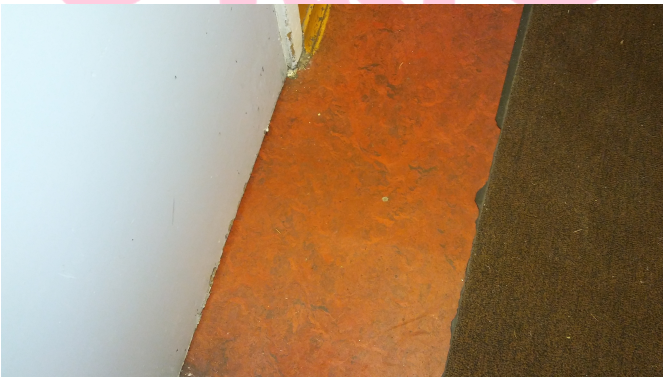
Item 30 Ref: As 374621-3

The floor covering in the Stairwell lobby (Rm 0/23) does not contain asbestos.

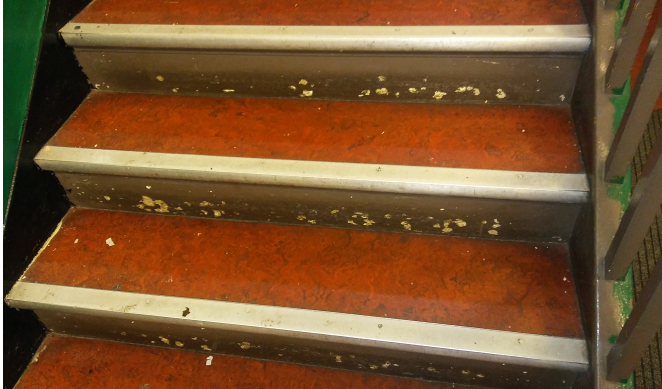
Item 31 Ref: As 374621-4

The stair nosing in the stairwell lobby (Rm 0/23) does contain asbestos.

Any change in appearance should be reported to Property Services.

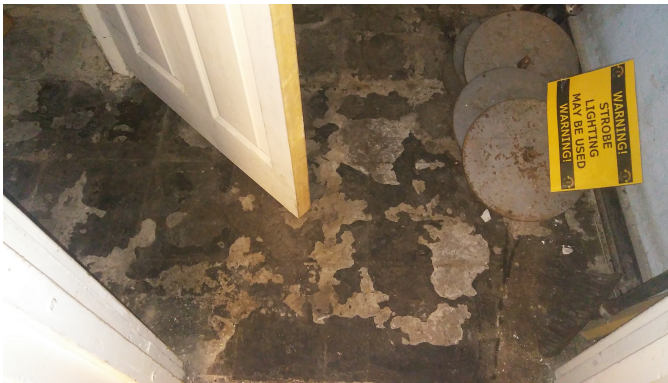
Item 32 Ref: 374621-2

The adhesive to floor in the Store (Rm 0/25) does contain asbestos.

Any change in appearance should be reported to Property Services.

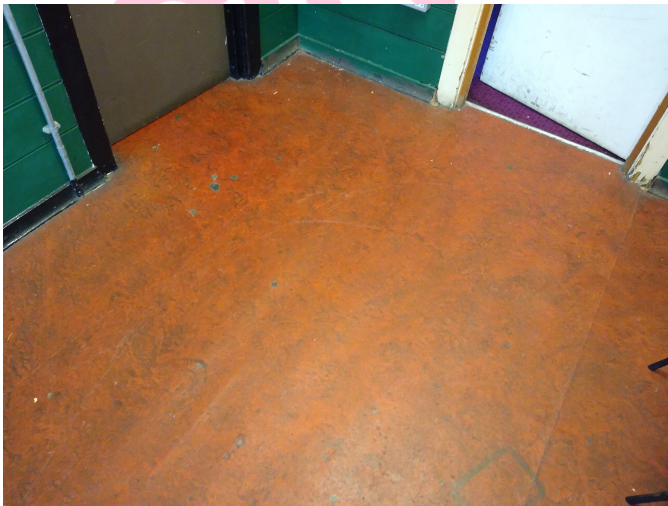
Item 33 Ref: As 374621-3

The floor covering in the landing (Rm 1/01) does not contain asbestos.

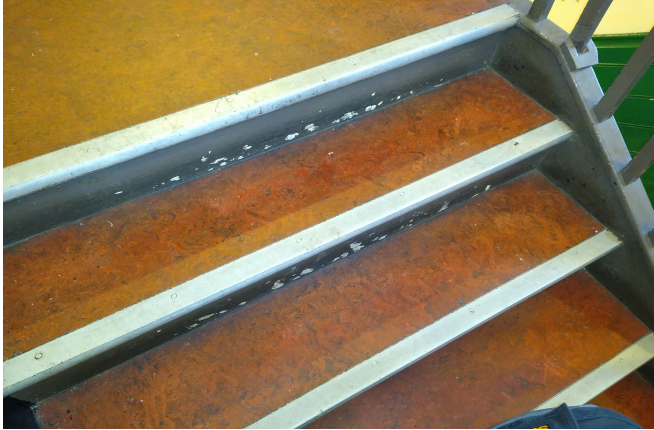
Item 34 Ref: As 374621-4

The stair nosing in the landing (Rm 1/01) does contain asbestos.

Any change in appearance should be reported to Property Services.

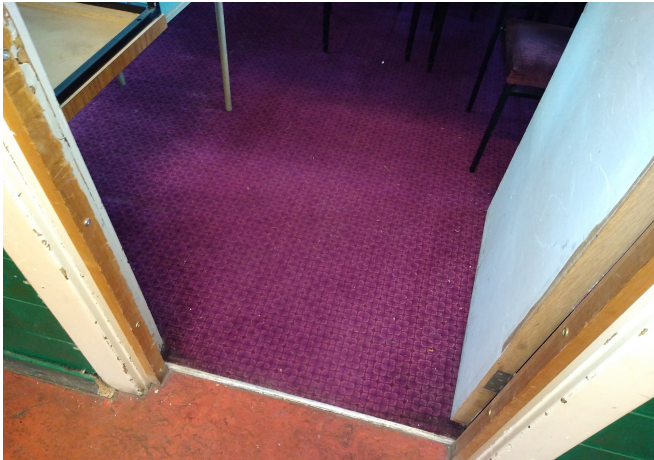
Item 35 Ref: As 374621-3

The floor covering in the lounge (Rm 1/02) does not contain asbestos.

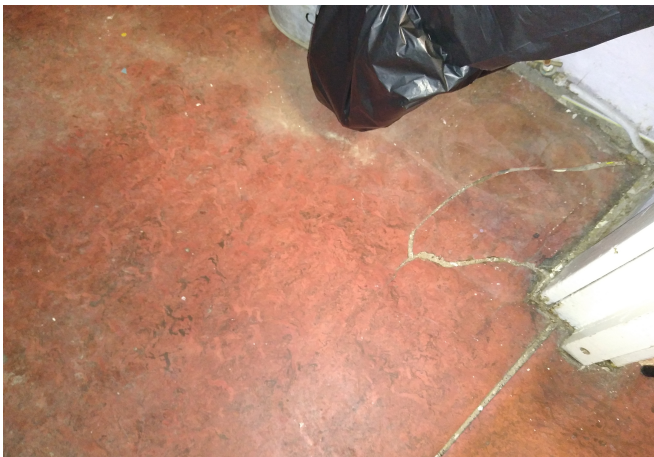
Item 36 Ref: As 374621-3

The floor covering in the toilet (Rm 1/03) does not contain asbestos.

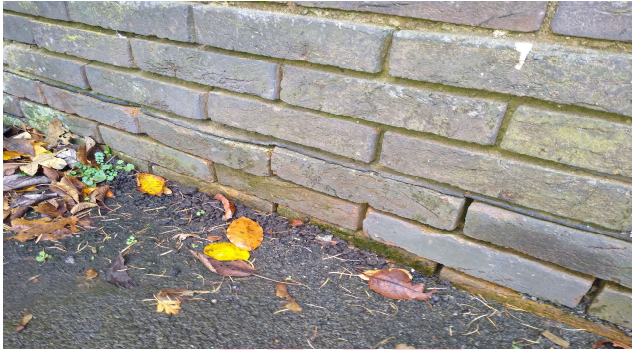
Item 38 Ref: 374621-21

The damp proof course
(Externally) does not contain
asbestos.

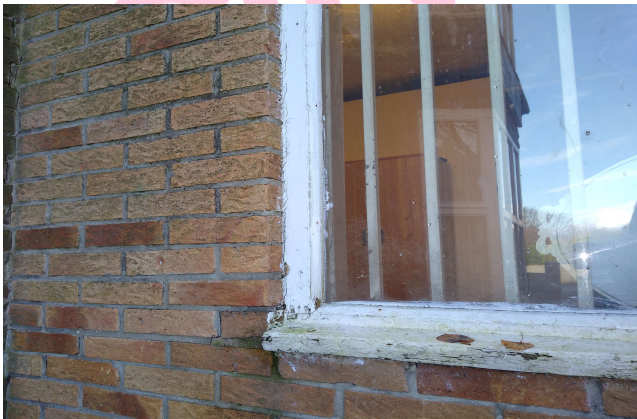
Item 39 Ref: As 374621-22

The sealant around window
frames (Externally) contains
asbestos.

Any change in appearance
should be reported to Property
Services.

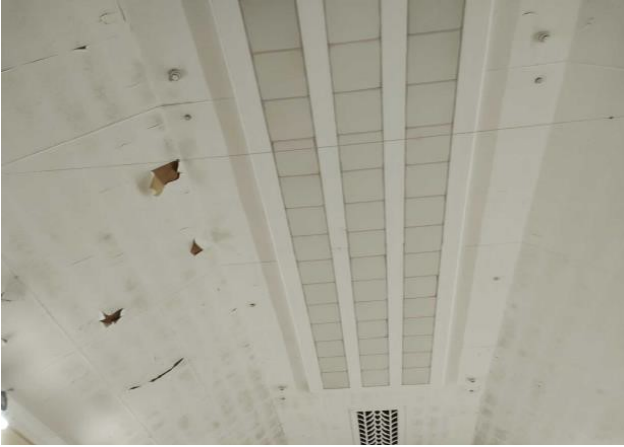
Item 40 Ref: 22-55274-10

The ceiling in the Main Hall and Stage (Area 8) does not contain asbestos.

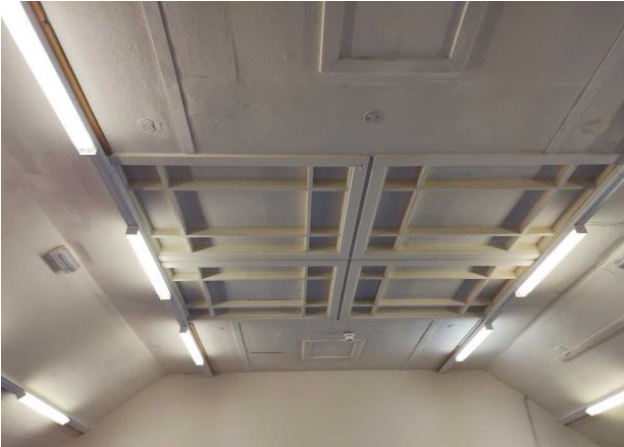
Item 41 Ref: 22-55274-10

The ceiling in the Multi use Room (Area 28) does not contain asbestos.

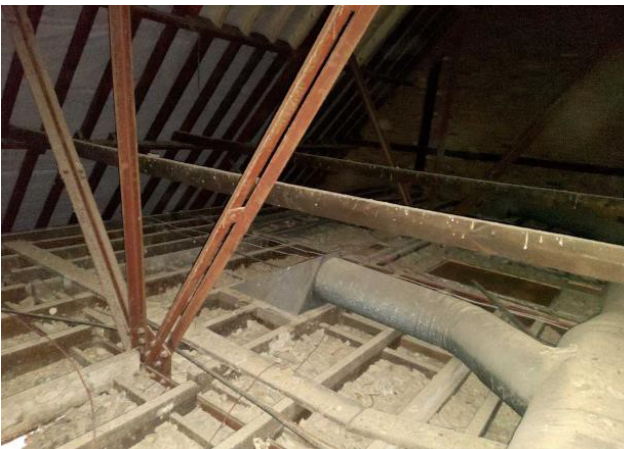
Item 42 Ref: 22-55274-11

The floor forming ceiling below in the loft – 008 and 1-004 (Area 31) does not contain asbestos.

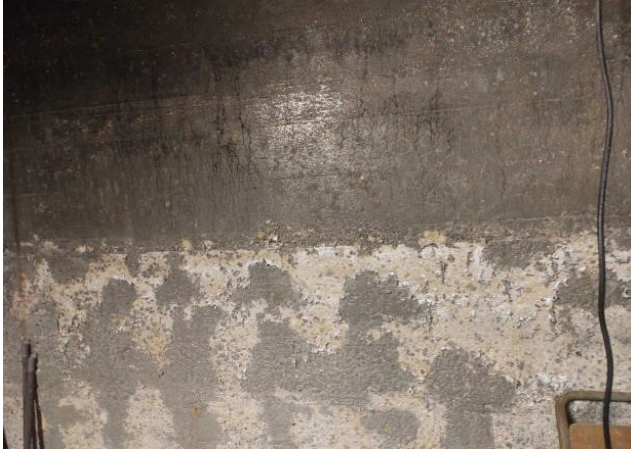
Item 43 Ref: 22-55274-3

The loose paint to walls in the Boiler Room (Area 32) does not contain asbestos.

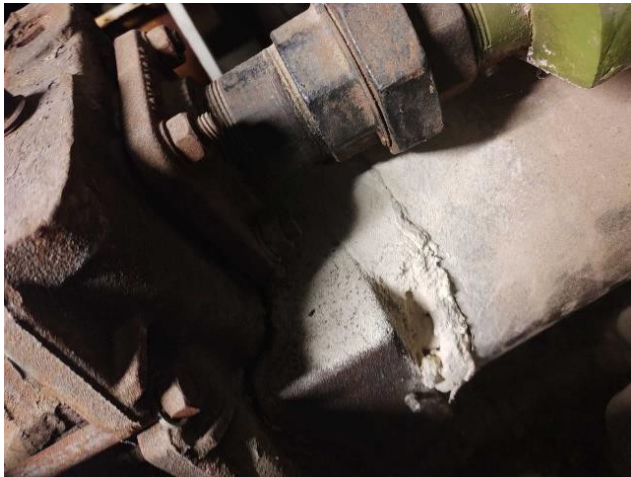
Item 44 Ref: 22-55274-5

The rope gasket to pipe inlet in the Boiler Room (Area 32) does contain asbestos.

Any change in appearance should be reported to Property Services.

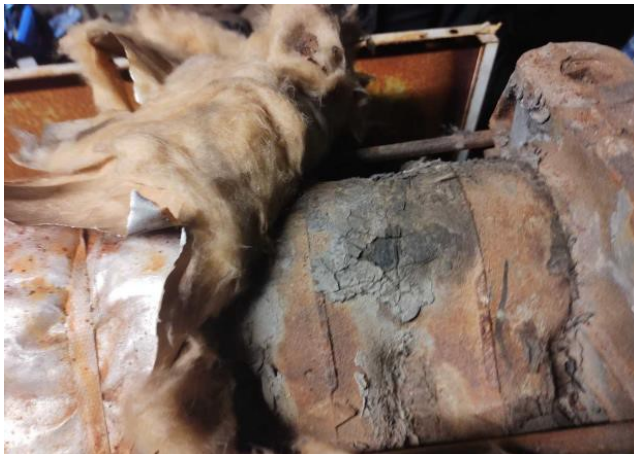
Item 45 Ref: 22-55274-6

The vessels- coating to boiler in the Boiler Room (Area 32) does not contain asbestos.

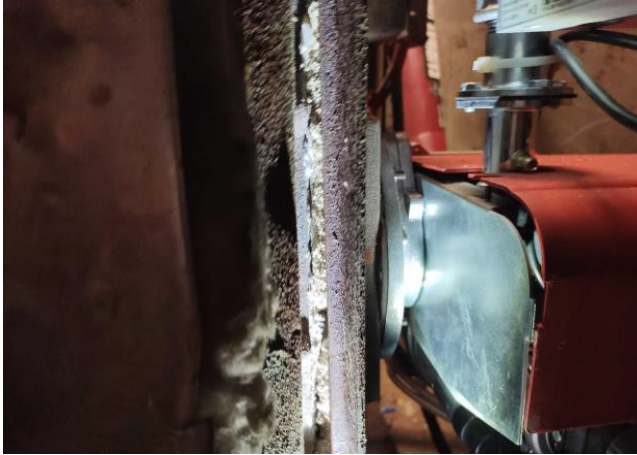
Item 46 Ref: 22-55274-7

The vessels – cork gasket seal to front plate in the Boiler Room (Area 32) does not contain asbestos.

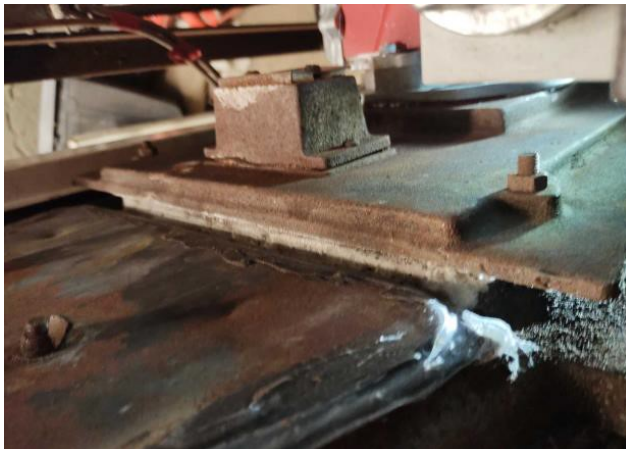
Item 47 Ref: 22-55274-8

The vessels – seal to top of plate in the Boiler Room (Area 32) does not contain asbestos.

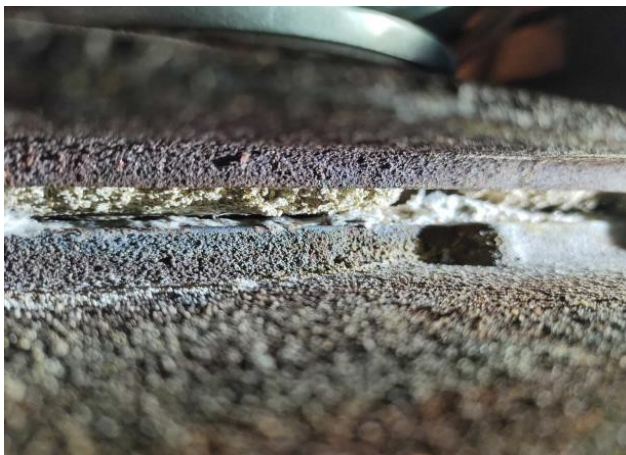
Item 48 Ref: 22-55274-9

The rope gasket to front plate to boiler in the Boiler Room (Area 32) does contain asbestos.

Any change in appearance should be reported to Property Services.
