### **ASBESTOS SURVEY REPORT FOR WASHINGTON F PIT MUSEUM, WASHINGTON**

## **Asbestos Register for WASHINGTON F PIT MUSEUM, WASHINGTON**

**UPRN: - 423190**

**Date: 07 August 2025**

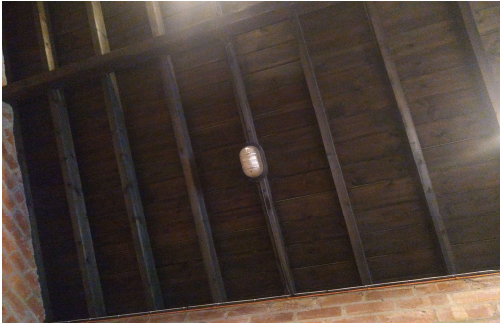
### **Item 1 Ref: As 423190-1**

- (Item 1) Ref: As 423190-1 Sealant to diffuser (Exhibition Space 0/001) – Very Low Risk
- (Item 2) Ref: 423190-2 – Sealant to door frame (Exhibition Space 0/001) – Very Low Risk

The sealant to diffuser of bulkhead light fittings in Exhibition Space 0/001 does contain asbestos.

Any change in its appearance should be recorded and reported to Property Services.

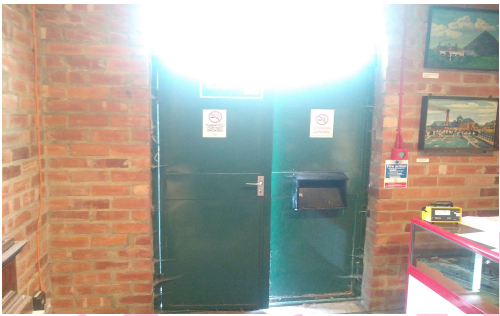
### **Item 2 Ref: 423190-2**

The sealant to door frame in Exhibition Space 0/001 does contain asbestos.

Any change in its appearance should be recorded and reported to Property Services.

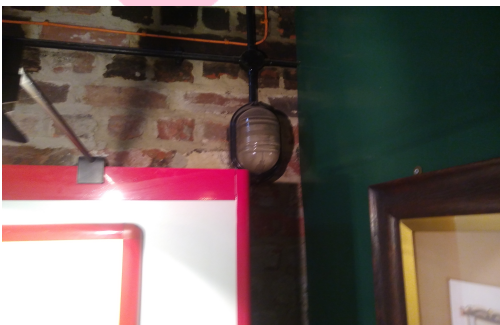
### **Item 3 Ref: 423190-1**

The sealant to diffuser of bulkhead light fittings in Exhibition Space 0/004 does contain asbestos.

Any change in its appearance should be recorded and reported to Property Services.

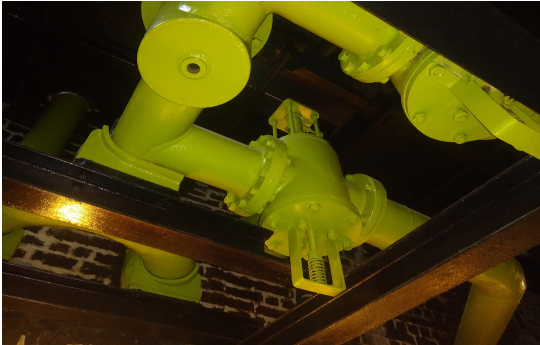
### **Item 4 Ref: 423190-3**

The pipework flange gaskets in Exhibition Space 0/004 contain asbestos.

Any change in its appearance should be recorded and reported to Property Services.

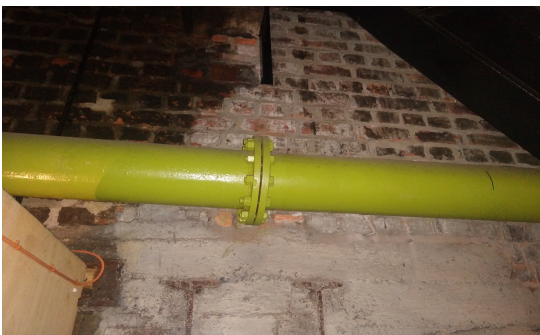
### **Item 5 Ref: As 423190-3**

The pipework flange gaskets Below Main Wheel 0/005 contain asbestos.

Any change in its appearance should be recorded and reported to Property Services.

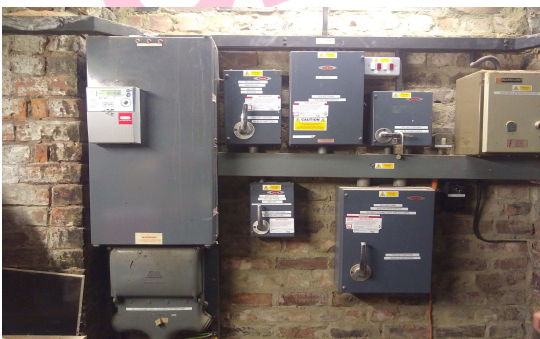
### **Item 6 Ref: Presumed**

The Mem/ Allenwest/ Lucy Oxford electrics Below Main Wheel 0/005 are presumed to contain asbestos.

Any change in its appearance should be recorded and reported to Property Services.

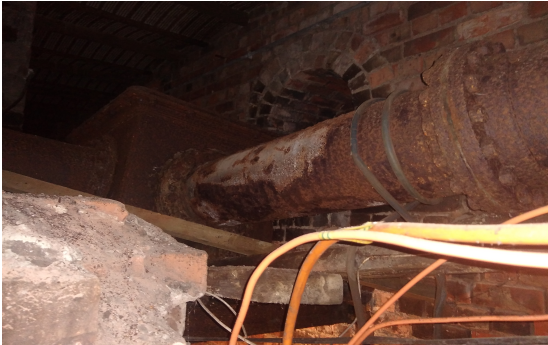
### **Item 7 Ref: 423190-4**

The pipework/ tank flange gasket in the Void 0/007 do not contain asbestos.

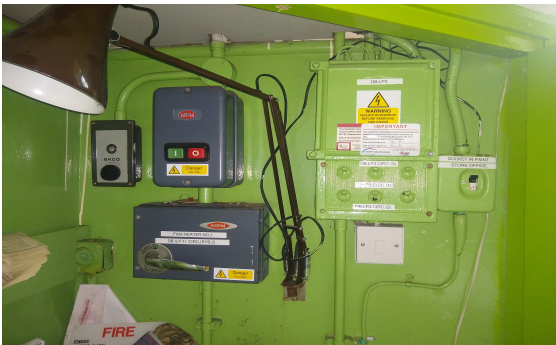
### **Item 8 Ref: Presumed**

The electrics in Engine Room 1/001 are presumed to contain asbestos.

Any change in its appearance should be recorded and reported to Property Services.

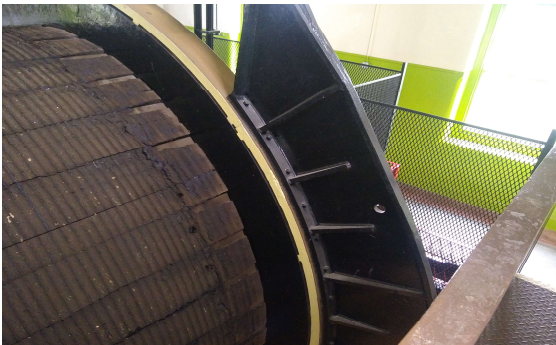
### **Item 9 Ref: 423190-5**

The brake pads to the main wheel in Engine Room 1/001 do contain asbestos.

Any change in its appearance should be recorded and reported to Property Services.

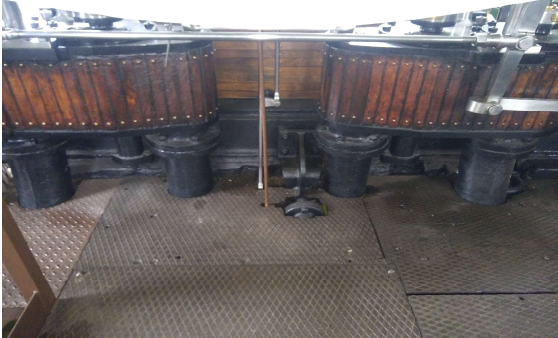
### **Item 10 Ref: As 423190-3**

The pipework flange gaskets in Engine Room 1/001 do contain asbestos.

Any change in its appearance should be recorded and reported to Property Services.

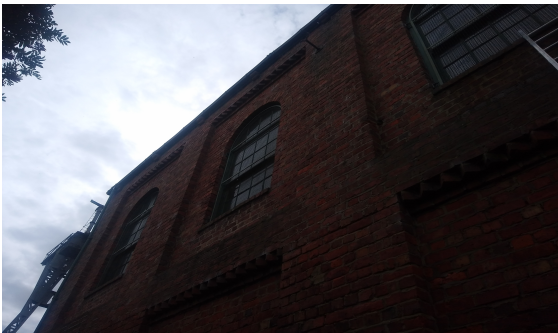
### **Item 11 Ref: 422590-5**

The sealant to window and door frames (External) does not contain asbestos.

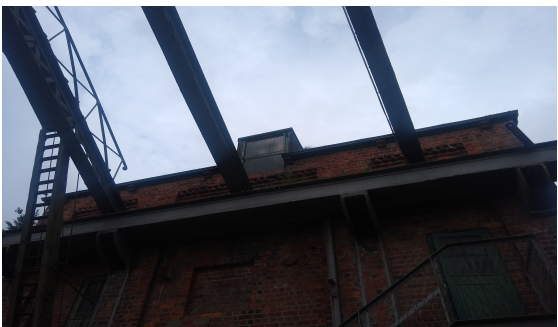
### **Item 12 Ref: 423190-7**

The covering to dormer (External) does not contain asbestos.

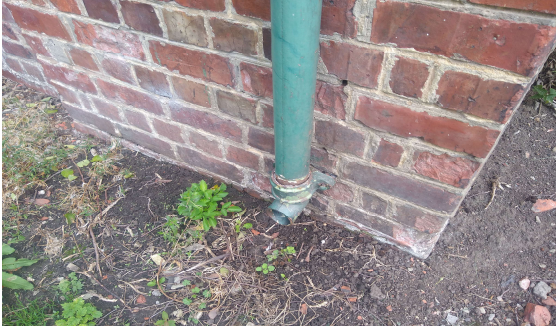
### **Item 13 Ref: 423190-8**

The sealant to downpipe collars (External) does not contain asbestos.

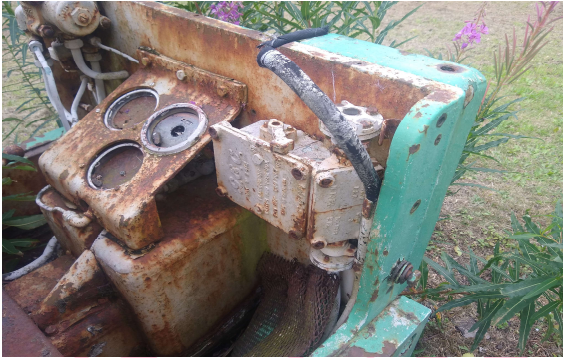
### **Item 14 Ref: Presumed**

The G&C switches to the Mine Train 0/001 is presumed to contain asbestos.

Any change in its appearance should be recorded and reported to Property Services.

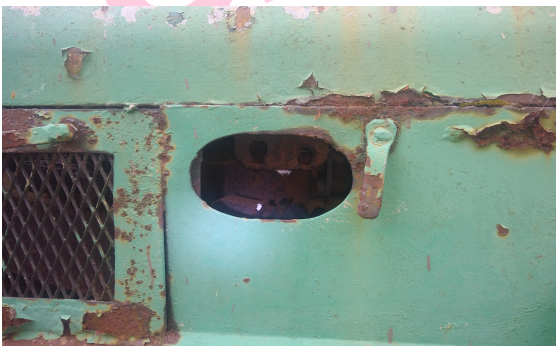
### **Item 15 Ref: 423190-9**

The flange gasket to engine in the Mine Train 0/001 contains asbestos.

Any change in its appearance should be recorded and reported to Property Services.

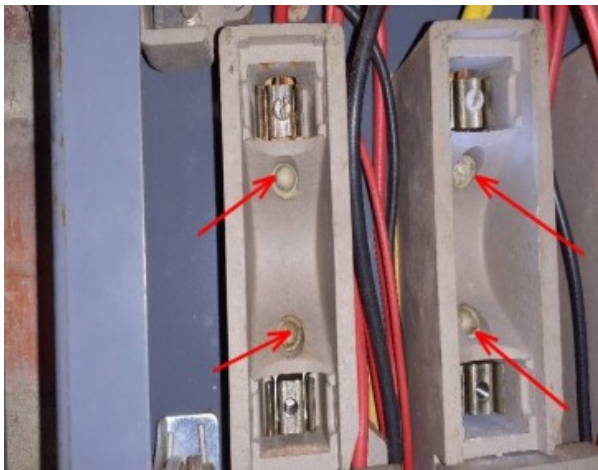
### **Item 22 Ref: OB001307**

The putty to MEM switch boxes in the mains electrical room G/01 contain asbestos.

Any change in appearance should be reported to Property Services.

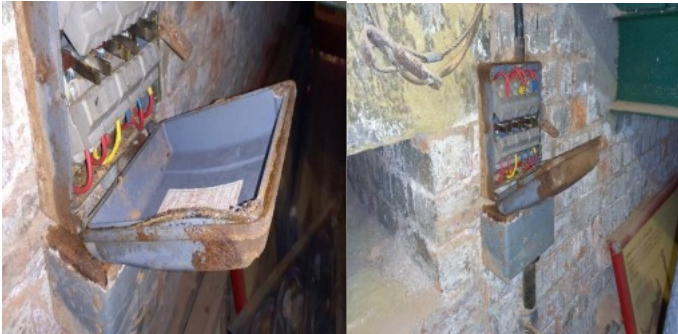
### **Item 23 Ref: OB001306**

The rope seal to MEMLOK isolate box in the mains electrical room (G/01) does not contain asbestos.

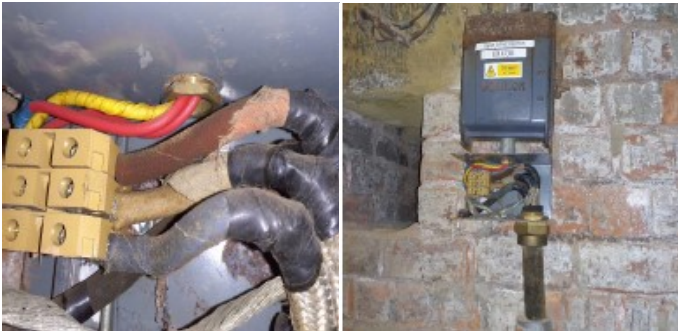
### **Item 24 Ref: RT000002**

The red, white and blue cable wrap in the Wheelhouse (G/01) does not contain asbestos.

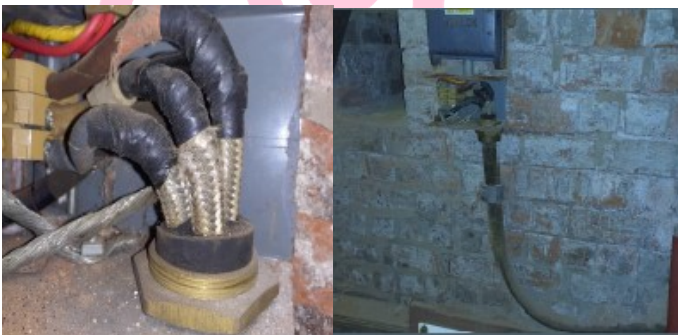
### **Item 25 Ref: RT000003**

The cable braiding in the Wheelhouse (G/01) does not contain asbestos.
