ASBESTOS SURVEY REPORT FOR WASHINGTON F PIT MUSEUM, WASHINGTON

Asbestos Register for

WASHINGTON F PIT MUSEUM, WASHINGTON

Date: 06 September 2024

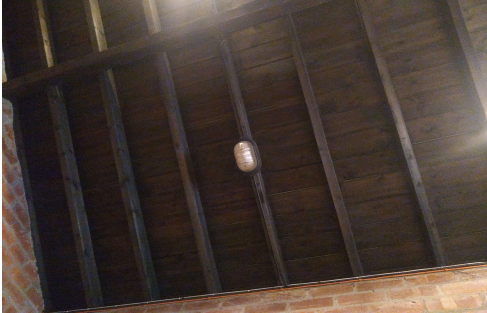
Item 1 Ref: As 423190-1

- (Item 1) Ref: As 423190-1 Sealant to diffuser (Exhibition Space 0/001) – Very Low Risk
- (Item 2) Ref: 423190-2 – Sealant to door frame (Exhibition Space 0/001) – Very Low Risk

The sealant to diffuser of bulkhead light fittings in Exhibition Space 0/001 does contain asbestos.

Any change in its appearance should be recorded and reported to Property Services.

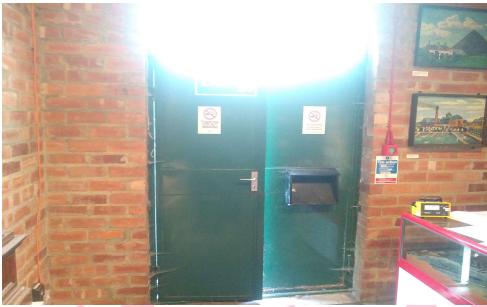
Item 2 Ref: 423190-2

The sealant to door frame in Exhibition Space 0/001 does contain asbestos.

Any change in its appearance should be recorded and reported to Property Services.

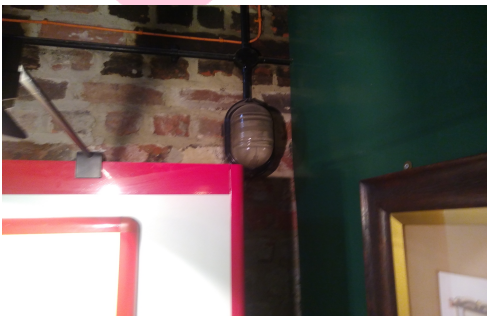
Item 3 Ref: 423190-1

The sealant to diffuser of bulkhead light fittings in Exhibition Space 0/004 does contain asbestos.

Any change in its appearance should be recorded and reported to Property Services.

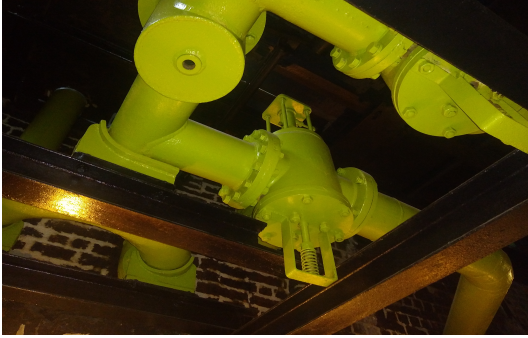
Item 4 Ref: 423190-3

The pipework flange gaskets in Exhibition Space 0/004 contain asbestos.

Any change in its appearance should be recorded and reported to Property Services.

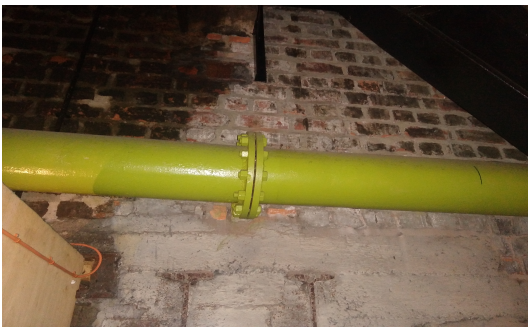
Item 5 Ref: As 423190-3

The pipework flange gaskets Below Main Wheel 0/005 contain asbestos.

Any change in its appearance should be recorded and reported to Property Services.

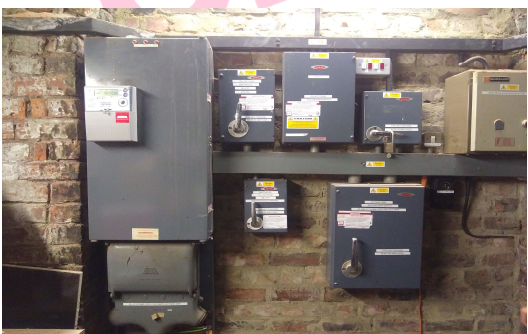
Item 6 Ref: Presumed

The Mem/ Allenwest/ Lucy Oxford electrics Below Main Wheel 0/005 are presumed to contain asbestos.

Any change in its appearance should be recorded and reported to Property Services.

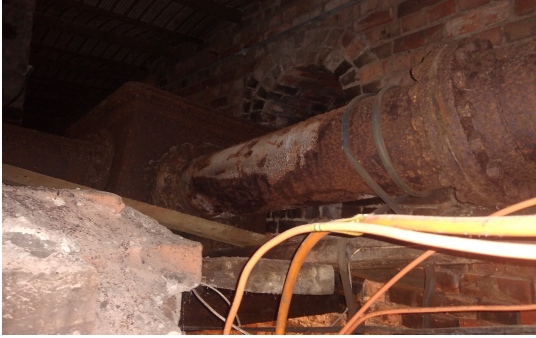
Item 7 Ref: 423190-4

The pipework/ tank flange gasket in the Void 0/007 do not contain asbestos.

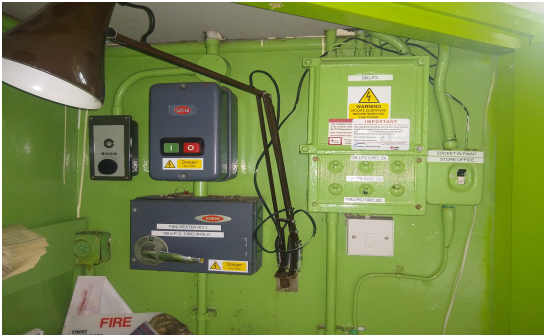
Item 8 Ref: Presumed

The electrics in Engine Room 1/001 are presumed to contain asbestos.

Any change in its appearance should be recorded and reported to Property Services.

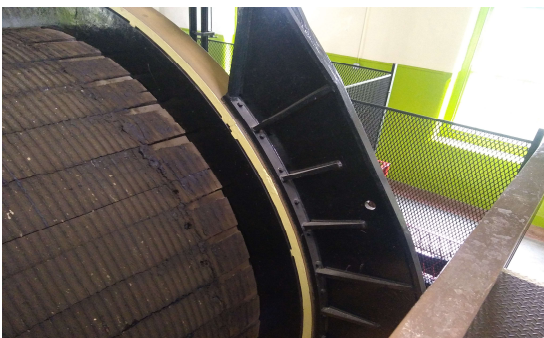
Item 9 Ref: 423190-5

The brake pads to the main wheel in Engine Room 1/001 do contain asbestos.

Any change in its appearance should be recorded and reported to Property Services.

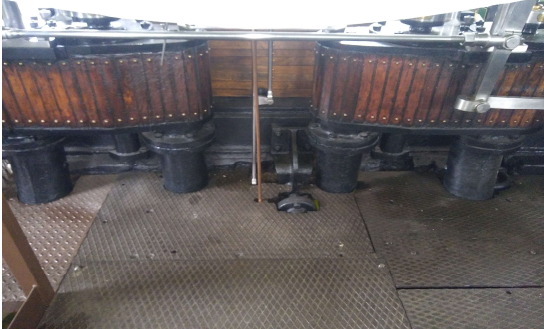
Item 10 Ref: As 423190-3

The pipework flange gaskets in Engine Room 1/001 do contain asbestos.

Any change in its appearance should be recorded and reported to Property Services.

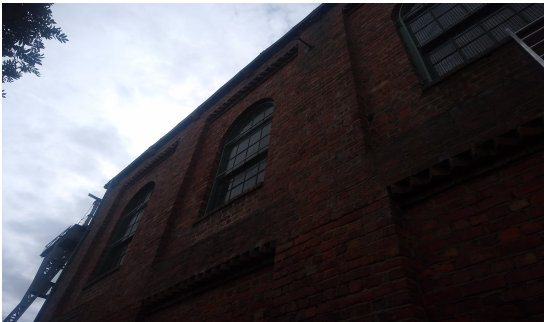
Item 11 Ref: 422590-5

The sealant to window and door frames (External) does not contain asbestos.

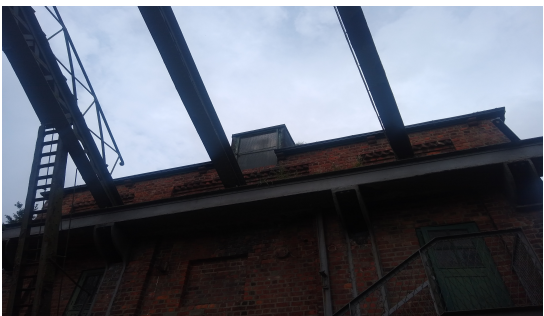
Item 12 Ref: 423190-7

The covering to dormer (External) does not contain asbestos.

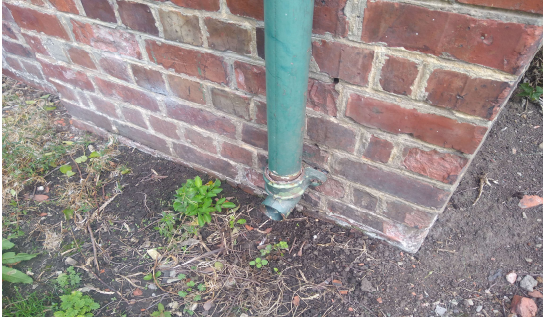
Item 13 Ref: 423190-8

The sealant to downpipe collars (External) does not contain asbestos.

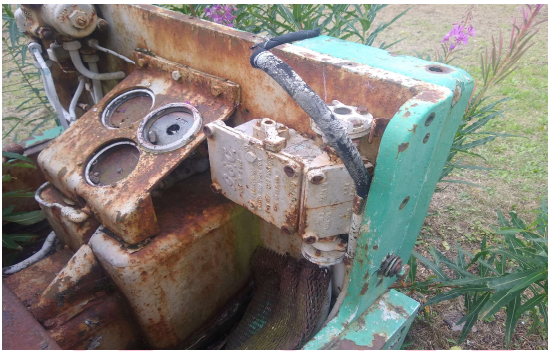
Item 14 Ref: Presumed

The G&C switches to the Mine Train 0/001 is presumed to contain asbestos.

Any change in its appearance should be recorded and reported to Property Services.

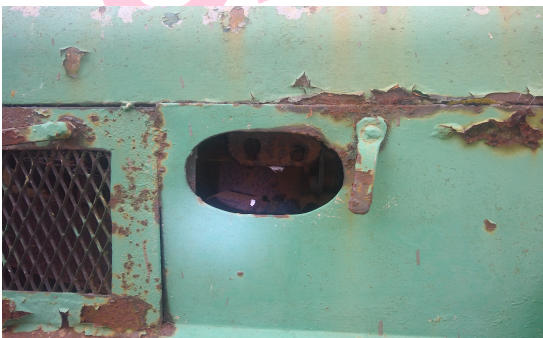
Item 15 Ref: 423190-9

The flange gasket to engine in the Mine Train 0/001 contains asbestos.

Any change in its appearance should be recorded and reported to Property Services.
