ASBESTOS SURVEY REPORT FOR 7 COLOMBO ROAD, HYLTON CASTLE, SUNDERLAND

Asbestos Register for

7 COLOMBO ROAD, HYLTON CASTLE, SUNDERLAND

Date: 14 February 2025

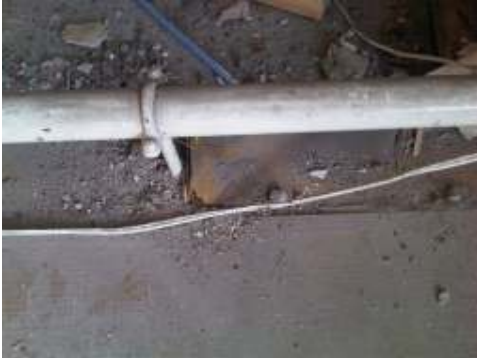
Item 1 Ref: NO10/

The flooring to the lounge (Room 1) does not contain asbestos.

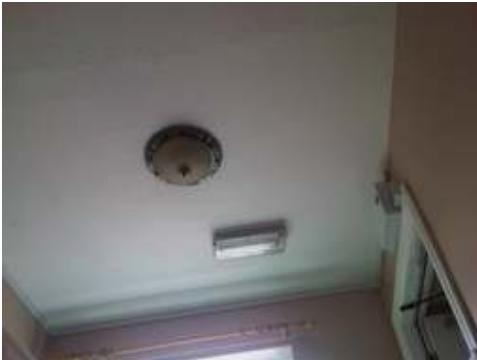
Various - Ref: NO10/8046

The textured coating to the ceiling of the stairs /landing/cupboards (Area 5) contains asbestos.

Rooms 5, 13 & 14 removed June 2024

Similar textured coating is located on the ceilings to rooms 12, 13, 14 and 15.

Any change in its appearance should be recorded and passed to Property Services.

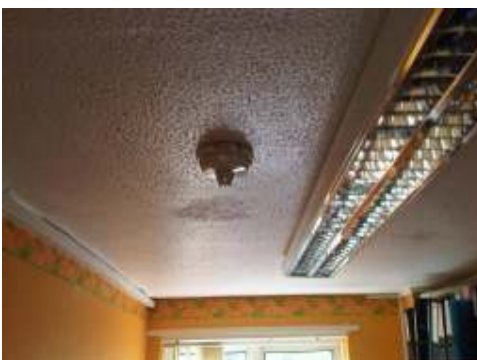
Item 3 - Ref: NO10/8047

The textured coating to the office (Room 7) contains asbestos.

Removed June 2024

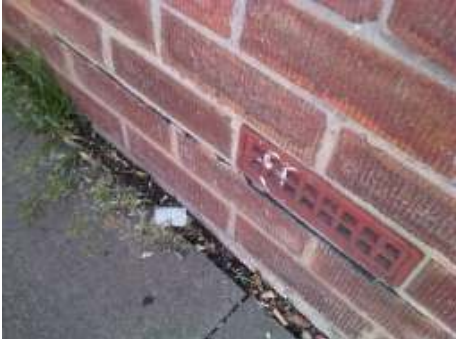
Item 8 - Ref: NO10/8048

The damp proof course to the external of the building does not contain asbestos.

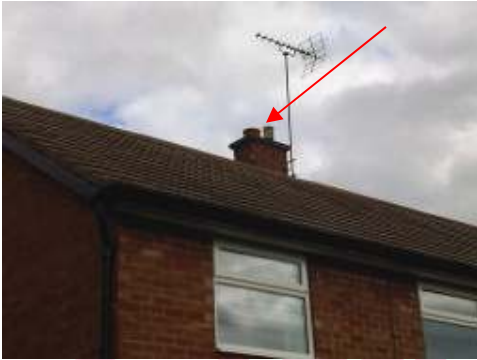
Item 9- Ref: Presumed

The cement cowl to the chimney on the roof is strongly presumed to contain asbestos.

Any change in its appearance should be recorded and passed to Property Services.

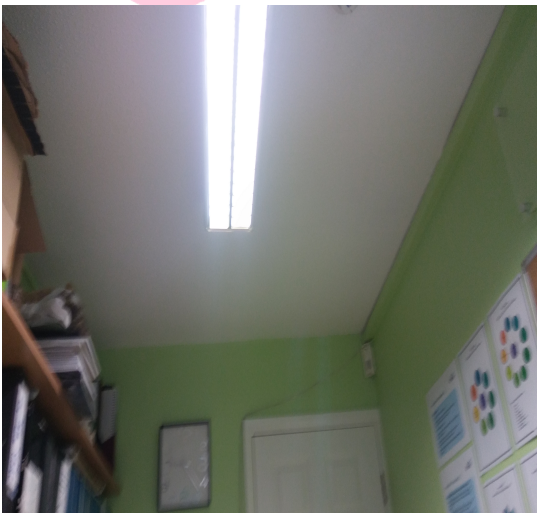
Item 10 - Ref: Presumed

The textured coating to the walls in the back Store area is strongly presumed to contain asbestos.

Any change in its appearance should be recorded and passed to Property Services.

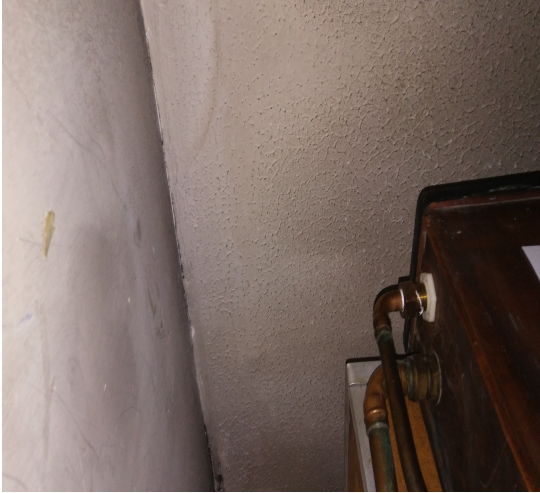
Item 11 - Ref: 275133-3

The textured coating to the ceiling in the tank cupboard area contains asbestos.

Any change in its appearance should be recorded and passed to Property Services.

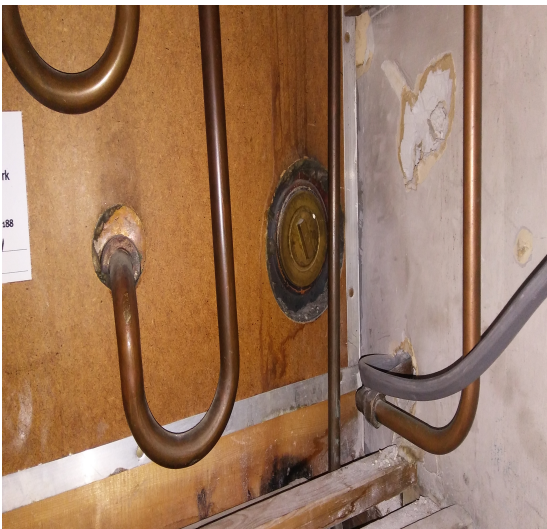
Item 12 - Ref: 275133-4

The gasket to tank in the tank cupboard area contains asbestos.

Removed September 2018.

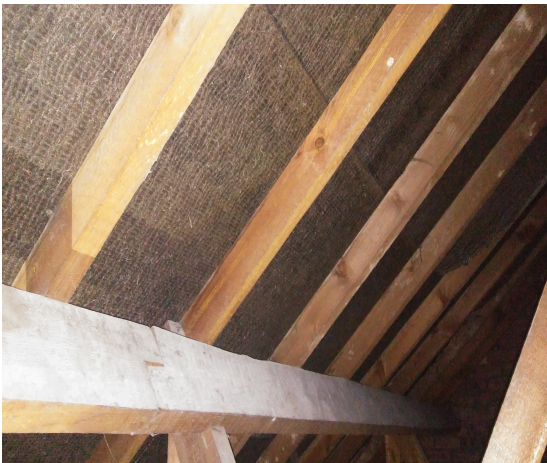
Item 13 - Ref: 275133-1

The sarking in the loft does not contain asbestos.

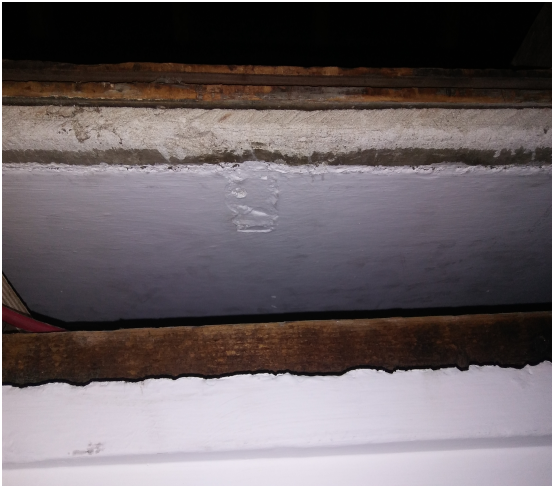
Item 14 - Ref: 275133-2

The panel to the left hatch does not contain asbestos.

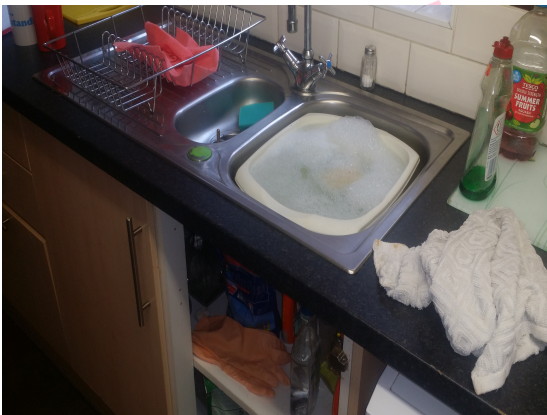
Item 15 - Ref: 315571-2

The sink pad in the kitchen does not contain asbestos.

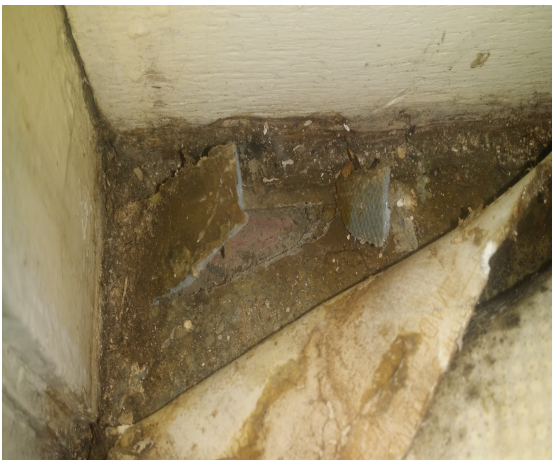
Item 16 - Ref: 315571-1

The linoleum in the kitchen does not contain asbestos.

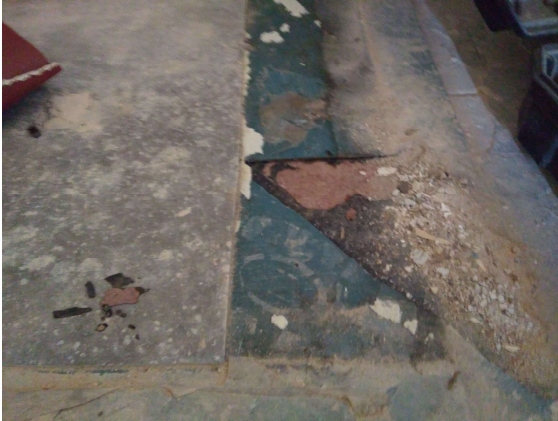
Item 17 - Ref: 275133-3

The sub floor covering below screed in the kitchen contains asbestos.

Removed May 2019

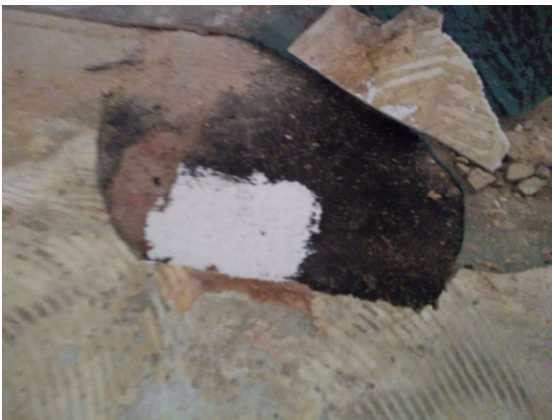
Item 18 - Ref: 315571-4

The bitumen to concrete floor below floor tiles in the kitchen contains asbestos.

Any change in its appearance should be recorded and passed to Property Services.

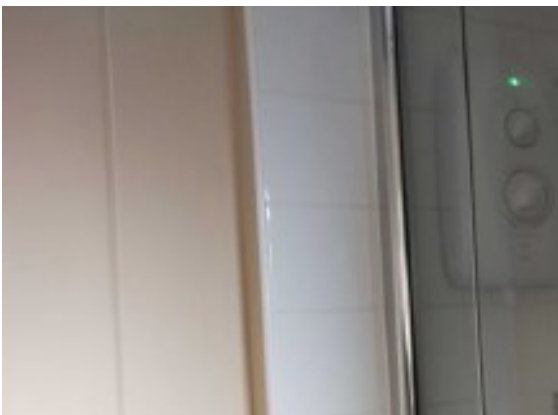
Item 19 - Ref: 22-41848-1

The adhesive to the walls in the Shower Room (Area 1) does not contain asbestos.

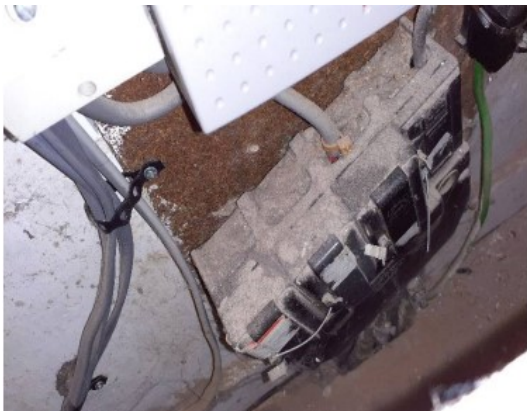
Item 20 - Presumed

The flashguards within electrics in the electric cupboard (Room G/03) are presumed to contain asbestos.

Any change in appearance should be recorded and passed to Property Services.

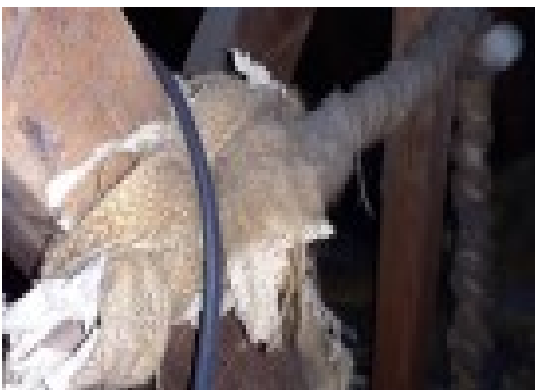
Item 21 - Ref: OB001299

The paper lining to hessian insulated pipework in the Loft (room R/001) does not contain asbestos.
