ASBESTOS SURVEY REPORT FOR 7 COLOMBO ROAD, HYLTON CASTLE, SUNDERLAND

7 COLOMBO ROAD, HYLTON CASTLE, SUNDERLAND

Date: 20 August 2025

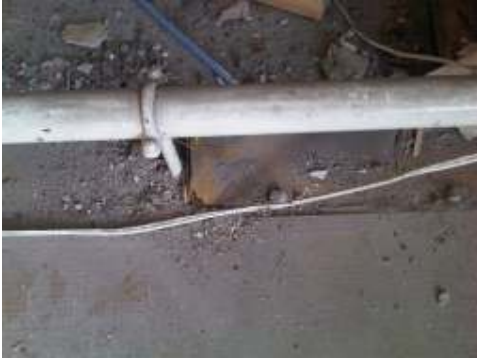
Item 1 Ref: NO10/

The flooring to the lounge (Room 1) does not contain asbestos.

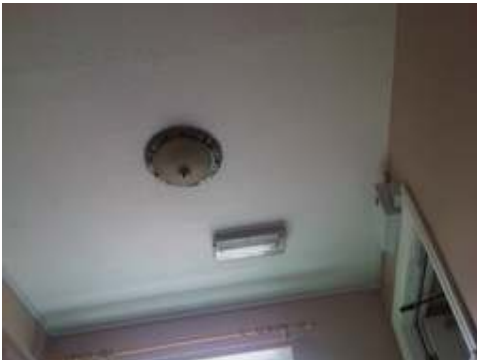
Various - Ref: NO10/8046

The textured coating to the ceiling of the stairs /landing/cupboards (Area 5) contains asbestos.

Rooms 5, 13 & 14 removed June 2024

Similar textured coating is located on the ceilings to rooms 12, 13, 14 and 15.

Any change in its appearance should be recorded and passed to Property Services.

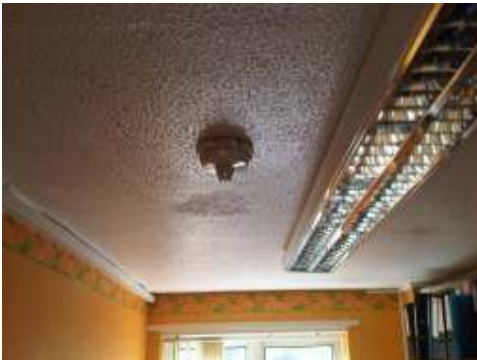
Item 3 - Ref: NO10/8047

The textured coating to the office (Room 7) contains asbestos.

Removed June 2024

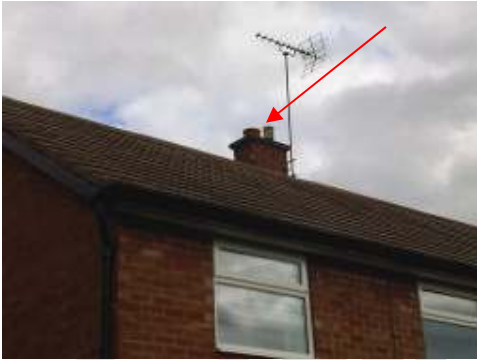
Item 9- Ref: Presumed

Presumed – Cowl to roof (External) (Item 9) Very Low Risk

The cement cowl to the chimney on the roof is strongly presumed to contain asbestos.

Any change in its appearance should be recorded and passed to Property Services.

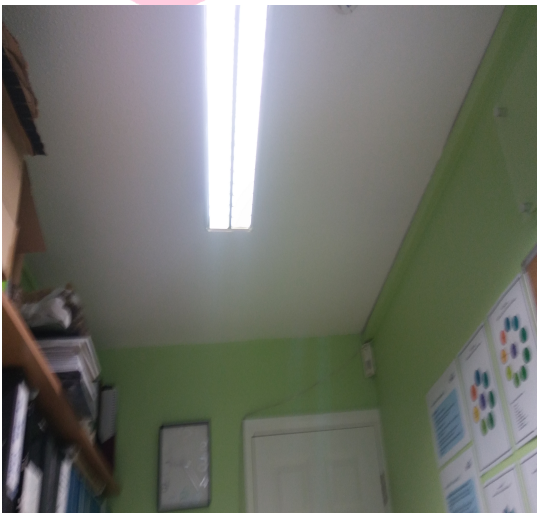
Item 10 - Ref: Presumed

Presumed – Textured coating to Walls (Back Office) (Item 10) Very low Risk

The textured coating to the walls in the back Store area is strongly presumed to contain asbestos.

Any change in its appearance should be recorded and passed to Property Services.

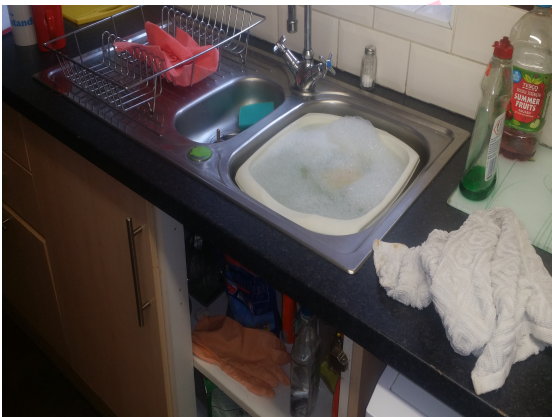
Item 15 - Ref: 315571-2

The sink pad in the kitchen does not contain asbestos.

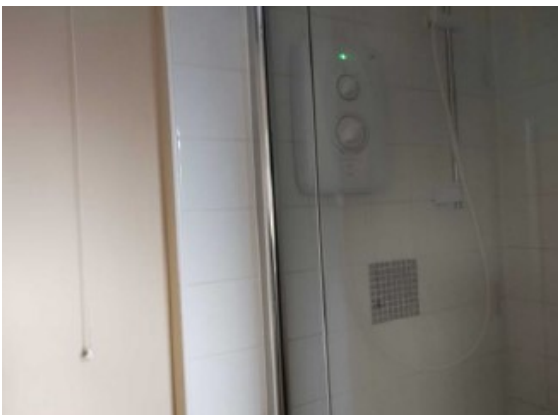
Item 19 - Ref: 22-41848-1

The adhesive to the walls in the Shower Room (Area 1) does not contain asbestos.
