ASBESTOS SURVEY REPORT FOR 20 VILLIERS STREET, SUNDERLAND,
SR1 1EJ

Asbestos Register for

20 Villiers Street, Sunderland, SR1 1EJ

Date: 24 April 2025

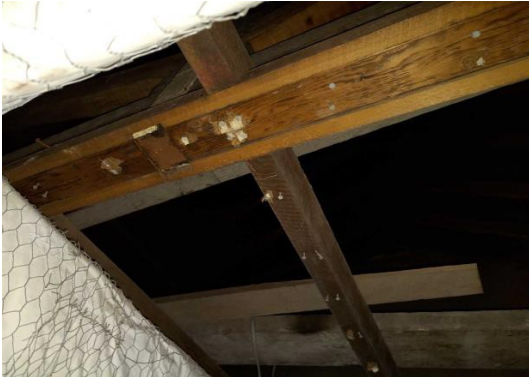
Item 1 Ref: 22-53656-1

The ceiling – fibre board
(Room/Area: 1 Loft Space)
does not contain asbestos.

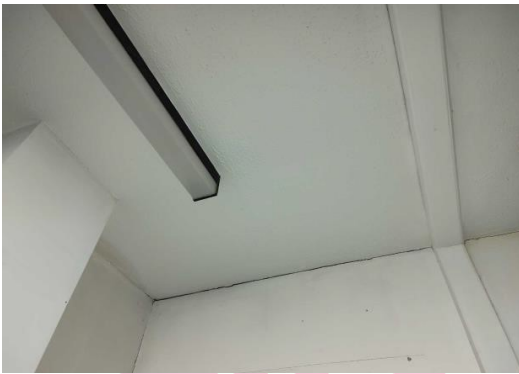
Item 2 Ref: 22-53656-2

The ceiling – textured coating
(Room/Area: 2 Studio) does
not contain asbestos.

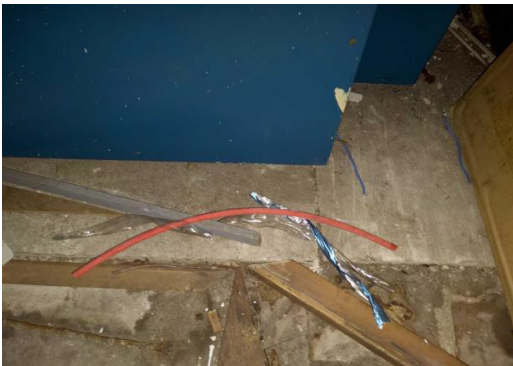
Item 3 Ref: 22-53656-3

The floor – insulating board
(Room/Area: 3 Boiler
Cupboard) does not contain
asbestos.

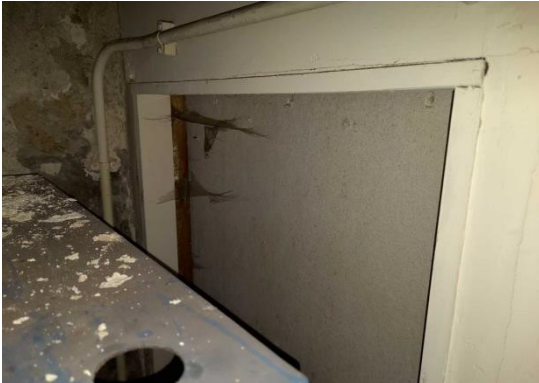
Item 4 Ref: 22-53656-3

The floor – infill panels
(Room/Area: 3 Boiler
Cupboard) does not contain
asbestos.

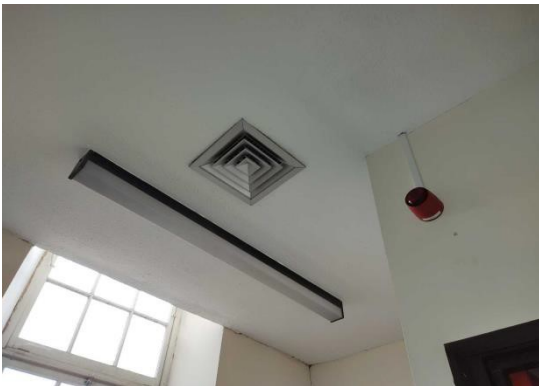
Item 5 Ref: 22-53656-2

The ceiling – textured coating
(Room/Area: 4 WC & Lobby)
does not contain asbestos.

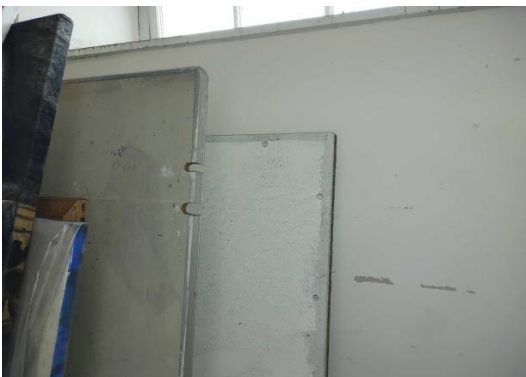
Item 6 Ref: 22-53656-3

The panel – insulating board
(Room/Area: 4 WC & Lobby)
does not contain asbestos.

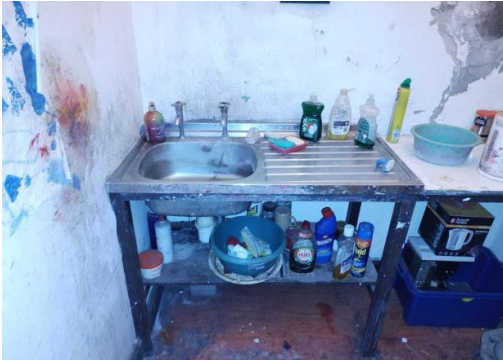
Item 7 Ref: 22-53656-4

5.	22-53656-2	Ceiling – textured coating	Room/Area: 4 WC & Lobby	No Risk
6.	22-53656-3	Panel – insulating board	Room/Area: 4 WC & Lobby	No Risk
7.	22-53656-4	Sink Pad – bitumen	Room/Area: 5 Beverage Bay	Low Risk – To be checked every 6 months

The sink pad – bitumen
(Room/Area: 5 Beverage Bay)
contains asbestos.

Any change in its appearance
should be recorded and
passed to Property Services.

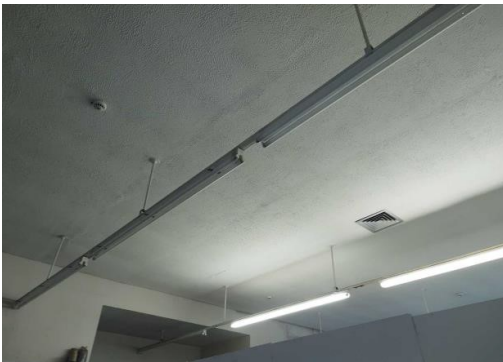
Item 8 Ref: 22-53656-2

The ceiling – textured coating
(Room/Area: 8 Main Studio)
does not contain asbestos.

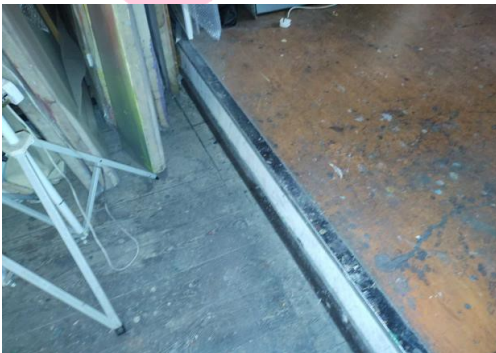
Item 9 Ref: 22-53656-5

The floor – composite
(Room/Area: 8 Main Studio)
does not contain asbestos.

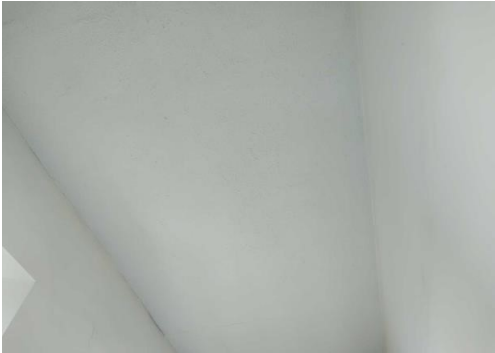
Item 10 Ref: 22-53656-2

The ceiling – textured coating (Room/Area: 9 Landing & Stairs) does not contain asbestos.

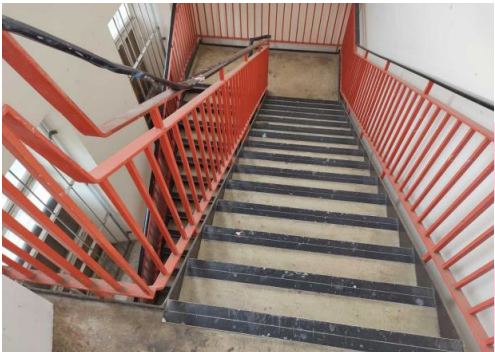
Item 11 Ref: 22-53656-6

The floor – stair nosing composite (Room/Area: 9 Landing & Stairs) does not contain asbestos.

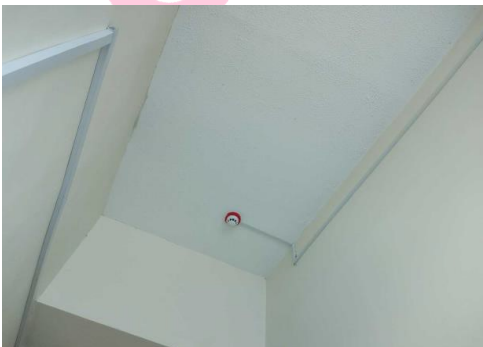
Item 12 Ref: 22-53656-7

The ceiling – textured coating (Room/Area: 11 Entrance Hall) does not contain asbestos.

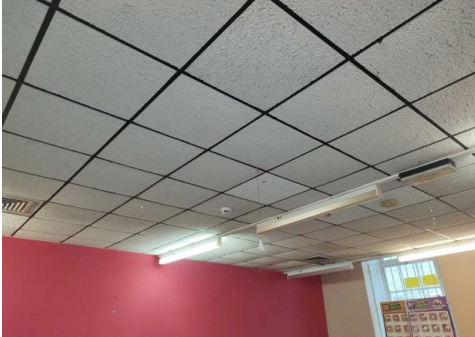
Item 13 Ref: 22-53656-8

The ceiling - suspended ceiling tiles insulating board (Room/Area: 12 Large Storeroom 1) does not contain asbestos.

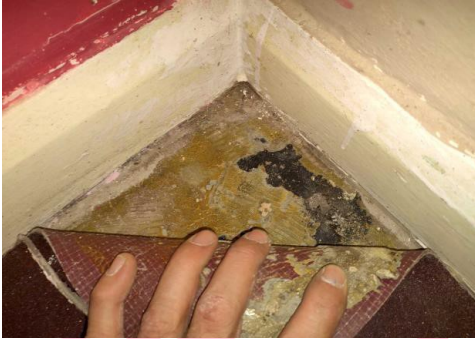
Item 14 Ref: 22-53656-9

The floor – asphalt bitumen (Room/Area: 12 Large Storeroom 1) does not contain asbestos.

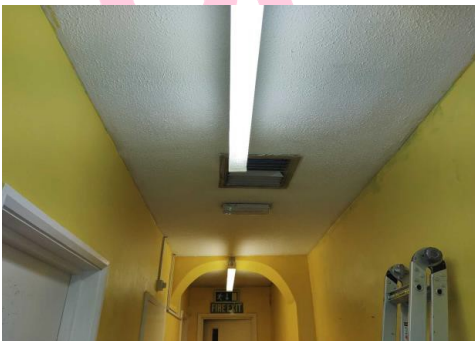
Item 15 Ref: 22-53656-7

The ceiling – textured coating (Room/Area: 15 Corridor) does not contain asbestos.

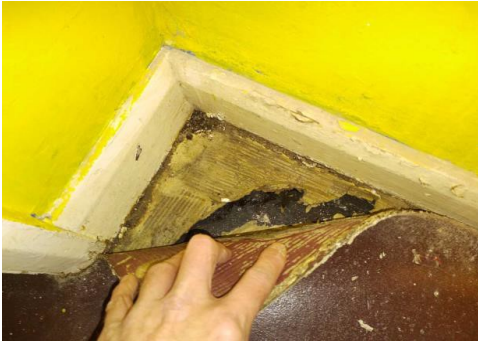
Item 16 Ref: 22-53656-9

The floor – asphalt bitumen
(Room/Area: 15 Corridor)
does not contain asbestos.

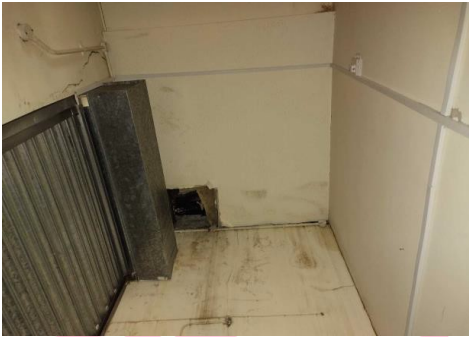
Item 17 Ref: 22-53656-7

The ceiling – textured coating
(Room/Area: 16 Fire Exit)
does not contain asbestos.

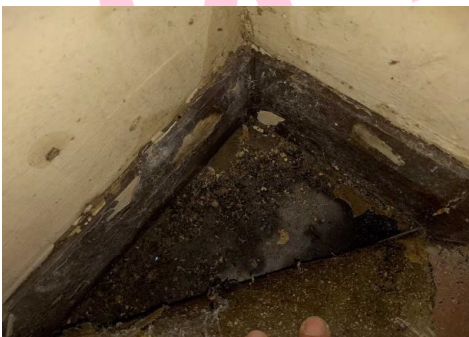
Item 18 Ref: 22-53656-9

The floor – asphalt bitumen
(Room/Area: 16 Fire Exit)
does not contain asbestos.

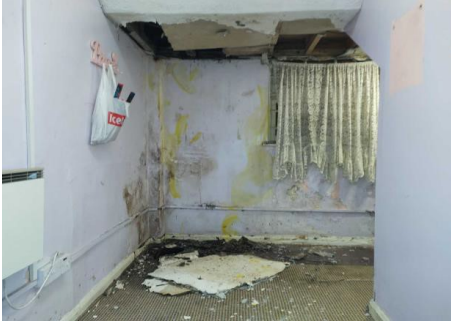
Item 19 Ref: 22-53656-10

The ceiling – textured coating ceiling & debris to floor (textured coating) (Room/Area: 17 First Aid Room) does not contain asbestos.

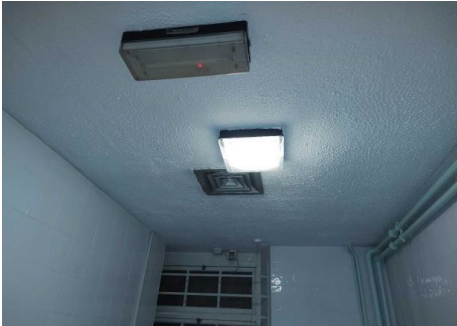
Item 20 Ref: 22-53656-7

The ceiling – textured coating (Room/Area: 18 Accessible WC) does not contain asbestos.

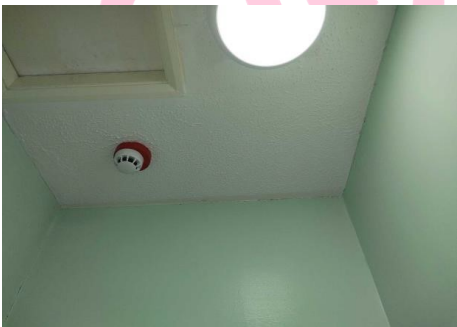
Item 21 Ref: 22-53656-7

The ceiling – textured coating (Room/Area: 19 Female WC) does not contain asbestos.

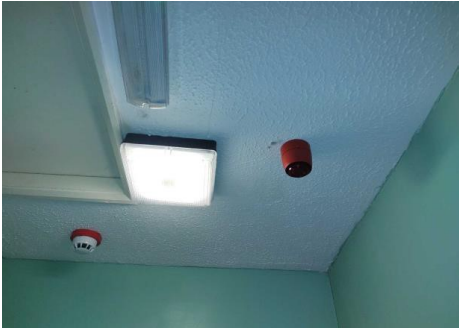
Item 22 Ref: 22-53656-7

The ceiling – textured coating (Room/Area: 21 Male WC & Lobby) does not contain asbestos.

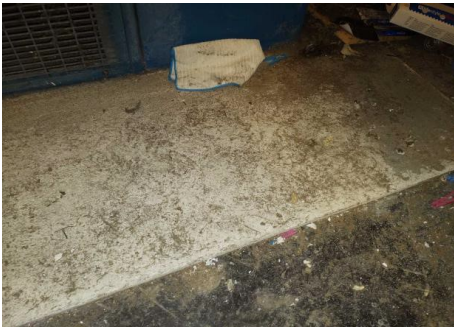
Item 23 Ref: 22-53656-3

The floor – insulating board (Room/Area: 23 Boiler Cupboard) does not contain asbestos.

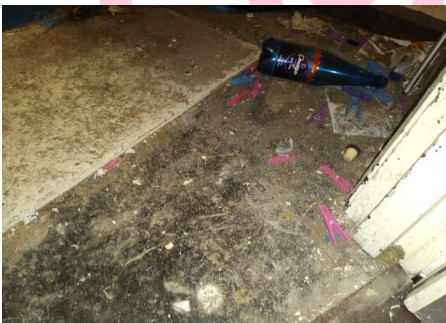
Item 24 Ref: 22-53656-9

The floor – asphalt bitumen (Room/Area: 23 Boiler Cupboard) does not contain asbestos.

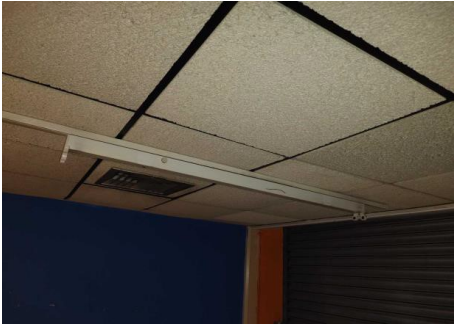
Item 25 Ref: 22-53656-8

The ceiling – suspended ceiling tiles insulating board (Room/Area: 24 Storage Room 2) does not contain asbestos.

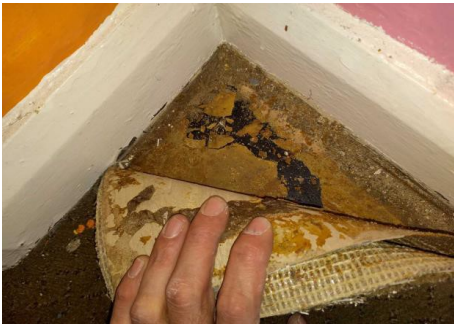
Item 26 Ref: 22-53656-9

The floor – asphalt bitumen (Room/Area: 24 Storage Room 2) does not contain asbestos.

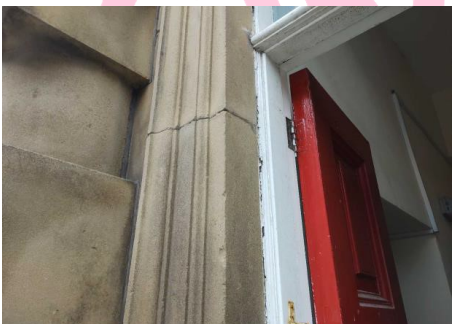
Item 27 Ref: 22-53656-11

The door – frame sealant mastic (Room/Area: 25 External) does not contain asbestos.

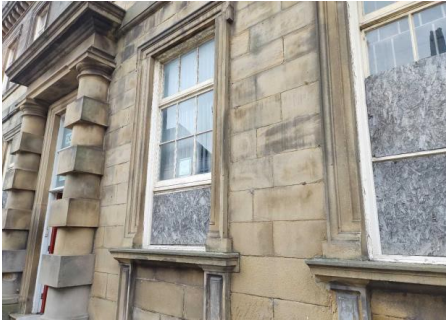
Item 28 Ref: 22-53656-12

The windows – frame sealant mastic (Room/Area: 25 External) contains asbestos.

28.	Windows – frame sealant mastic	Room/Area: 25 External	Low Risk – To be checked every 6 months	18/10/25		Yes/No	
29.	Windows – glazing putty	Room/Area: 25 External	No Risk	N/A	N/A	N/A	N/A

Any change in its appearance should be recorded and passed to Property Services.

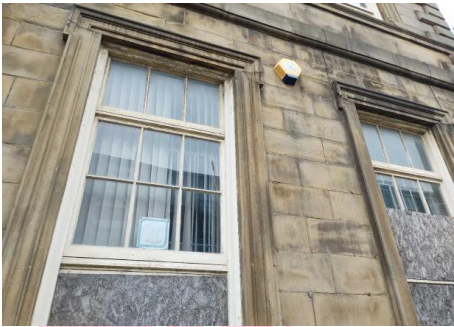
Item 29 Ref: 22-53656-13

The windows – glazing putty (Room/Area: 25 External) does not contain asbestos.
