ASBESTOS SURVEY REPORT FOR RYHOPE RECREATION PARK, SUNDERLAND

Asbestos Register for Ryhope Park

Ryhope Recreation Park Last updated 15/05/2024 V.2.0

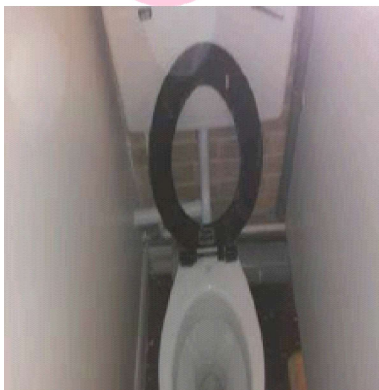
Item 5: As EA003364

The brown vinyl flooring to the female toilets (Room 4) does not contain asbestos.

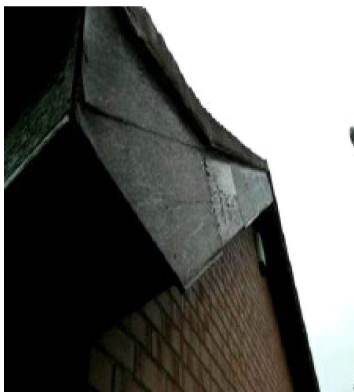
Item 10: Ref: EA003368

The under tile edging to the roof (External) contains asbestos. Any change in its appearance should be noted passed to Property Services.

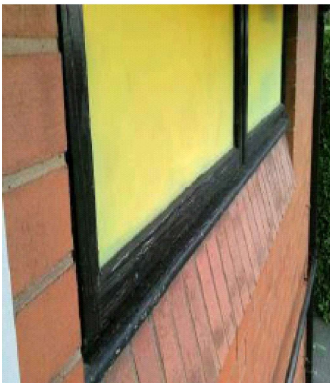
Item 12: Ref: EA003370

The window putty to the external contains asbestos. Any change in its appearance should be noted passed to Property Services.

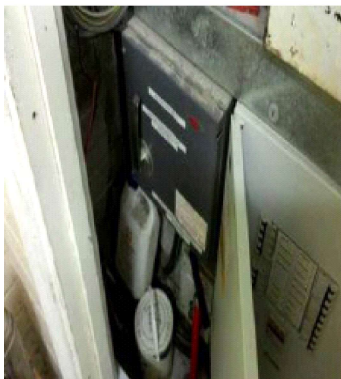
Item 30: Ref: Presumed

The flash guards within the electrics to the electrical cupboard are presumed to contain asbestos. Any change in its appearance should be noted and passed to Property Services.

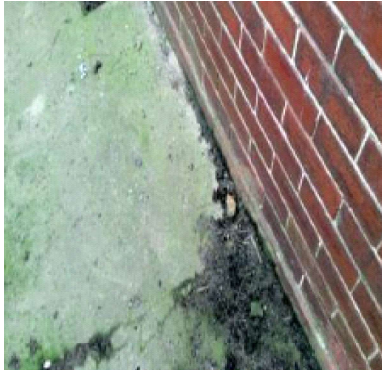
Item 35 Ref: EA003361

The damp proof course to the external contains asbestos. Any change in its appearance should be noted and passed to Property Services.

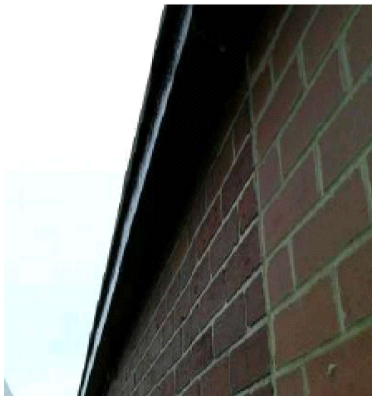
Item 36 Ref: EA003361

The external soffits to the changing rooms contain asbestos. Any change in its appearance should be noted and passed to Property Services.

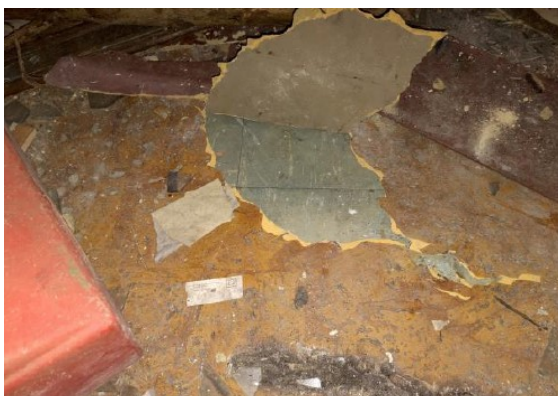
Item 45 Ref: 21-38916-2

The floor tiles and adhesive (Kitchen) contain asbestos.

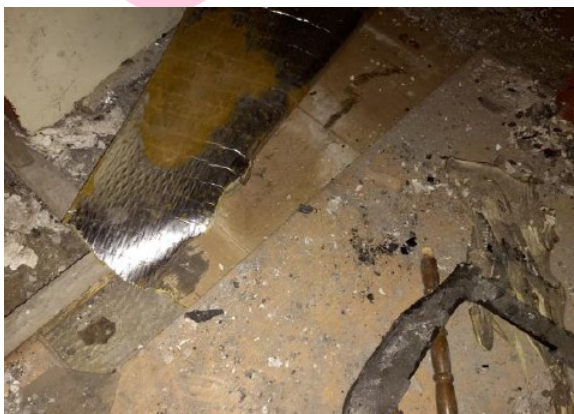
Item 48 Ref: 21-38916-3

The floor tiles and adhesive (Hall) contain asbestos.

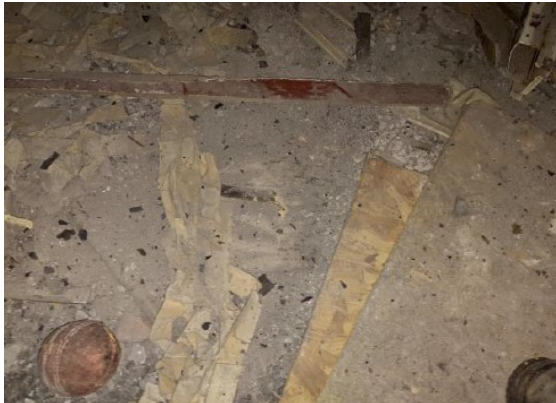
Item 49 Ref: 21-38916-4

The floor tiles and adhesive (Lounge) contain asbestos.

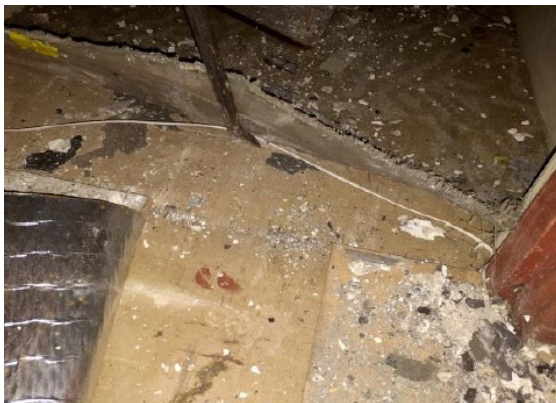
Item 50 Ref: 21-38916-3

The floor tiles and adhesive (Cupboard Understairs) contain asbestos.

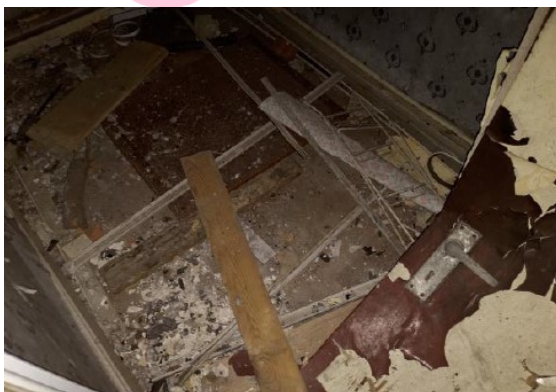
Item 51 Ref: 21-38916-3

The floor tiles and adhesive (WC) contain asbestos.

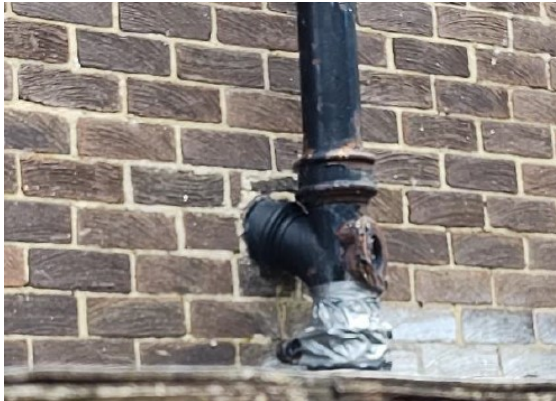
Item 55 Ref: 21-38916-10

The putty to joint capping soil pipe (External) contains asbestos.

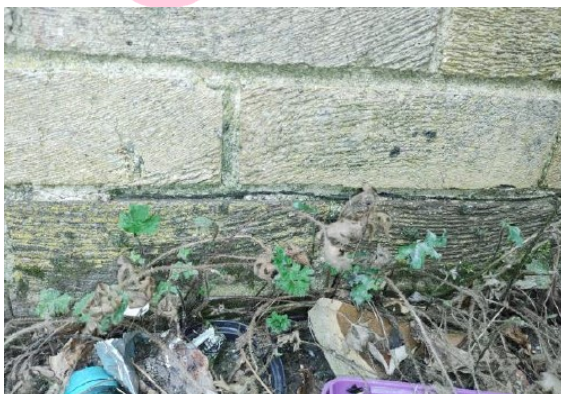
Item 57 Ref: 21-38916-5

The damp proof course (External) contains asbestos.

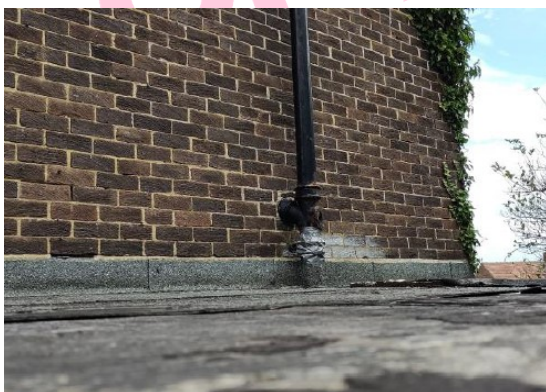
Item 63 Ref: 21-38916-9

The insulation joint compound to soil pipe (External) contains asbestos.
