ASBESTOS SURVEY REPORT FOR RYHOPE RECREATION PARK, SUNDERLAND

Asbestos Register for Ryhope Park

Date: 03 April 2025

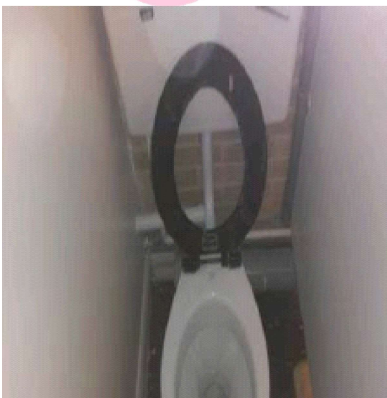
Item 5: As EA003364

The brown vinyl flooring to the female toilets (Room 4) does not contain asbestos.

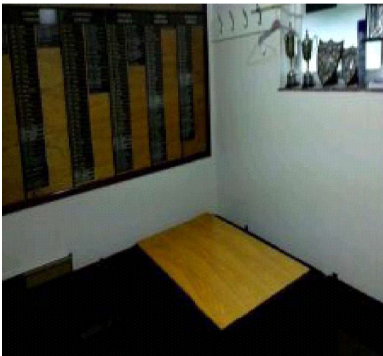
Room 5 (Male changing area) was accessed, and no suspect materials were found.

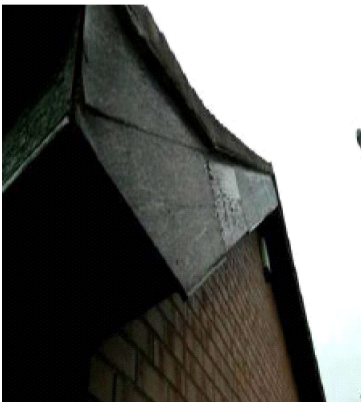
Item 10: Ref: EA003368

The under tile edging to the roof (External) contains asbestos. Any change in its appearance should be noted passed to Property Services.

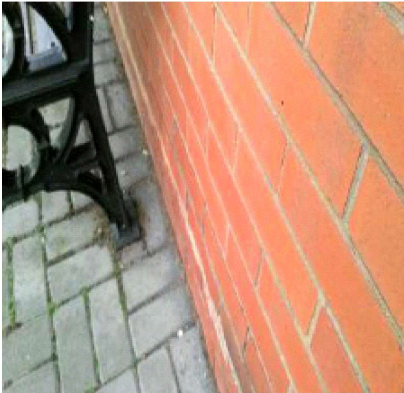
Item 11: Ref: EA003369

The damp proof course to the external does not contain asbestos.

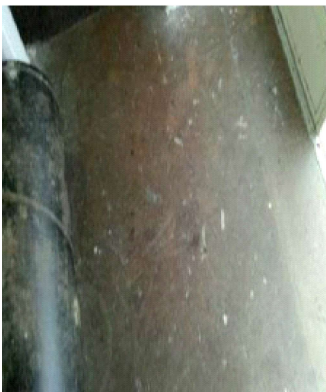
Item 13: Ref: EA003352

The brown vinyl flooring to the lobby (Room 1) does not contain asbestos.

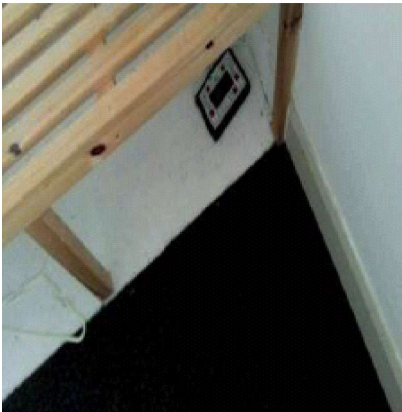
Item 15: As EA003352

The brown vinyl flooring to the umpire's room (Room 3) does not contain asbestos.

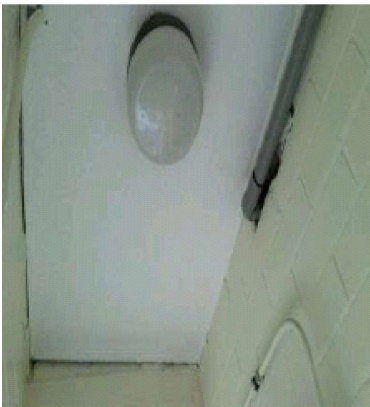
Item 17: As: EA003353

The fibreboard ceiling panels to the toilet on the left-hand side (Room 6) do not contain asbestos.

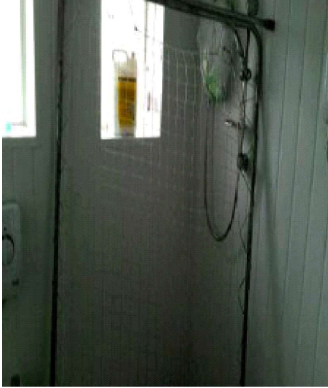
Room 8 (Shower - RHS) was accessed and no suspect materials were found.

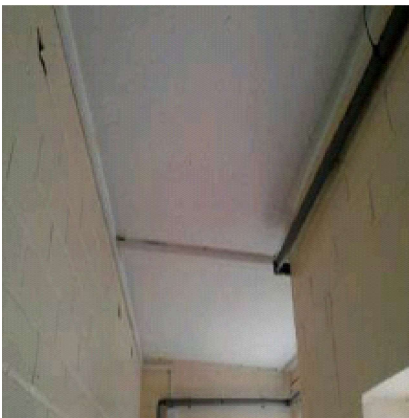
Item 22: As: EA003353

The fibreglass ceiling panels to the gent's toilet (Room 13) do not contain asbestos.

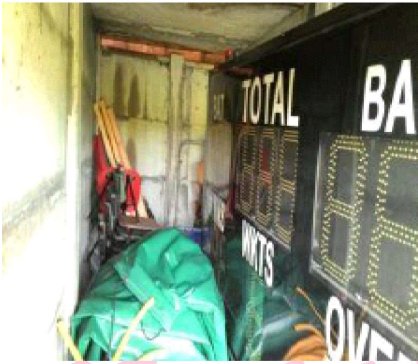
The cricket store (Room 1) was accessed, and no suspect materials were found.

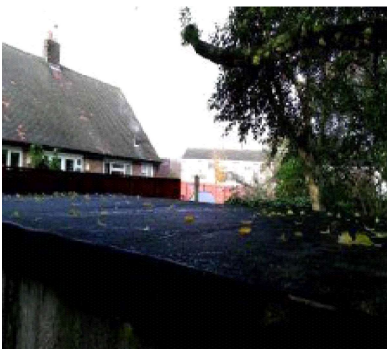
Item 26: Ref: EA003376

The bitumen to the flat roof (external) of the cricket store does not contain asbestos.

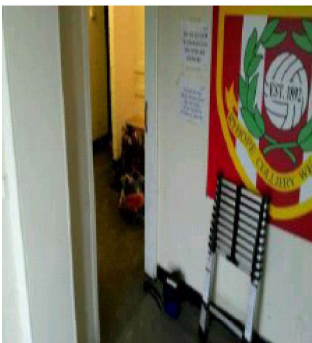
Room 1 (Lobby) was accessed, and no suspect materials were found.

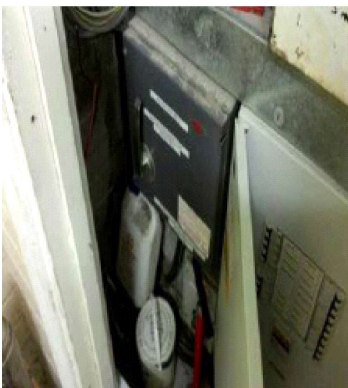
Item 30: Ref: Presumed

The flash guards within the electrics to the electrical cupboard are presumed to contain asbestos. Any change in its appearance should be noted and passed to Property Services.

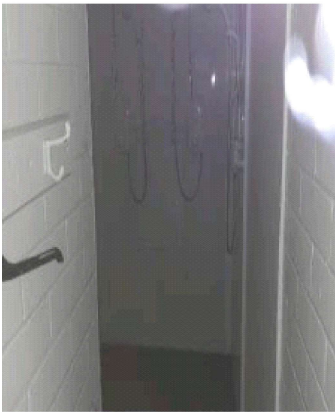
Room 4 (Home showers) was accessed, and no suspect materials were found.

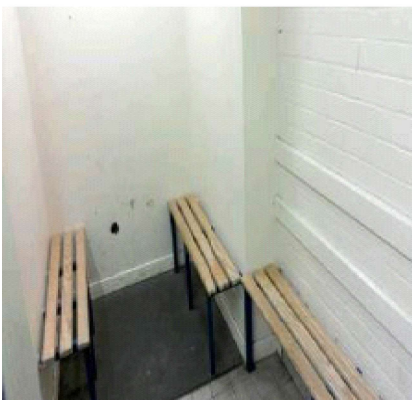
Room 6 (Away changing room) was accessed, and no suspect materials were found.

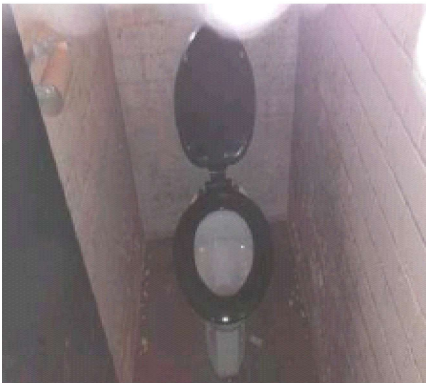
Item 34: As: EA003358

The WC seat to the toilet (Room 9) does not contain asbestos.

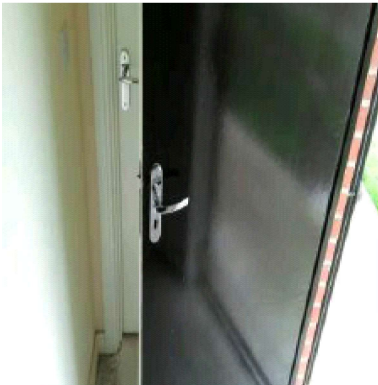
Room 10 (Vestibule) was accessed, and no suspect materials were found.

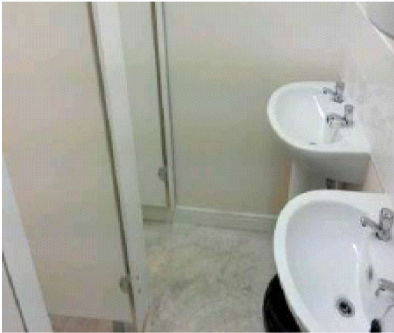
Room 12 (Female toilets) was accessed and no suspect materials were found.

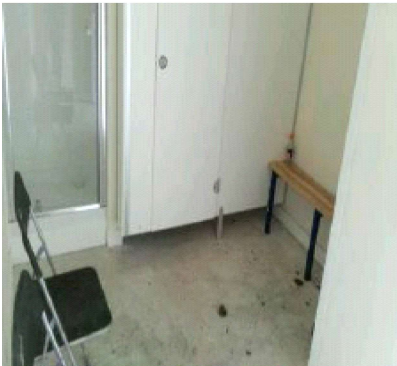
Room 13 (Officials area) was accessed and no suspect materials were found.

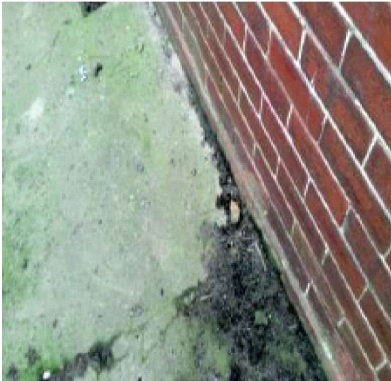
Item 35 Ref: EA003361

The damp proof course to the external contains asbestos. Any change in its appearance should be noted and passed to Property Services.

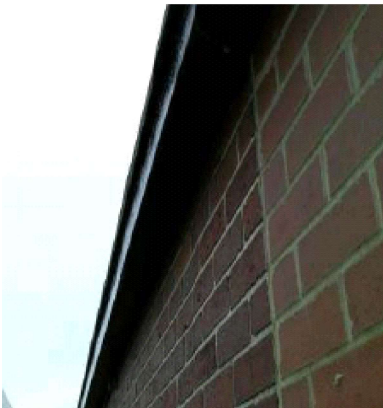
Item 36 Ref: EA003361

The external soffits to the changing rooms contain asbestos. Any change in its appearance should be noted and passed to Property Services.

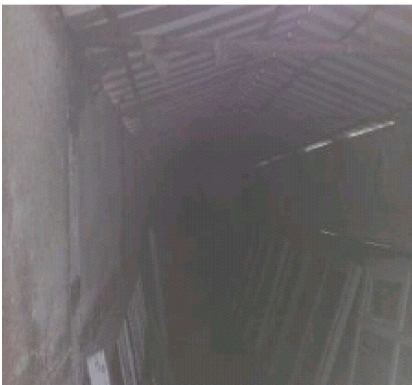
The internal area to the garage behind the staff cabin was accessed and no suspect materials were found.

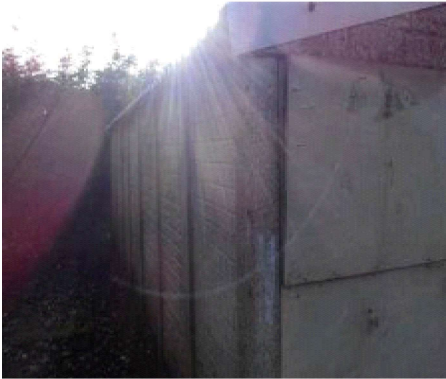
The external area to the garage behind the staff cabin was accessed and no suspect materials were found.

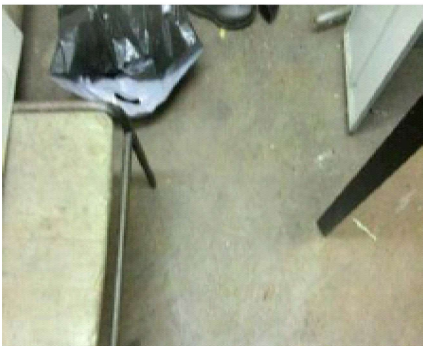
Item 37 Ref:EA003348

The red vinyl flooring to the office (Room 2) does not contain asbestos.

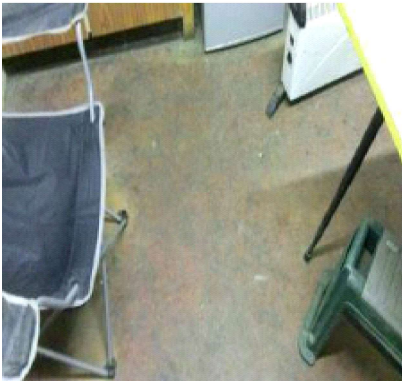
Item 39 As EA003348

The red vinyl floor covering to the staff room (Room 3) does not contain asbestos.

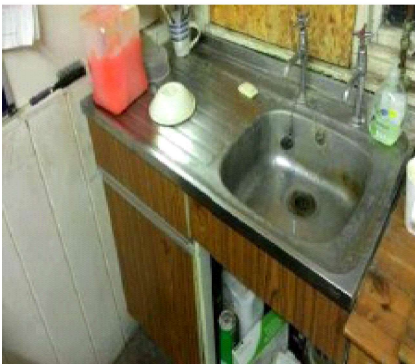
Item 40 Ref: EA003350

The sink pads to the sink and drainer in the staff room (Room 3) do not contain asbestos.

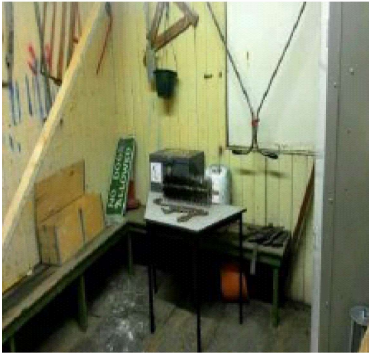
Room 4 (store) was accessed and no suspect materials were found.

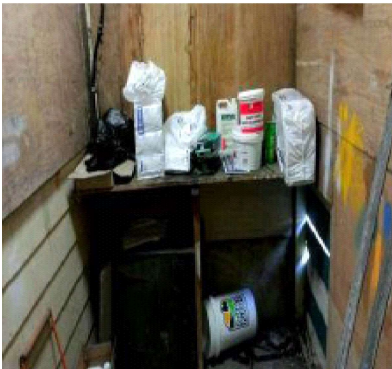
The store room (room 5) was accessed and no suspect materials were found.

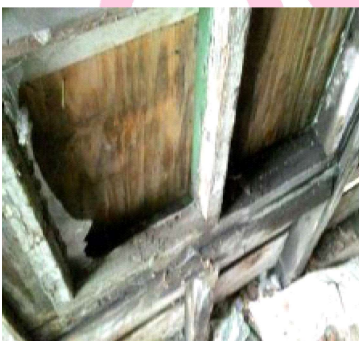
Item 41 Ref: EA003351

The window putty to the external of the mess / storage area does not contain asbestos.

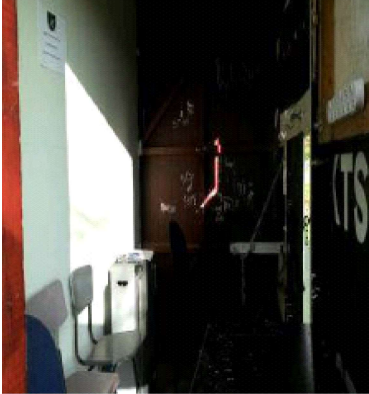
The scoreboard was accessed and no suspect materials were found.

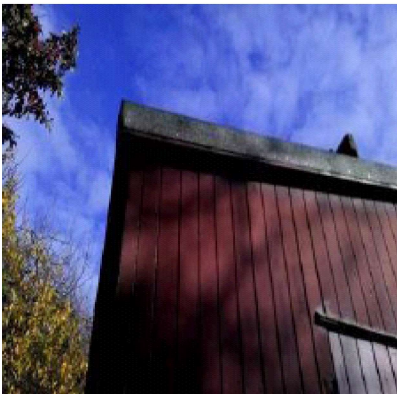
Item 42 Ref: EA003377

The bitumen felt to the flat roof of the scoreboard does not contain asbestos.

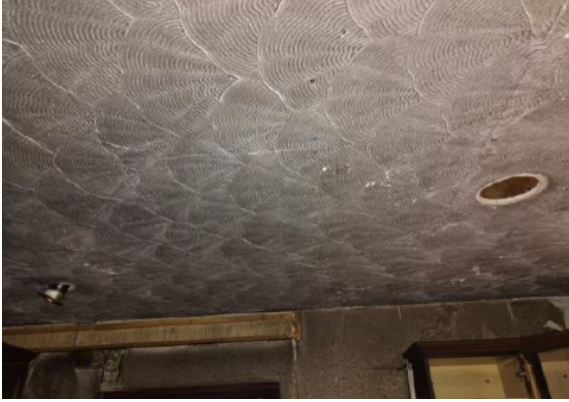
Item 43 Ref: 21-38916-1

The textured coated ceiling (Kitchen) does not contain asbestos.

Demolished 2022.

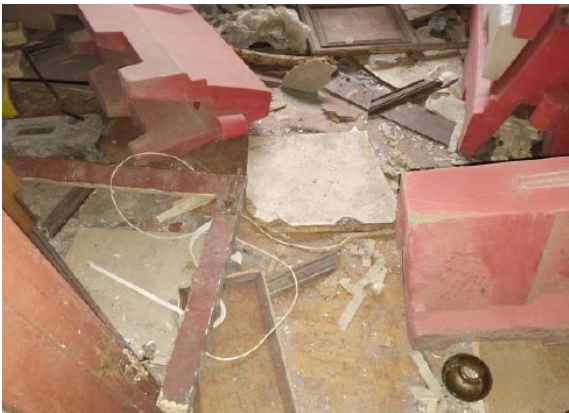
Item 44 Ref: 21-38916-1

The debris from ceiling to floor (Kitchen) does not contain asbestos.

Demolished 2022.

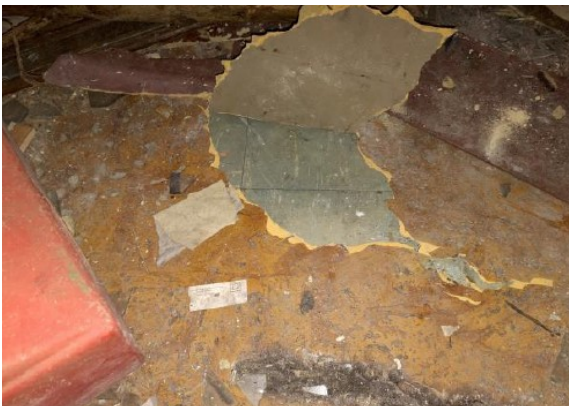
Item 45 Ref: 21-38916-2

The floor tiles and adhesive (Kitchen) contain asbestos.

Demolished 2022.

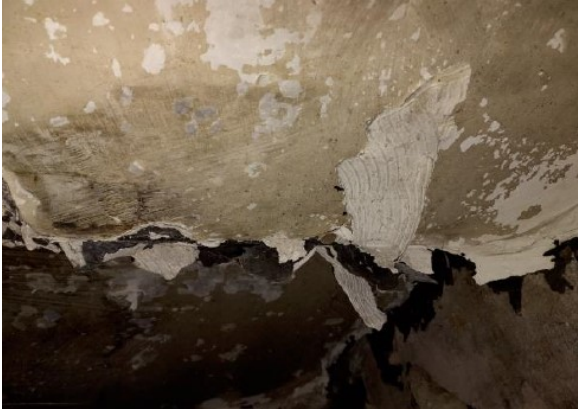
Item 46 Ref: 21-38916-1

The textured coated ceiling (Hall) does not contain asbestos.

Demolished 2022.

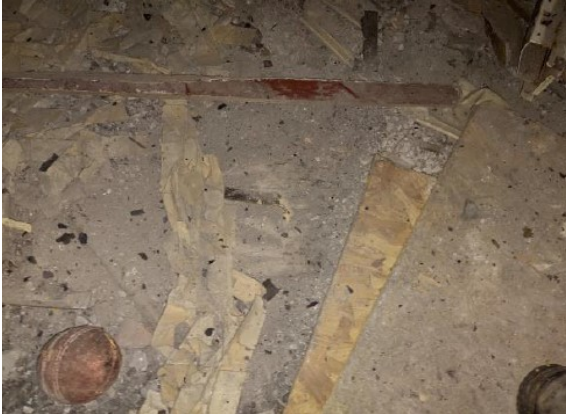
Item 49 Ref: 21-38916-4

The floor tiles and adhesive (Lounge) contain asbestos.

Demolished 2022.

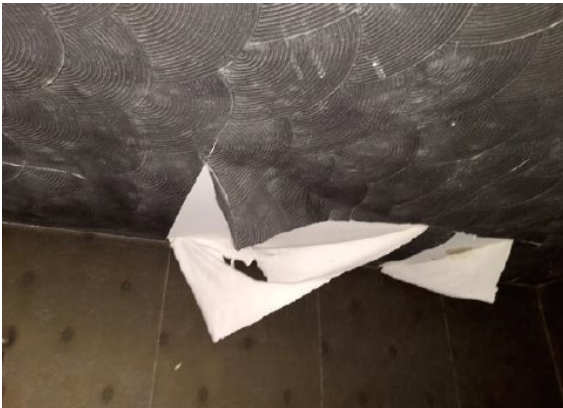
Item 52 Ref: 21-38916-1

The textured coated ceiling (Stairs and Landing) does not contain asbestos.

Demolished 2022.

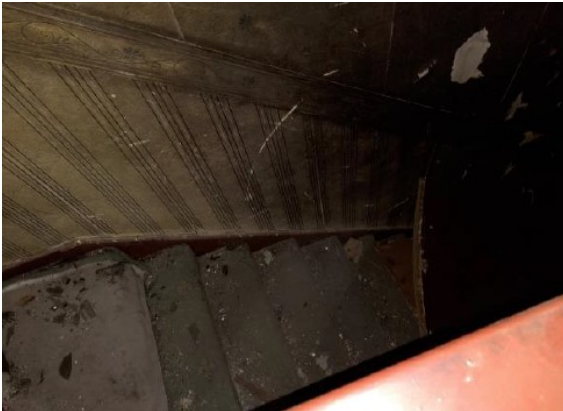
Item 53 Ref: 21-38916-1

The textured coated ceiling (Stairs and Landing) does not contain asbestos.

Demolished 2022.

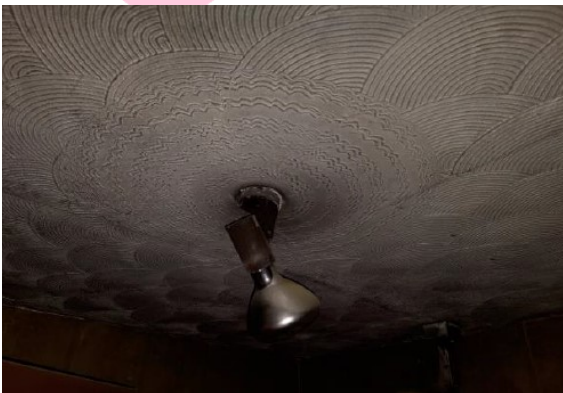
Item 54 Ref: 21-38916-1

The textured coated ceiling (Bathroom) does not contain asbestos.

Demolished 2022.

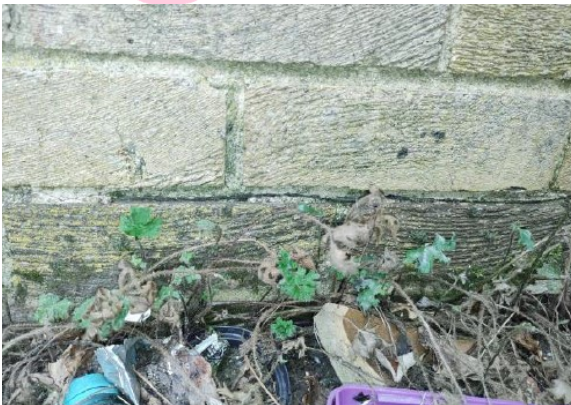
Item 57 Ref: 21-38916-5

The damp proof course (External) contains asbestos.

Demolished 2022.

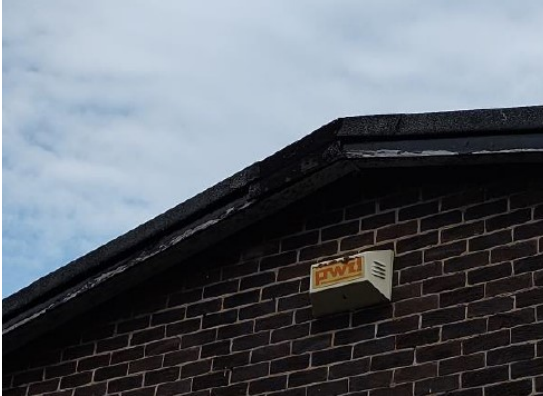
Item 58 Ref: 21-38916-6

The felt bitumen to roof (External) does not contain asbestos.

Demolished 2022.

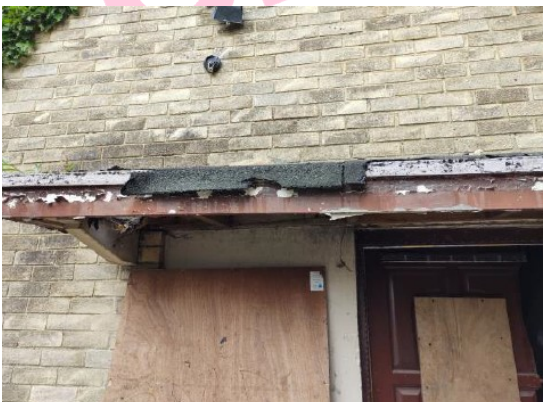
Item 60 Ref: 21-38916-6

The felt bitumen to canopy roof (External) does not contain asbestos.

Demolished 2022.

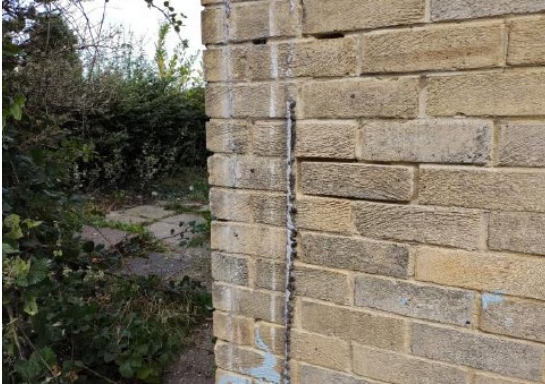
Item 61 Ref: 21-38916-7

The frame sealant to outhouse walls (External) does not contain asbestos.

Demolished 2022.

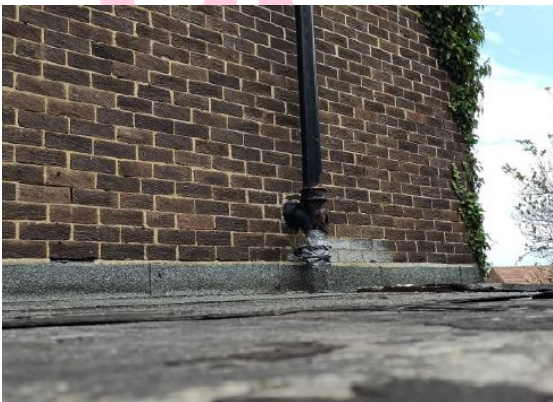
Item 63 Ref: 21-38916-9

The insulation joint compound to soil pipe (External) contains asbestos.

Demolished 2022.
