ASBESTOS SURVEY REPORT FOR GLEBE COLLIERY WELFARE PARK, WASHINGTON

Asbestos Register for

Glebe Colliery Welfare Park, Washington

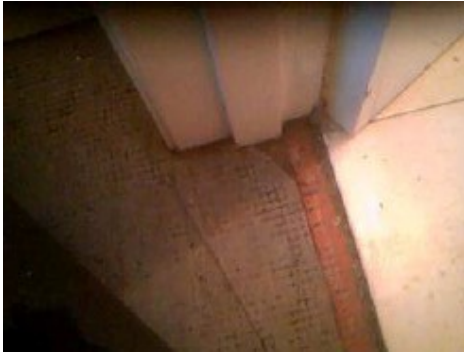
Item 1 - Ref: CB008861

The lino beneath the carpet in Room 1 (Lobby) contains asbestos.

Any change in its appearance should be recorded and passed to Property Services.

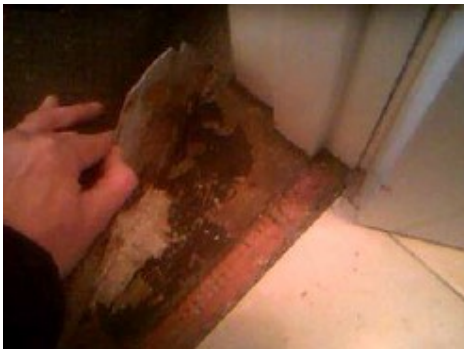
Item 2 - Ref: CB008862

The bitumen to concrete floor in Room 1 (Lobby) contains asbestos.

Any change in its appearance should be recorded and passed to Property Services.

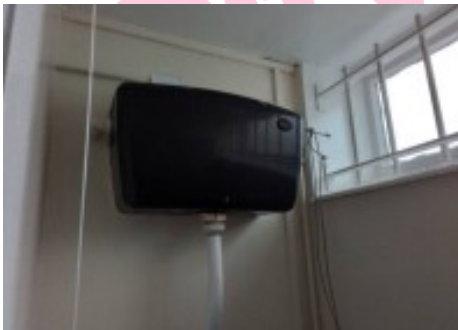
Item 3 - Ref: QY000252

The cisterns in Room 2 (Men's WC) contain asbestos.

Any change in its appearance should be recorded and passed to Property Services.

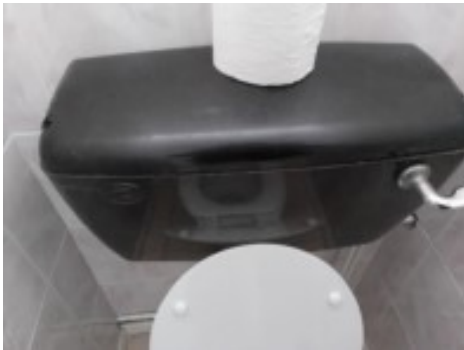
Item 4 - Ref: As QY000252

The cisterns in Room 3 (Ladies WC) contain asbestos.

Any change in its appearance should be recorded and passed to Property Services.

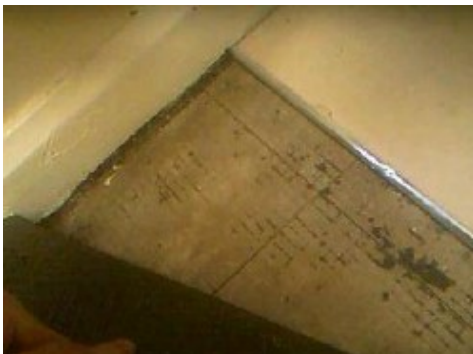
Item 5 - Ref: CB008864

The floor tiles beneath the carpet in Room 4 (Kitchen) contain asbestos.

Any change in its appearance should be recorded and passed to Property Services.

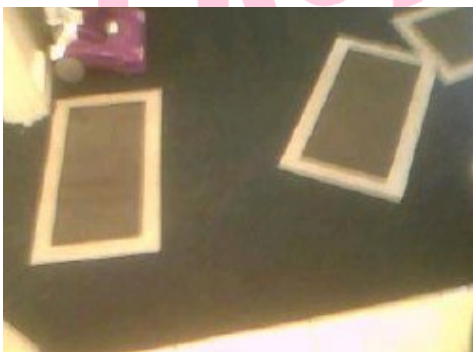
Item 6 - Ref: As CB008862

The bitumen to concrete floor in Room 4 (Kitchen) contains asbestos.

Any change in its appearance should be recorded and passed to Property Services.

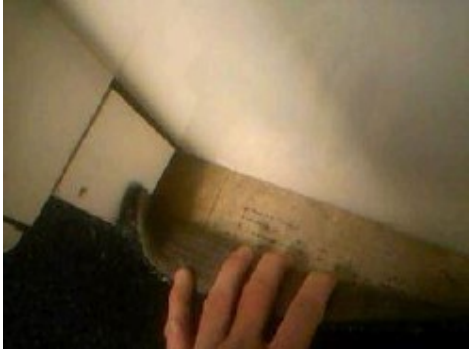
Item 7 - Ref: As CB008864

The floor tiles beneath the carpet in Room 5 (Lounge) contain asbestos.

Any change in its appearance should be recorded and passed to Property Services.

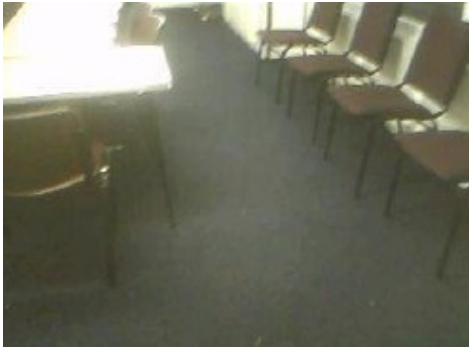
Item 8 - Ref: As CB008862

The bitumen to concrete floor in Room 5 (Lounge) contains asbestos.

Any change in its appearance should be recorded and passed to Property Services.

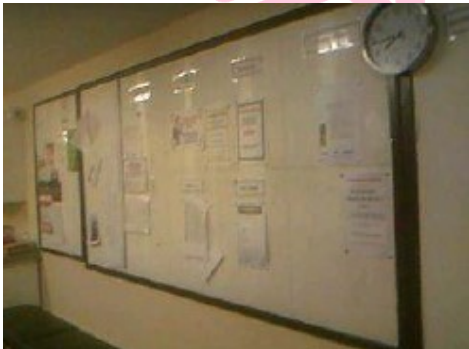
Item 9 - Ref: CB008865

The fibre board notice boards in Room 5 (Lounge) do not contain asbestos.

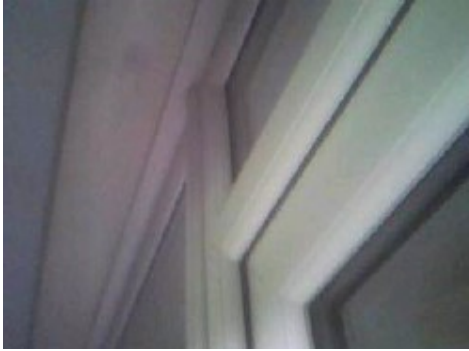
Item 10 - Ref: CB008866

The soffit above entrance (External) contains asbestos.

Any change in its appearance should be recorded and passed to Property Services.

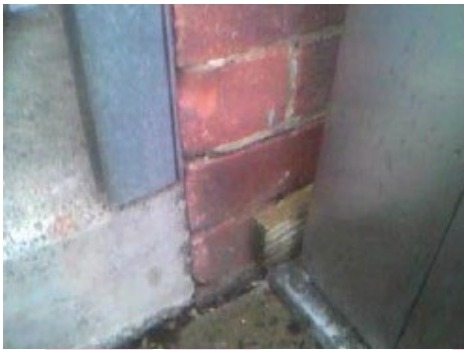
Item 11 - Ref: CB008867

The damp proof course (External) does not contain asbestos.

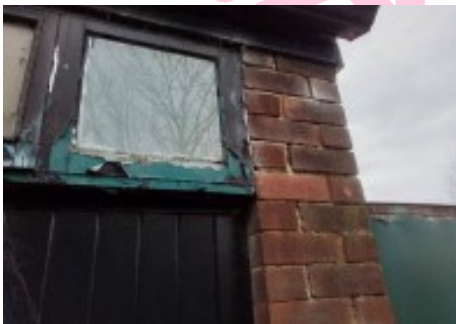
Item 12 Ref: QY000248

The Window - Beading Outer frame to wall (External) contains asbestos.

Removed April 2024

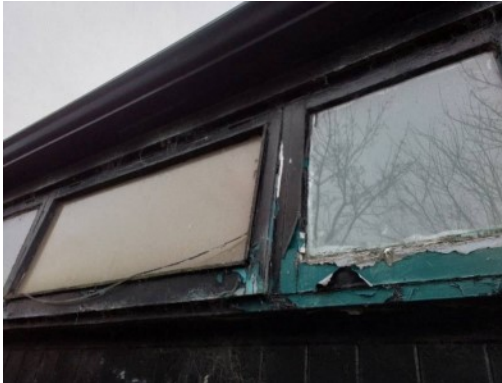
Item 13 Ref: QY000249

Window Putty/seal (External)
does not contain asbestos.

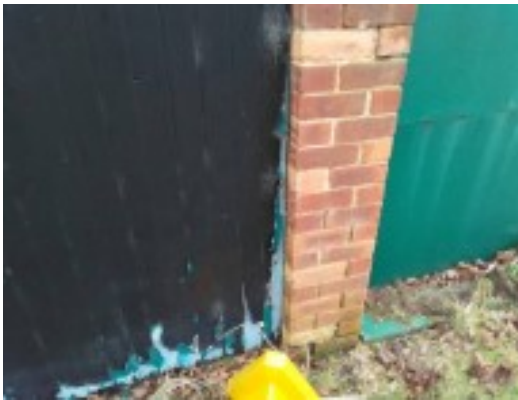
Item 14 Ref: QY000250

The Wall - Sheet/Cladding
Beading to wall (External)
contains asbestos.

Removed April 2024

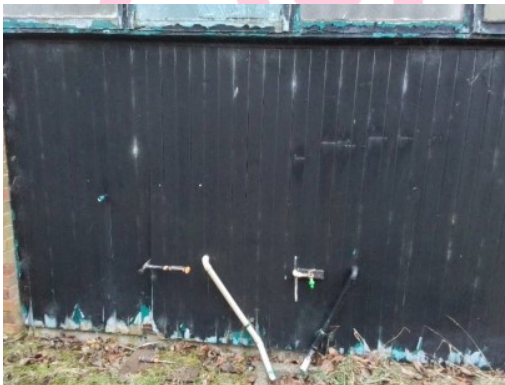
Item 15 Ref: QY000251

Wall - Lining Behind timber
cladding (External) does not
contain asbestos.
