ASBESTOS SURVEY REPORT FOR PENNYWELL CA, PORTSMOUTH ROAD, SUNDERLAND

Asbestos Register for

**PENNYWELL CA, PORTSMOUTH ROAD
SUNDERLAND**

Date: 19 June 2025

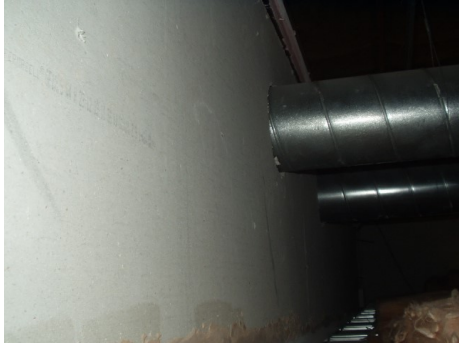
Item 1 Ref: AW0099/08

The fire break to the ceiling void in the multipurpose room (Rm 0/01) does not contain asbestos.

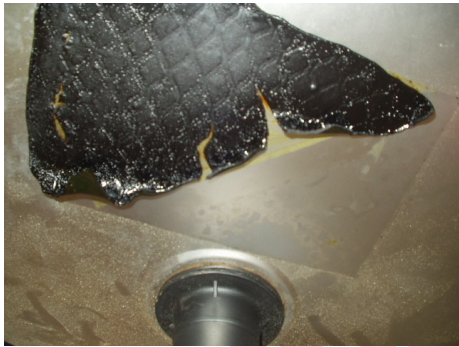
Item 2 - Ref: AW0100/08

The sink pad to the small kitchen (Rm 0/08) does not contain asbestos.

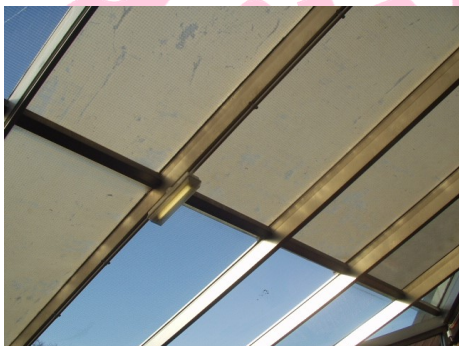
Item 3 - Ref: Presumed

The window gaskets to the porch (Rm 0/12) are presumed to contain asbestos.

Any change in its appearance should be recorded and passed to Property Services.

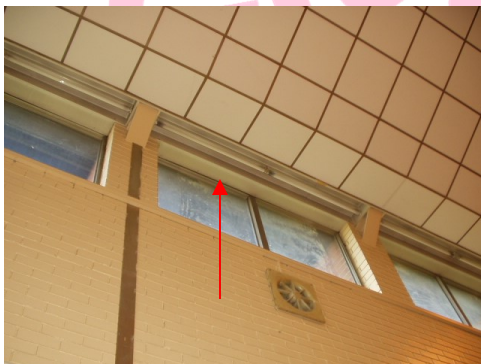
Item 6 - Ref: Presumed

The soffits above the windows/lights in the main hall (Rm 0/14) are presumed to contain asbestos.

Any change in its appearance should be recorded and passed to Property Services.

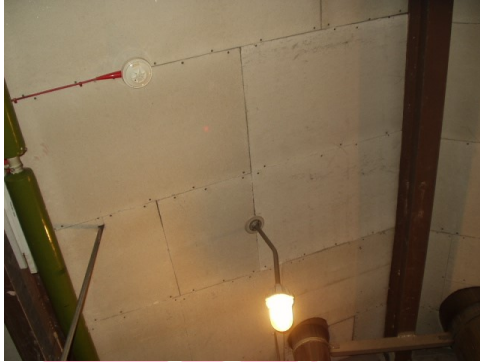
Item 8 - Ref: AW0104/08

The ceiling to the boiler room (Rm 0/25) does not contain asbestos.

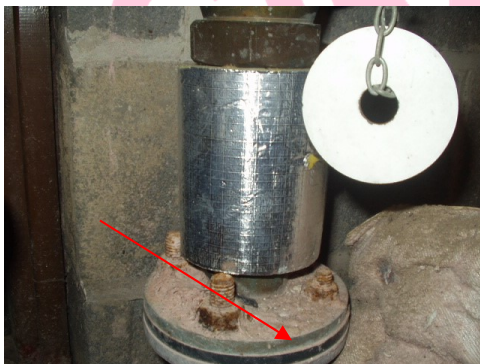
Item 9 - Ref: Presumed

The pipework flange gaskets to the pipework in the boiler room (Rm 0/25) are presumed to contain asbestos.

Any change in its appearance should be recorded and passed to Property Services.

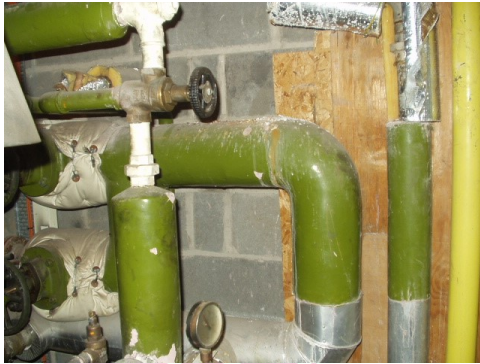
Item 11 - Ref: AW0107/08

The insulation to the pipework in the boiler room (Rm 0/25) does not contain asbestos.

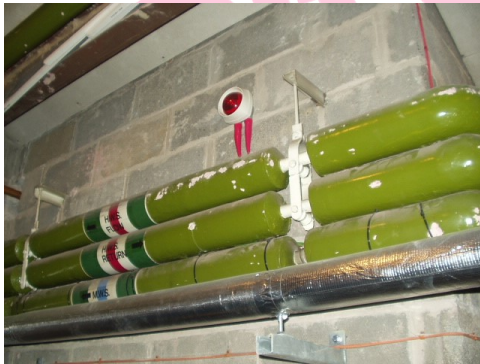
Item 12 - Ref: AW0105/08

The insulation to the pipework in the boiler room (Rm 0/25) does not contain asbestos.

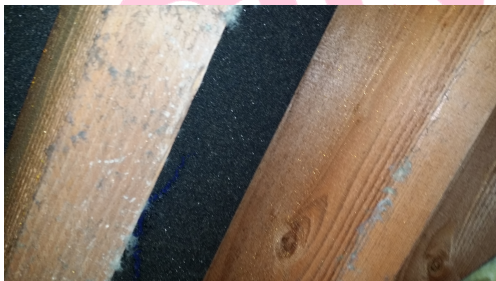
Item 15 - Ref: 220084-2

The Sarking- bituminous felt in the multipurpose room-void above suspended ceiling- localised to proposed refurb works (Rm 0/01) - does not contain asbestos.

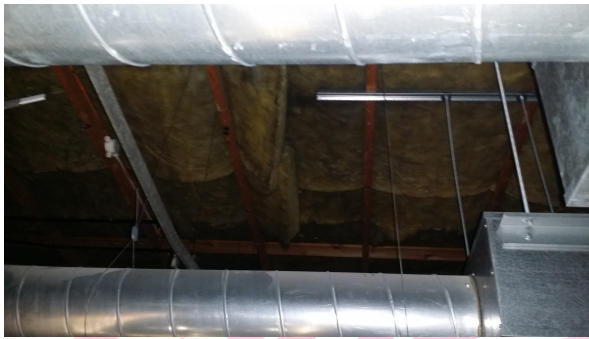
Item 17-Ref: As 220084-2

The Sarking- bituminous felt in the computer room/coffee area-void above suspended ceiling- localised to proposed refurb works (Rm 0/02) - does not contain asbestos.

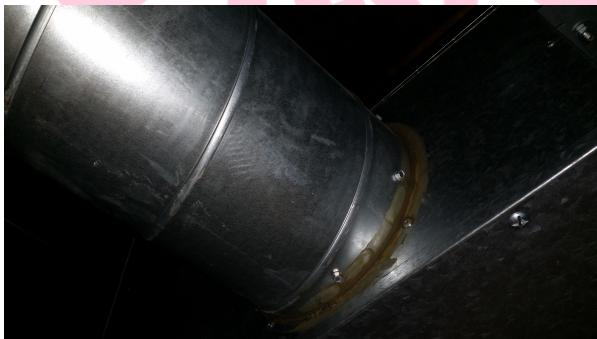
Item 18-Ref: As 220084-3

The Sealant to ductwork in the computer room/coffee area - void above suspended ceiling- localised to proposed refurb works (Rm 0/02) - does not contain asbestos.

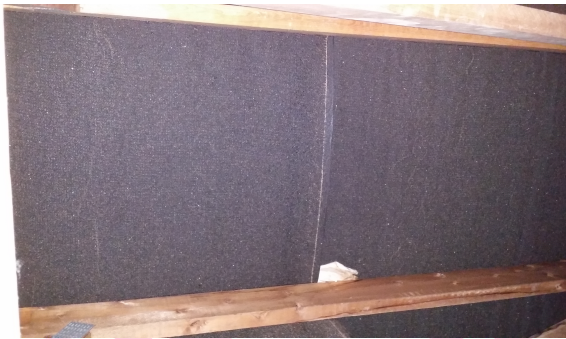
Item 20-Ref: As 220084-1

The Roof Sarking bituminous felt in the Utility room-void above suspended ceiling- localised to proposed refurb works (Rm 0/04) - does not contain asbestos.

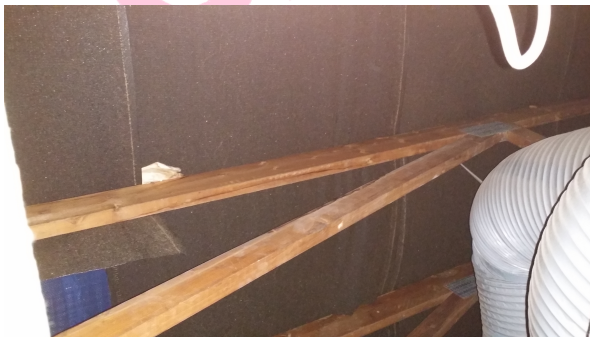
Item 21-Ref: As 220084-1

The Roof Sarking bituminous felt in the Corridor-void above suspended ceiling- localised to proposed refurb works (Rm 0/05) - does not contain asbestos.

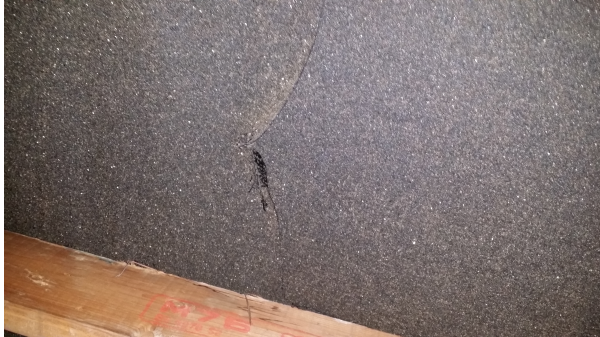
Item 22-Ref: As 220084-1

The Roof Sarking bituminous felt in the Female WC-void above suspended ceiling- localised to proposed refurb works (Rm 0/06) - does not contain asbestos.

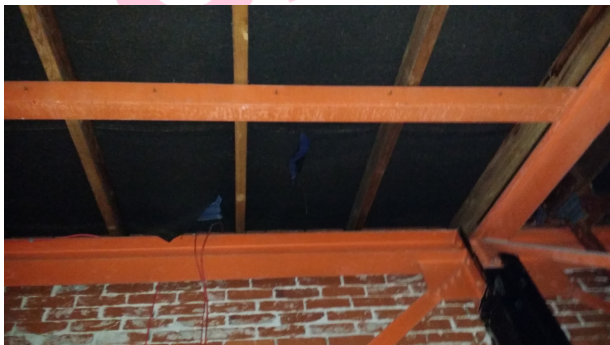
Item 24-Ref: As 220084-2

The Roof Sarking bituminous felt in the snack bar-void above suspended ceiling- localised to proposed refurb works (Rm 0/08) - does not contain asbestos.

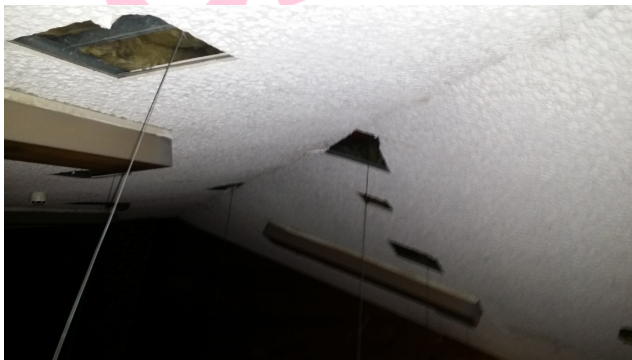
Item 30-Ref: As 220084-4

The Previous suspended ceiling tiles in the games room- localised to proposed refurb works (Rm 0/13) - does not contain asbestos.

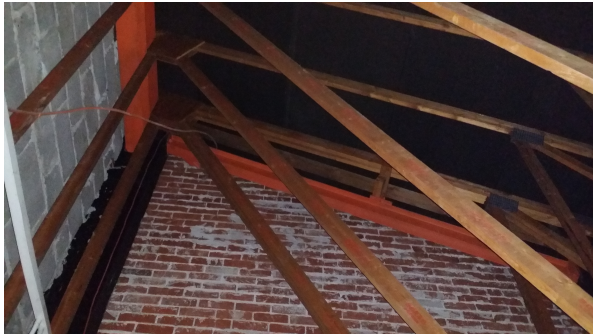
Item 31-Ref: 220084-5

The Roof Sarking in the loft space- localised to proposed refurb works (Rm 1/01) - does not contain asbestos.

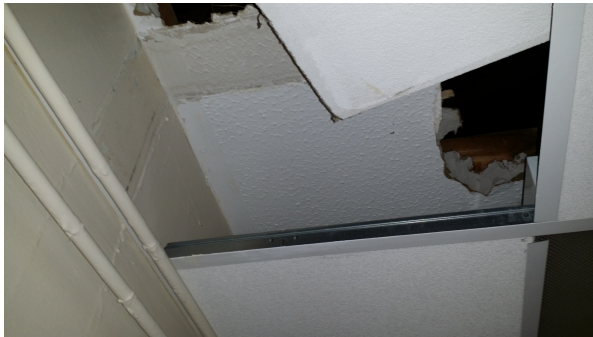
Item 32-Ref: 220084-6

The coating to previous fixed ceiling in the loft space (Rm 1/01) is presumed to contain asbestos.

Any change in its appearance should be recorded and passed to Property Services.

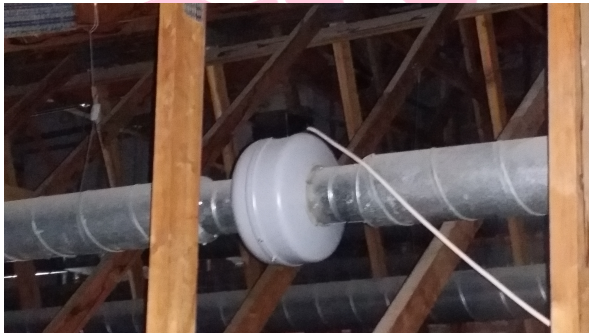
Item 33-Ref: As 220084-3

The Sealant to ductwork in the loft space-localised to proposed refurb works (Rm 1/01) - does not contain asbestos.

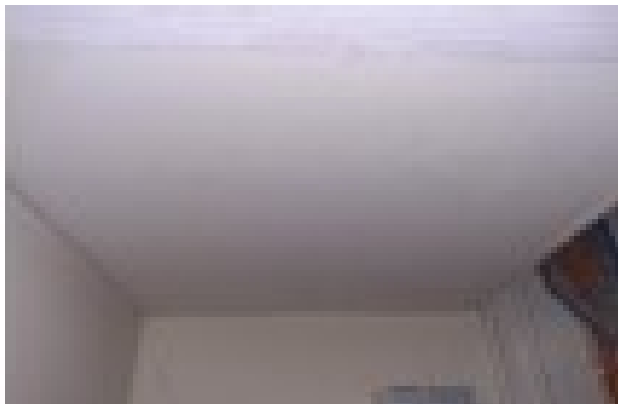
Item 36 : RT000198

The Insulating board to ceiling (Electrical cupboard G/01) does not contain asbestos.

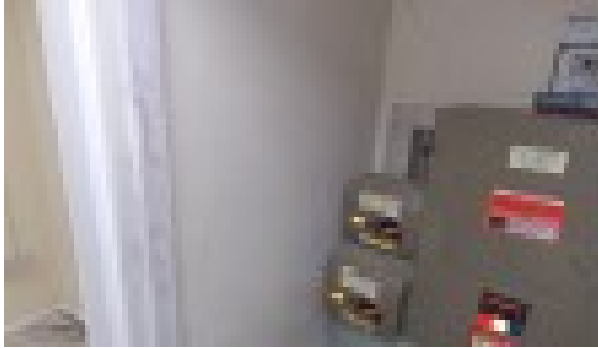
Item 37 : Ref RT000199

The Insulating board to walls (LHS and over door only) (Electrical Cupboard G/01) does not contain asbestos.

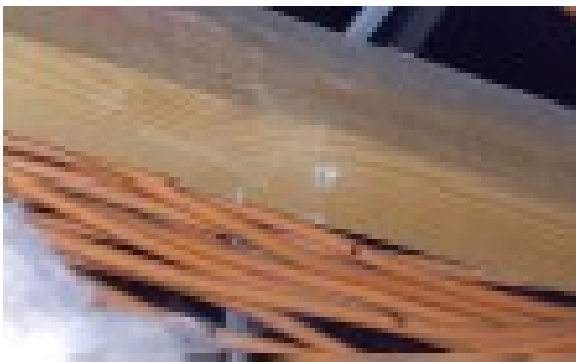
Item 39 : Ref RT000201

The Insulating board debris to timbers/screw holes in void (Office G/02) does not contain asbestos.
