ASBESTOS SURVEY REPORT FOR PENNYWELL CA, PORTSMOUTH ROAD, SUNDERLAND

Asbestos Register for

**PENNYWELL CA, PORTSMOUTH ROAD
SUNDERLAND**

Date: 07 February 2025

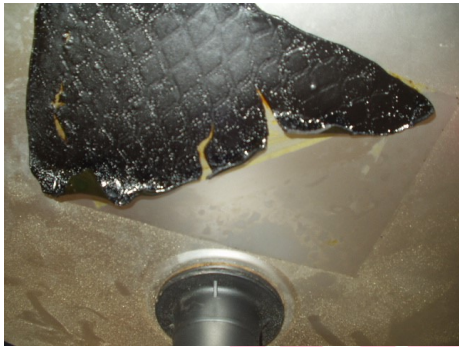
Item 2 - Ref: AW0100/08

The sink pad to the small kitchen (Rm 0/08) does not contain asbestos.

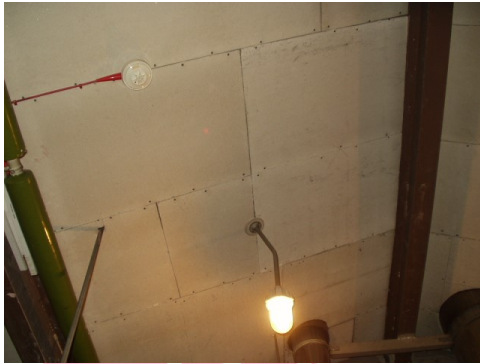
Item 8 - Ref: AW0104/08

The ceiling to the boiler room (Rm 0/25) does not contain asbestos.

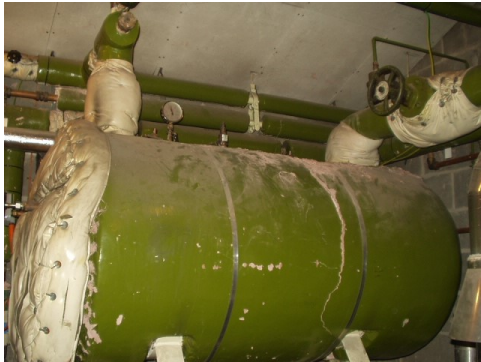
Item 14 - Ref: AW0109/08

The insulation to the tank in the boiler room (Rm 0/25) does not contain asbestos.

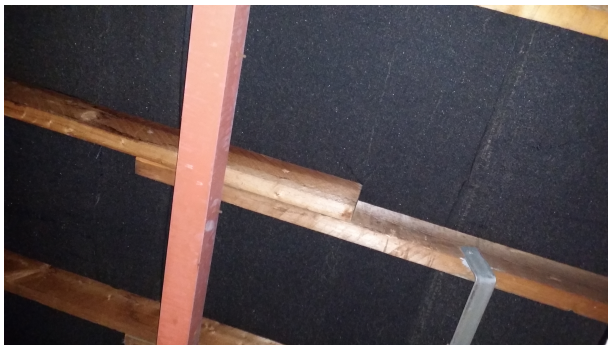
Item 27-Ref: As 220084-1

The Roof Sarking bituminous felt in the Caretakers Office-void above suspended ceiling- localised to proposed refurb works (Rm 0/11) - does not contain asbestos.

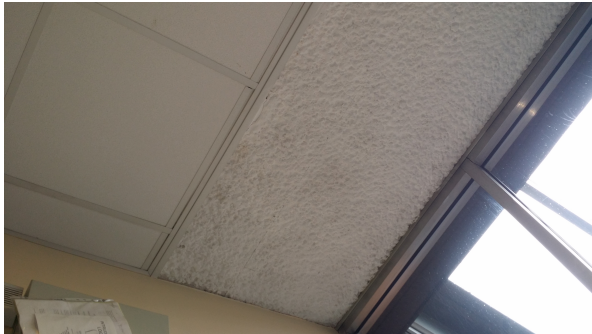
Item 28-Ref: 220084-4

The Previous suspended ceiling tiles in the games room- localised to proposed refurb works (Rm 0/13) - does not contain asbestos.

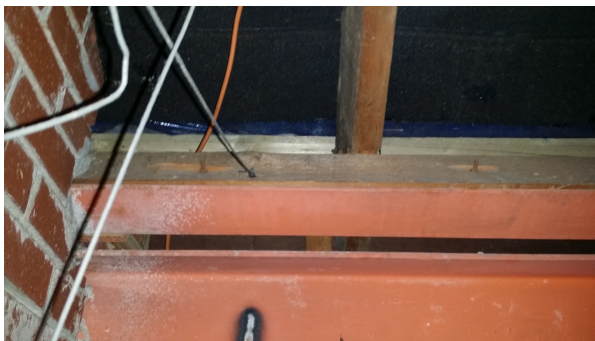
Item 29-Ref: As 220084-2

The Sarking bituminous felt in the games room-void above suspended ceiling- localised to proposed refurb works (Rm 0/13) - does not contain asbestos.

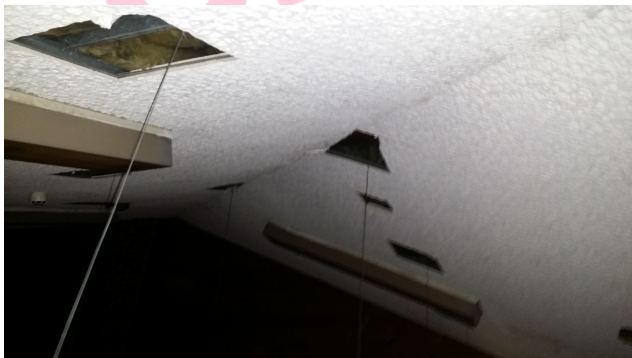
Item 30-Ref: As 220084-4

The Previous suspended ceiling tiles in the games room- localised to proposed refurb works (Rm 0/13) - does not contain asbestos.
