ASBESTOS SURVEY REPORT FOR ELEMORE GOLF CLUB, ELEMORE LANE, HOUGHTON LE SPRING

*Control of Asbestos
Regulations 2012*

**ELEMORE GOLF CLUB,
ELEMORE LANE, EASINGTON LANE**

Date: 17 November 2022

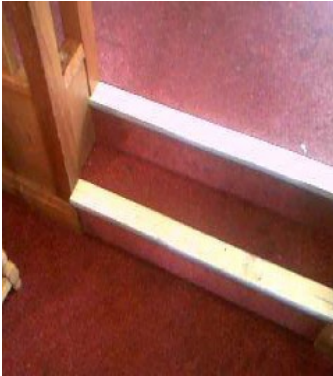
Item 1 Ref: AD001152

The stair nosing to the bar area (Room 5) does not contain asbestos.

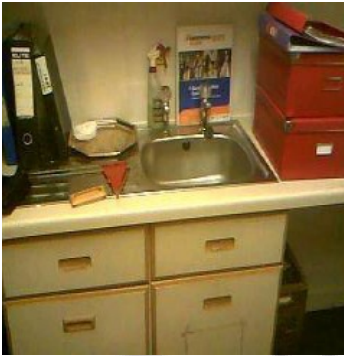
Item 2 - Ref: AD001151

The bitumen pad to the sink in the supervisors office (Room 14) does not contain asbestos.

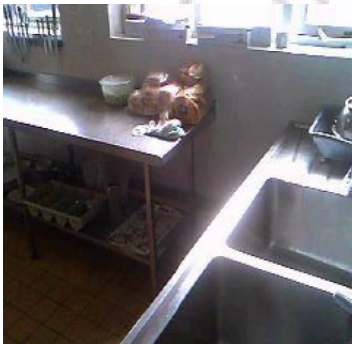
Item 3 - Ref: AD001153

The adhesive to the underside of the benches in the kitchen (Room 17) does not contain asbestos.

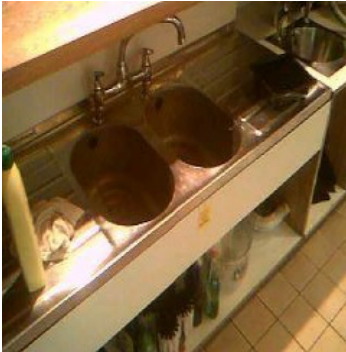
Item 4 - Ref: AD001154

The sink pad to the sink the in bar (Room 19) does not contain asbestos.

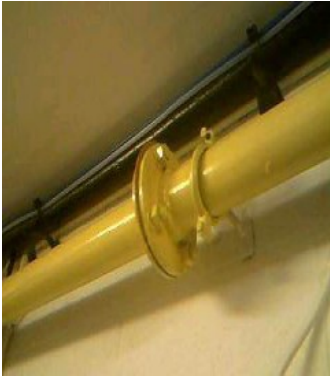
Item 5 - Ref: AD001155

The gaskets to the pipework in the cellar (Room 20) do not contain asbestos.

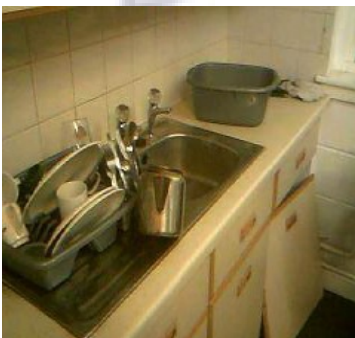
Item 6 - Ref: AD001156

The sink pad to the sink in the parks rest area (Room 24) does not contain asbestos.

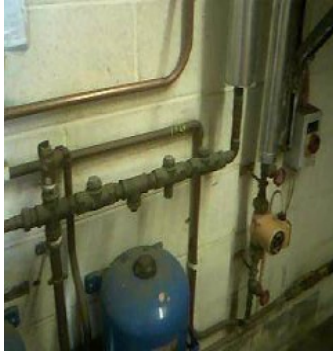
Item 7 - Ref: AD001157

The residue to the pipework in the plant room (Room 25) does not contain asbestos.

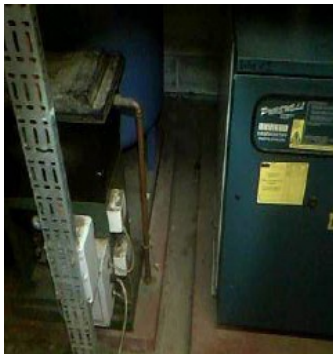
Item 8 - Ref: AD001158

The debris to the floor in the plant room (Room 25) does not contain asbestos.

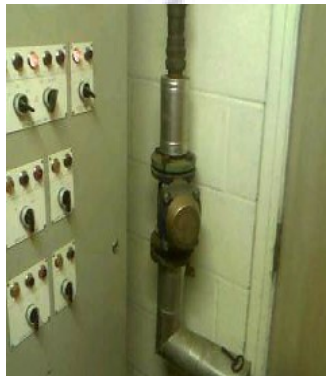
Item 9 - Ref: AD001159

The pipework gasket to the plant room (Room 25) does not contain asbestos.

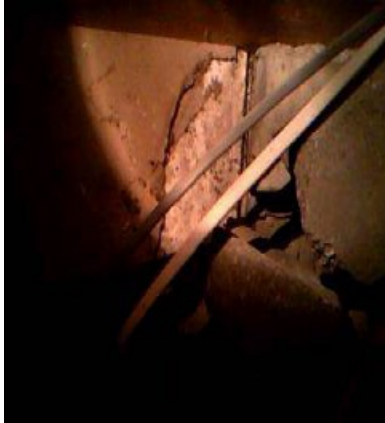
Item 10 - Ref: CB000370

The insulating board in the ceiling void to the porch area (Room 1) does not contain asbestos.

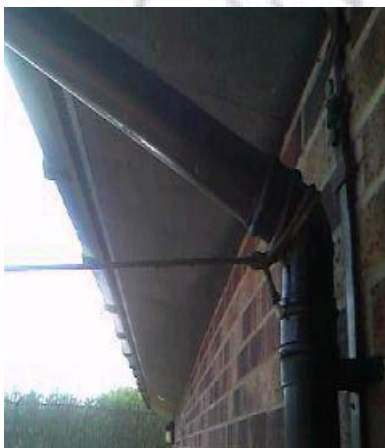
Item 12 - Ref: AD001160

The rope line to the external of the building does not contain asbestos.

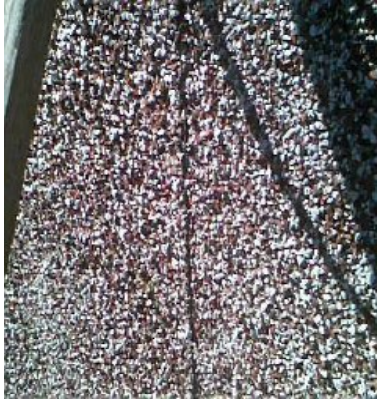
Item 13 - Ref: AD001161

The putty to the wall sections to the external of the building does not contain asbestos.

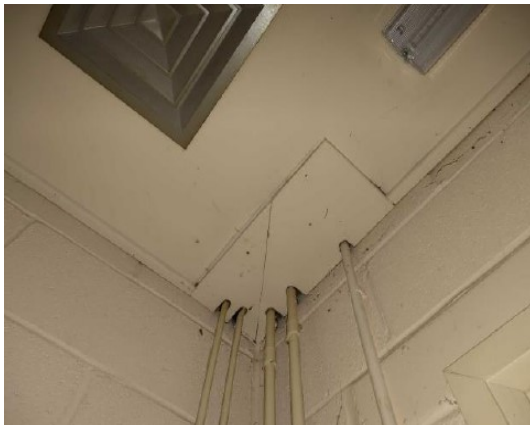
Item 14 - Ref: 21-41443-1

The infill panels to pipe penetration on ceiling (insulating board) in Area 6 – Cleaners Cupboard does not contain asbestos.

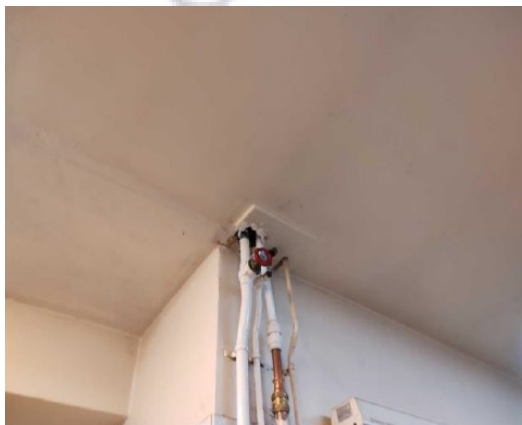
Item 15 - Ref: 21-41443-1

The infill panels to pipe penetration on ceiling (insulating board) in Area 15 – Kitchen does not contain asbestos.

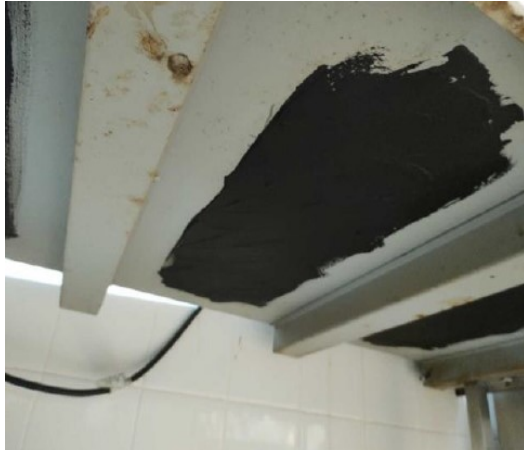
Item 16 - Ref: 21-41443-3

The bitumen to underside of worktops in Area 15 – Kitchen does not contain asbestos.

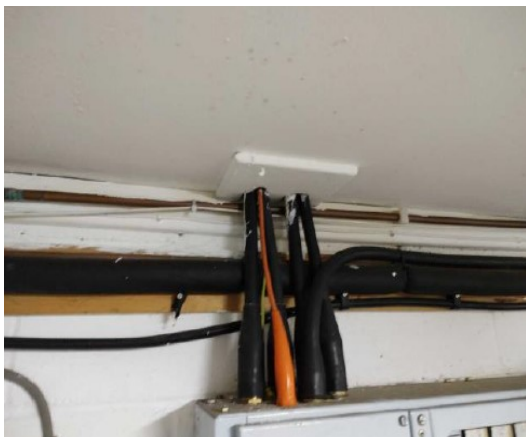
Item 17 - Ref: 21-41443-1

The infill panels to pipe penetration on ceiling (insulating board) in Area 20 – Cellar does not contain asbestos.

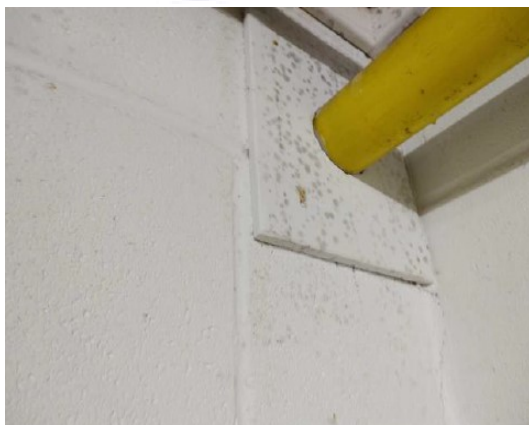
Item 18 - Ref: 21-41443-1

The infill panels to wall where the gas inlet pipe penetrates (insulating board) in Area 20 – Cellar does not contain asbestos.

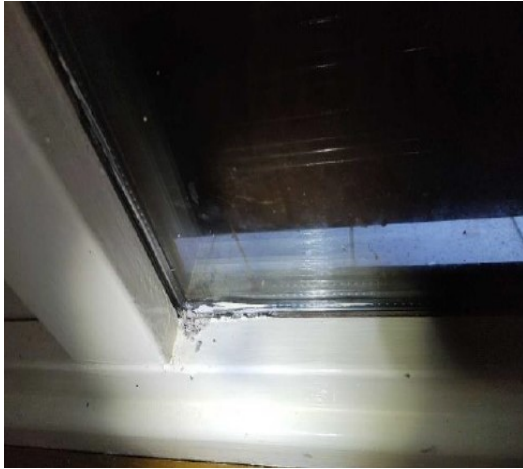
Item 19 - Ref: 21-41443-6

The window glazing putty in Area 21 – Lounge does not contain asbestos.

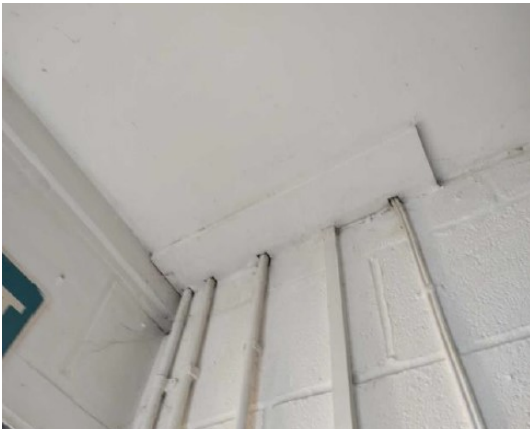
Item 20 - Ref: 21-41443-1

The infill panels to pipe penetration on ceiling (insulating board) in Area 24 – Garage Lobby does not contain asbestos.

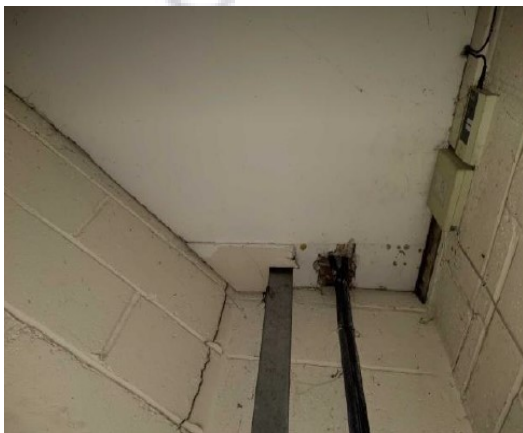
Item 21 - Ref: 21-41443-1

The infill panels to pipe penetration on ceiling (insulating board) in Area 25 – Vehicle Store does not contain asbestos.

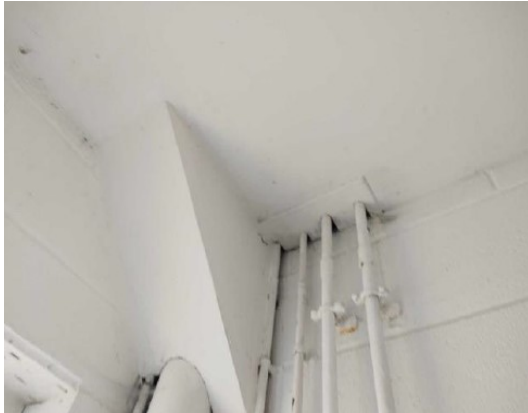
Item 22 - Ref: 21-41443-1

The infill panels to pipe penetration on ceiling (insulating board) in Area 26 – Staff WC does not contain asbestos.

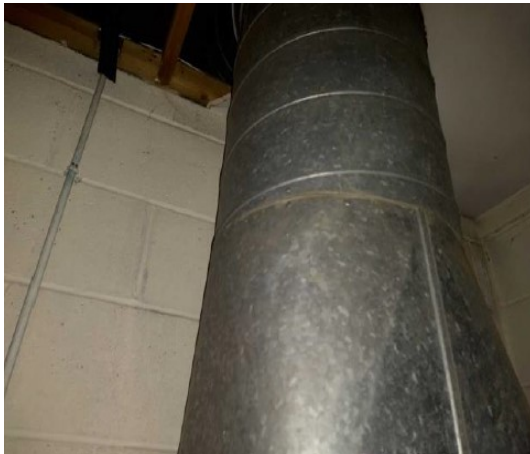
Item 23 - Ref: 21-41443-5

The mastic to ducting joints in Area 28 – Boiler Room does not contain asbestos.

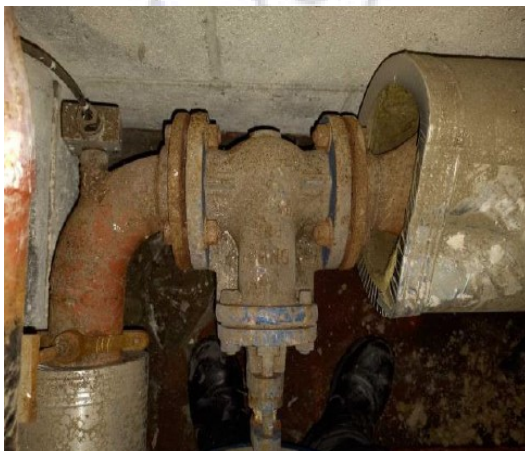
Item 24 - Ref: 21-41443-8

The gasket to pipes in Area 28 – Boiler Room does not contain asbestos.

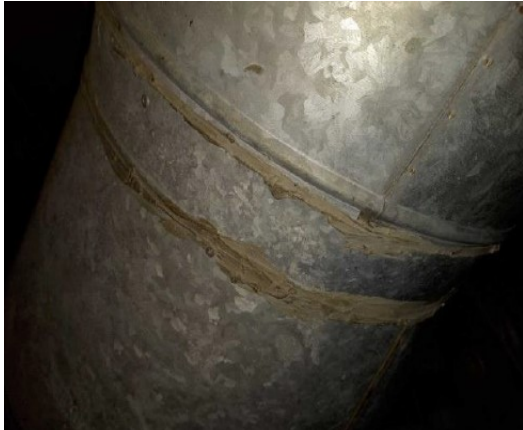
Item 25 - Ref: 21-41443-5

The mastic to ducting joints in Area 29 – Loft Space does not contain asbestos.
