ASBESTOS SURVEY REPORT FOR HOUGHTON RACECOURSE COMMUNITY CENTRE, BURDON AVENUE, HOUGHTON LE SPRING.

**Asbestos Register for**

**HOUGHTON RACECOURSE COMMUNITY CENTRE**

**Date: 04 February 2025**

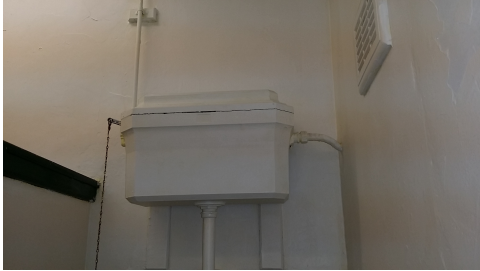
### **Item 1 Ref: 181279-3**

181279-3 – Toilet cistern (Male WC) (Item 1) – Removed April 2017

The toilet cistern in the Male WC (Room 001) contain asbestos.

*(Item has been removed April 2017)*

Any change in its appearance should be recorded, and passed to Property Services.

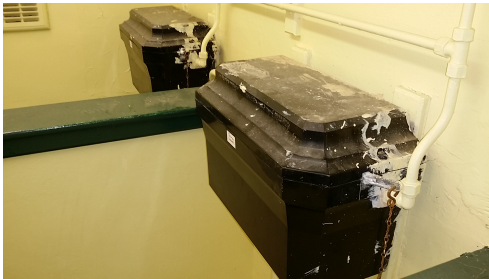
### **Item 2: As 181279-3**

As 181279-3 – Toilet cistern (Female WC) (Item 2) – Removed April 2017

The toilet cistern in the Female WC (Room 003) contain asbestos.

*(Item has been removed April 2017)*

Any change in its appearance should be recorded, and passed to Property Services.

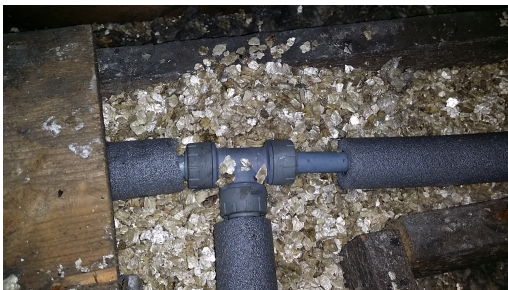
### **Item 3 Ref: 181279-1**

The loose insulation in the loft void of the Female WC (Room 003) does not contain asbestos.

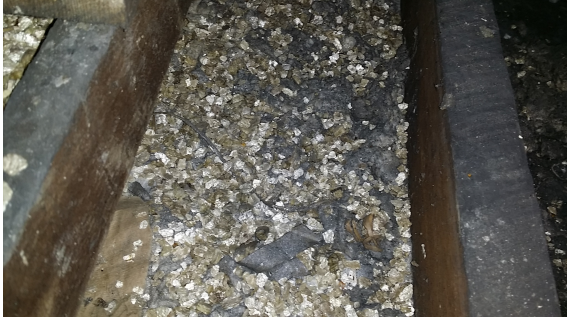
### **Item 4 Ref: As 181279-1**

The loose insulation in the loft void of the Female WC (Room 003) does not contain asbestos.

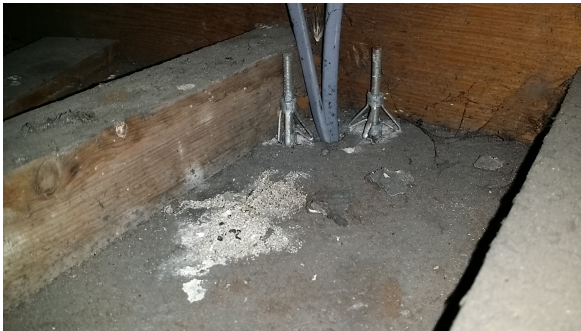
### **Item 5 Ref: 181279-2**

181279-2 – Debris to top of canopy (Female WC) (Item 5) – Very Low Risk

The debris to the top of the canopy in the loft void of the Female WC (Room 003) contain asbestos.

Any change in its appearance should be recorded, and passed to Property Services.

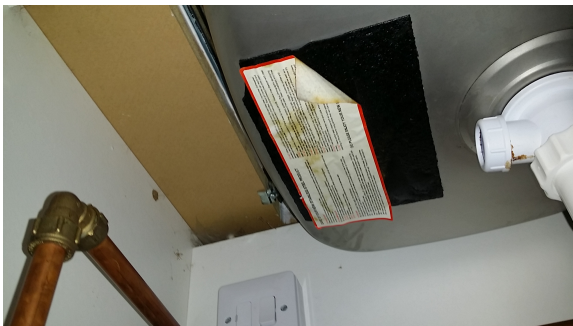
### **Item 6 Ref: 181279-4**

The sink pad in the kitchen (Room 004) does not contain asbestos.

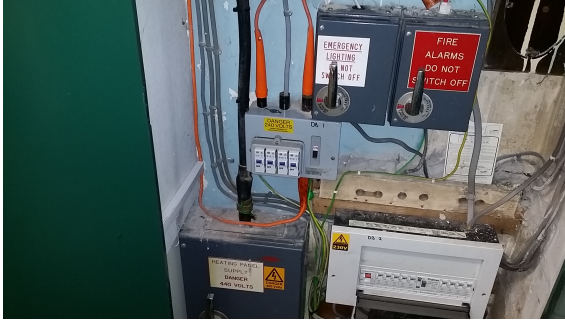
### **Item 7 Ref: Presumed**

The flash guards in the electric cupboard in the kitchen (Room 004) are presumed to contain asbestos.

*Removed confirmed on reinspection survey J152715*

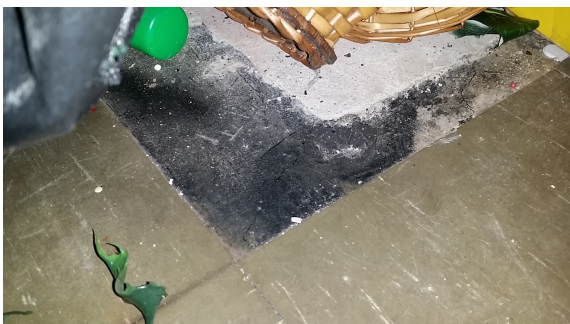
### **Item 9 Ref: 181279-8**

181279-8 – Floor covering below floor tile (Store) (Item 9) – Very Low Risk

The floor covering below the floor tiles in the Store (Room 007) contain asbestos.

Any change in its appearance should be recorded, and passed to Property Services.

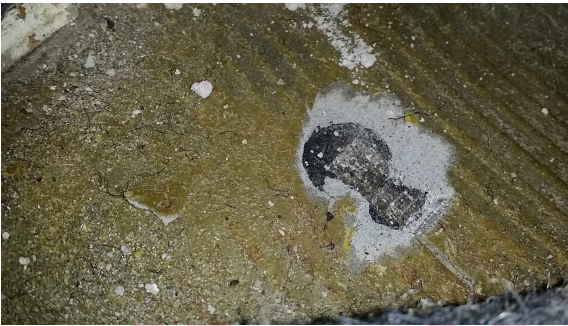
### **Item 11 Ref: 181279-6**

The floor covering below the carpet in the Lobby (Room 008) does not contain asbestos.

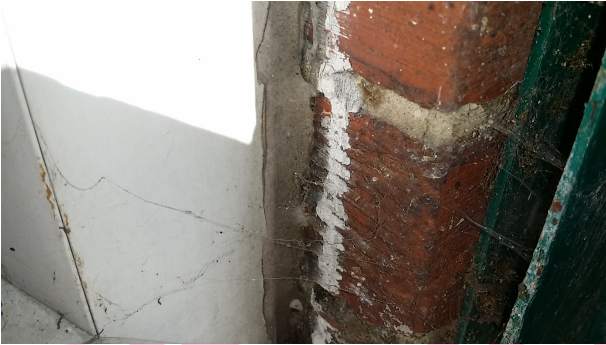
**Item 14 Ref: 181279-9**

The mastic in brick reveals (External) does not contain asbestos.

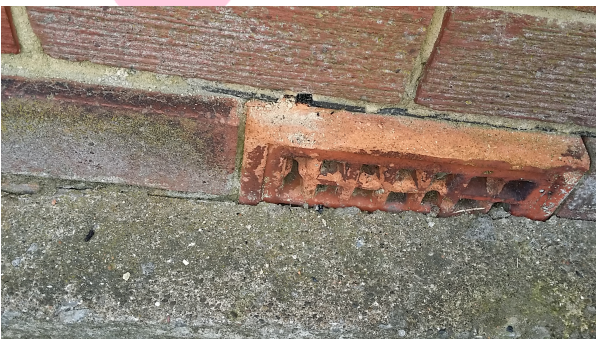
**Item 15 Ref: 181279-10**

The damp proof course (External) does not contain asbestos.

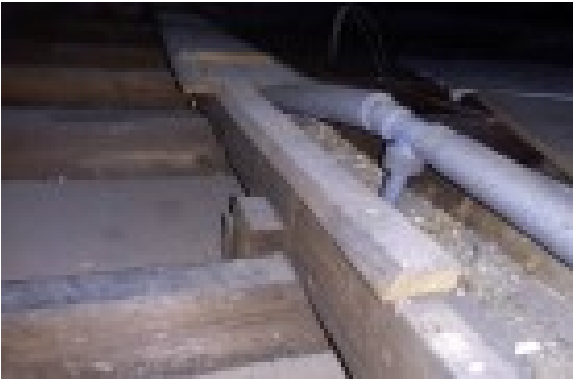
### **Item 19 Ref: KG000460**

The insulation floor in the loft void above WC (L/01) does not contain asbestos.

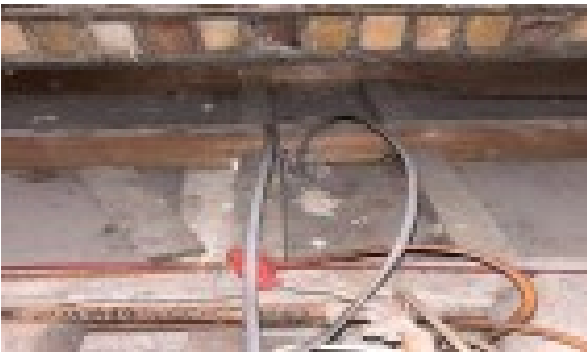
### **Item 20 Ref: As KG000458**

As KG000458 – Cement debris and panel soffit above entrance (Loft void above WC L/01) (Item 20) – Low Risk

The cement debris and panel soffit above entrance (Loft void above WC L/01) does contain asbestos.

Any change in its appearance should be recorded, and passed to Property Services.
