ASBESTOS SURVEY REPORT FOR 22-29 BURLINGTON CLOSE,
SUNDERLAND

Asbestos Register for

22-29 Burlington Close, SUNDERLAND

Date: 30th September 2024

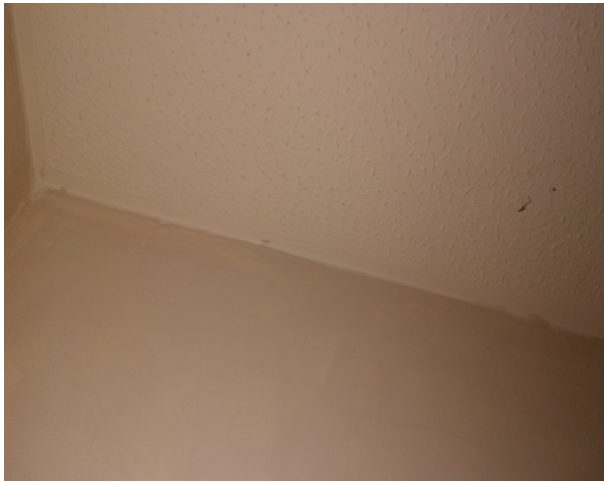
Item 1: 218354-1

The textured coating to the ceiling in the cupboard of 22 Burlington Close does contain asbestos.

Any change in its appearance should be recorded and passed to Property Services.

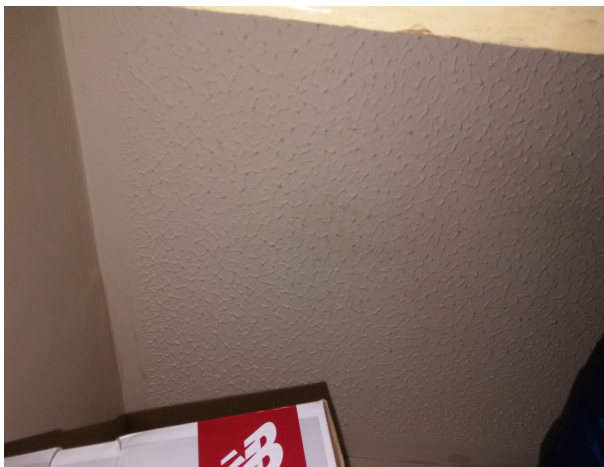
Item 2: As 218354-1

The textured coating to the ceiling in the cupboard of 25 Burlington Close does contain asbestos.

Any change in its appearance should be recorded and passed to Property Services.

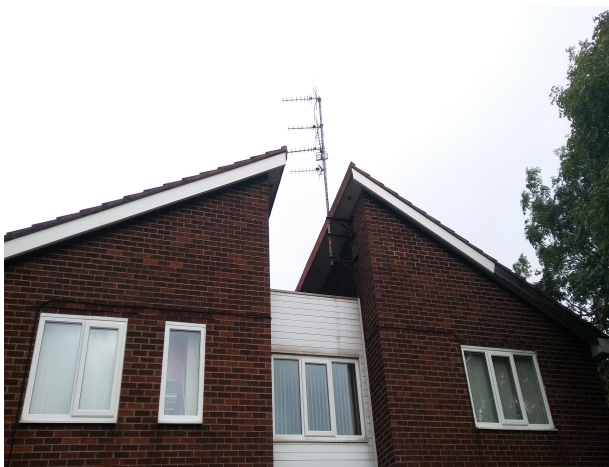
Item 3: 218354-2

The cement roof undercloak to the external of 25 Burlington Close does contain asbestos.

Any change in its appearance should be recorded and passed to Property Services.

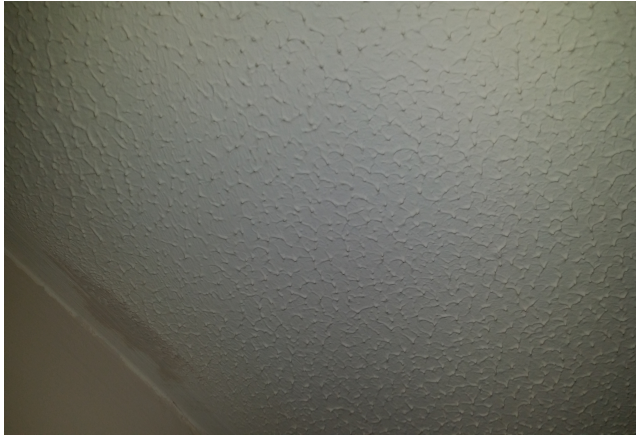
Item 4: 218354-7

The textured coating to the ceiling in the cupboard of 26 Burlington Close does contain asbestos.

Any change in its appearance should be recorded and passed to Property Services.

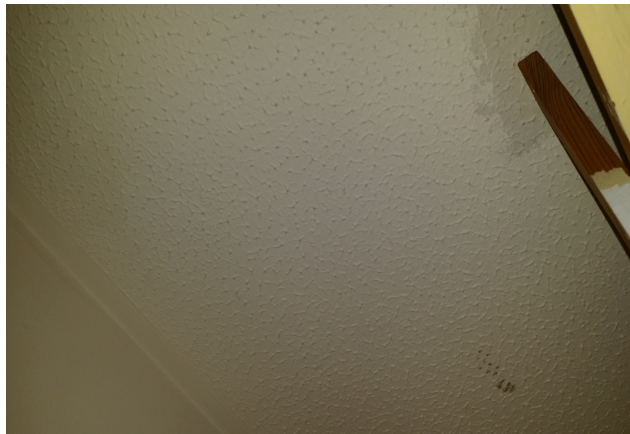
Item 5: 218354-4

The textured coating to the ceiling in the cupboard of 27 Burlington Close does contain asbestos.

Any change in its appearance should be recorded and passed to Property Services.

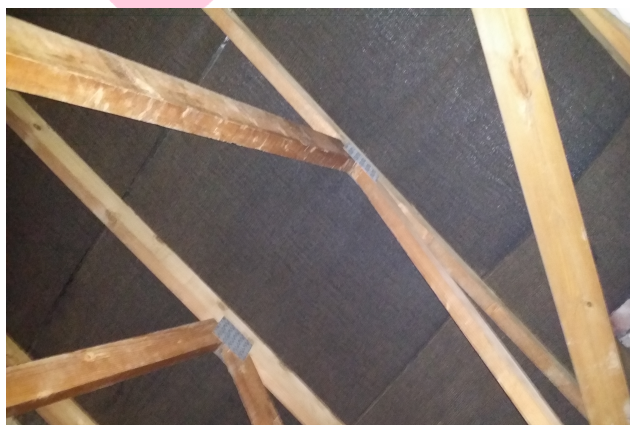
Item 6: 218354-3

The roof felt in the roof void of 27 Burlington Close does not contain asbestos.

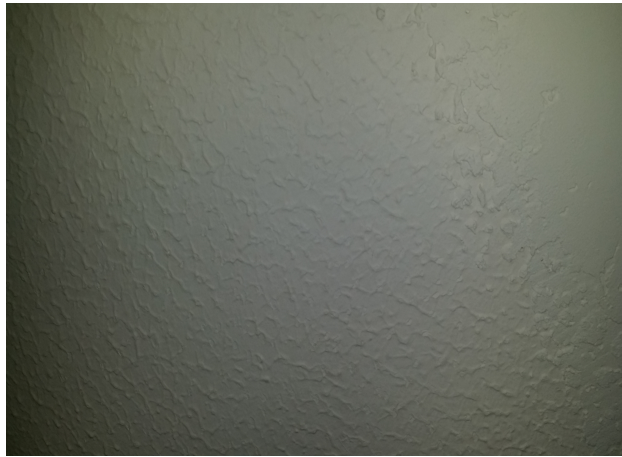
Item 7: 218354-5

The textured coating to the ceiling in the cupboard of 28 Burlington Close does contain asbestos.

Any change in its appearance should be recorded and passed to Property Services.

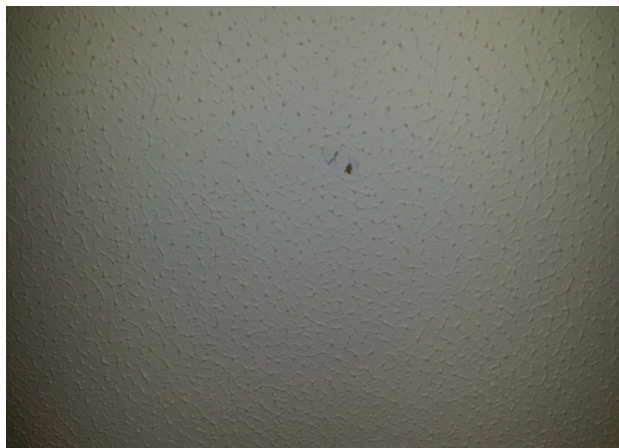
Item 8: 218354-6

The textured coating to the ceiling in the cupboard of 29 Burlington Close does contain asbestos.

Any change in its appearance should be recorded and passed to Property Services.

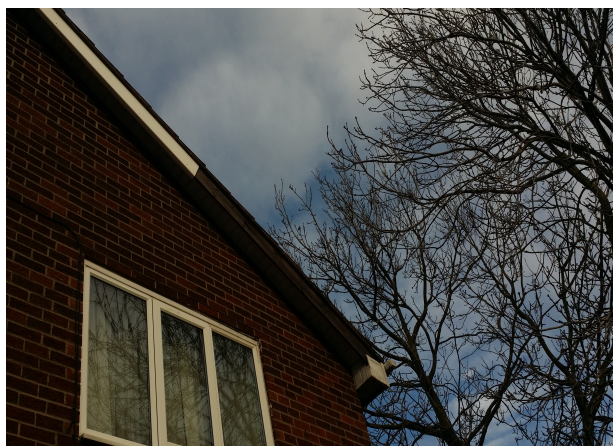
Item 9: As 218354-2

The cement roof undercloak to the external of Burlington Close does contain asbestos.

Any change in its appearance should be recorded and passed to Property Services.
