### ASBESTOS SURVEY REPORT FOR 4 PARK LANE, SUNDERLAND, SR1 3NX

**Asbestos Register for**

**4 Park Lane, Sunderland**

**Date: 30 November 2023**

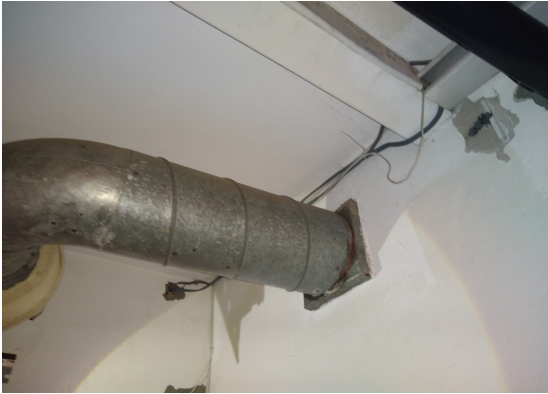
### **Item 1 Ref: 346635-7**

- (Item 1) 346635-7 – Mastic to ducting (Rm 0/03 Cellar) – Very Low Risk
- (Item 2) As 346635-6 – Stair nosing (Rm 0/06 Fire Exit) – No Risk
- (Item 3) As 346635-1 – Textured coating above fixed ceiling (Rm 1/02 Cocktail Bar) – Very Low Risk

The mastic to ducting (Rm 0/03 Cellar) does contain asbestos.

Any change in its appearance should be recorded and passed to Property Services.

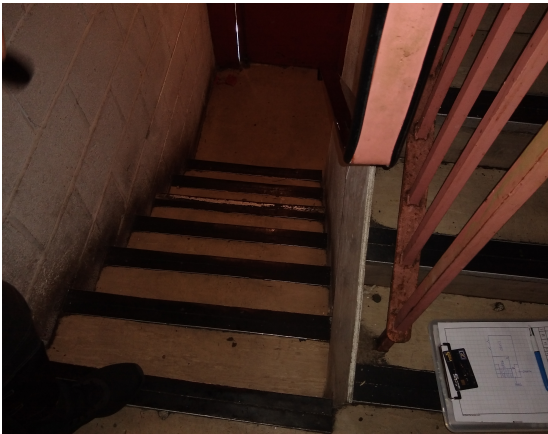
### **Item 2 Ref: As 346635-6**

The stair nosing (Rm 0/06 Fire Exit) does not contain asbestos.

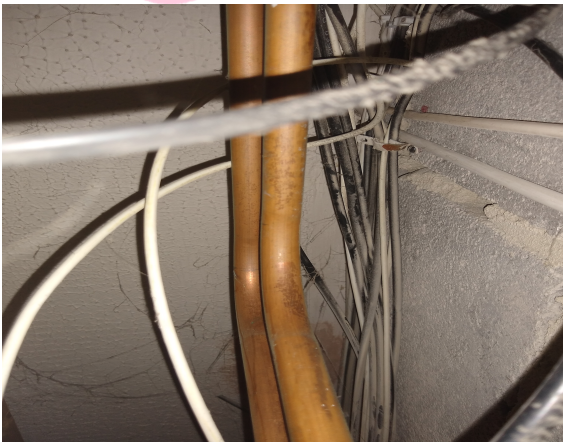
### **Item 3 Ref: As 346635-1**

The textured coating ceiling above the fixed ceiling (Rm 1/02 Cocktail Bar) does contain asbestos.

Any change in its appearance should be recorded and passed to Property Services.

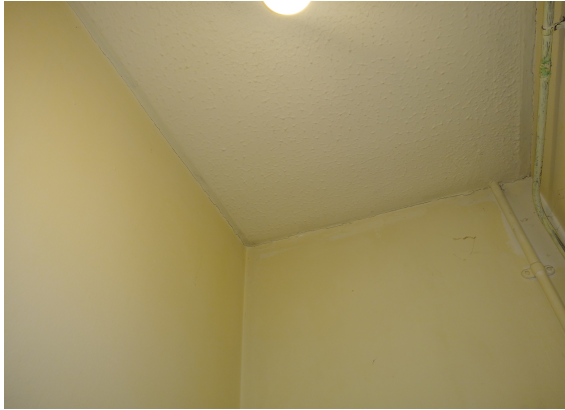
**Item 4 Ref: 346635-1**

The textured coating ceiling (Rm 1/03 WC) does contain asbestos.

Removed as detailed in SGS survey J217462

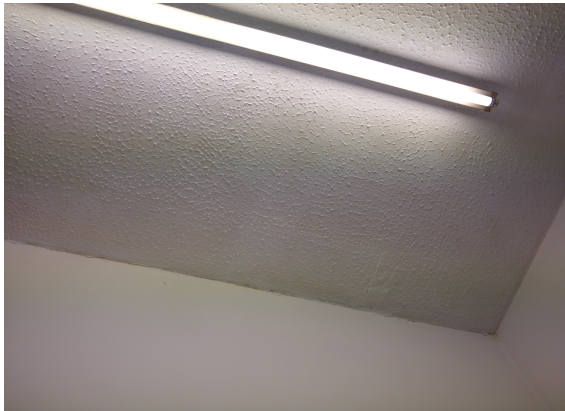
**Item 5 Ref: As 346635-1**

The textured coating ceiling (Rm 1/04 Spirit Store) does contain asbestos.

Any change in its appearance should be recorded and passed to Property Services.

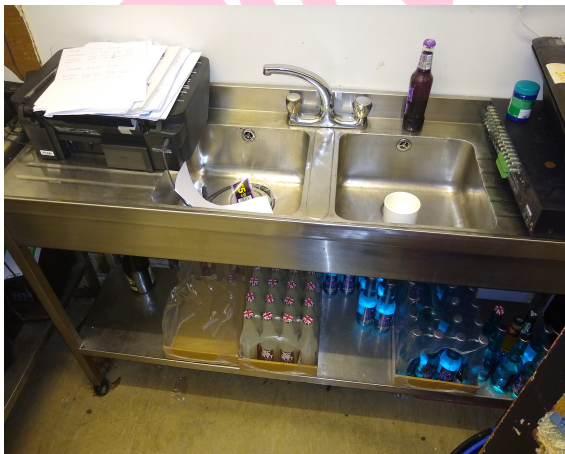
**Item 6 Ref: 346635-2**

The sink pad (Rm 1/04 Spirit Store) does not contain asbestos.

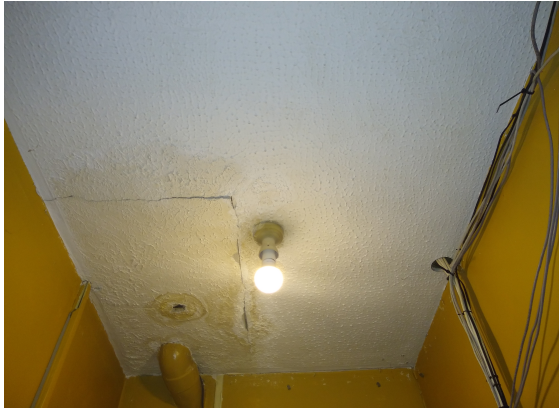
**Item 7 Ref: As 346635-1**

The textured coating ceiling (Rm 1/05 Cash Office) does contain asbestos.

Removed as detailed in SGS survey J217462

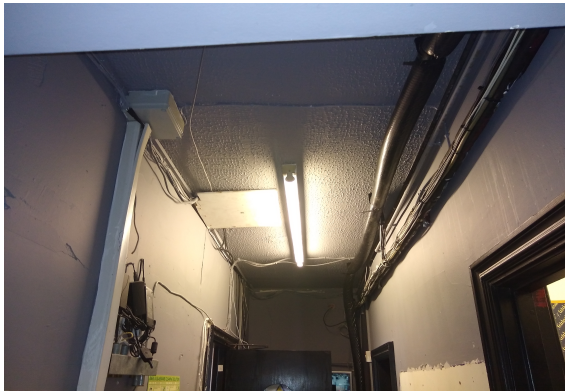
**Item 8 Ref: 346635-3**

The textured coating ceiling (Rm 1/06 Corridor) does contain asbestos.

Any change in its appearance should be recorded and passed to Property Services.

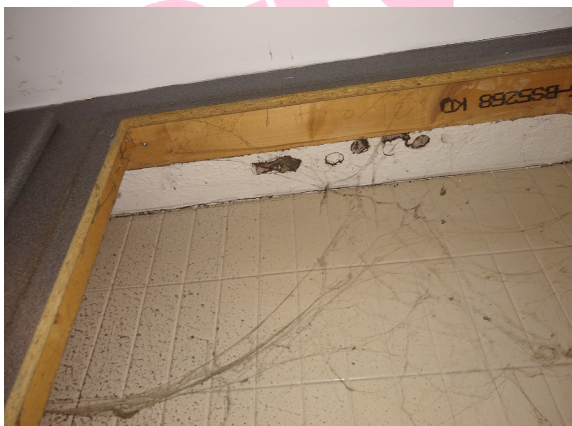
**Item 9 Ref: 346635-4**

The textured coating ceiling (Rm 1/08 Gents toilet and vestibule) does not contain asbestos.

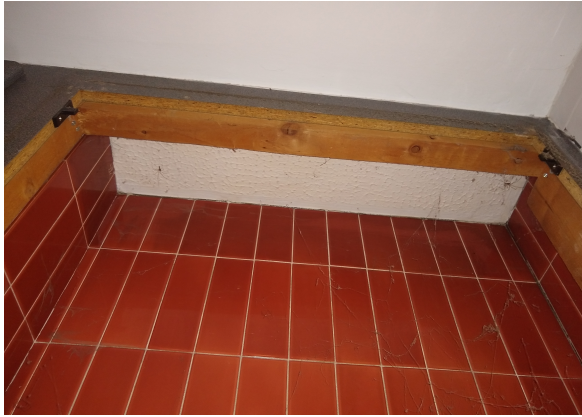
**Item 10 Ref: As 346635-4**

The textured coating ceiling (Rm 1/09 Ladies toilet and vestibule) does not contain asbestos.

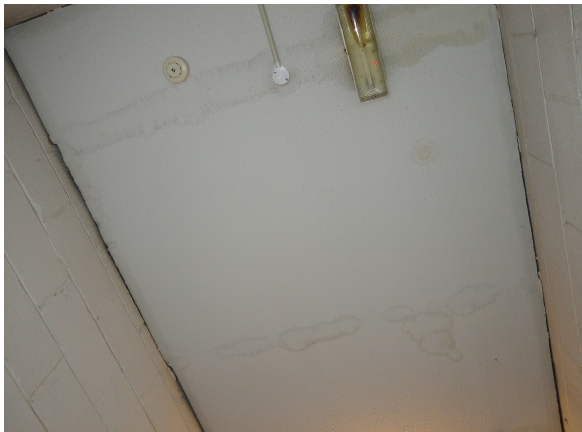
**Item 11 Ref: 346635-5**

The textured coating ceiling (Rm 1/10 Fire Exit) does contain asbestos.

Removed as detailed in SGS survey J217462

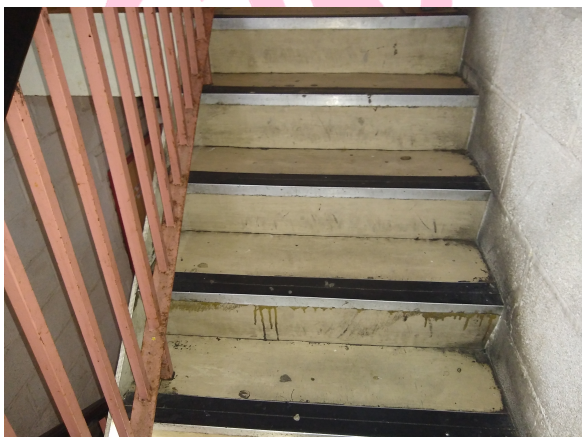
**Item 12 Ref: 346635-6**

The stair nosing (Rm 1/10 Fire Exit) does not contain asbestos.

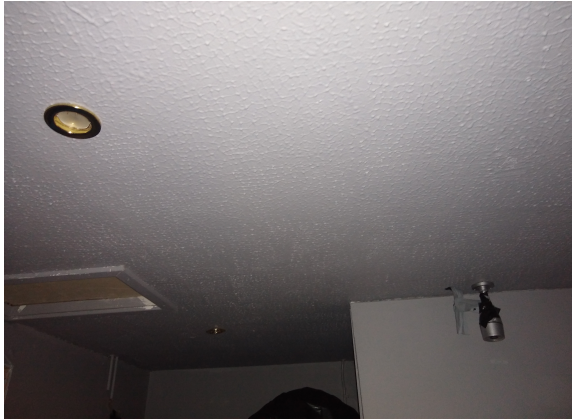
**Item 13 Ref: As 346635-5**

The textured coating ceiling above the fixed ceiling (Rm 1/11 Cocktail Bar) does contain asbestos.

Any change in its appearance should be recorded and passed to Property Services.

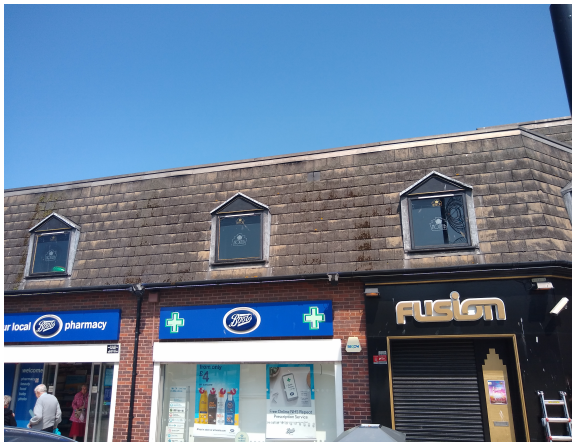
**Item 14 Ref: 346635-8**

The roof tiles (External) does not contain asbestos.

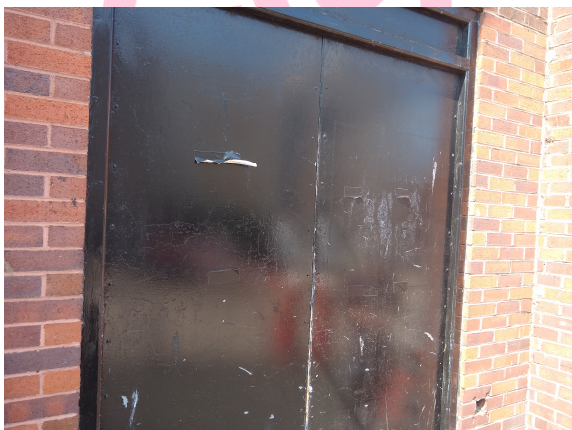
**Item 15 Ref: 346635-9**

The mastic to cellar door (External) does not contain asbestos.
