ASBESTOS SURVEY REPORT FOR SOUTHWICK CEMETERY, SUNDERLAND

SOUTHWICK CEMETERY, SUNDERLAND

Date: 02 October 2024

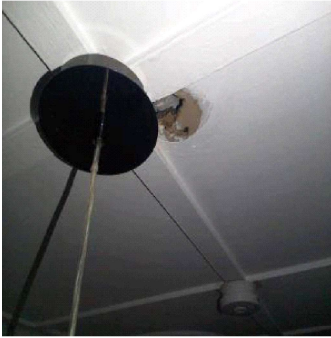
Item 2 - Ref: FB000132

FB000132 – Ceiling (Room 3) (Item 2) – No Risk

The ceiling to the hall (Room 3) does not contain asbestos.

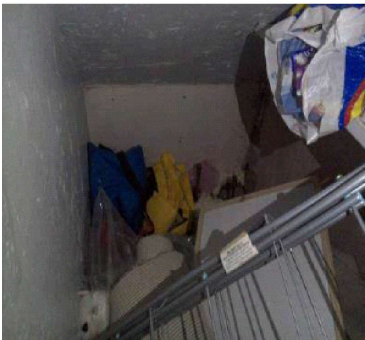
Item 3 - Ref: Presumed

NZ000573 – Panel (Room 4) (Item 3) – No Risk

The panel to the insulation board in the cupboard under the stairs (Room 4) does not contain asbestos.

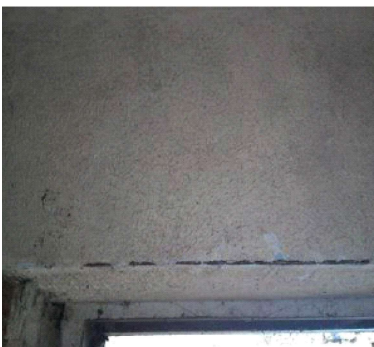
Item 4 - Ref: FB000133

FB000133 – Wall coating surrounding door (Room 1) (Item 4) – Low Risk

The textured coating to the walls to the shed to East Lodge (Room 1) was removed however there remains item surrounding door. Any change in its appearance should be noted and passed to Property Services.

Item 4	East Lodge - Shed Walls remains surrounding door (Room 1)	Low	6 monthly	08/02/2025
Item 5	East Lodge – Shed –Ceiling Room1	Low	6 monthly	Removed 2021

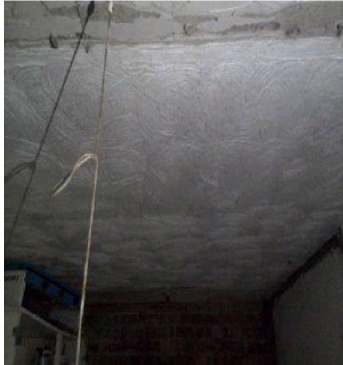
Item 5 - As: FB000133

As FB00133 – Ceiling coating (Room 1) (Item 5) – Removed 2021

The textured coating to the ceiling in the shed to East Lodge (Room 1) contains asbestos.

This item removed 2021

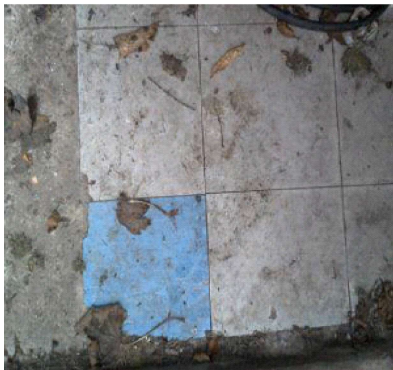
Item 6 - Ref: FB000134

FB00134 – Flooring (Room 1) (Item 6) – Low Risk

The vinyl flooring to the shed (Room 1) contains asbestos.

Item 6	East Lodge – Shed Flooring – Room1	Low	6 monthly	08/02/2025
Item 7	East Lodge – Undercloaking	Very Low	12 monthly	08/08/2025
<i>Item 8</i>	<i>No asbestos</i>	<i>Is present</i>		
<i>Item 9</i>	<i>No asbestos</i>	<i>Is present</i>

Any change in its appearance should be noted and passed to Property Services.

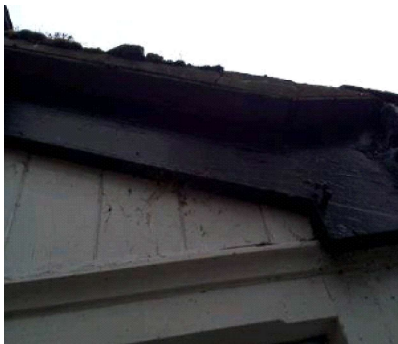
Item 7 - Ref: FB000134

FB000135 – Under cloaking (External) (Item 7) – Very Low Risk

The under cladding to the external contains asbestos.

Any change in its appearance should be noted and passed to Property Services.

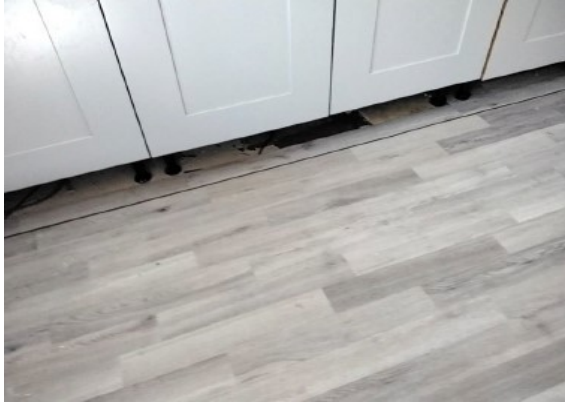
Item 11 – Ref: KX001941

The floor tile (Under floor covering) in the Kitchen (Room G/006) does not contain asbestos.

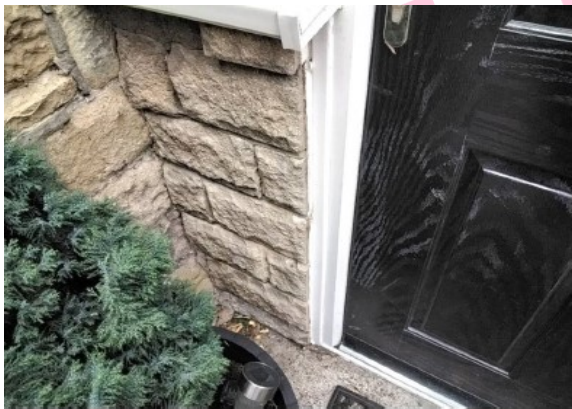
Item 12 - Ref: KX001931

The door seal remnants under modern silicon (External E/001) does not contain asbestos.

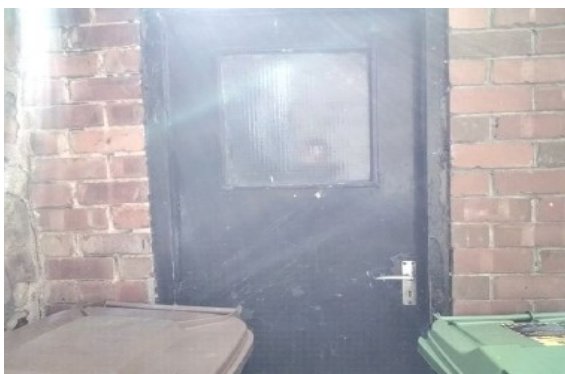
Item 13 - Ref: KX001933

The door seal gaskets to outhouse door (External E/001) does not contain asbestos.

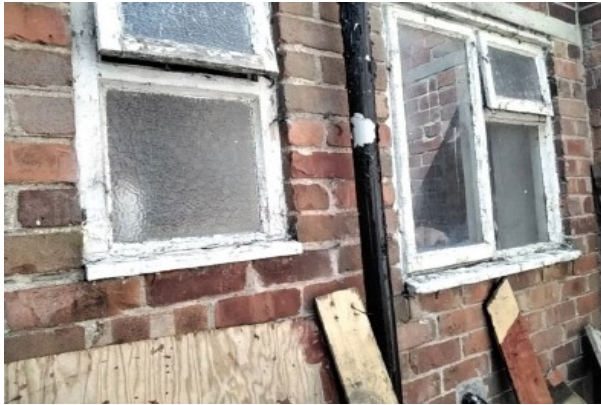
Item 14 Ref: KX001932

The window putty/seal to outhouse windows (External E/001) does not contain asbestos.

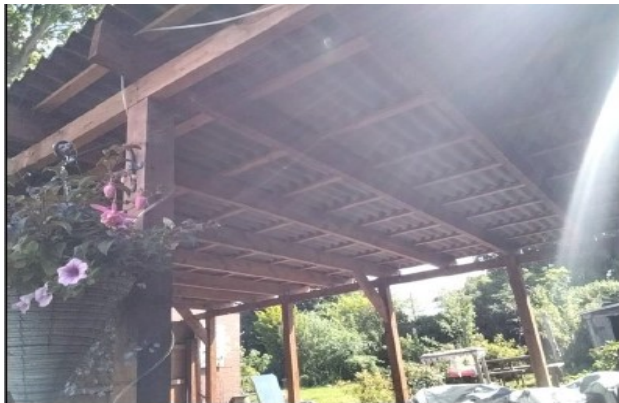
Item 15 - Ref: KX001927

The roof – sheet cladding to the conservatory/sun room (External E/002) does not contain asbestos.

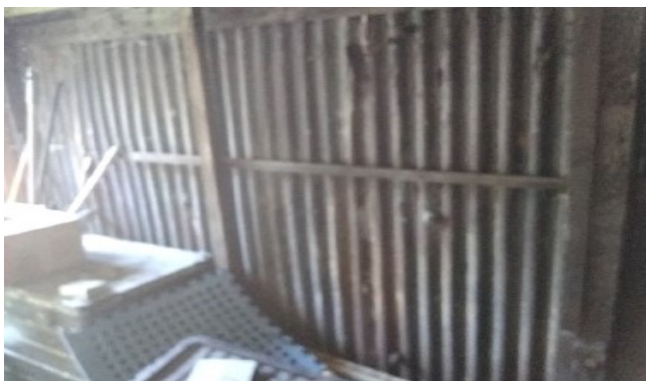
Item 16 - Ref: KX001928

The wall sheet cladding to the garage (External E/003) does not contain asbestos.

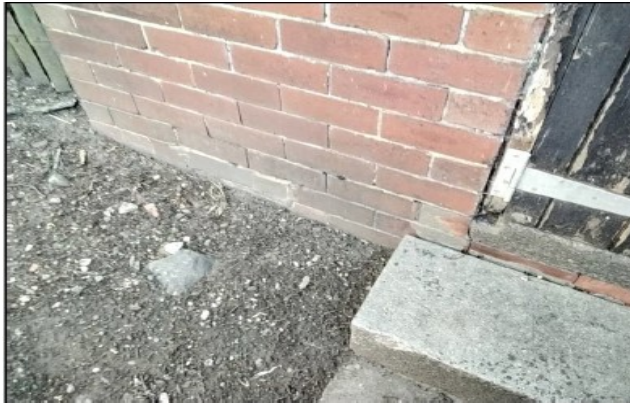
Item 17 – Ref: KX001929

The damp proof course to the toilets (External E/005) does not contain asbestos.

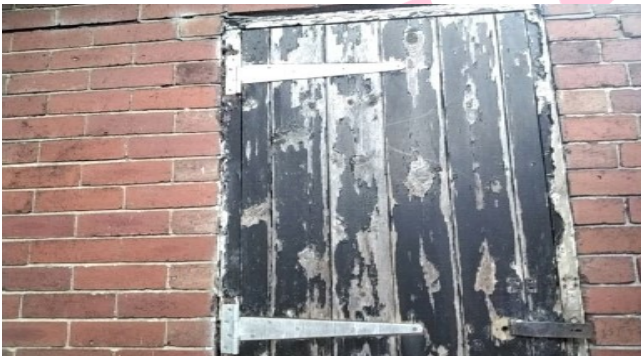
Item 18 - Ref: KX001937

The door seal/gasket to the toilets (External E/005) does not contain asbestos.

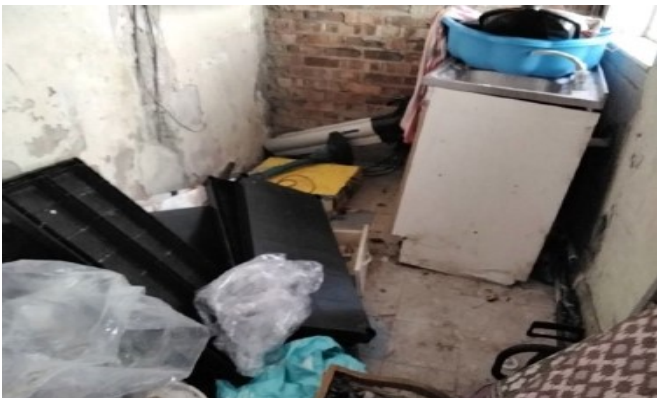
Item 19 - Ref: KX001934

KX001934 – Floor tile grey and blue (Outhouse E/006) (Item 19) – Very Low Risk

The floor tile grey and blue in the outhouse (External E/006) contains asbestos.

Item 19	Floor tile grey and blue (Outhouse E/006)	Very Low Risk	12 monthly	02/08/2025
<i>Item 20</i>	<i>No asbestos</i>	<i>Is present</i>		
Item 21	Wall coating from around door and lintel (Outhouse E/006)	Low Risk	6 monthly	02/02/2025
<i>Item 22</i>	<i>No asbestos</i>	<i>Is present</i>

Any change in its appearance should be noted and passed to Property Services.

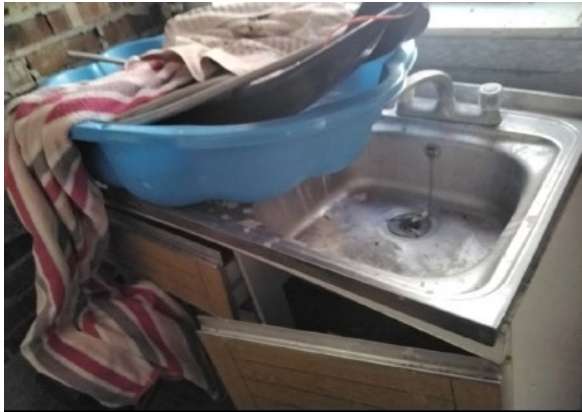
Item 20 – Ref: KX001935

The under sink mat in the outhouse (External E/006) does not contain asbestos.

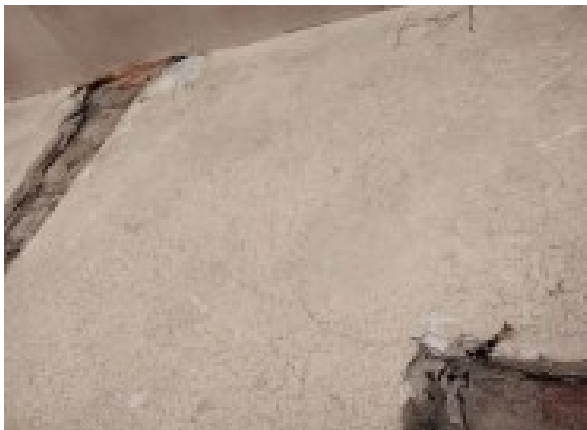
Item 21 - Ref: KX001936

KX001936 – Wall coating from around door and lintel (Outhouse E/006) (Item 21) – Low Risk

The wall coating from around the door and lintel in the outhouse (External E/006) contains asbestos.

Any change in its appearance should be noted and passed to Property Services.

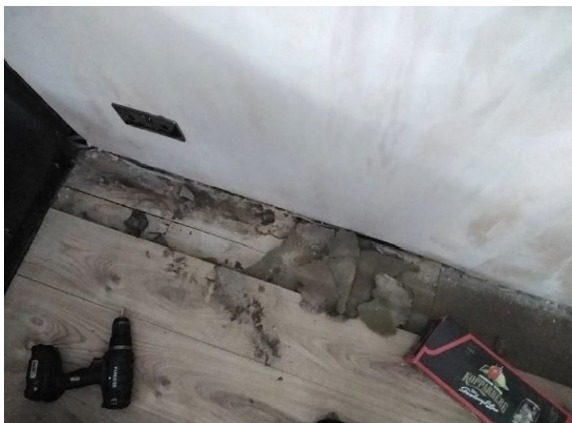
Item 21 - Ref: KX001936

The floor covering beneath the laminate in the Utility /room (G/001) does not contain asbestos.

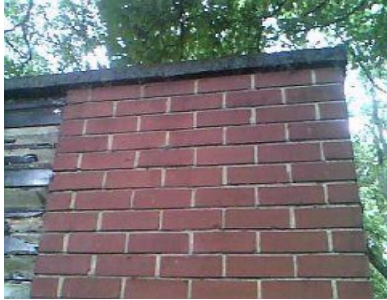
Item 8 - Ref: BB005402

The roof felt to the external of the toilet block does not contain asbestos.

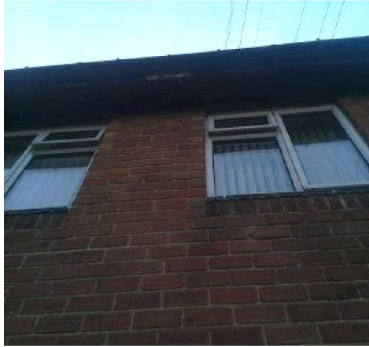
Item 10 - Presumed

Presumed – Soffits (External) (Item 10) – Very Low Risk

The soffits to the external are presumed to contain asbestos.

Any change in its appearance should be noted and passed to Property Services.
