ASBESTOS SURVEY REPORT FOR MERE KNOLLS CEMETERY, TORVER CRESCENT, SUNDERLAND

Asbestos Register for MERE KNOLLS CEMETERY, SUNDERLAND

Date: 28 March 2025

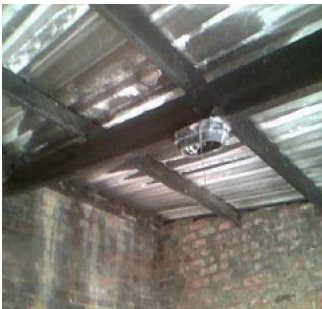
Garage 1 (Room1) was accessed and no suspect materials were found.

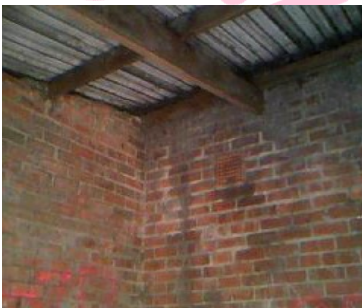
Garage 2 (Room 2) was accessed and no suspect materials were found.

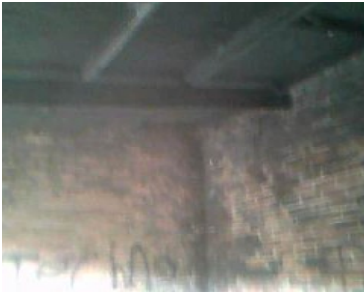
Garage 3 (Room 3) was accessed and no suspect materials were found.

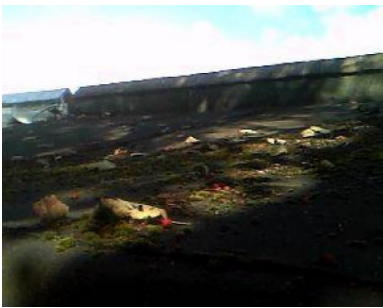
Item 1 – BB005403

BB005403 – Roof Felt (Garage3) (Item 1) – No Risk

The roof felt to garage 3 (Room 3) does not contain asbestos.

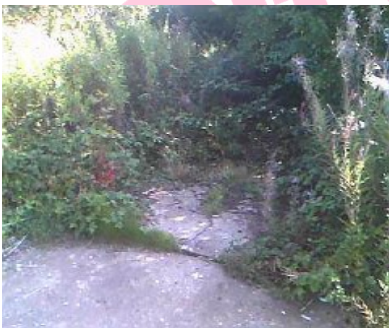
The greenhouses have been demolished, the concrete plinth remains.

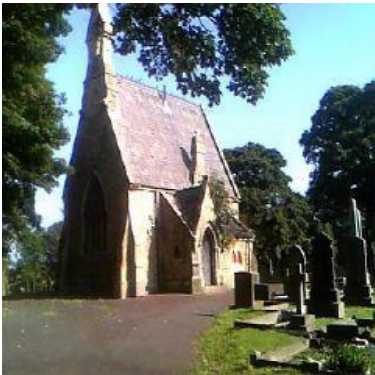
The North Chapel of Rest could not be entered due to the unsound structure of the building. Further investigation should be carried out prior to entering.

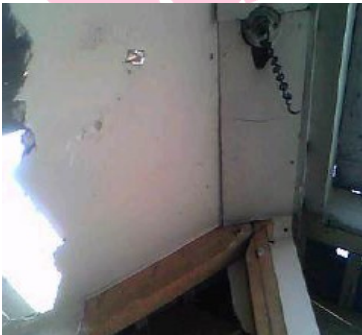
Item 2 – BB005404

The broken ceiling and upstanding panels in room 2 did not contain asbestos.

These sheds were demolished in April 2016.

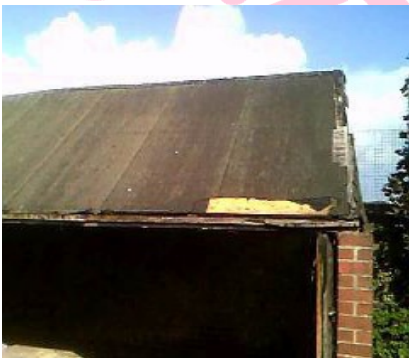
Item 5 Ref: BB005407

The roof felt to the potting sheds did not contain asbestos.

These potting sheds were demolished in April 2015.

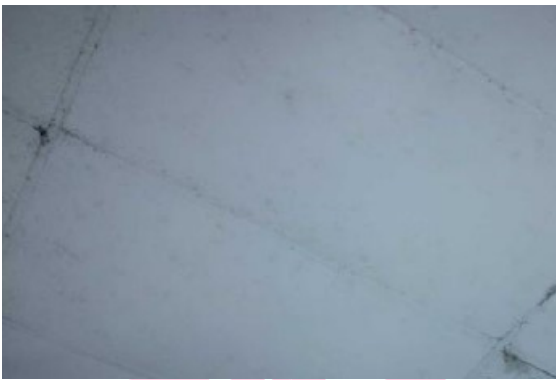
Item 11 Ref: 23-61648-1

23-61648-1 – Ceiling Tiles (Church Hall/Area 1) (Item 11) – No Risk

The ceiling tiles in the Church Hall (Area 1) does not contain asbestos.

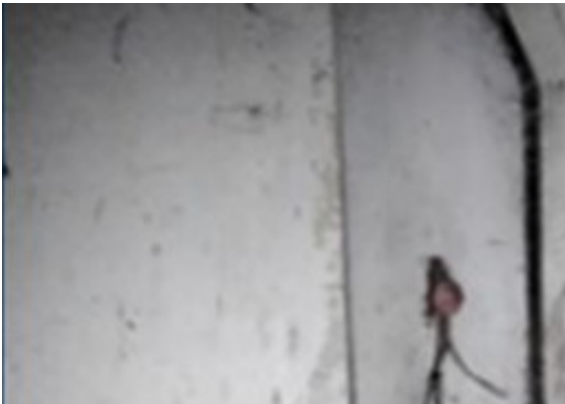
Item 12 Ref: VA006307

VA006307 – Alcove to wall insulation board (Church Hall) (Item 12) – Very Low Risk

The alcove to wall insulation board in the Church Hall does contain asbestos.

Item 12	Alcove to wall insulation board (Church Hall)	Very Low Risk	12 monthly	16/01/2026
West Lodge				
Item 13	Floor covering (Porch G/001)	Very Low Risk	12 monthly	16/01/2025
<i>Item 14</i>	<i>No asbestos</i>	<i>Is present</i>

Any change in appearance should be reported to Property Services.

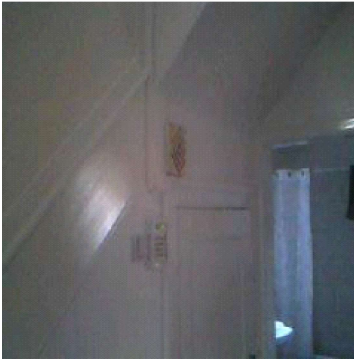
The hall (Room 1) was accessed and no suspect materials were found.

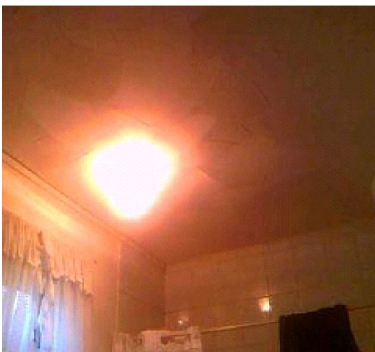
Item 6 Ref:CB008695

CB008695 – Textured coating (Room 3) (Item 6) - No Risk

The textured coating to the ceiling in the bathroom (Room 3) does not contain asbestos.

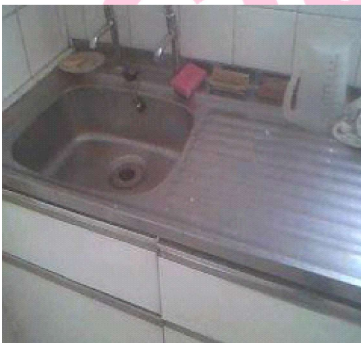
Item 7 Ref:CB008696

The sink pads to the drainer in the kitchen (Room 4) contain asbestos.

Removed April 2021

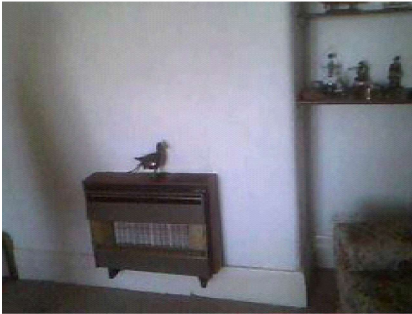
The living room (Room 6) was accessed and no suspect materials were found.

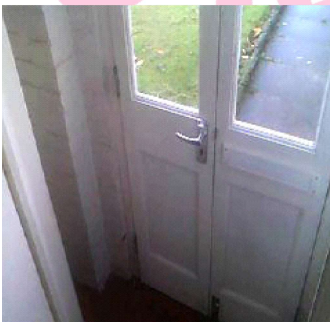
The porch (Room 7) was accessed and no suspect materials were found.

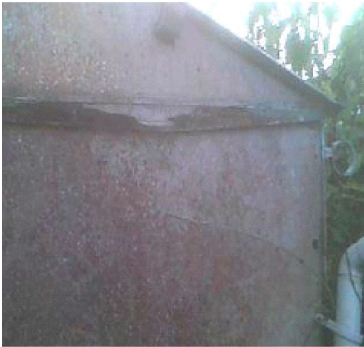
Item 9 Ref:CB008699

The cement walls to the garage (Room 8) contained asbestos.

This was demolished in October 2015.

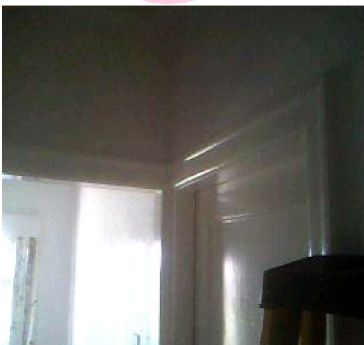
The 1st floor landing (Room 1) was accessed and no suspect materials were found.

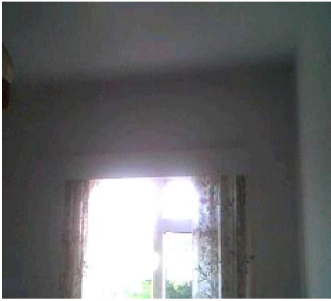
The 1st floor Bedroom 1 (Room 2) was accessed and no suspect materials were found.

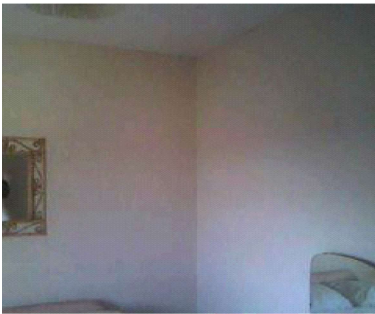
The 1st floor Bedroom 2 (Room 3) was accessed and no suspect materials were found.

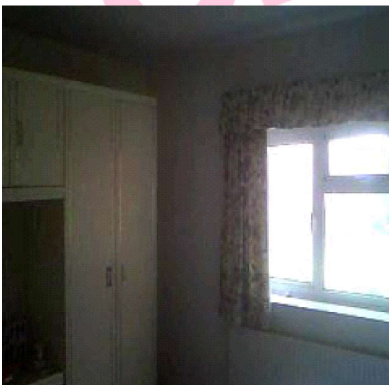
The 1st floor Bedroom 3 (Room 4) was accessed and no suspect materials were found.

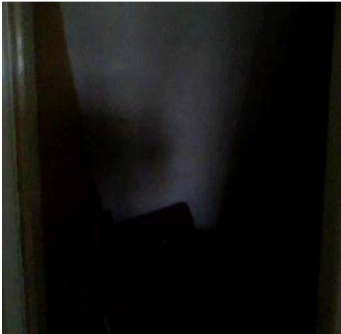
The 1st floor store room (Room 5) was accessed and no suspect materials were found.

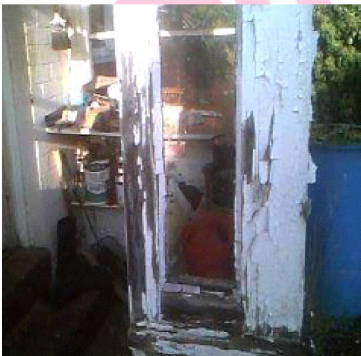
Item 10 Ref:CB008699

CB008697 – Window putty (External) (Item 10) – No Risk

The window putty to the external of the building does not contain asbestos.

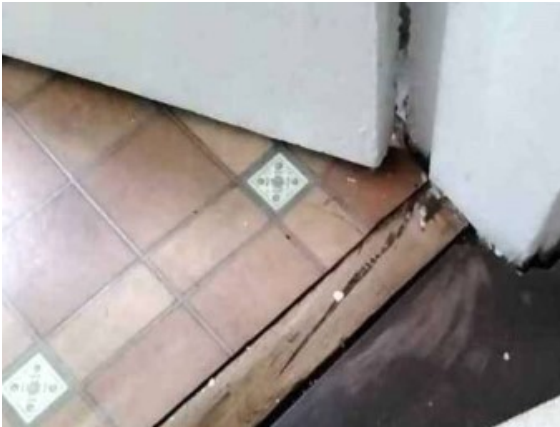
Item 14 Ref: AW005798

AW005798 – Floor covering lower layer (Kitchen G/011) (Item 14) – No Risk

The floor covering lower layer in the Kitchen (Room G/011) does not contain asbestos.

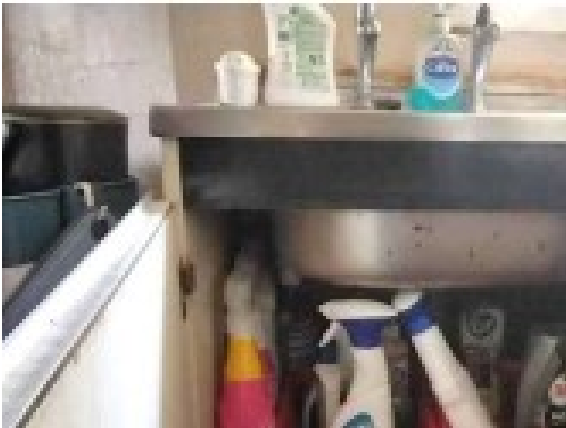
Item 15 Ref: AW005799

AW005799 – Under sink mat (Kitchen G/011) (Item 15) – Very Low Risk

The under sink mat in the Kitchen (Room G/011) does contain asbestos.

Item 15	Under sink mat (Kitchen G/011)	Very Low Risk	12 monthly	16/01/2025
<i>Item 16</i>	<i>No asbestos</i>	<i>Is present</i>		
Item 17	Toilet Cisterns (Toilet G/015)	Very Low Risk	12 monthly	16/01/2025
<i>Item 18</i>	<i>No asbestos</i>	<i>Is present</i>

Any change in appearance should be reported to Property Services.

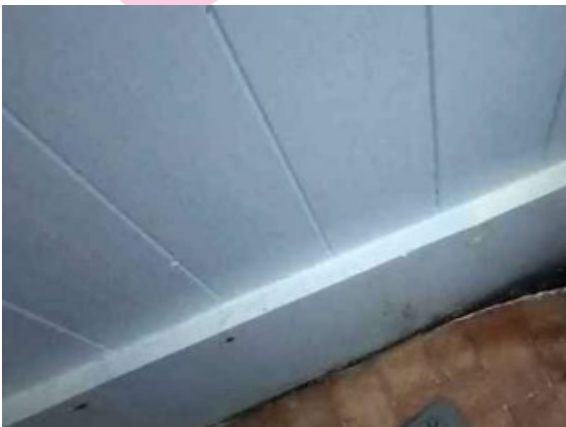
Item 16 Ref: AW005780

AW005780 – Floor covering (Store Cupboard G/013) (Item 16) – No Risk

The floor covering in the Store Cupboard (Room G/013) does not contain asbestos.

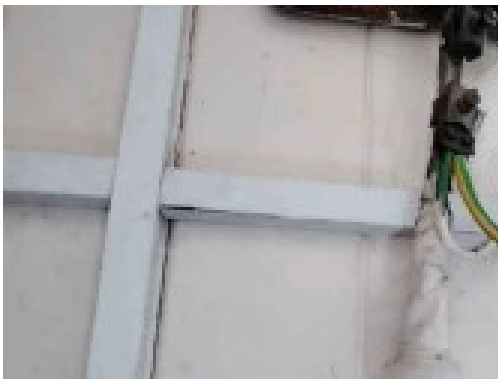
Item 19 Ref: Presumed

Presumed – Wrap to electrical mains incomer (Office G/018) (Item 19) – Very Low Risk

The wrap to electrical mains incomer in the Office (G/018) is presumed to contain asbestos.

Any change in appearance should be reported to Property Services.

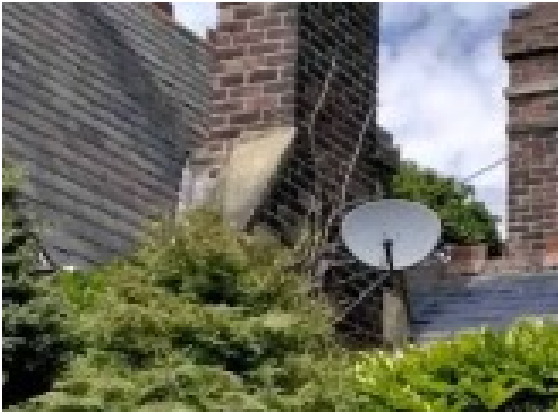
Item 20 Ref: Presumed

Presumed – Roof repair tiles (External E/001) (Item 20) – Very Low Risk

The roof repair tiles External (E/001) is presumed to contain asbestos.

Any change in appearance should be reported to Property Services.

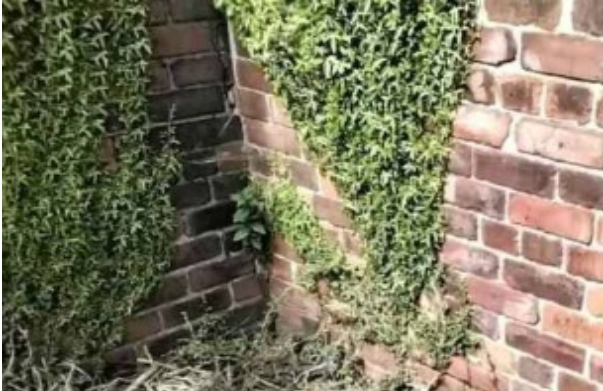
Item 23 Ref: AW005802

AW005802 - Damp proof course (Outhouse/Shed E/004) (Item 23) – No Risk

The damp proof course to the outhouse (E/004) does not contain asbestos.

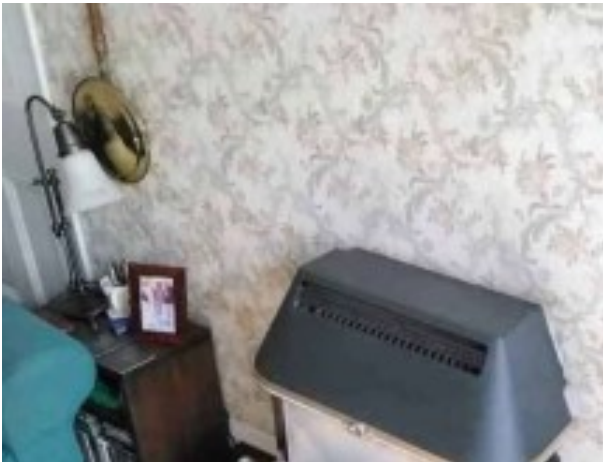
Item 24 Ref: AW006135

AW006135 – *Chimney breast internal soffit (Living Room/Lounge G/006) (Item 24) – Removed November 2024*

The chimney breast (internal soffit) in the Lounge/Living room G/006 contains asbestos.

Removed November 2024
