ASBESTOS SURVEY REPORT FOR MERE KNOLLS CEMETERY, TORVER CRESCENT, SUNDERLAND

Asbestos Register for MERE KNOLLS CEMETERY, SUNDERLAND

Date: 20 November 2024

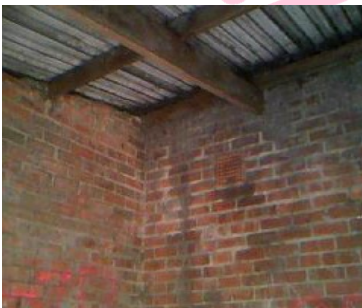
Garage 2 (Room 2) was accessed and no suspect materials were found.

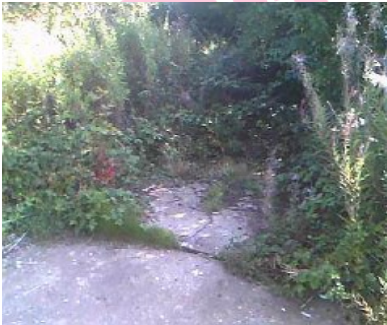
The greenhouses have been demolished, the concrete plinth remains.

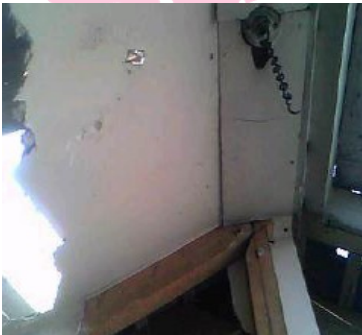
Item 2 – BB005404

The broken ceiling and upstanding panels in room 2 did not contain asbestos.

These sheds were demolished in April 2016.

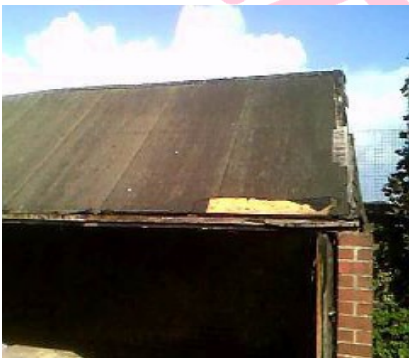
Item 5 Ref: BB005407

The roof felt to the potting sheds did not contain asbestos.

These potting sheds were demolished in April 2015.

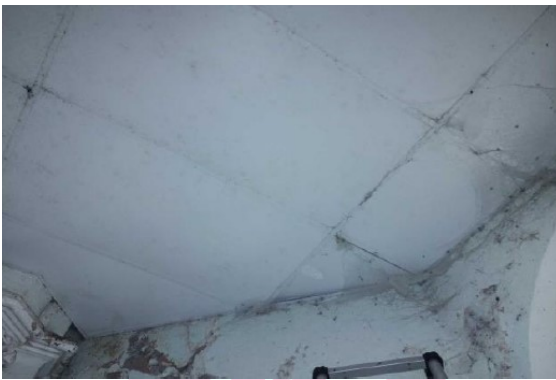
Item 11 Ref: 23-61648-1

The ceiling tiles in the Church Hall (Area 1) does not contain asbestos.

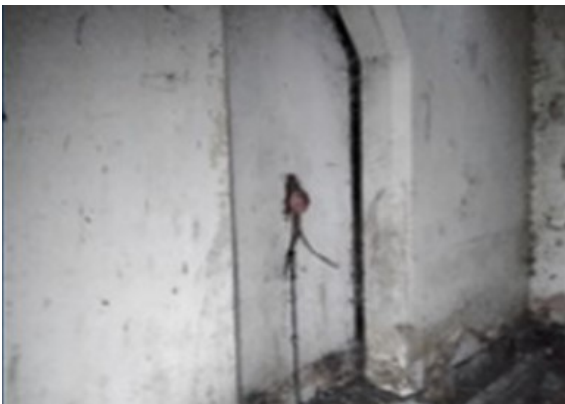
Item 12 Ref: VA006307

VA006307 – Alcove to wall insulation board (Church Hall) (Item 12) – Very Low Risk

The alcove to wall insulation board in the Church Hall does contain asbestos.

Any change in appearance should be reported to Property Services.

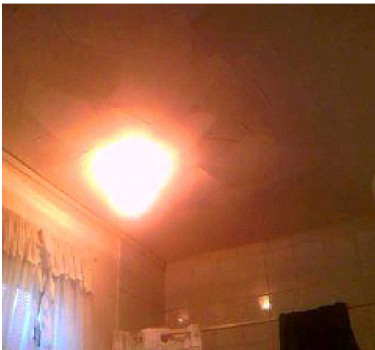
Item 6 Ref:CB008695

The textured coating to the ceiling in the bathroom (Room 3) does not contain asbestos.

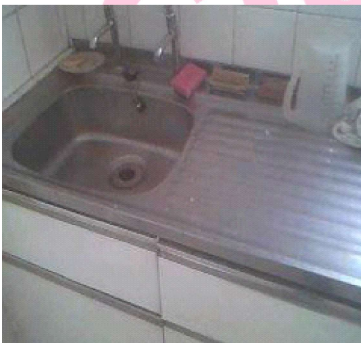
Item 7 Ref:CB008696

The sink pads to the drainer in the kitchen (Room 4) contain asbestos.

Removed April 2021

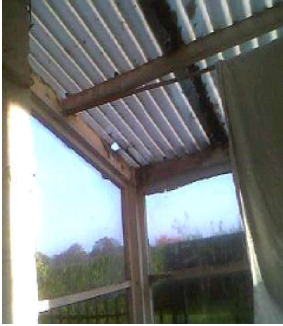
The rear porch (Room 5) was accessed and no suspect materials were found.

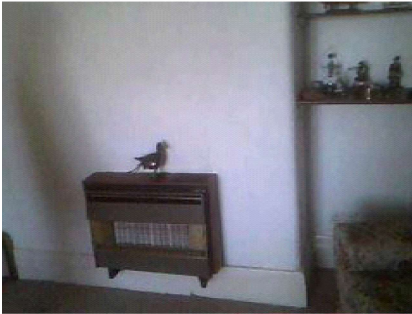
The living room (Room 6) was accessed and no suspect materials were found.

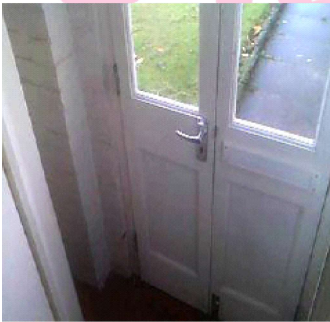
The porch (Room 7) was accessed and no suspect materials were found.

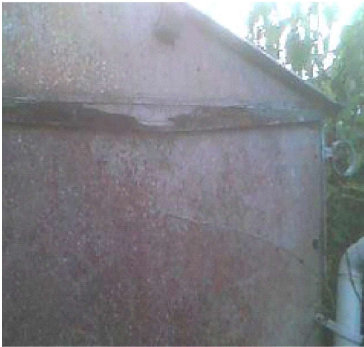
Item 9 Ref:CB008699

The cement walls to the garage (Room 8) contained asbestos.

This was demolished in October 2015.

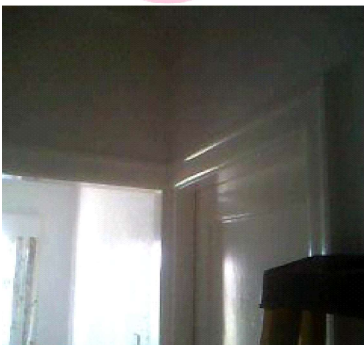
The 1st floor landing (Room 1) was accessed and no suspect materials were found.

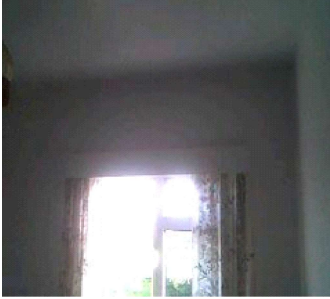
The 1st floor Bedroom 1 (Room 2) was accessed and no suspect materials were found.

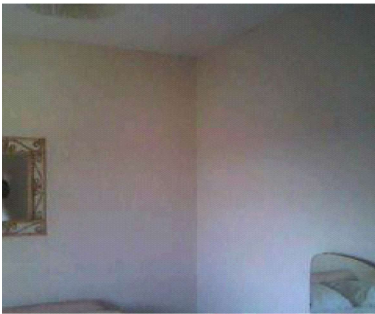
The 1st floor Bedroom 2 (Room 3) was accessed and no suspect materials were found.

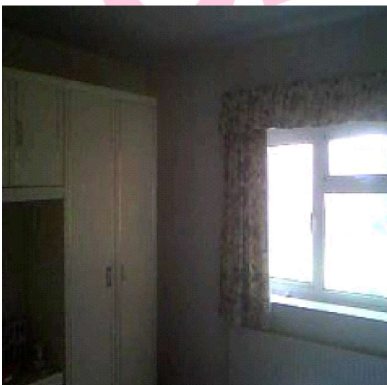
The 1st floor Bedroom 3 (Room 4) was accessed and no suspect materials were found.

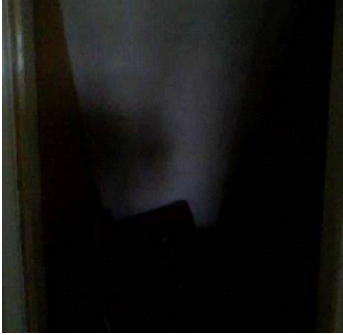
The 1st floor store room (Room 5) was accessed and no suspect materials were found.

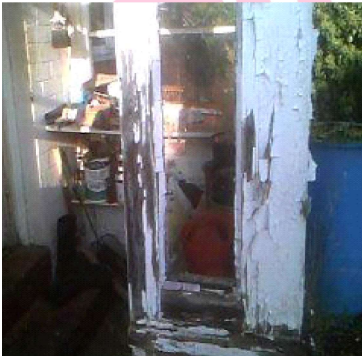
Item 10 Ref:CB008699

The window putty to the external of the building does not contain asbestos.

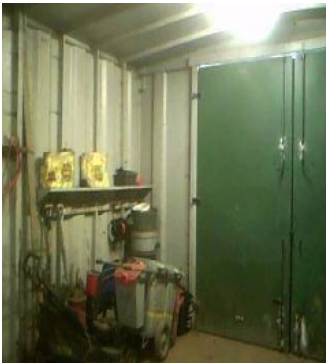
The stores (Room1) was accessed and no suspect materials were found.

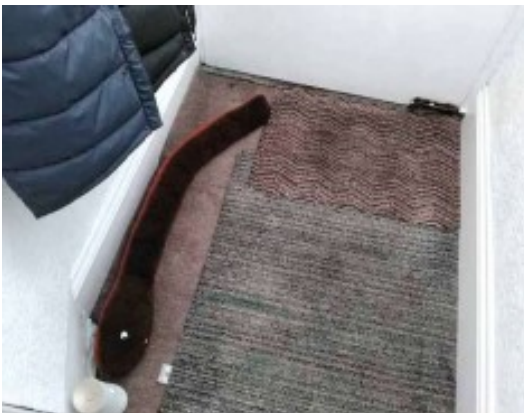
Item 13 Ref: AW005797

AW005797 – Floor covering (Porch G/001) (Item 13) – Very Low Risk

The floor covering in the Porch (Room G/001) does contain asbestos.

Any change in appearance should be reported to Property Services.

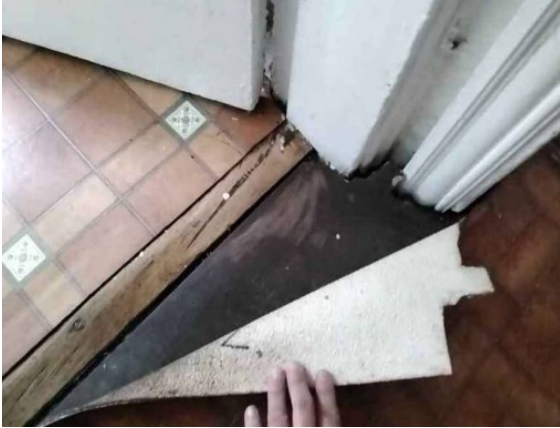
Item 14 Ref: AW005798

The floor covering lower layer in the Kitchen (Room G/011) does not contain asbestos.

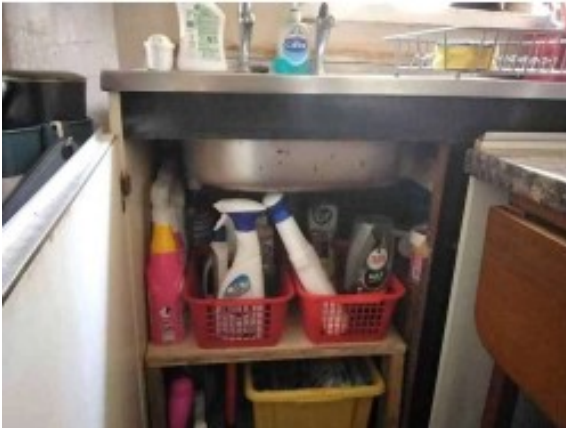
Item 15 Ref: AW005799

AW005799 – Under sink mat (Kitchen G/011) (Item 15) – Very Low Risk

The under sink mat in the Kitchen (Room G/011) does contain asbestos.

Any change in appearance should be reported to Property Services.

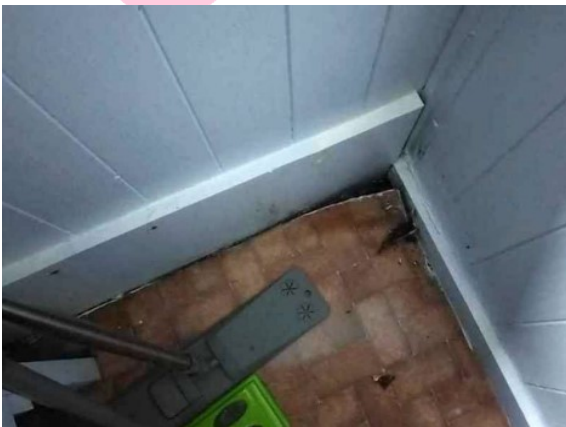
Item 16 Ref: AW005780

The floor covering in the Store Cupboard (Room G/013) does not contain asbestos.

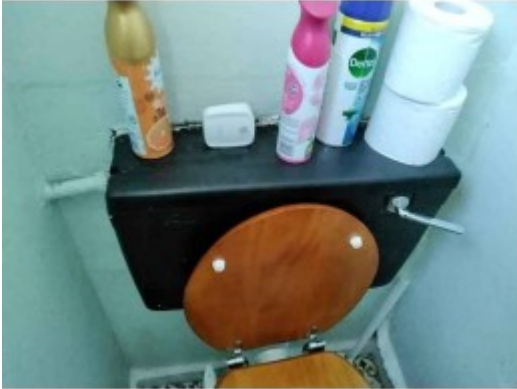
Item 17 Ref: Presumed

Presumed – Toilet Cisterns (Toilet G/015) (Item 17) – Very Low Risk

The toilet cistern in the toilet (Room G/015) does contain asbestos.

Any change in appearance should be reported to Property Services.

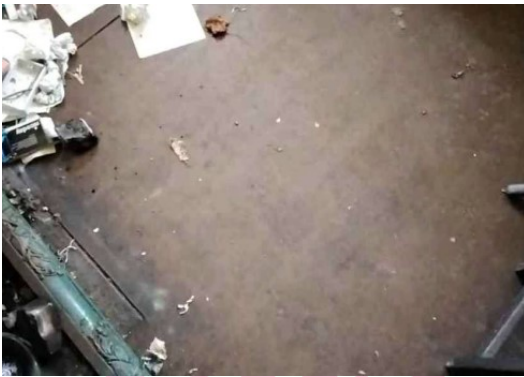
Item 18 Ref: AW005801

The floor covering in the Office (Room G/018) does not contain asbestos.

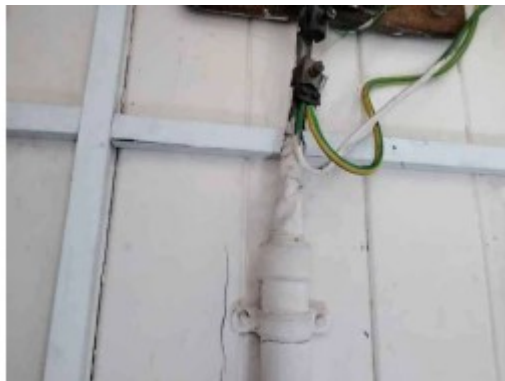
Item 19 Ref: Presumed

Presumed – Wrap to electrical mains incomer (Office G/018) (Item 19) – Very Low Risk

The wrap to electrical mains incomer in the Office (G/018) is presumed to contain asbestos.

Any change in appearance should be reported to Property Services.

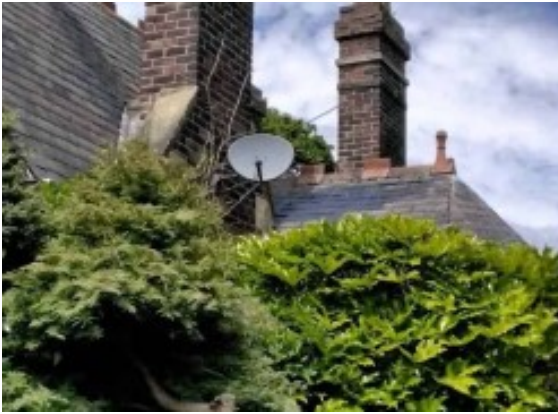
Item 20 Ref: Presumed

Presumed – Roof repair tiles (External E/001) (Item 20) – Very Low Risk

The roof repair tiles External (E/001) is presumed to contain asbestos.

Any change in appearance should be reported to Property Services.

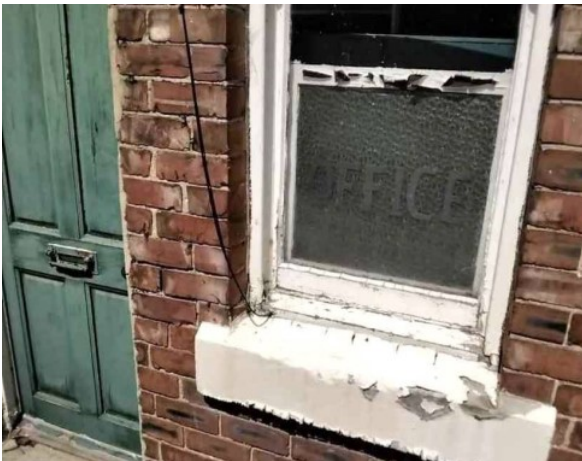
Item 21 Ref: AW005803

The window putty seal to timber windows (External E/001) does not contain asbestos.

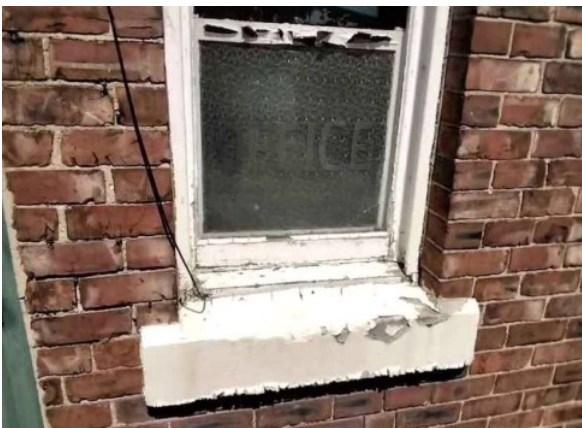
Item 22 Ref: AW005804

The window frame sealant (External E/001) does not contain asbestos.

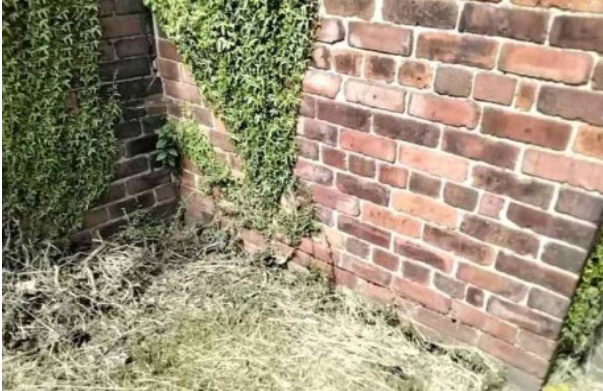
Item 23 Ref: AW005802

The damp proof course to the outhouse (E/004) does not contain asbestos.

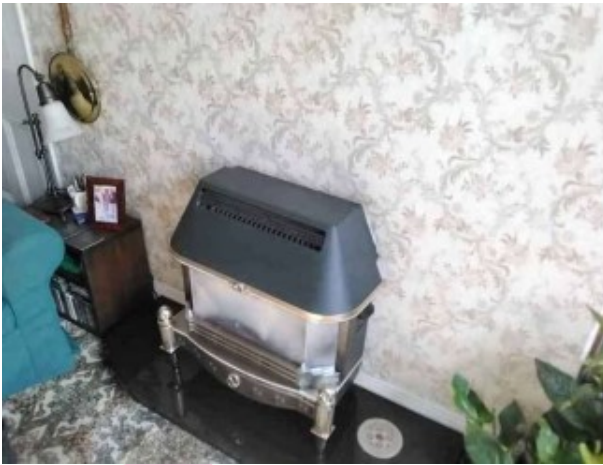
Item 24 Ref: AW006135

The chimney breast (internal soffit) in the Lounge/Living room G/006 contains asbestos.

Removed November 2024
