ASBESTOS SURVEY REPORT FOR PUBLIC CONVENIENCES, THE TRAM SHELTER TOILETS, QUEENS PARADE, SUNDERLAND.

**Asbestos Register for**

**PUBLIC CONVENIENCES, THE TRAM SHELTER  
TOILETS, QUEENS PARADE, SUNDERLAND**

**Date: 17 November 2022**

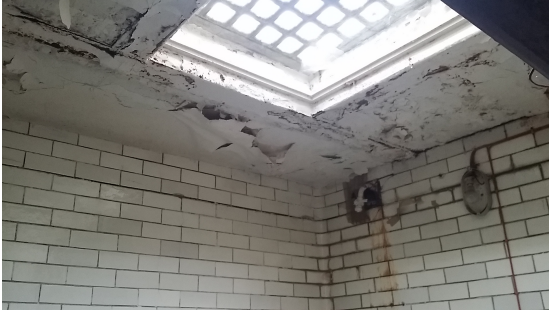
### **Item 1 Ref: 116366-15**

The coating to concrete ceiling  
- room 01/cleaners office -  
does not contain asbestos

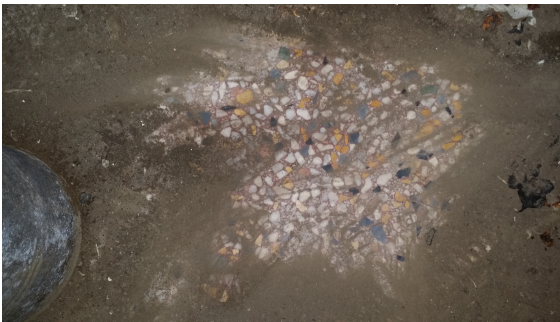
### **Item 2 Ref: 116366-1**

The floor covering (terrazzo) -  
room 01/cleaners office - does  
not contain asbestos

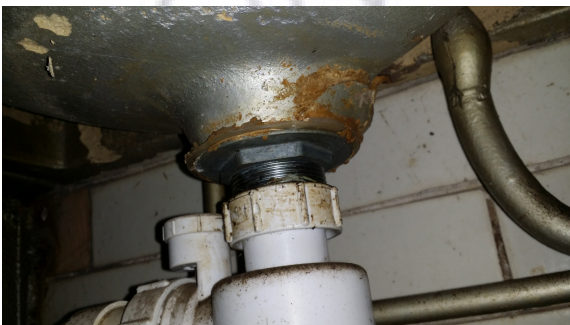
### **Item 3 Ref: 116366-2**

The sealant to plastic gasket  
below sink mastic - room  
01/cleaners office - does not  
contain asbestos

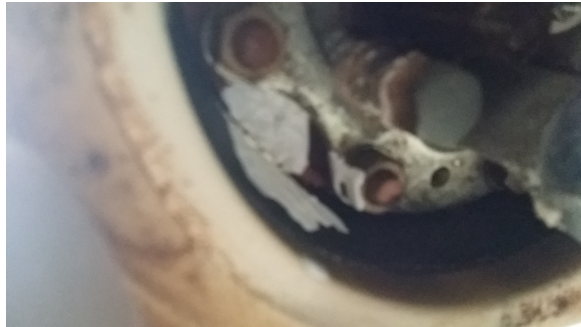
**Item 4 Ref: 116366-16**

The water heater sadia -  
gasket - room 01/cleaners  
office - contains asbestos

**This was removed April  
2018.**

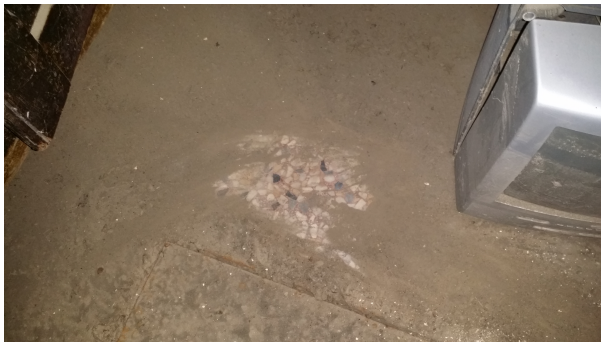
**Item 5 Ref: As 116366-1**

The floor covering (terrazzo) -  
room 02/store - does not  
contain asbestos

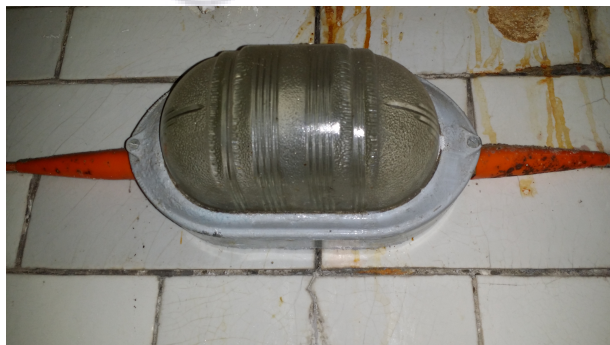
**Item 6 Ref: 116366-3**

The gasket to metal light  
casing - room 02/store -  
contains asbestos

**This was removed April  
2018.**

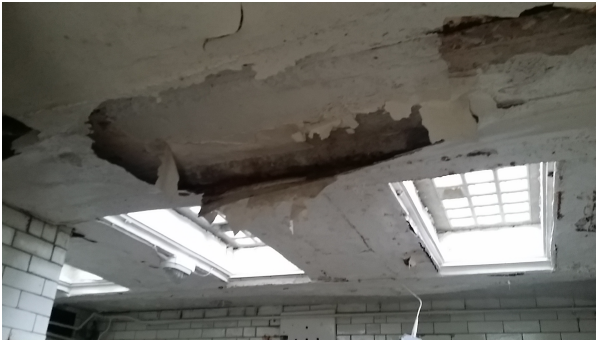
**Item 7 Ref: 116366-14**

The coating to concrete ceiling  
– room 03/female wc - does  
not contain asbestos

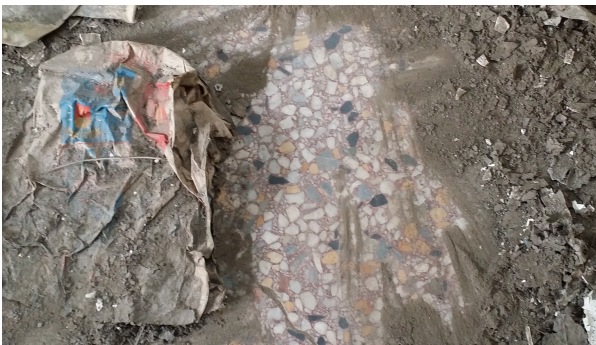
**Item 8 Ref: As 116366-1**

The floor covering (terrazzo) -  
room 03/female wc - does not  
contain asbestos

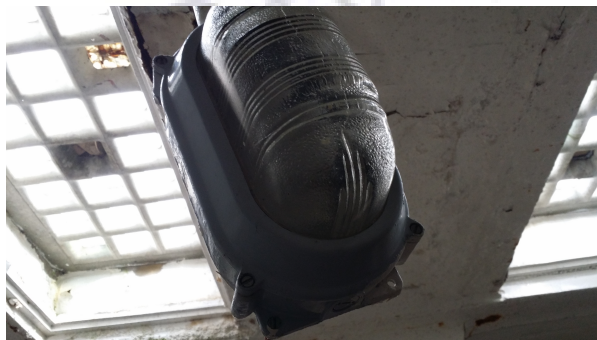
**Item 9 Ref: As 116366-3**

The gasket to metal light  
casings - room 03/female wc -  
contains asbestos

**This was removed April  
2018.**

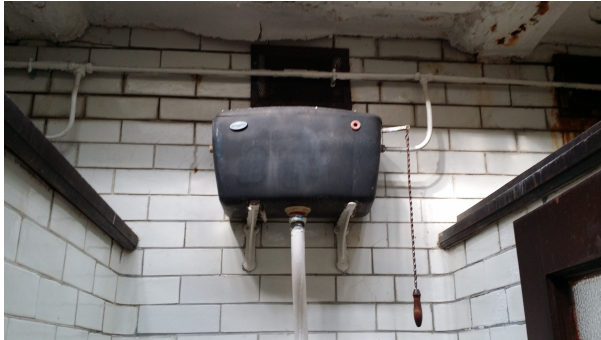
**Item 10 Ref: 116366-4**

The toilet cistern - room 03/female wc - contains asbestos

**This was removed April 2018.**

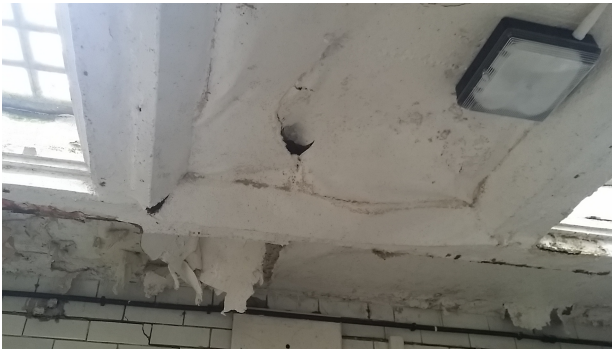
**Item 11 Ref: 116366-12**

The ceiling paint – room 04/male wc - does not contain asbestos

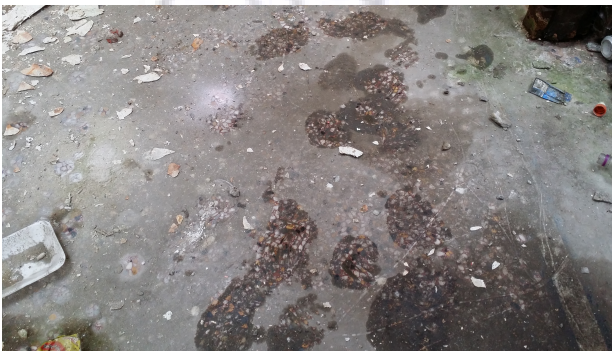
**Item 12 Ref: 116366-8**

The floor covering (terrazzo) - room 04/male wc - does not contain asbestos

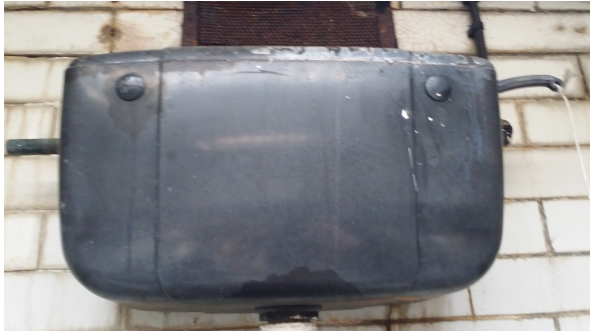
**Item 13 Ref: 116366-9**

The toilet cistern - room 04/male wc - contains asbestos

**This was removed April 2018.**

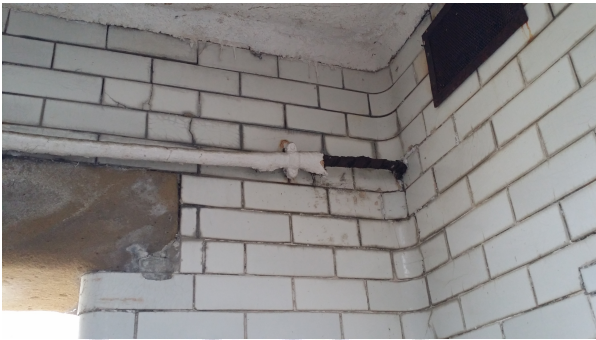
**Item 14 Ref: 116366-10**

The pipe lagging above entrance – room 04/male wc - does not contain asbestos

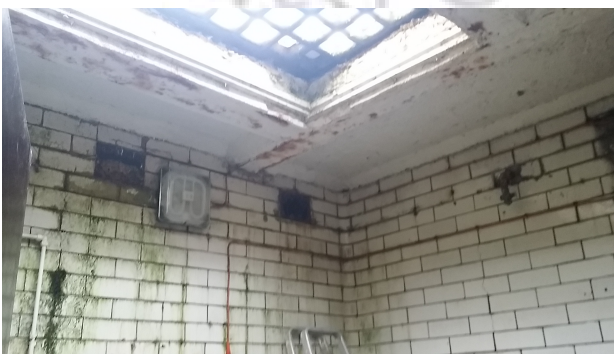
**Item 15 Ref: 116366-13**

The coating to concrete ceiling – room 05/cleaners office - does not contain asbestos

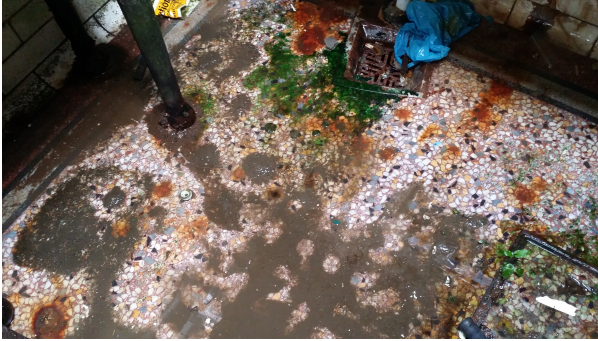
**Item 16 Ref: As 116366-8**

The floor covering (terrazzo) - room 05/cleaners office - does not contain asbestos

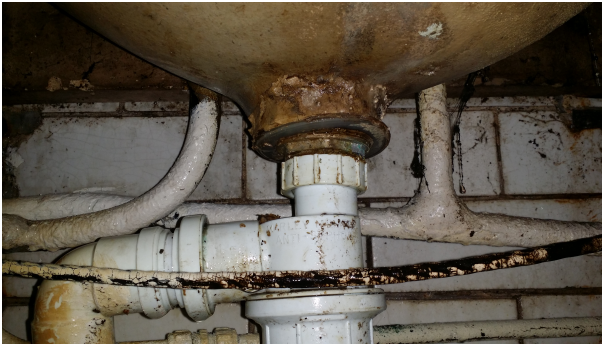
**Item 17 Ref: 116366-11**

The sealant to plastic gasket below sink - room 05/cleaners office - does not contain asbestos

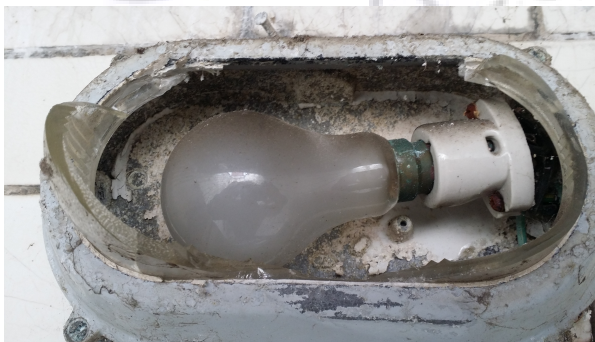
**Item 18 Ref: 116366-5**

The gasket to metal lighting casing - external - contains asbestos

**This was removed April 2018.**

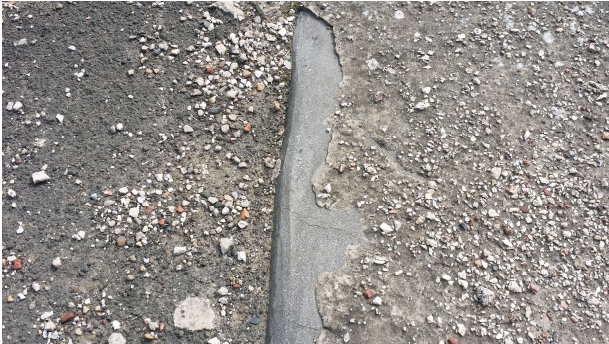
**Item 19 Ref: 116366-6**

The roof covering - external - does not contain asbestos

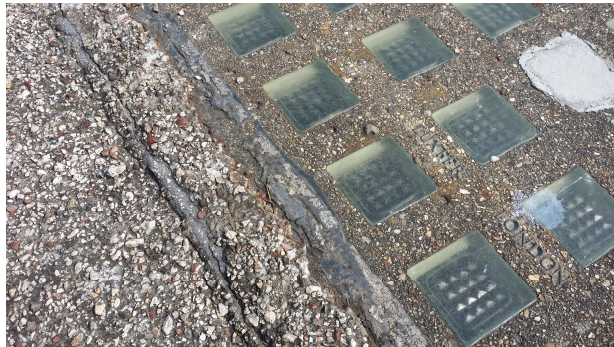
**Item 20 Ref: 116366-7**

The sealant to skylight – external (female wc) - contains asbestos

**This was removed April 2018.**
