ASBESTOS SURVEY REPORT FOR BARLEY MOW PARK, RYHOPE ROAD, SUNDERLAND, SR2 7DN.

Asbestos Register for

Barley Mow Park, Ryhope Road, SR2 7DN

Date: 15 January 2025

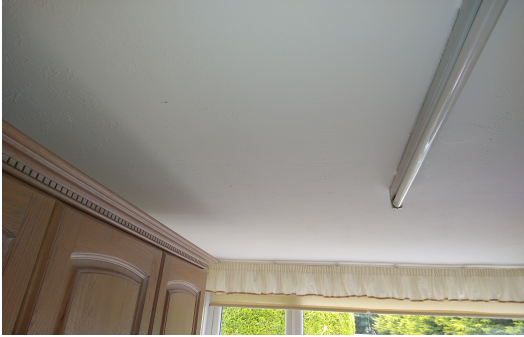
Item 1 Ref: 416023-5

The ceiling in the kitchen (Rm 0/004) does not contain asbestos.

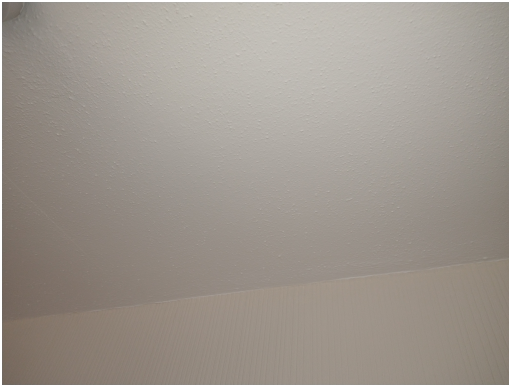
Item 2 Ref: 416023-6

The ceiling in the landing (Rm 1/001) does not contain asbestos.

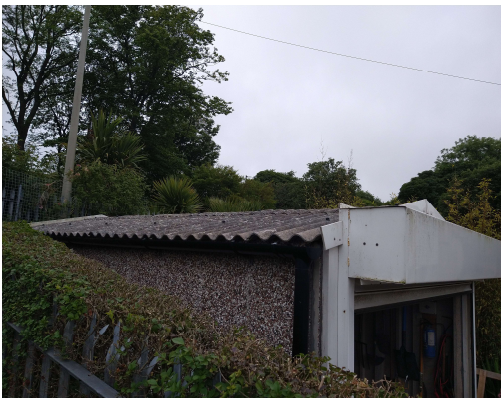
Item 3 Ref: 416023-7

The roof to the garage (External) does not contain asbestos.

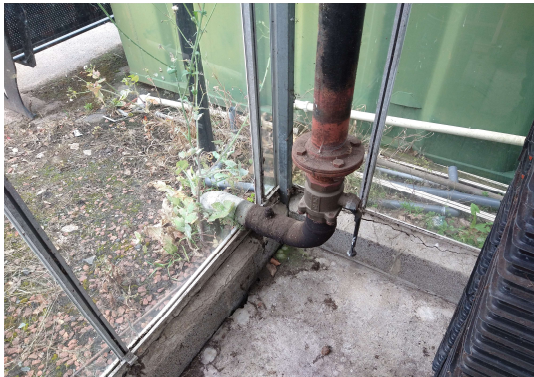
Item 5 Ref: Presume

The pipework flange gasket in Greenhouses potting area 1 (Rm 0/001) is presumed to contain asbestos.

Any change in appearance should be reported to Property Services.

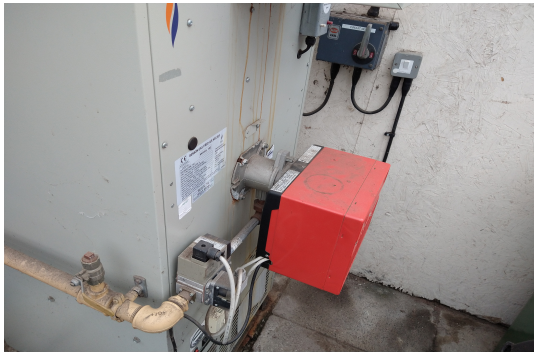
Item 6 Ref: As 416023-8

The gasket to the Benson heater in the Greenhouses potting area 2 (Rm 0/002) does not contain asbestos.

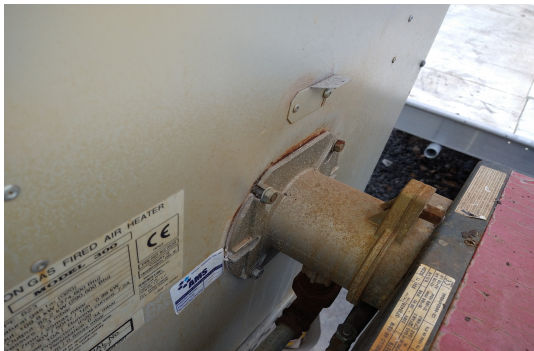
Item 7 Ref: 416023-8

The gasket to the Benson heater in the Greenhouse 1 (Rm 0/003) does not contain asbestos.

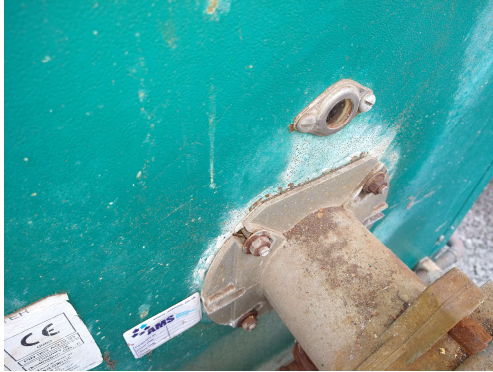
Item 8 Ref: As 416023-8

The gasket to the Benson heater in the Greenhouse 2 (Rm 0/004) does not contain asbestos.

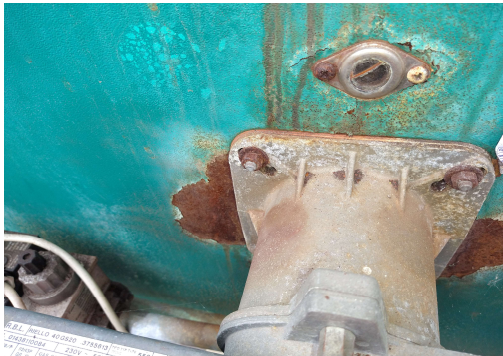
Item 9 Ref: As 416023-8

The gasket to the Benson heater in the Greenhouse 3 (Rm 0/005) does not contain asbestos.

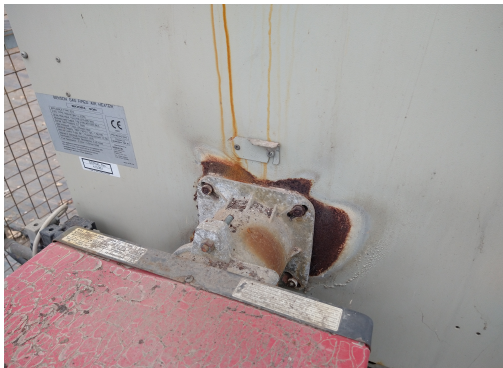
Item 10 Ref: As 416023-8

The gasket to the Benson heater in the redundant polythene tunnels (External) does not contain asbestos.

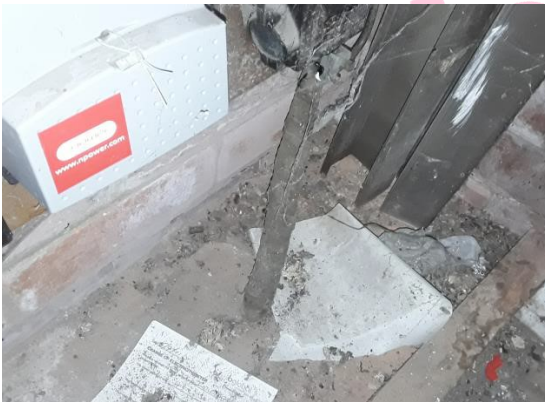
Item 16 Ref: 20-29035-3

The sheath to mains electric cable (Electric Meter Cupboard) does not contain asbestos.

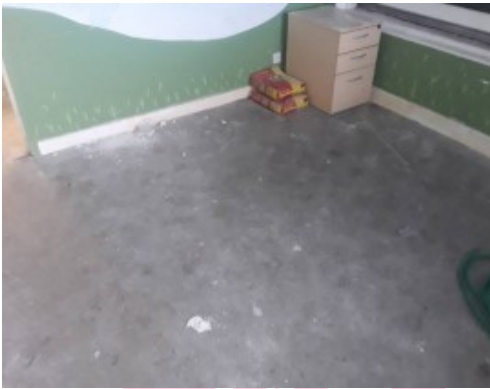
Item 19 Ref: NZ000679

The floor adhesive under modern flooring and screed (Entrance Hall/Foyer Lobby Rm G/001) does not contain asbestos.

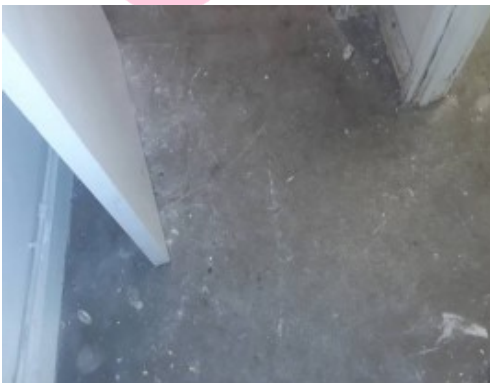
Item 20 Ref: As NZ000679

The floor adhesive under modern flooring and screed (Hallway/Passageway Rm G/002) does not contain asbestos.

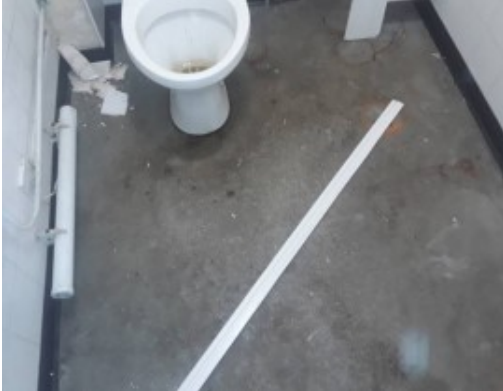
Item 21 Ref: As NZ000679

The floor adhesive under modern flooring and screed (Toilets Rm G/003) does not contain asbestos.

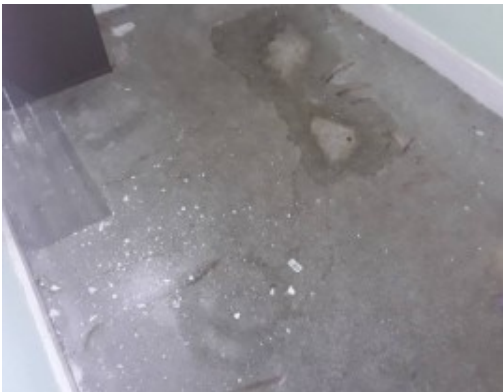
Item 22 Ref: As NZ000679

The floor adhesive under modern flooring and screed (Office Rm G/004) does not contain asbestos.

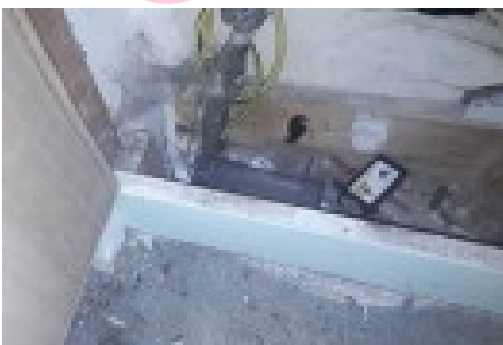
Item 23 Ref: Presumed

The cable braiding/insulation live services (Office Rm G/004) is presumed to contain asbestos.

Any change in appearance should be reported to Property Services.

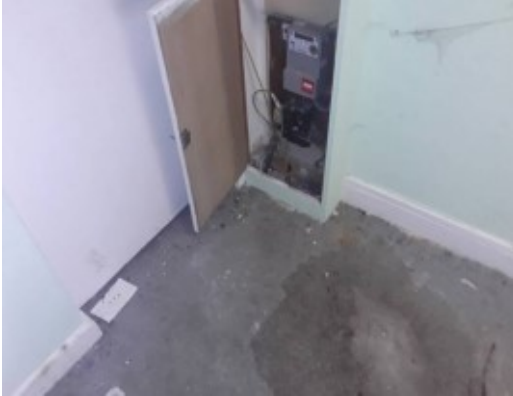
Item 24 Ref: As NZ000678

The floor tiles with adhesive remnants within electrical services boxing (Office Rm G/004) do not contain asbestos.
