### ASBESTOS SURVEY REPORT FOR WASHINGTON TOWN CENTRE LIBRARY, WASHINGTON

**WASHINGTON TOWN CENTRE LIBRARY,  
WASHINGTON**

**Date: 10 June 2025**

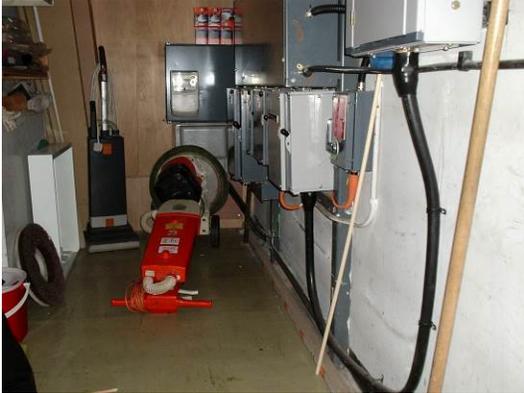
**Ref: JP0126/07**

The cream floor tile to the service cupboard under the stairs (Rm 0/2) contained asbestos.

*These were removed in May 2008.*

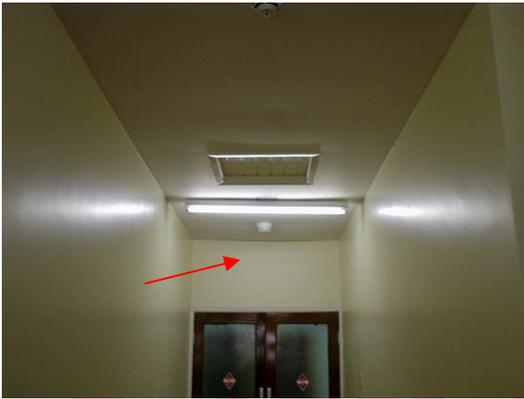
**Ref: As JP0127/07**

The header panel above the glass door in the corridor fire escape (Rm 0/3) contained asbestos.

*This was removed in May 2008.*

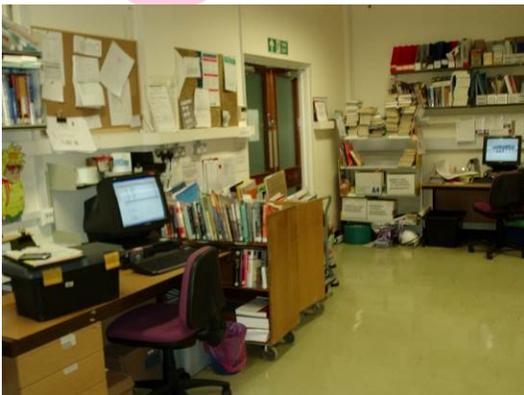
**Ref: JP0128/07**

The cream floor tiles to the Office/Store room (Rm 0/12) contained asbestos. Similar flooring is located in rooms 0/13, 0/14 and 0/16.

*These were all removed in May 2008.*

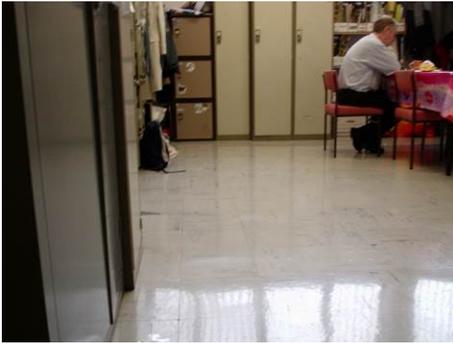
**Ref: JP0129/07**

The marbled floor tiles to the staff room (Rm 0/18) contained asbestos.

*These were removed in May 2008 along with JP0130/07 – Lino which did not contain asbestos*

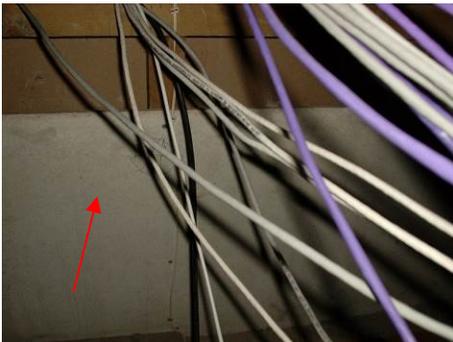
**Ref: JP0127/07**

The fire break in the loft space above the doors on the ground floor (L0/3) contained asbestos.

*This was removed in May 2008.*

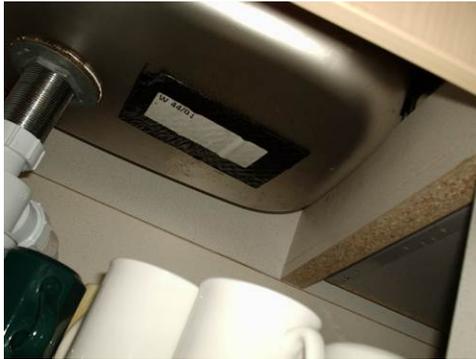
### **Item 1 - Ref: JP0131/07**

The sink pad to the staff room (Rm 0/18) does not contain asbestos.

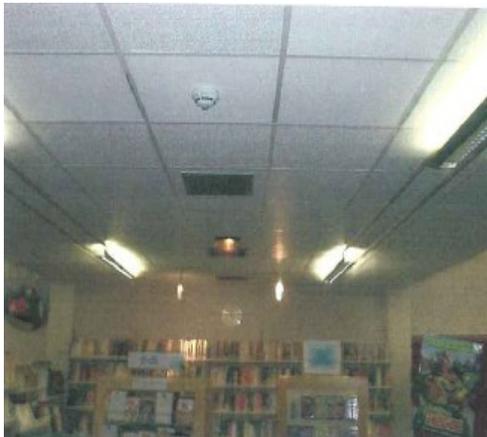
### **Item 2 - Ref: JP0121/07**

The ceiling tiles to the children's library (Rm 1/1) does not contain asbestos.

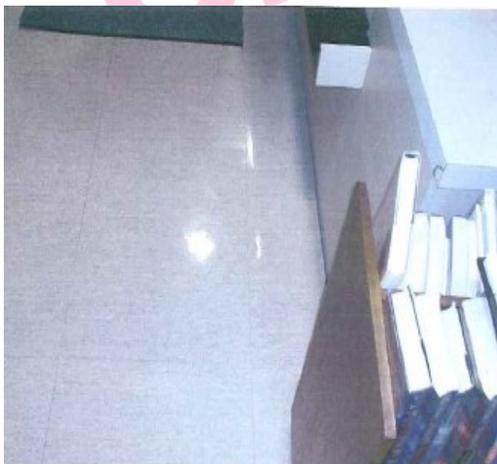
### **Item 3 - Ref: JP0030/07**

The floor tiles in the first floor reception (Rm 1/3) does not contain asbestos.

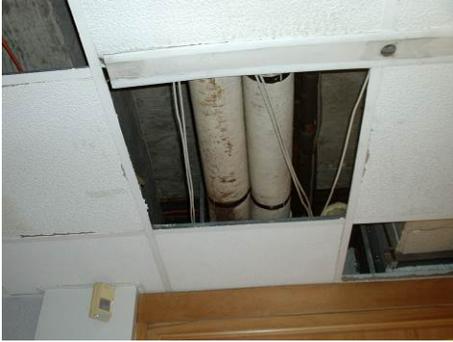
**Item 4 - Ref: JP0031/07**

The pipework insulation to the first floor reception (Rm 1/3) does not contain asbestos.

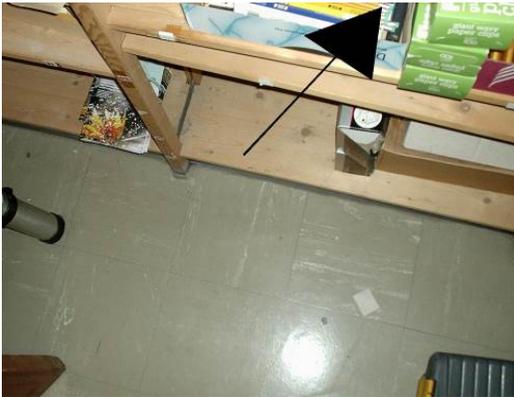
**Item 8 - Ref: JP0124/07**

The floor tile in the first floor store cupboard (Rm 1/6) does not contain asbestos.

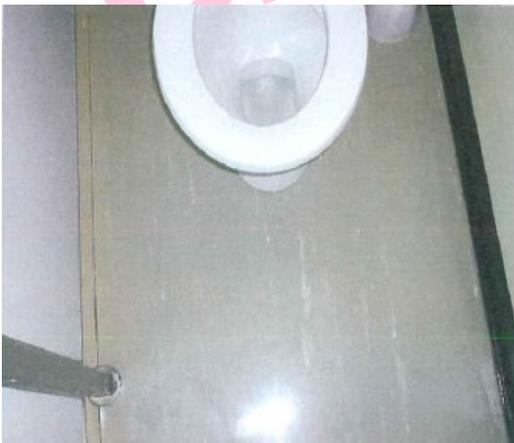
**Item 9 - Ref: JP0122/07**

The floor covering in the first floor female toilets (Rm 1/7) does not contain asbestos.

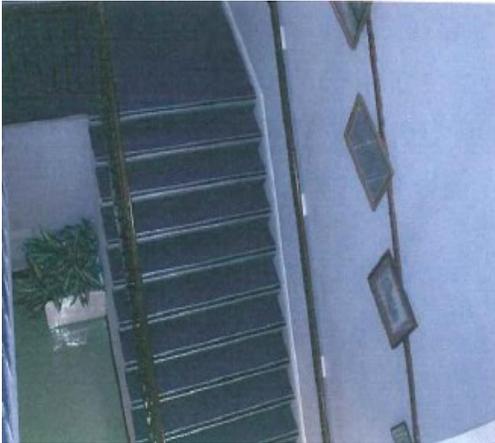
**Item 10 - Ref: JP0125/07**

The stair nosing to staircase (Rm 1/8) does not contain asbestos.

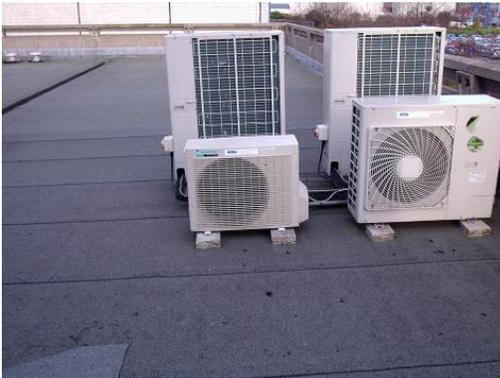
**Item 11 - Ref: JP0133/07**

The roof felt to the external (E/1) does not contain asbestos.

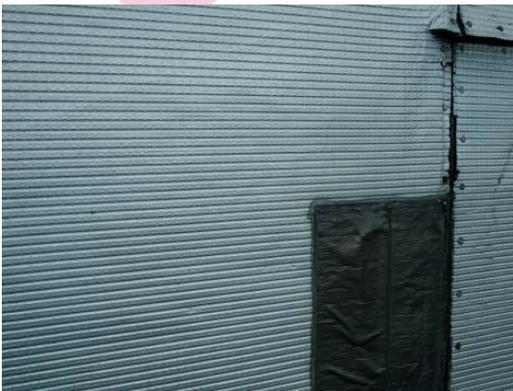
**Item 12 - Ref: JP0132/07**

The wall lining around the plant and life machinery room does not contain asbestos.

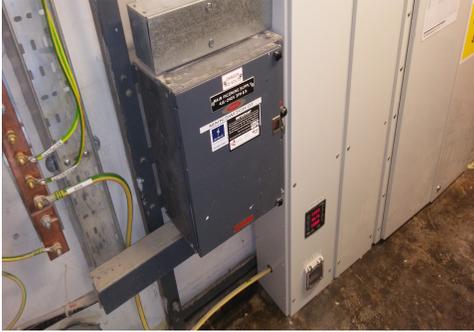
### **Item 13 - Ref: Presumed**

The MEM isolation switch in the downstairs electrical cupboard is presumed to contain asbestos.

Any planned works will require further investigation.

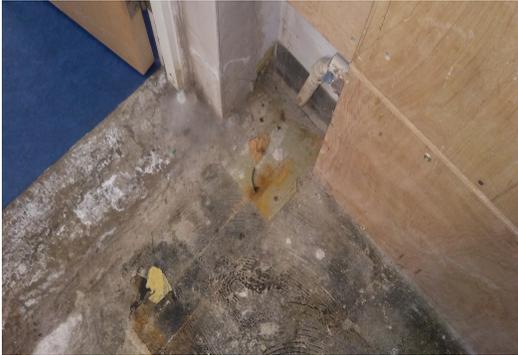
### **Item 14 - Ref: 334398-1**

The remnant floor covering in the downstairs electrical cupboard contains asbestos.

Any change in appearance should be reported to Property Services.

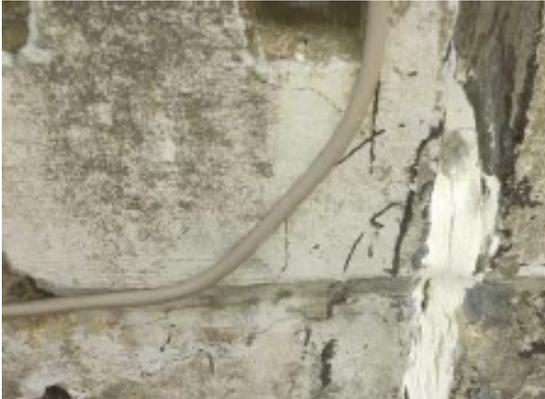
**Item 16 - Ref: 22-41634-1**

The putty between expansion joints in the walls (Area 1/External) does not contain asbestos.

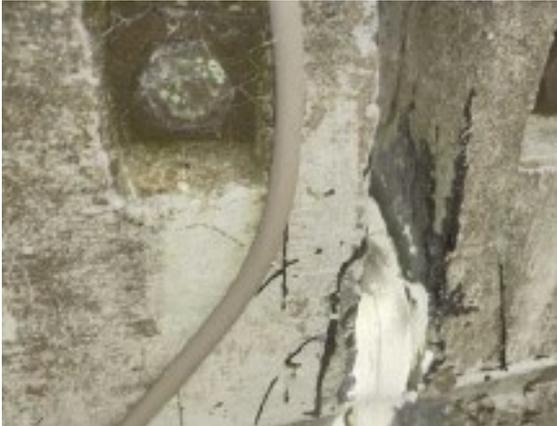
**Item 17 - Ref: 22-41634-2**

The residue to parapet around expansion joints in the walls (Area 1/External) does not contain asbestos.

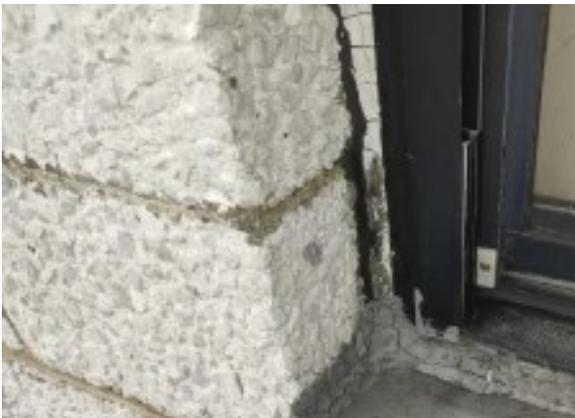
**Item 18 - Ref: 22-41634-3**

The sealant around the windows to the connexions building (Area 1/External) does not contain asbestos.

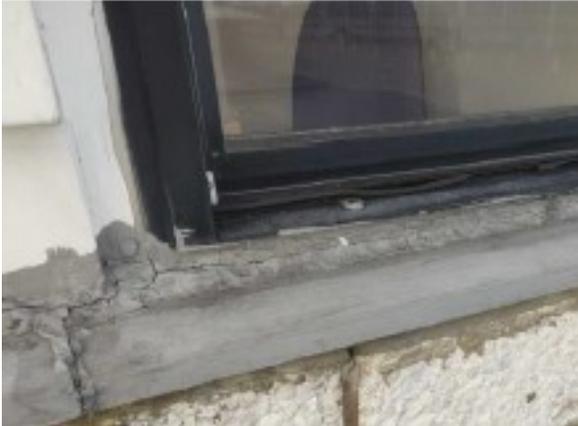
### **Item 19 - Ref: 22-41634-4**

The sills below the windows to the connexions building (Area 1/External) does not contain asbestos.

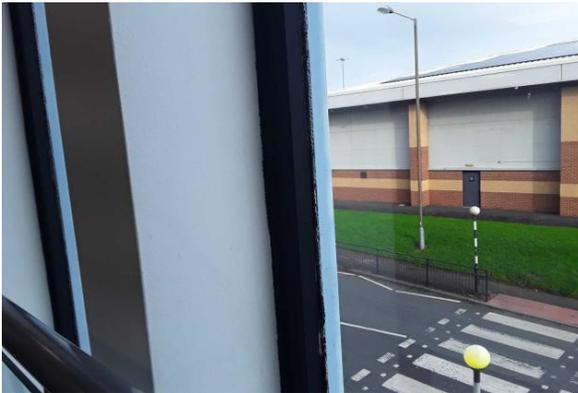
### **Item 20 Ref: 22-52610-1**

The window - internal nsl frames (Mastic) (Area: 25 External) do not contain asbestos.

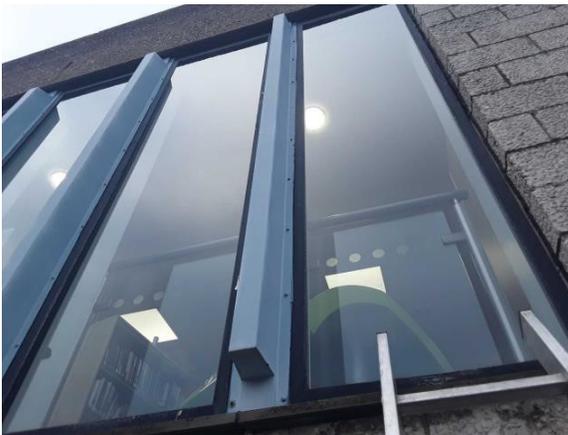
### **Item 21 Ref: 22-52610-2**

The external metal windows (Putty) (Area: 25 External) do not contain asbestos.

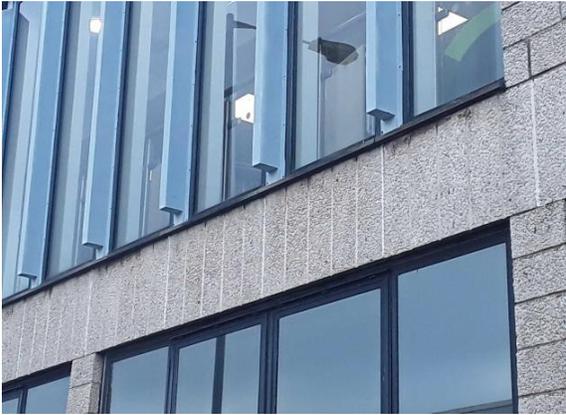
### **Item 22 Ref: 22-52610-3**

The window – external sills (Cement) (Area: 25 External) do not contain asbestos.

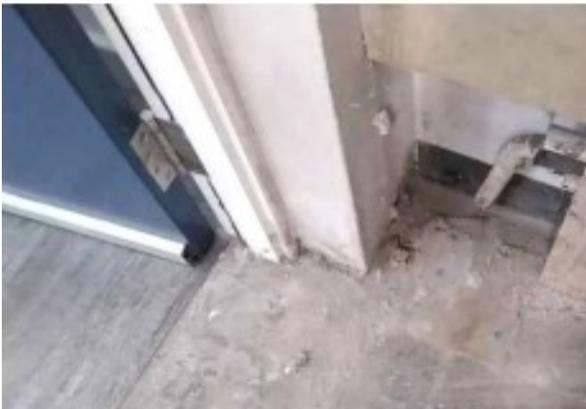
### **Item 23 Ref: Presumed**

The floor tiles and adhesive in the Switch Room (Z1/001) is presumed to contain asbestos.

(Item duplicated – see items 14 & 15)
