ASBESTOS SURVEY REPORT FOR WASHINGTON TOWN CENTRE LIBRARY, WASHINGTON

Asbestos Register for

**WASHINGTON TOWN CENTRE LIBRARY,
WASHINGTON**

Date: 03 February 2025

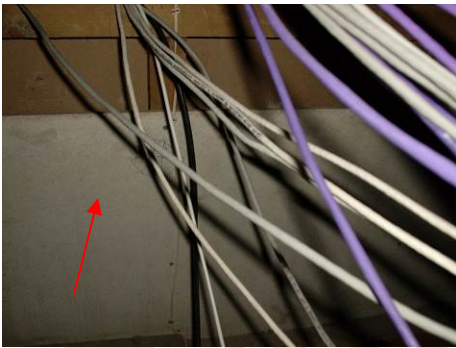
Ref: JP0127/07

The fire break in the loft space above the doors on the ground floor (L0/3) contained asbestos.

This was removed in May 2008.

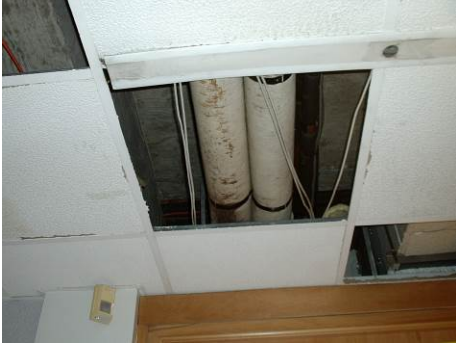
Item 4 - Ref: JP0031/07

The pipework insulation to the first floor reception (Rm 1/3) does not contain asbestos.

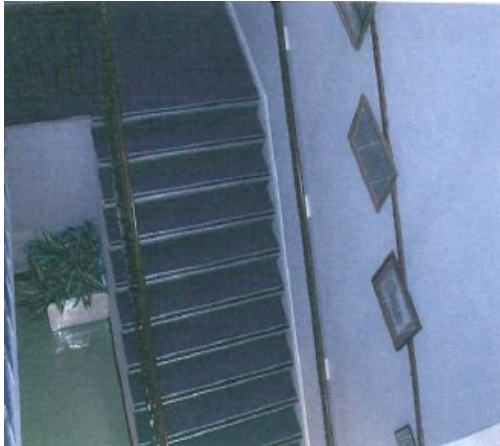
Item 10 - Ref: JP0125/07

The stair nosing to staircase (Rm 1/8) does not contain asbestos.

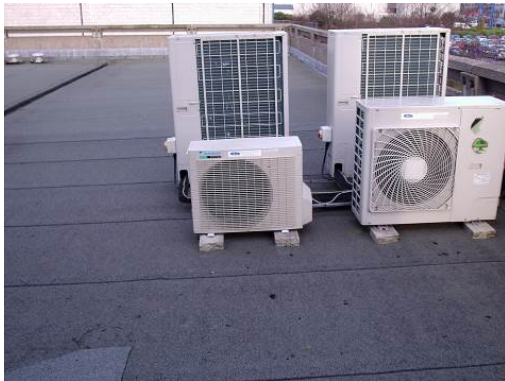
Item 11 - Ref: JP0133/07

The roof felt to the external (E/1) does not contain asbestos.

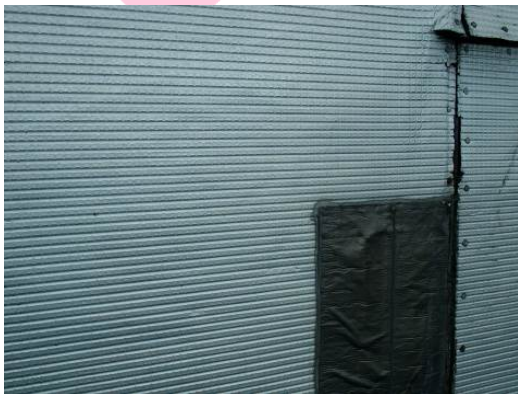
Item 12 - Ref: JP0132/07

The wall lining around the plant and life machinery room does not contain asbestos.

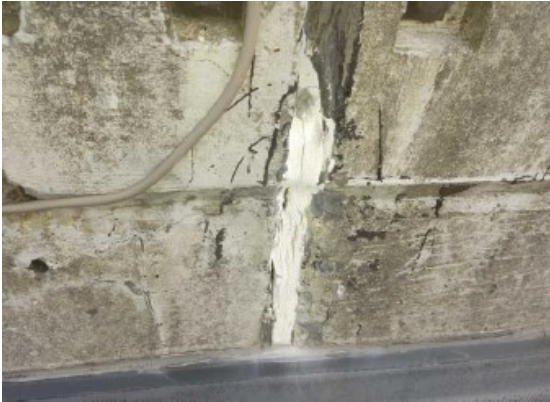
Item 16 - Ref: 22-41634-1

The putty between expansion joints in the walls (Area 1/External) does not contain asbestos.

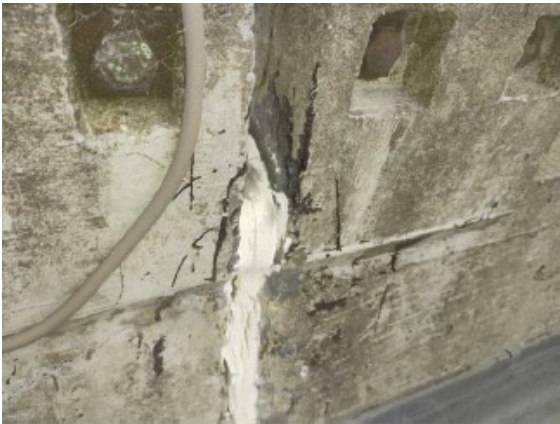
Item 17 - Ref: 22-41634-2

The residue to parapet around expansion joints in the walls (Area 1/External) does not contain asbestos.

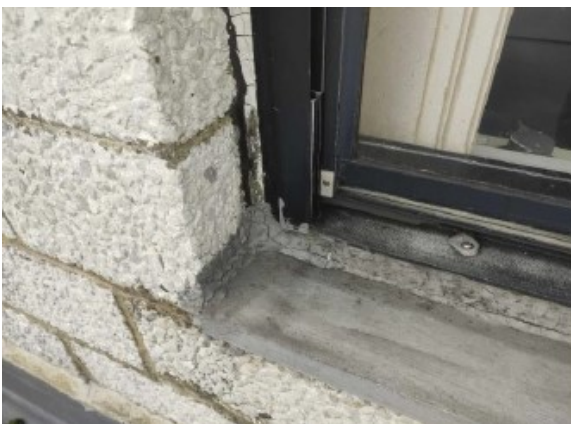
Item 18 - Ref: 22-41634-3

The sealant around the windows to the connexions building (Area 1/External) does not contain asbestos.

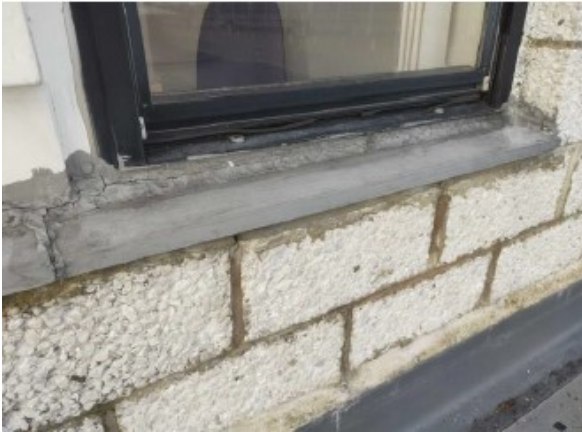
Item 19 - Ref: 22-41634-4

The sills below the windows to the connexions building (Area 1/External) does not contain asbestos.

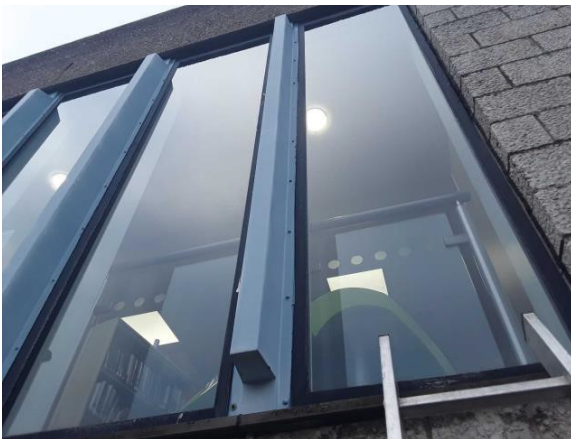
Item 21 Ref: 22-52610-2

The external metal windows (Putty) (Area: 25 External) do not contain asbestos.

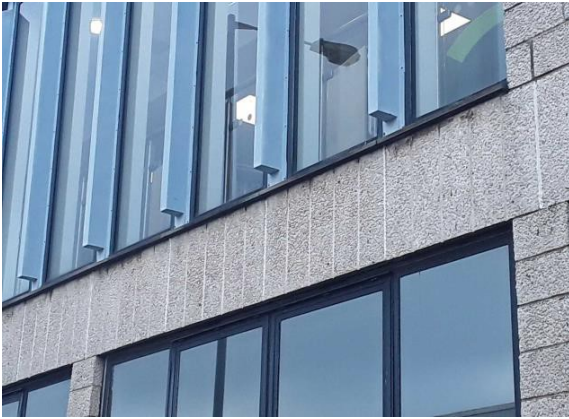
Item 22 Ref: 22-52610-3

The window – external sills (Cement) (Area: 25 External) do not contain asbestos.

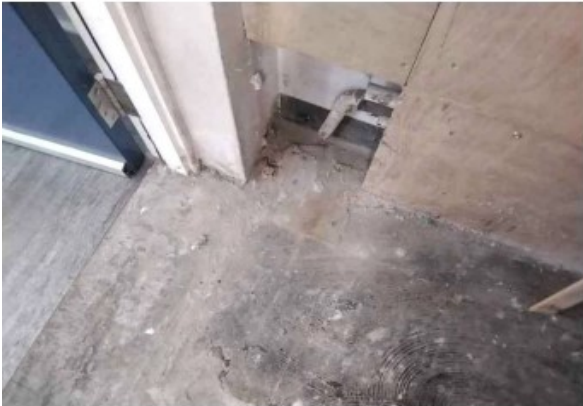
Item 23 Ref: Presumed

The floor tiles and adhesive in the Switch Room (Z1/001) is presumed to contain asbestos.

(Item duplicated – see items 14 & 15)
