ASBESTOS SURVEY REPORT FOR UNITS 11 PHOENIX WAY, RAINTON
BRIDGE INDUSTRIAL ESTATE, SUNDERLAND, DH4 5SA

**Units 11 Phoenix Way, Rainton Bridge Industrial Estate,
Sunderland, DH4 5SA**

Date: 10 October 2024

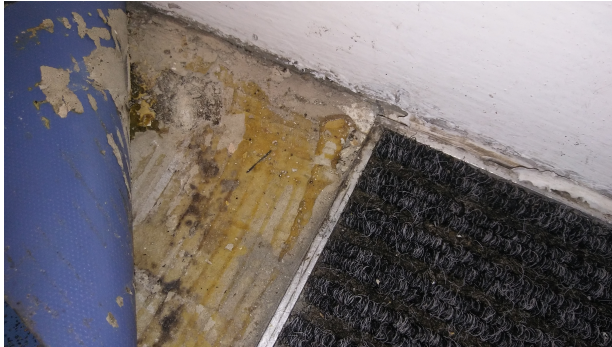
Item 1 Ref: 359885-1

- (Item 1) Ref: 359885-1 – Remnant adhesive below modern screed (Room 001/Lobby) – No Risk
- (Item 2) Ref: 359885-2 – Red mastic to ductwork (Room 001/lobby – void above) – No Risk

The Remnant adhesive below modern screed (Room 001/Lobby) does not contain asbestos.

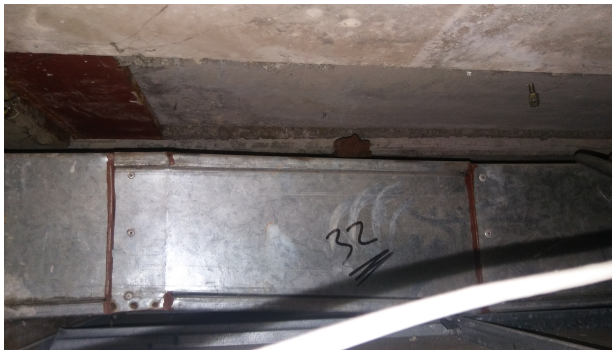
Item 2 Ref: 359885-2

The Red mastic to ductwork (Room 001/lobby – void above) does not contain asbestos.

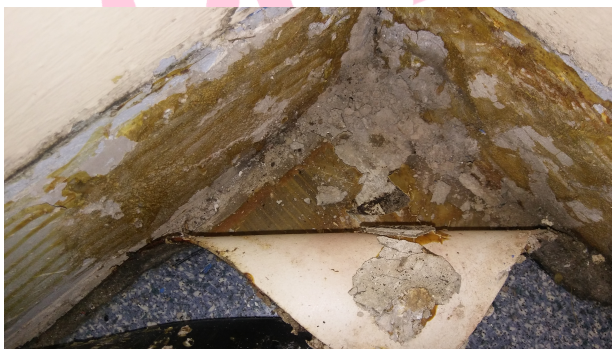
Item 3 Ref: As 359885-1

The Remnant adhesive below modern screed (Room 002/male wc and lobby) does not contain asbestos.

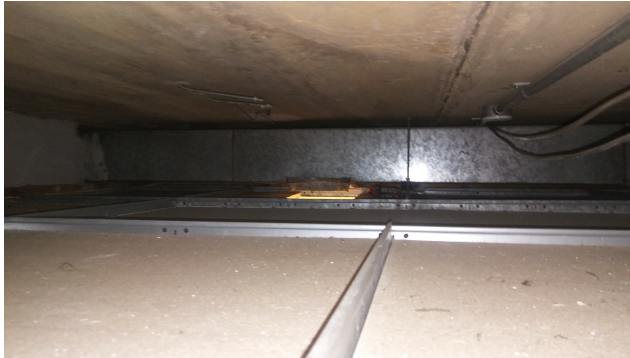
Item 4 Ref: As 359885-2

The Red mastic to ductwork (Room 002/male wc and lobby – void above) does not contain asbestos.

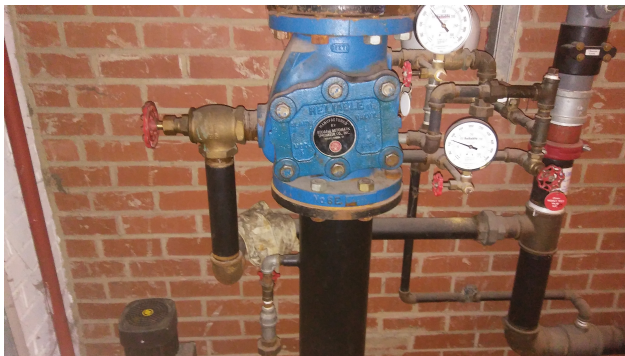
Item 5 Ref: 359885-3

- (Item 5) Ref: 359885-3 – Pipework flange gasket to bottom flange (Room 003/plant room) – Very Low Risk
- (Item 6) Ref: 359885-4 – Floor covering (Room 005/stairwell) – No Risk

The Pipework flange gasket to bottom flange (Room 003/plant room) contains asbestos.

Item 5	Pipework flange gasket (Room 003/plant room)	Very Low	12 monthly	25.09.2025
Item 6	No asbestos	Is present		
Item 7	No asbestos	Is present		
Item 8	No asbestos	Is present

Any change in its appearance should be recorded and passed to Property Services.

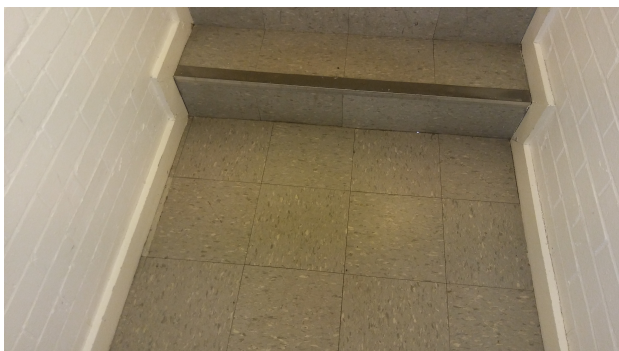
Item 6 Ref: 359885-4

The Floor covering (Room 005/stairwell) does not contain asbestos.

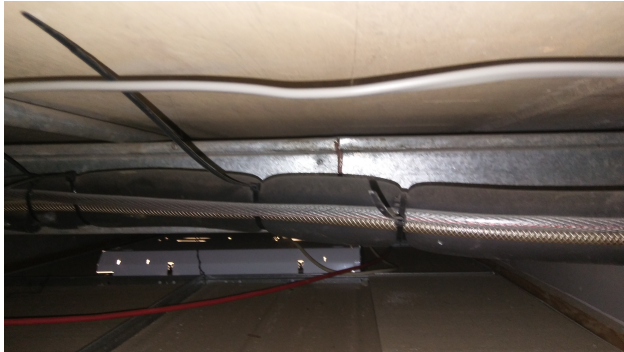
Item 7 Ref: 359885-7

The Red mastic to ductwork (Room 006/corridor and changing room – void above) does not contain asbestos.

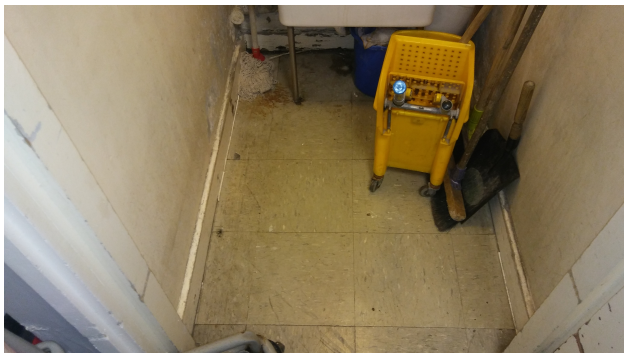
Item 8 Ref: 359885-5

The Floor covering (Room 007/store) does not contain asbestos.

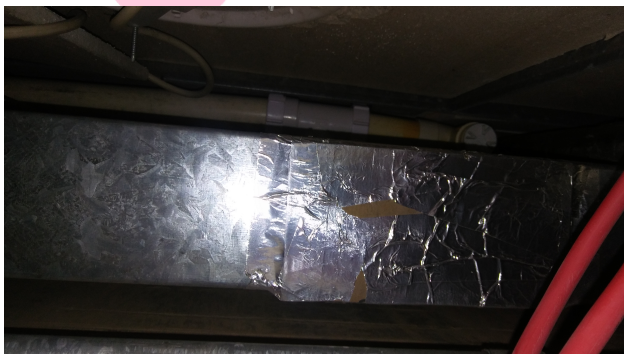
Item 9 Ref: As 359885-2

The Red mastic to ductwork (Room 007/store – void above) does not contain asbestos.

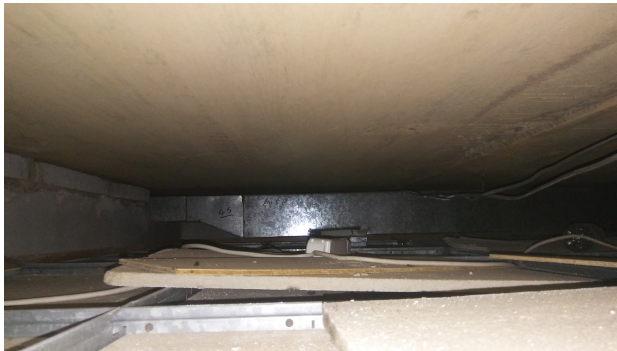
Item 11 Ref: As 359885-2

The Red mastic to ductwork (Room 008/female wc and lobby – void above) does not contain asbestos.

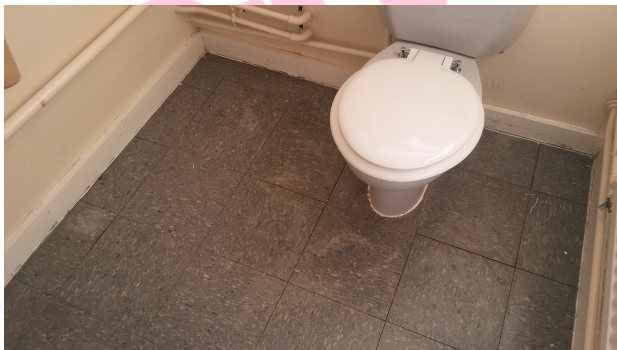
Item 12 Ref: 359885-6

The Floor covering (Room 009/disabled wc) does not contain asbestos.

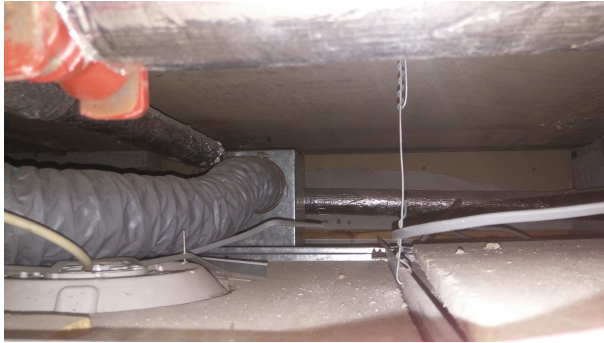
Item 13 Ref: As 359885-2

The Red mastic to ductwork (Room 009/disabled wc – void above) does not contain asbestos.

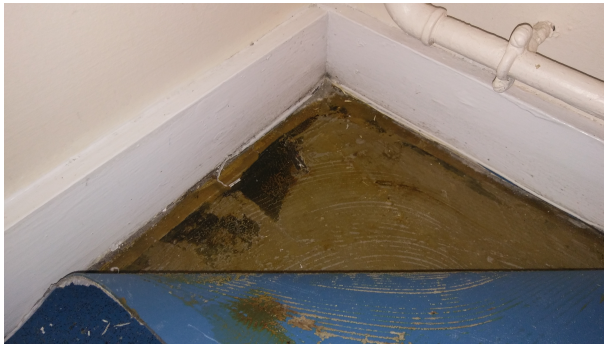
Item 14 Ref: 359885-8

The Remnant adhesive below modern screed (Room 011/male wc and lobby) does not contain asbestos.

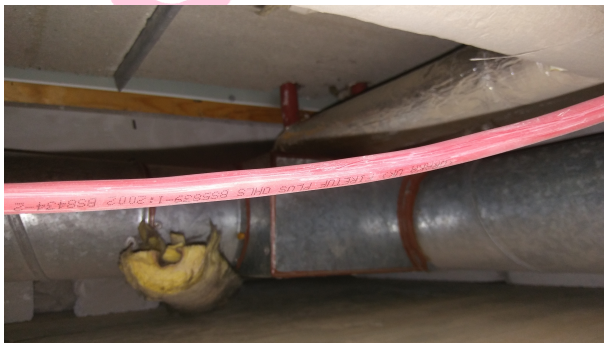
Item 15 Ref: As 359885-7

The Red mastic to ductwork (Room 011/male wc and lobby – void above) does not contain asbestos.

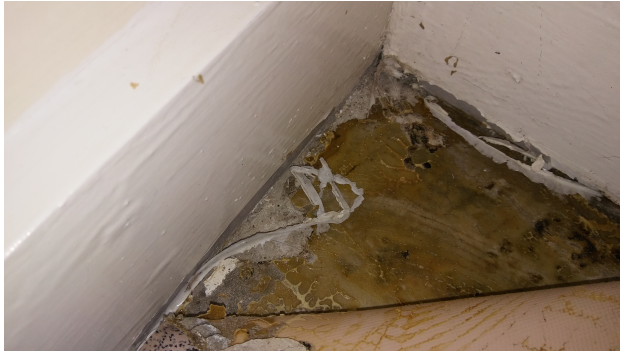
Item 16 Ref: As 359885-8

The Remnant adhesive below modern screed (Room 012/female wc and lobby) does not contain asbestos.

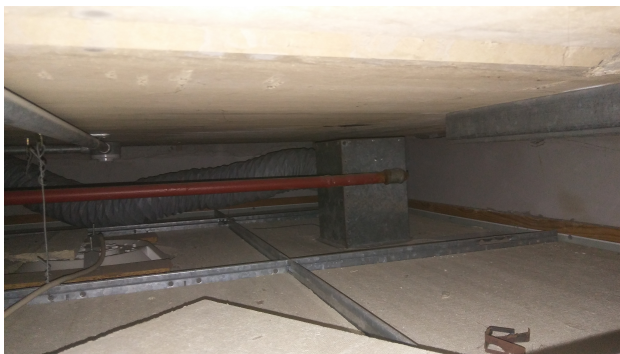
Item 17 Ref: As 359885-7

The Red mastic to ductwork (Room 012/female wc and lobby – void above) does not contain asbestos.

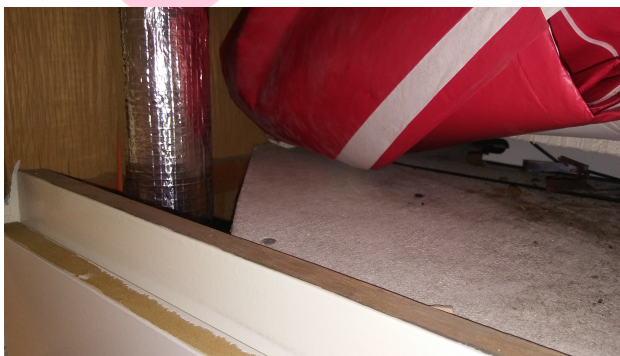
Item 18 Ref: 359885-9

The Shelf panels within cupboard and to base of heater (Room 013/medial room) does not contain asbestos.

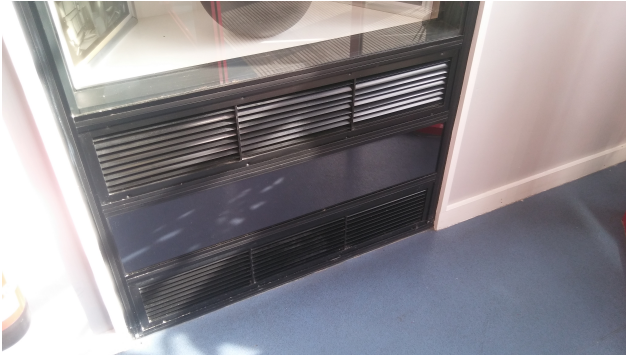
Item 19 Ref: As 359885-9

The Panels to low level heater (Room 014/main reception) does not contain asbestos.

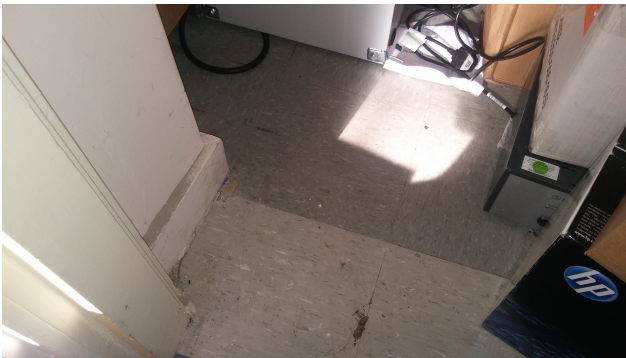
Item 20 Ref: 359885-10

The Floor covering (Room 015/store) does not contain asbestos.

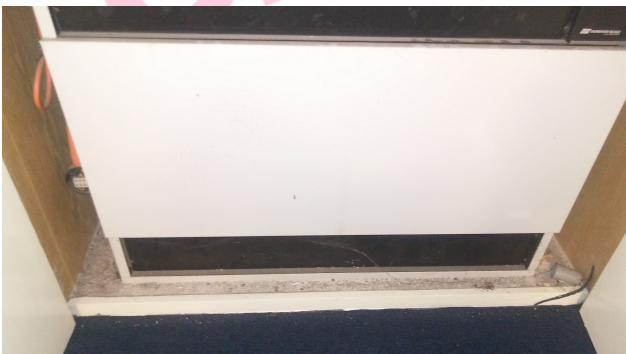
Item 21 Ref: As 359885-9

The Shelf panels within cupboard and base of heater (Room 017/meeting room 1) does not contain asbestos.

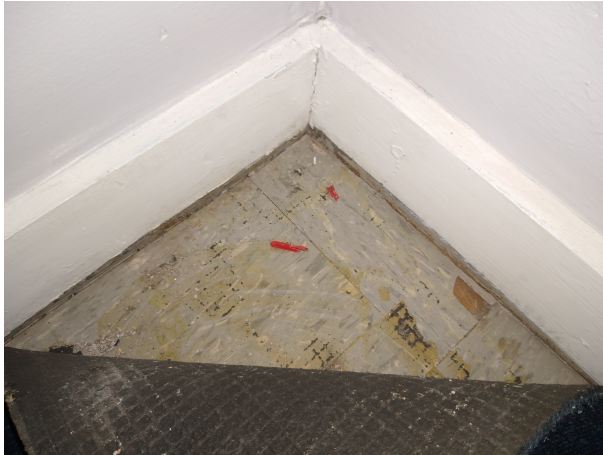
Item 22 Ref: 359885-11

The Subfloor covering (Room 020/lobby and stairwell) does not contain asbestos.

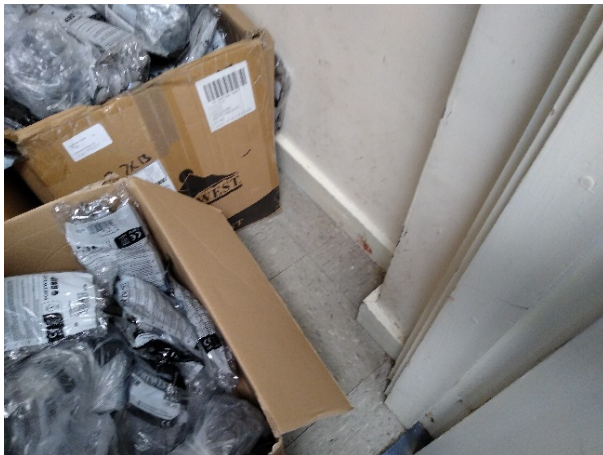
Item 23 Ref: As 359885-10

The Floor covering (Room 021/cupboard) does not contain asbestos.

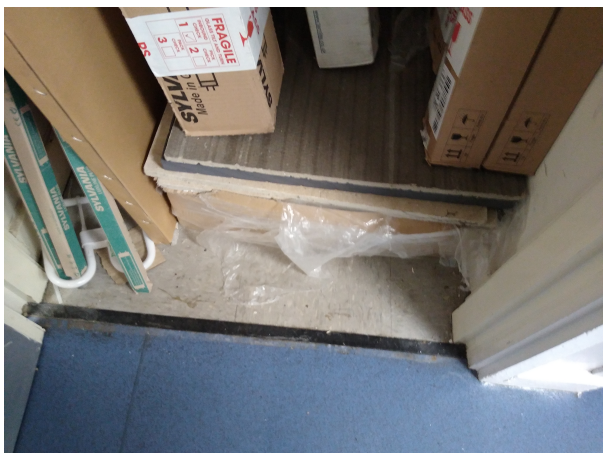
Item 24 Ref: As 359885-11

The Floor covering (Room 022a/cupboard) does not contain asbestos.

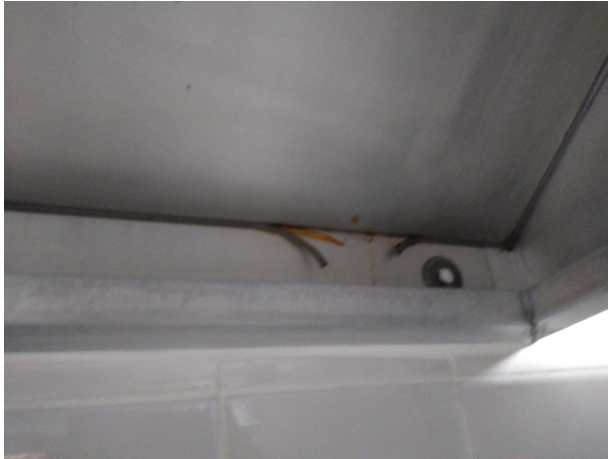
Item 25 Ref: 359885-12

The Mastic to cooker hood (Room 024/kitchen) does not contain asbestos.

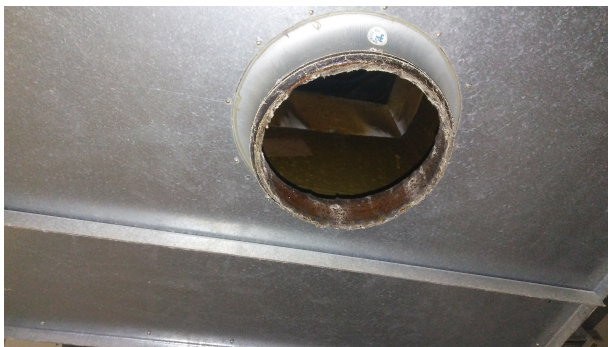
Item 26 Ref: 359885-17

The Mastic to redundant ductwork highlevel (Room 033/main factory) does not contain asbestos.

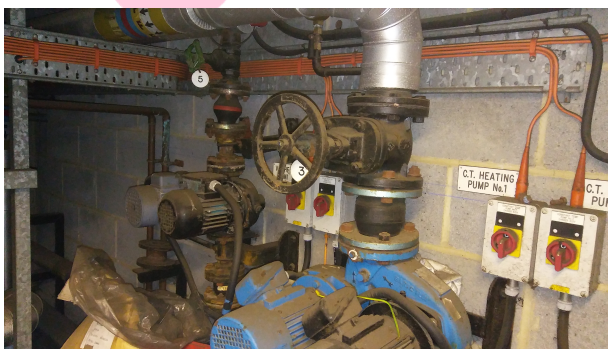
Item 27 Ref: 359885-15

- (Item 27) Ref: 359885-15 – Pipework flange gasket to north wall (Room 038/plant room) – Very Low Risk
- (Item 28) Ref: 359885-16 – Pipework flange gasket to boilers (Room 038/plant room) – Very Low Risk

The Pipework flange gasket to north wall (Room 038/plant room) contains asbestos.

Item 24	No asbestos	Is present		
Item 25	No asbestos	Is present		
Item 26	No asbestos	Is present		
Item 27	Pipework flange gasket (Room 038/plant room)	Very Low	12 monthly	25.09.2025

Any change in its appearance should be recorded and passed to Property Services.

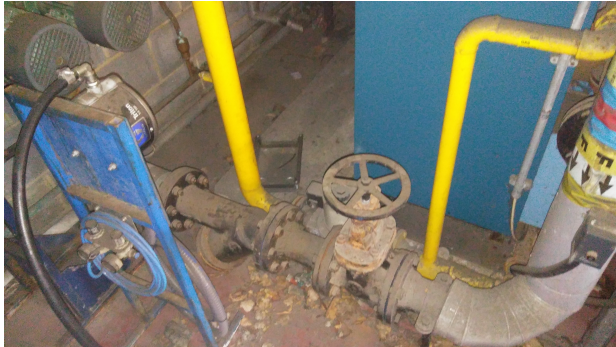
Item 28 Ref: 359885-16

The Pipework flange gasket to boilers (Room 038/plant room) contains asbestos.

Item 28	Pipework flange gasket (Room 038/plant room)	Very low	12 monthly	25.09.2025
Item 29	No asbestos	Is present

Any change in its appearance should be recorded and passed to Property Services.

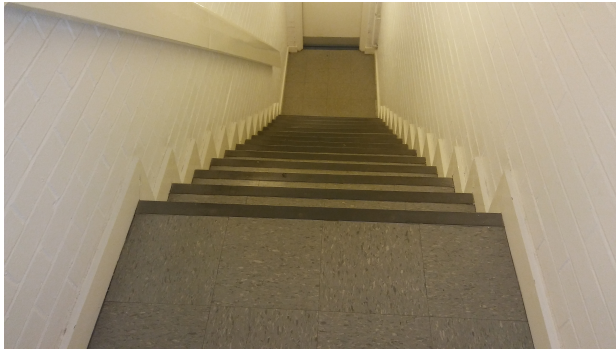
Item 29 Ref: 359885-13

The Floor covering (Level 1 Room 003/stairwell) does not contain asbestos.

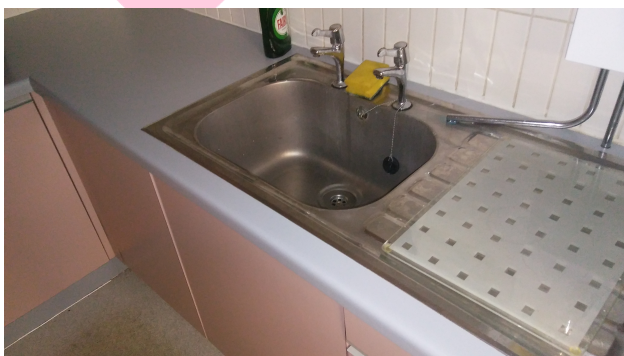
Item 30 Ref: 359885-14

The Sink pad (Level 1 Room 004/beverage bay) does not contain asbestos.

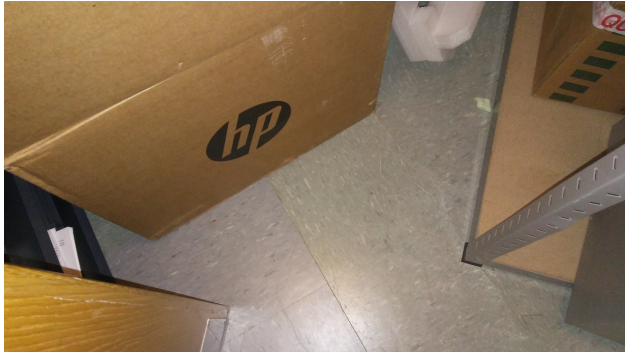
Item 31 Ref: As 359885-13

The Floor covering (Level 1 Room 007/store) does not contain asbestos.

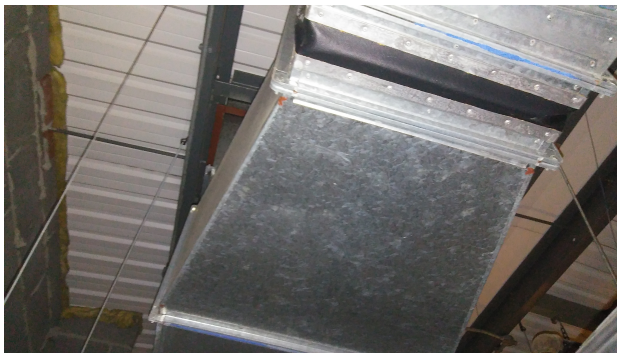
Item 32 Ref: As 359885-2

The Red mastic to ductwork (Level 1 Room 010/female wc – void above) does not contain asbestos.

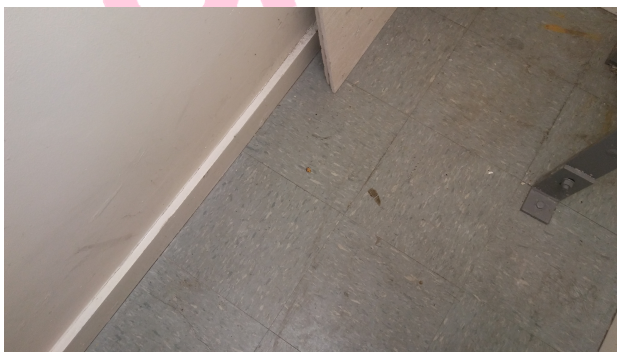
Item 33 Ref: As 359885-13

The Floor covering (Level 1 Room 011/roof access room) does not contain asbestos.

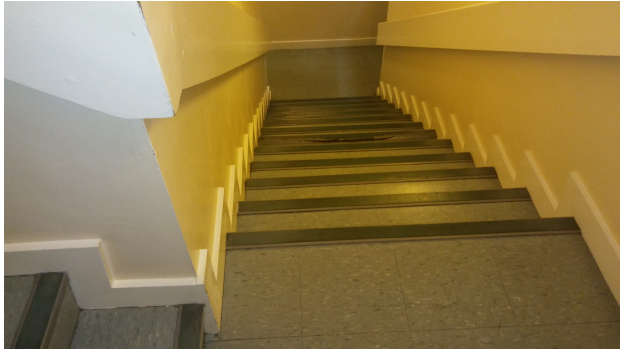
Item 34 Ref: As 359885-13

The Floor covering (Level 1 Room 024/stairwell) does not contain asbestos.

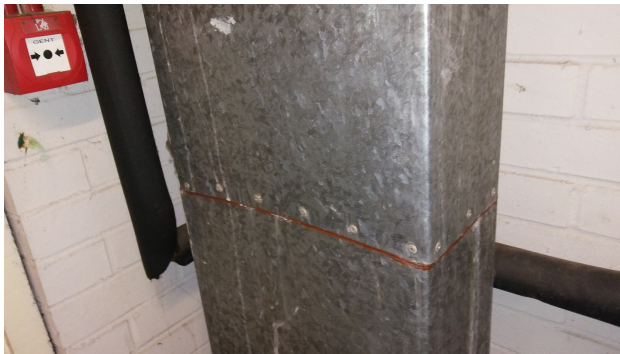
Item 35 Ref: As 359885-2

The Red mastic to ductwork (Level 1 Room 025/plant room) does not contain asbestos.

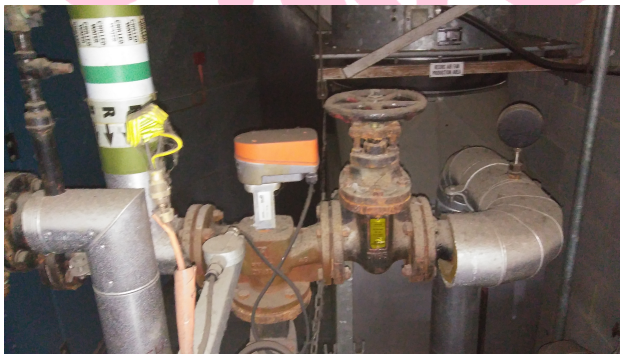
Item 36 Ref: As 359885-15

- (Item 35) Ref: As 359885-2 – Red mastic to ductwork (Level 1 Room 025/plant room) – No Risk
- (Item 36) Ref: As 359885-15 – Pipework flange gasket (Level 1 Room 026/plant room – above 0/038) – Very Low Risk

The Pipework flange gasket (Level 1 Room 026/plant room – above 0/038) contains asbestos.

Any change in its appearance should be recorded and passed to Property Services.

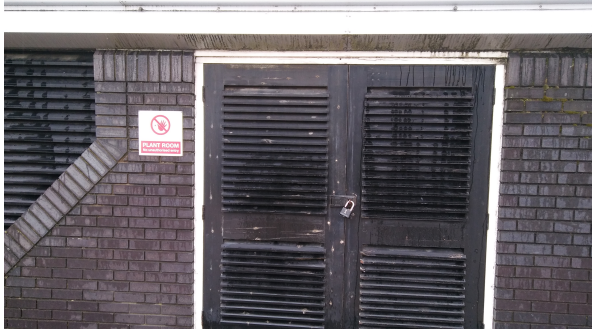
Item 37 Ref: 359885-18

The Mastic to plant room door (999-externals) does not contain asbestos.

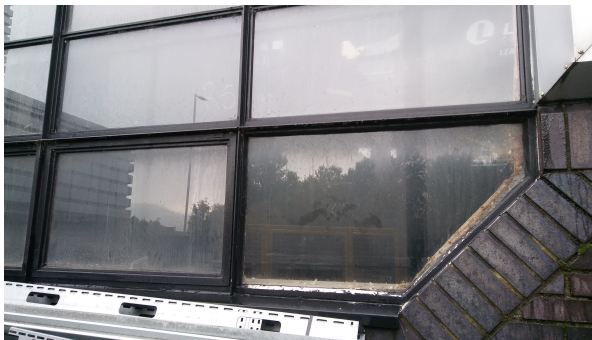
Item 38 Ref: 359885-19

The Mastic to windows East (999-externals) does not contain asbestos.
