### **ASBESTOS SURVEY REPORT FOR ROKER PARK, ROKER, SUNDERLAND**

## **Asbestos Register for Roker Park, Sunderland**

**Date: 16 July 2025**

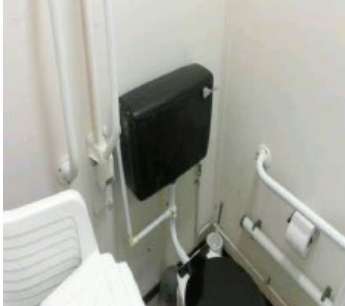
#### **Item 1 – EC002367**

The cistern to the Gents WC (Room 2) does not contain asbestos.

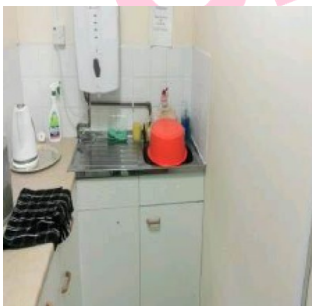
#### **Item 3 Ref: EC002368**

The sink pad to the kitchen (Room 5) does not contain asbestos.

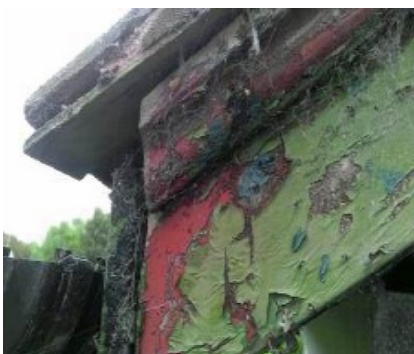
**Item 7 Ref: EC002372**

The cement verging to the external cement roof tiles does not contain asbestos.

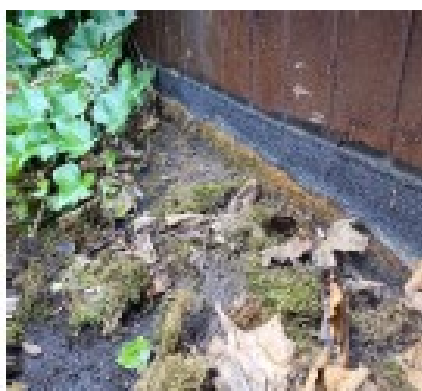
**Item 24 Ref: RT000239**

The felt covering to roof external does not contain asbestos.

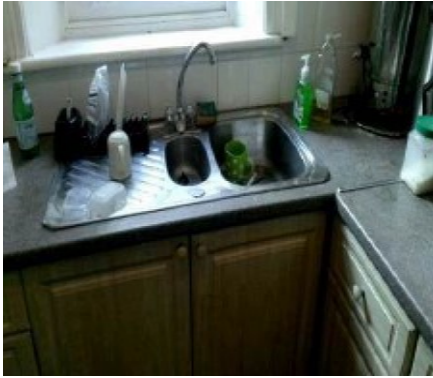
**Item 10 Ref: EC002362**

The sink pad to the kitchen (Room 8) does not contain asbestos.

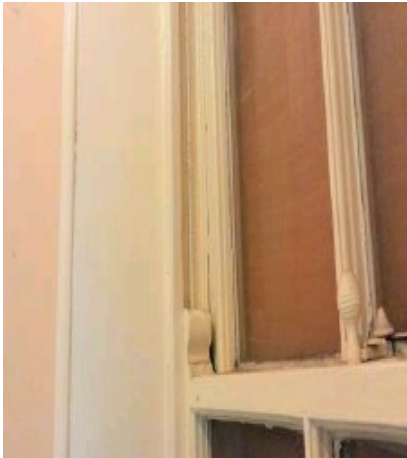
**Item 11 Ref: EC002360**

The composite rope pulleys to the windows throughout the property do not contain asbestos.

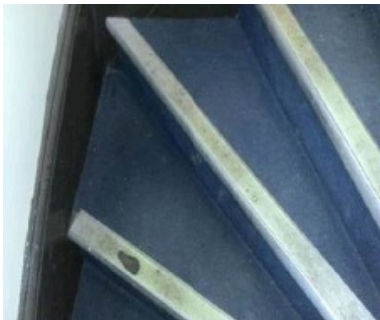
**Item 12 Ref: EC002361**

The stair nosing to the 1<sup>st</sup> floor landing does not contain asbestos.

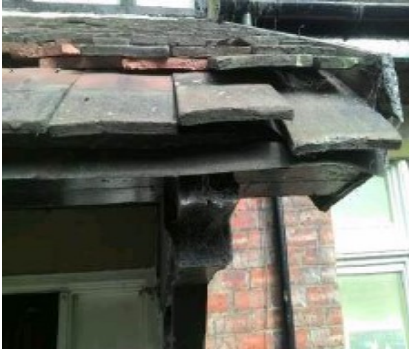
#### **Item 13 Ref: EC002363**

The roof felt to the external does not contain asbestos.

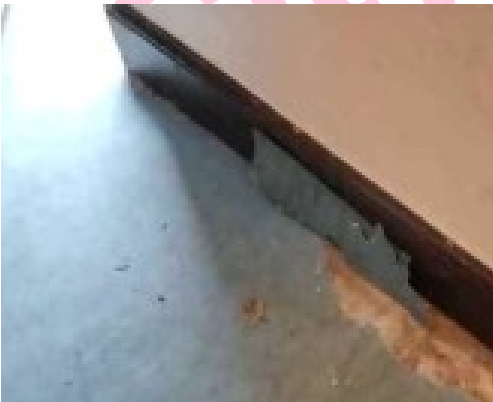
#### **Item 15 Ref: AW005659**

The floor screed in the Entrance Hall (Room G/001) does not contain asbestos.

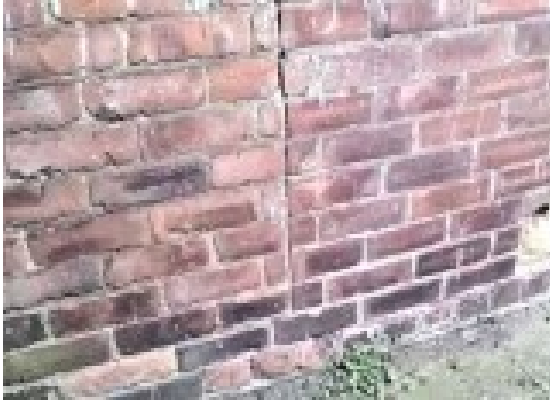
#### **Item 22 Ref: AW005665**

The damp proof course  
External (E/001) does not  
contain asbestos.

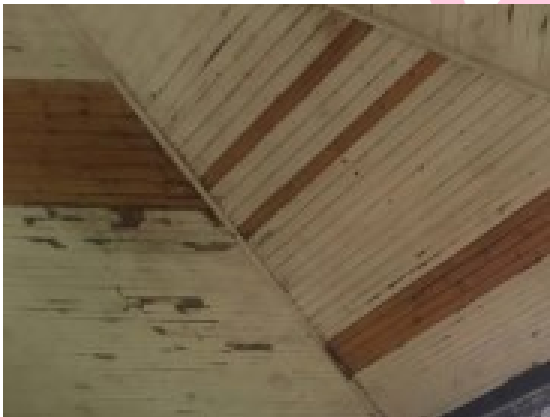
#### **Item 23 Ref: NZ001432**

The roof - sheet/cladding  
jointing compound to roof  
(Putty) (External E/001) does  
not contain asbestos.
