### ASBESTOS SURVEY REPORT FOR ROKER PARK, ROKER, SUNDERLAND

## **Asbestos Register for Roker Park, Sunderland**

Roker Park Last updated 13/06/2024 Version 2

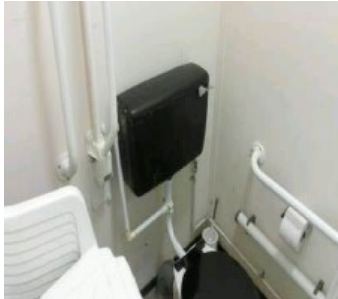
#### **Item 1 – EC002367**

The cistern to the Gents WC (Room 2) does not contain asbestos.

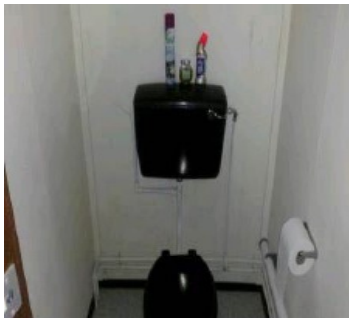
#### **Item 2 As EC002367**

The cisterns to the Ladies WC (Room 4) does not contain asbestos.

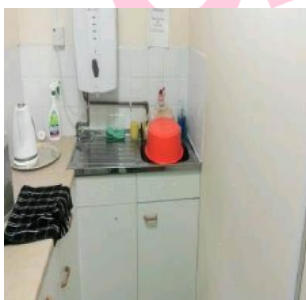
#### **Item 3 Ref: EC002368**

The sink pad to the kitchen (Room 5) does not contain asbestos.

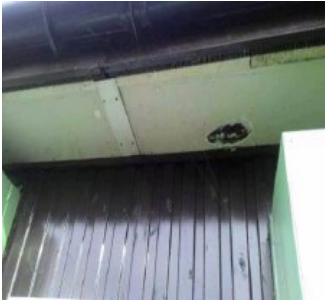
#### **Item 4 Ref: EC002369**

The soffit board to the external of the building does not contain asbestos.

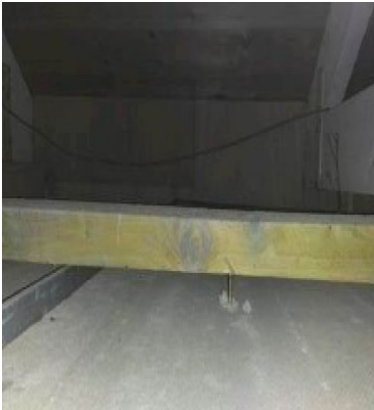
#### **Item 5 Ref: EC002370**

The random debris top the ceiling void in above the kitchen (Room 6) does not contain asbestos.

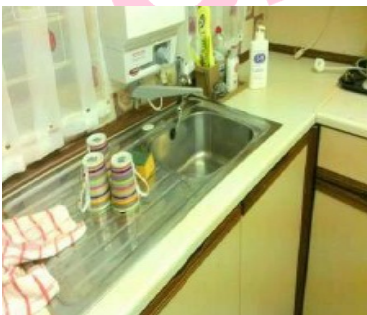
#### **Item 6 Ref: EC002371**

The sink pad to the kitchen (Room 6) does not contain asbestos.

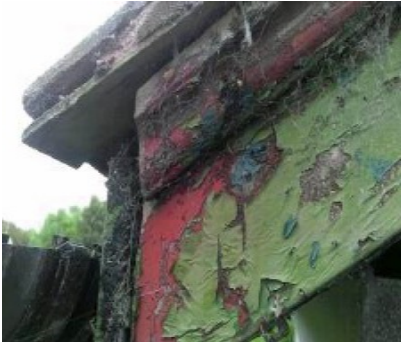
**Item 7 Ref: EC002372**

The cement verging to the external cement roof tiles does not contain asbestos.

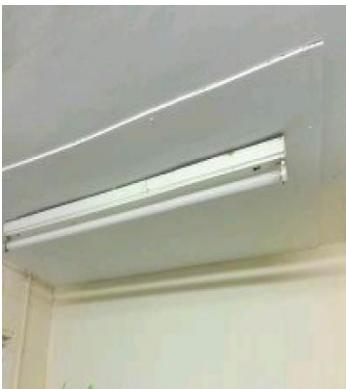
**Item 8 Ref: EC002366**

The ceiling boards to the Mess room (Room 7) do not contain asbestos.

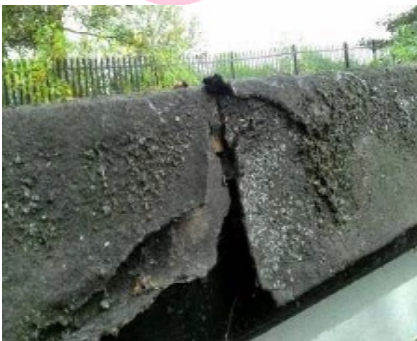
**Item 9 Ref: EC002365**

The roof felt to the external does not contain asbestos.

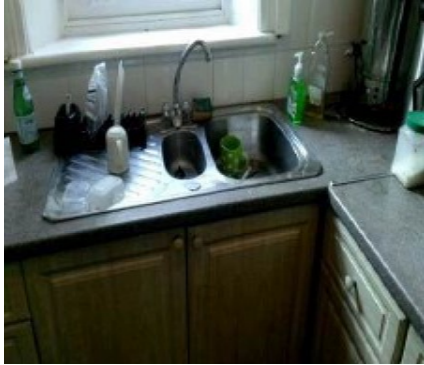
#### **Item 10 Ref: EC002362**

The sink pad to the kitchen (Room 8) does not contain asbestos.

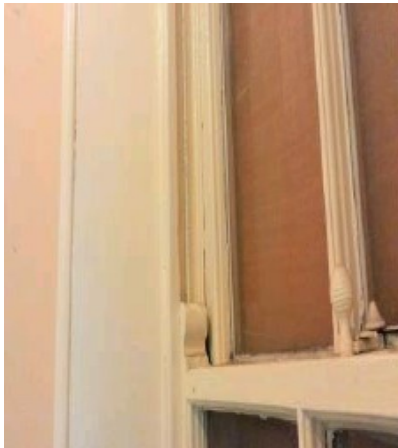
#### **Item 11 Ref: EC002360**

The composite rope pulleys to the windows throughout the property do not contain asbestos.

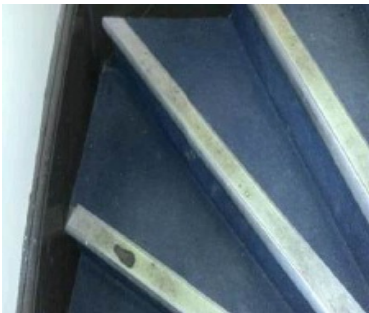
#### **Item 12 Ref: EC002361**

The stair nosing to the 1<sup>st</sup> floor landing does not contain asbestos.

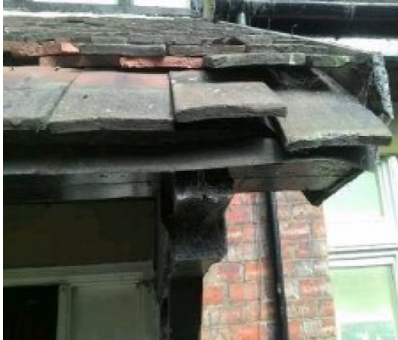
**Item 13 Ref: EC002363**

The roof felt to the external does not contain asbestos.

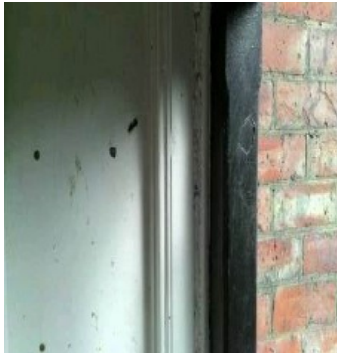
**Item 14 Ref: EC002364**

Door sealant to the external door does not contain asbestos.

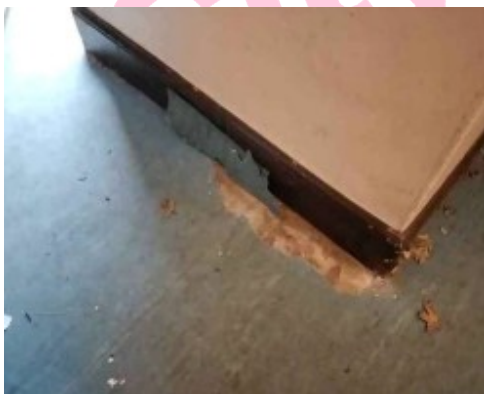
**Item 15 Ref: AW005659**

The floor screed in the Entrance Hall (Room G/001) does not contain asbestos.

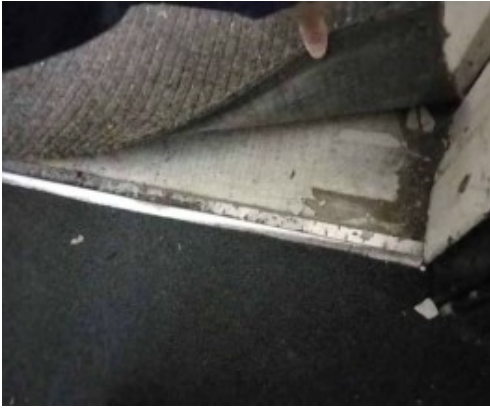
#### **Item 16 Ref: AW005660**

The floor screed in the Porch (Room G/002) does not contain asbestos.

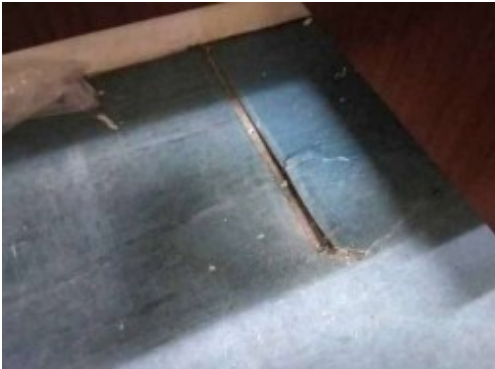
#### **Item 17 Ref: AW005661**

The floor covering lower layer in the Office (Room G/006) does not contain asbestos.

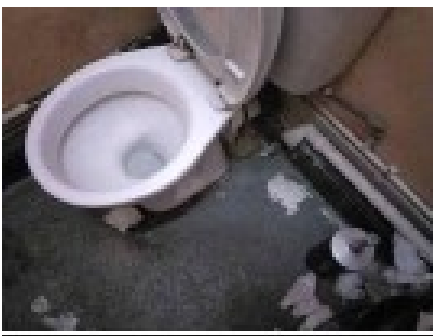
#### **Item 18 Ref: AW005663**

The floor tile beneath modern lino in the toilet (Room G/008) does contain asbestos.

<b>Item 18</b>	<b>Floor tile beneath modern lino (Toilet G/008)</b>	<b>Very Low Risk</b>	<b>12 monthly</b>	<b>10/05/2025</b>
<b>Item 19</b>	<b>Electrical services cable/braiding insulation (Electrical Cupboard G/009)</b>	<b>Very Low Risk</b>	<b>12 monthly</b>	<b>10/05/2025</b>
<i>Item 20</i>	<i>No asbestos</i>	<i>Is present</i>		
<i>Item 21</i>	<i>No asbestos</i>	<i>Is present</i>		
<i>Item 22</i>	<i>No asbestos</i>	<i>Is present</i>		
<i>Item 23</i>	<i>No asbestos</i>	<i>Is present</i>

Any change in appearance should be reported to Property Services.

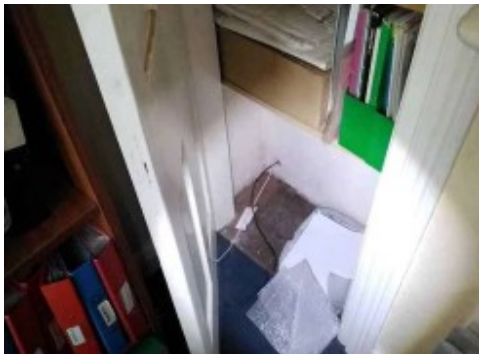
#### **Item 20 Ref: AW005664**

The floor covering in the Cupboard (Room 1/003) does not contain asbestos.

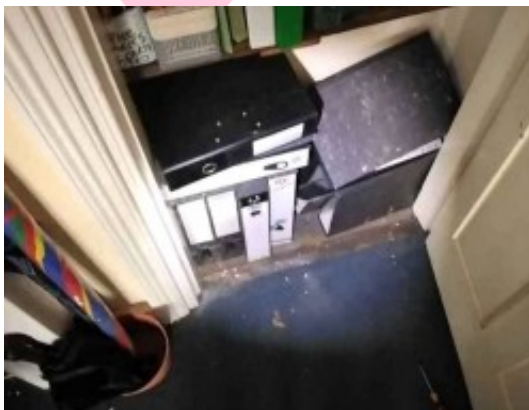
#### **Item 21 Ref: As AW005664**

The floor covering in the Cupboard (Room 1/004) does not contain asbestos.

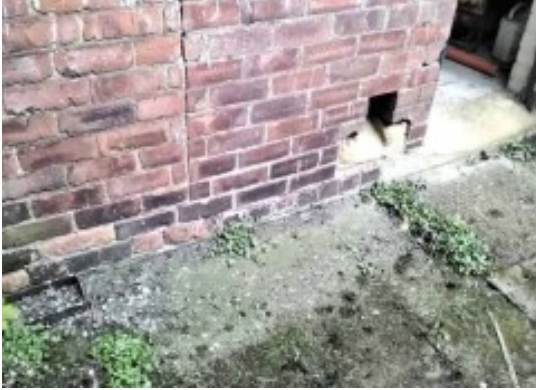
**Item 22 Ref: AW005665**

The damp proof course  
External (E/001) does not  
contain asbestos.

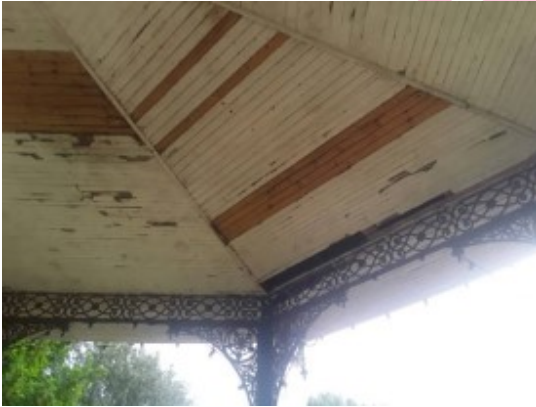
**Item 23 Ref: NZ001432**

The roof - sheet/cladding  
jointing compound to roof  
(Putty) (External E/001) does  
not contain asbestos.
