ASBESTOS SURVEY REPORT FOR MOWBRAY PARK, BURDON ROAD, SUNDERLAND

Asbestos Register for MOWBRAY PARK, SUNDERLAND

Mowbray Park Last updated 19/05/2025 – Version 2.0

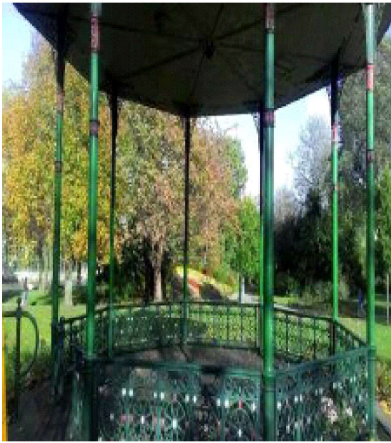
The bandstand was accessed and no suspect material was found.

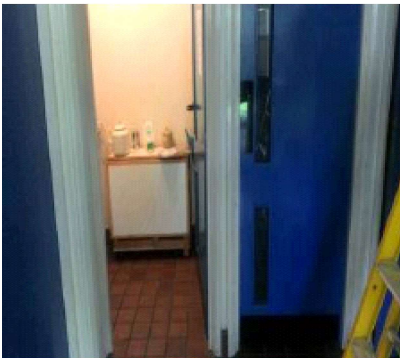
The lobby to the bowls pavilion (Room 1) was accessed and no suspect materials were found.

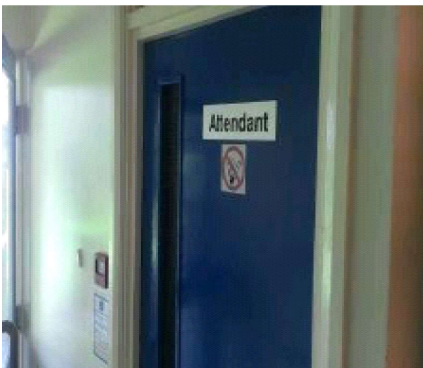
The attendants office was inaccessible at the time of the survey. This requires further investigation.

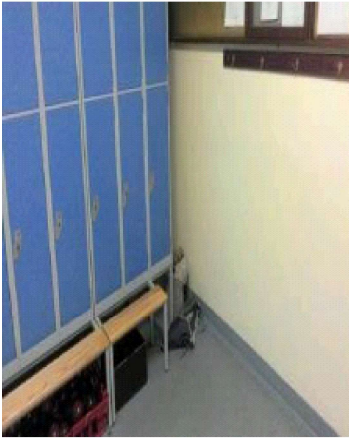
The home changing area to the pavilion (Room 3) was accessed and no suspect materials were found.

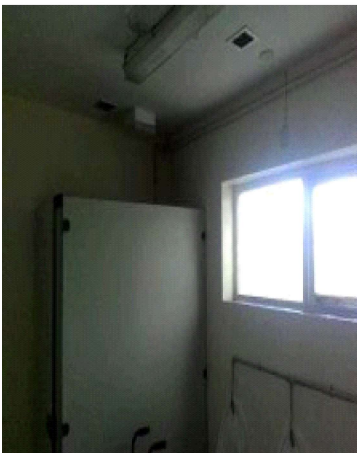
Toilet 1 to the pavilion (Room 4) was accessed and no suspect materials were found. asbestos.

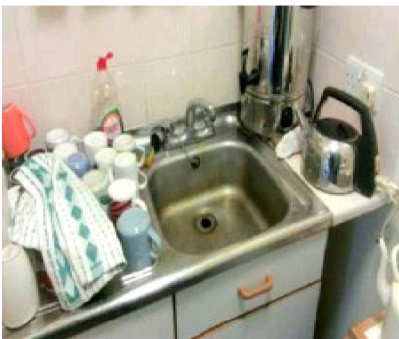
Item 1 Ref:EC002470

EC002470 – Sink pad (Room 5) (Item 1) - No Risk

The sink pad to the kitchen in the pavilion (Room 5) does not contain asbestos.

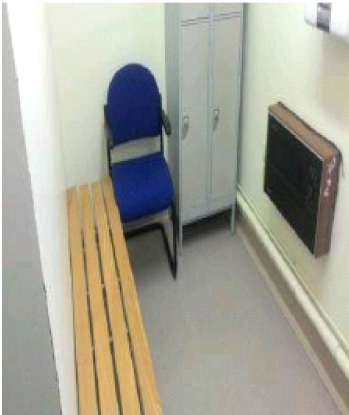
The ladies wc (Room 6) to the pavilion was accessed and no suspect materials were found.

There was no access to the storage heater however, as it was live.

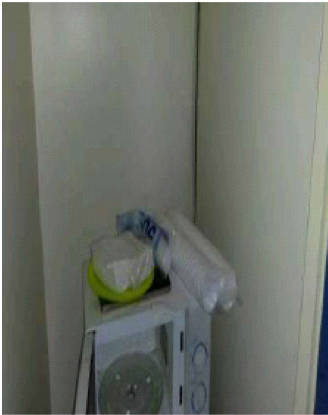
The cupboard to the pavilion (Room 7) was accessed and no suspect materials were found.

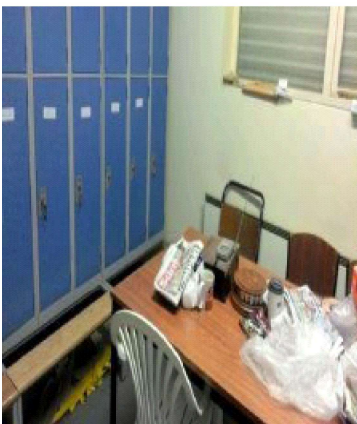
The visitors changing area to the pavilion (Room 8) was accessed and no suspect materials were found.

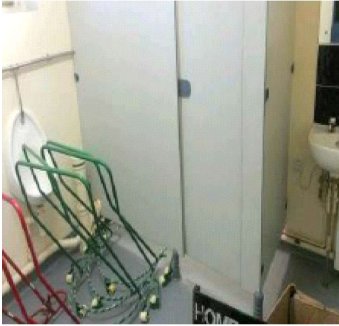
Toilet 2 in the pavilion (Room 9) was accessed and no suspect materials were found.

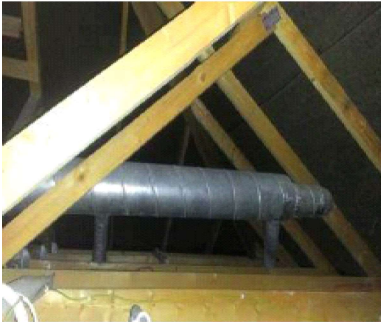
The roof void to the pavilion was accessed and no suspect materials were found.

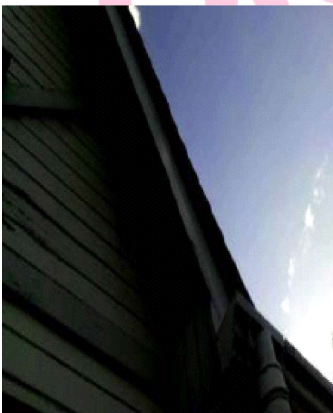
Item 2 Ref: - EC002471

EC002471 – Cement Verge (External) (Item 2) - No Risk

The cement verge edging to the external does not contain asbestos.

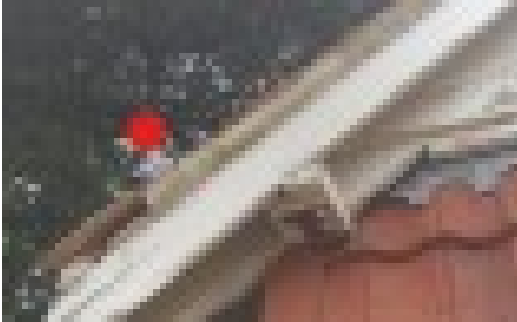
Item 12 Ref: - NM001127

NM001127 – Undercloaking (External) (Item 12) – No Risk

The undercloak externally does not contain asbestos.

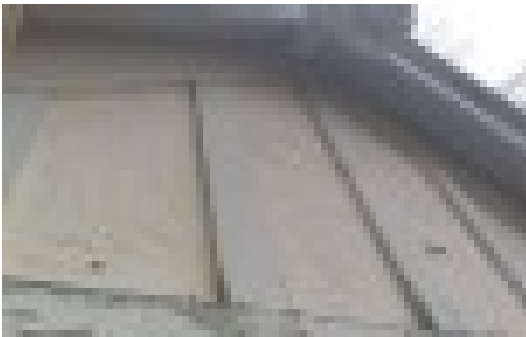
Item 13 Ref: - NM001128

NM001128 – Decorative Coating (External roof elevation) (Item 13) – No Risk

The decorative coating to roof elevation externally does not contain asbestos.

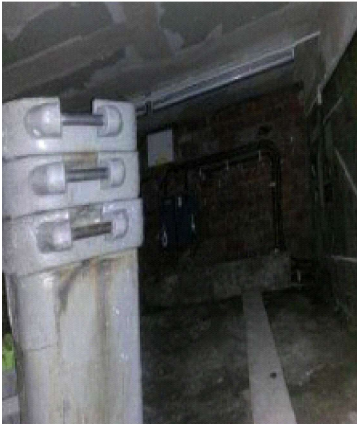
The basement store to the mess room was accessed and no suspect materials were found.

However there was no access to the electrics as they were ..

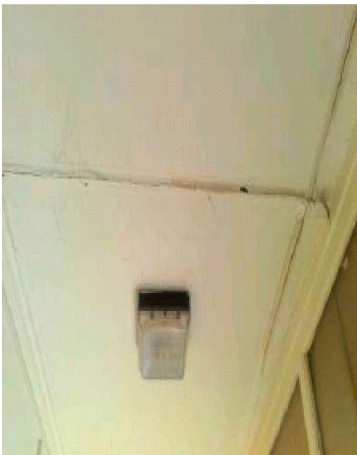
Item 3 Ref: - EC002465

EC002465 – Ceiling (Room 1) (Item 3) - No Risk

The ceiling to the hall in the mess room (Room 1) does not contain asbestos.

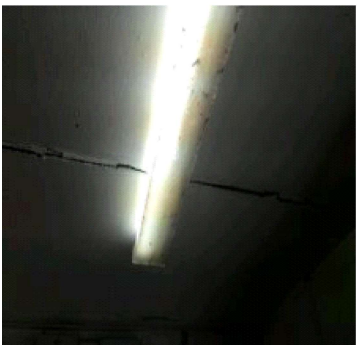
Item 4 As EC002465

As EC002465 – Ceiling (Room 2) (Item 4) - No Risk

The ceiling to the office (Room 2) in the mess room does not contain asbestos.

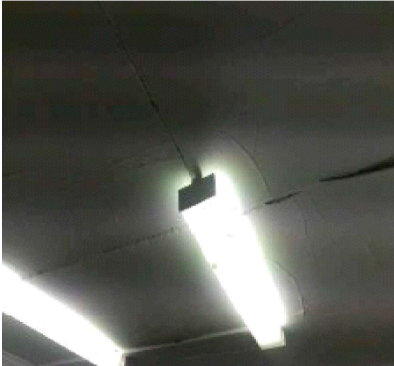
Item 5 As EC002465

As EC002465 – Ceiling (Room 3) (Item 5) – No Risk

The ceiling to the mess room (Room 3) does not contain asbestos.

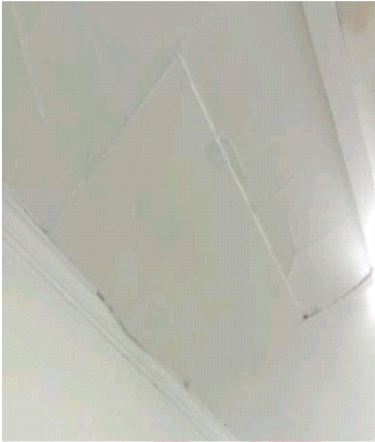
Item 6 Ref: EC002466

EC002466 – Ceiling (Room 3) (Item 6) – No Risk

The ceiling to the mess room (Room 3) does not contain asbestos.

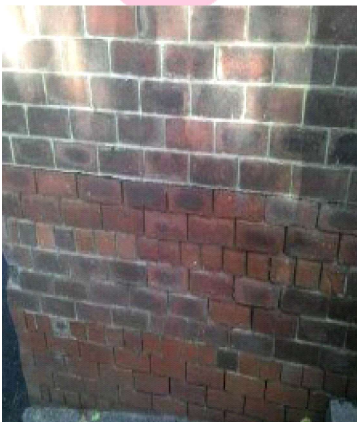
Item 7 Ref: - EC002467

EC002467 – Damp proof course (Item 7) - No Risk

The damp proof course to the external of the mess room does not contain asbestos.

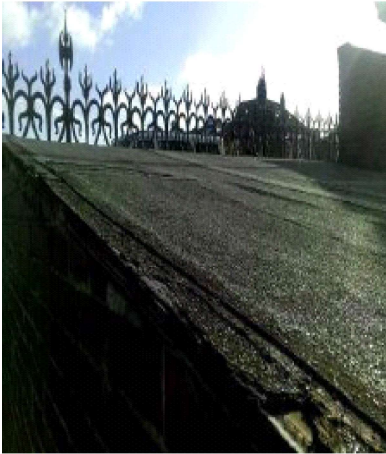
Item 8 As EC002469

EC002469 – Garage Roof (External) (Item 8) - No Risk

The bitumen roof felt to the garages does not contain asbestos.

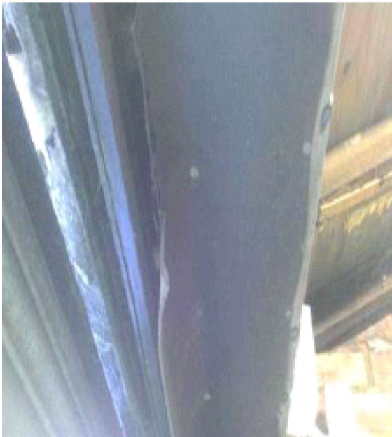
Item 9 Ref: EC002468

EC002468 – Damp proof course (External) (item 9) – No Risk

The damp proof course to garage 1 does not contain asbestos.

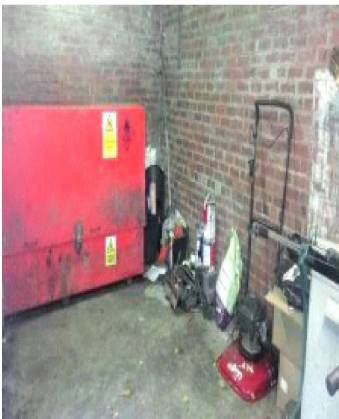
Garage 2 was accessed and no suspect materials were found.

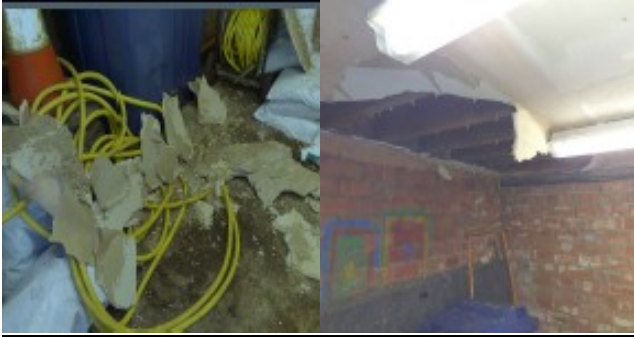
Item15 Ref: KG000581

KG000581 – Plaster ceiling and floor (Store Room) (Item 15) – No Risk

The plaster ceiling and floor in the Store Room (01) does not contain asbestos.

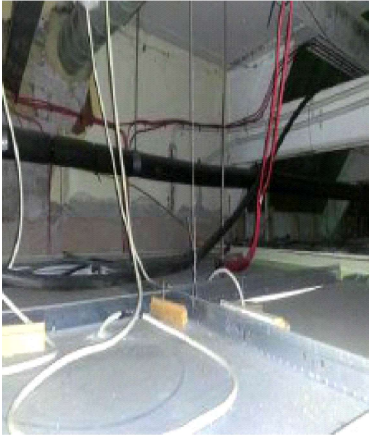
The lobby to the base (Room 1) was accessed and no suspect materials were found.

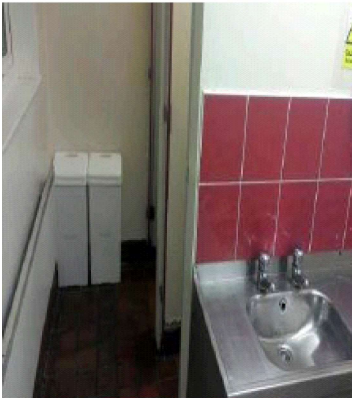
The ladies wc to the base (Room 2) was accessed and no suspect materials were found.

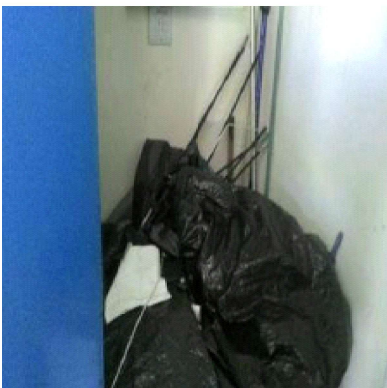
The cupboard (Room 3) was accessed and no suspect materials were found.

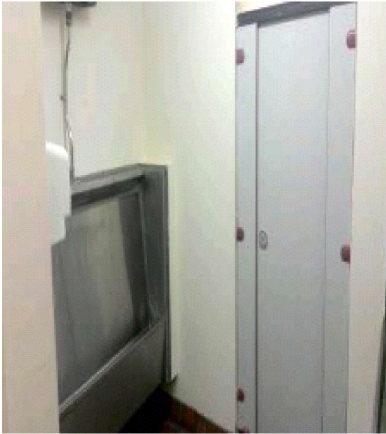
The mens wc (Room 4) was accessed and no suspect materials were found.

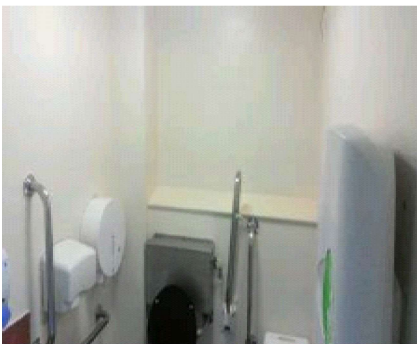
The disabled wc to the base (Room 5) was accessed and no suspect materials were found.

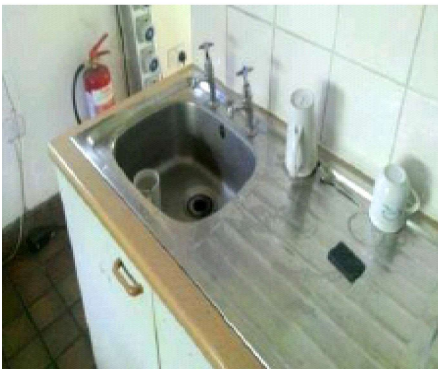
Item 10 Ref: EC002473

EC002473 – Sink pad (Room 6) (Item 10) - No Risk

The sink pad to the Park rangers office (Room 6) does not contain asbestos.

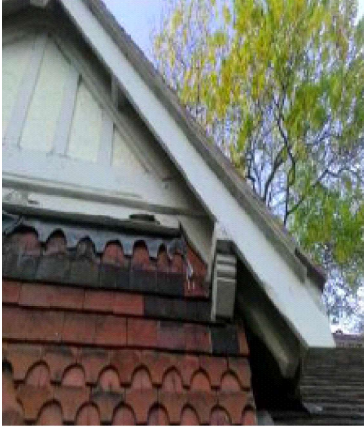
Item 11 Ref: EC002472

EC002472 – Cement Verge (External) (Item 11) - No Risk

The verge tiles and the cement sheet to the external do not contain asbestos.
