ASBESTOS SURVEY REPORT FOR NEW HERRINGTON RECREATION PARK, NEW HERRINGTON DH4 4LN.

Asbestos Register for New Herrington Recreation Park

UPRN: - 298726

Date: 22 November 2022

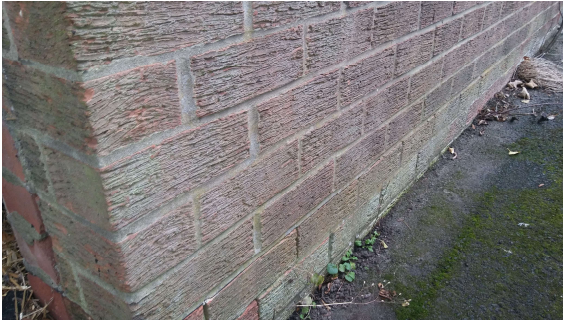
Item 1 Ref: 298726-6

The damp proof course to the externals to the toilet does not contain asbestos.

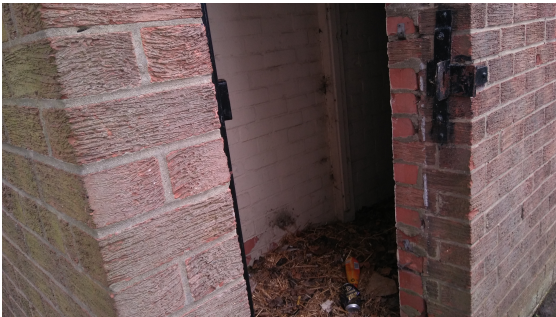
Item 2 Ref: 298726-7

The remnant sealant to walls to the externals to the toilet does not contain asbestos.

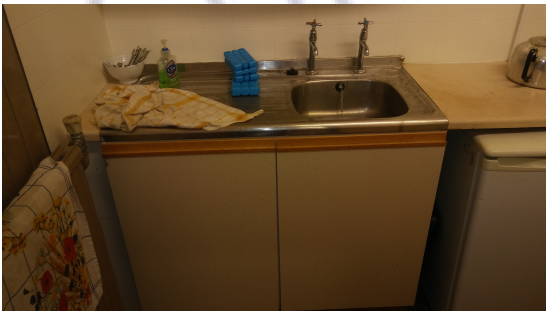
Item 3 Ref: 298726-1

The sink pad in the lounge and kitchen (Rm 002) does not contain asbestos.

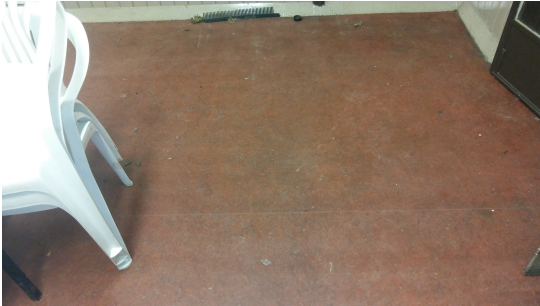
Item 4 Ref: 298726-2

The floor covering in the lounge and kitchen (Rm 002) does not contain asbestos.

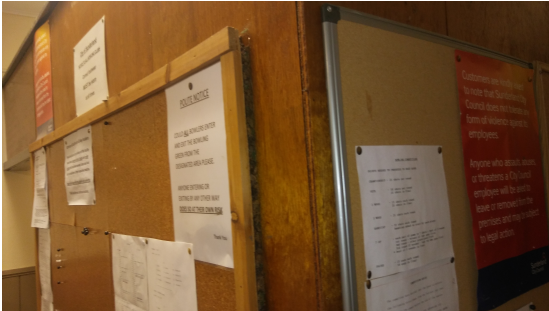
Item 5 Ref: 298726-3

The packers to the notice board in the lounge and kitchen (Rm 002) does not contain asbestos.

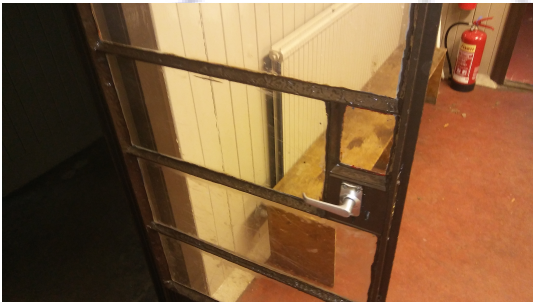
Item 6 Ref: 298726-4

The sealant to the metal door in the corridor (Room 003) does not contain asbestos.

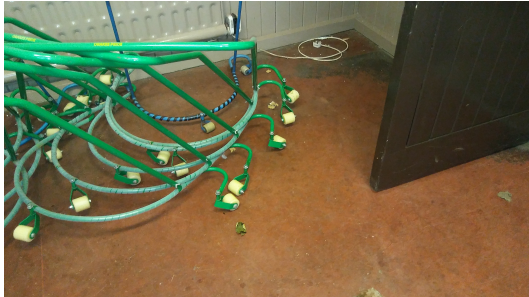
Item 7 Ref: As 298726-2

The floor covering in the kitchen (Rm 004) does not contain asbestos.

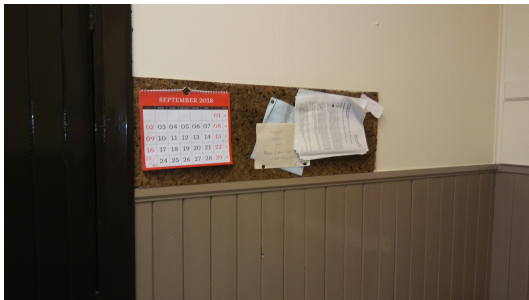
Item 8 Ref: As 298726-3

The pin board in the kitchen (Rm 004) does not contain asbestos.

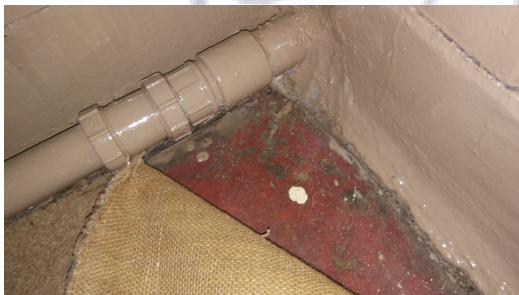
Item 9 Ref: As 298726-2

The floor covering in the WC (Room 005) does not contain asbestos.

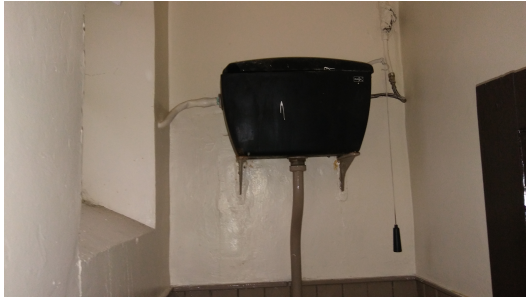
Item 10 Ref: 298726-5

The toilet cistern in the wc (Room 005) does not contain asbestos.

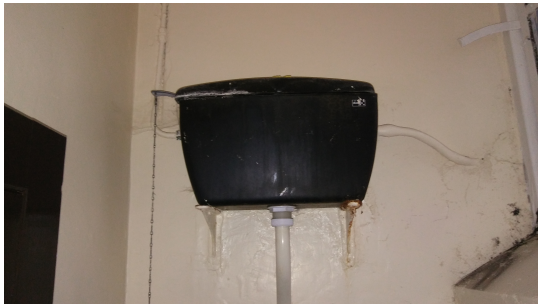
Item 11 Ref: As 298726-5

The toilet cistern in the wc (Rm 006) does not contain asbestos.

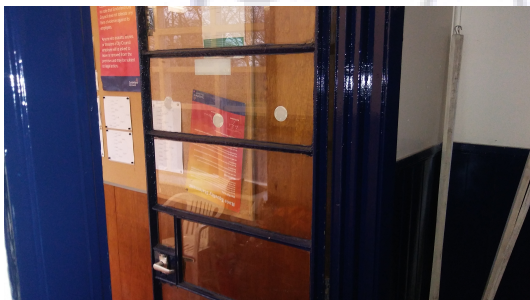
Item 12 Ref: As 298726-4

The sealant to metal door frame in the corridor (Room 008) does not contain asbestos.

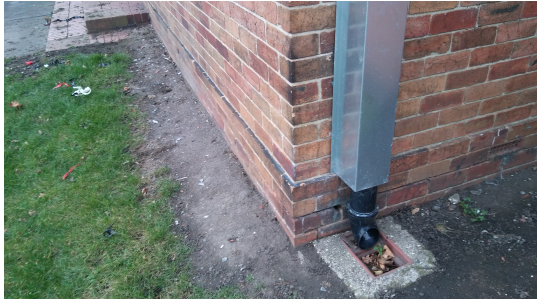
Item 13 Ref: 298726-10

The damp proof course external to bowls pavilion does not contain asbestos.

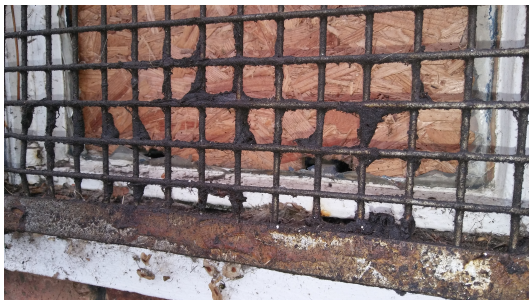
Item 14 Ref: 298726-8

The sealant to the metal window frames external to bowls pavilion does not contain asbestos.

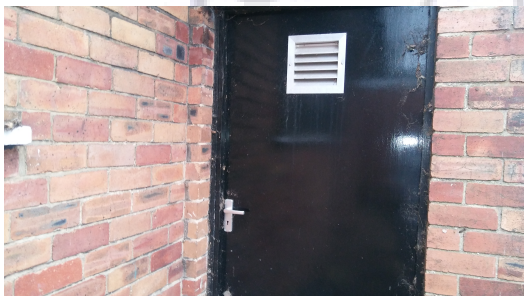
Item 15 Ref: 298726-9

The sealant to door frames external to bowls pavilion does not contain asbestos.
