ASBESTOS SURVEY REPORT FOR CONNEXIONS CENTRE, THE GALLERIES, WASHINGTON.

**Connexions Centre, The Galleries, Washington,
NE38 7RZ**

Date: 07 May 2025

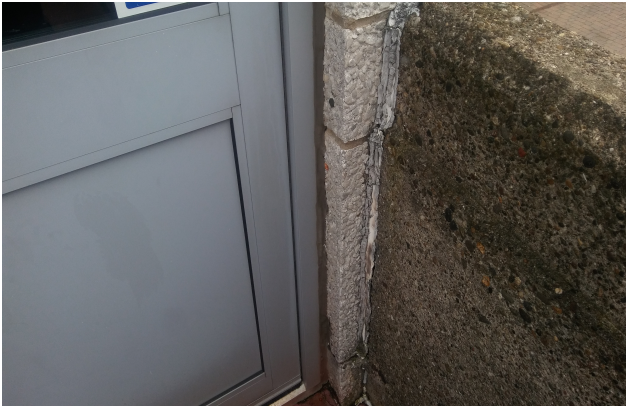
Item 1 Ref: 218435-1

218435-1 Mastic to door frame (External) (Item 1) – No Risk

The mastic around the door frame (External) does not contain asbestos.

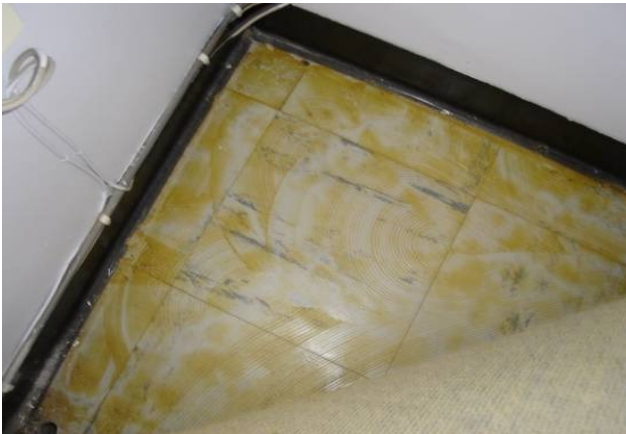
Item 2 Ref:As FP09-453-3

As FP09-453-3 – Floor tiles below carpet - Tiles removed bitumen remains
(Interview Rm 9 / Rm 0/002) (Item 2) – Very Low Risk (*Pattinsons Survey ref 21-30945-1/Office 6/Interview Room 1*)

The floor tiles – below carpet in Interview Room 9 (Rm 0/002) do contain asbestos. Tiles removed bitumen remains.

Any change in its appearance should be recorded and passed to Property Services.

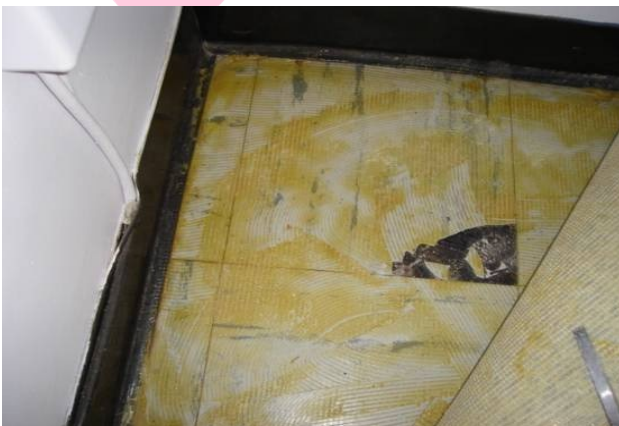
Item 3 Ref: FP09-453-3

FP09-453-3 – Floor tiles (Kitchen / Rm 0/003) (Item 3) – Very Low Risk
(*Pattinsons Survey ref 21-30945-1/Kitchen*)

The floor tiles in the Kitchen (Rm 0/003) do contain asbestos.

Any change in its appearance should be recorded and passed to Property Services.

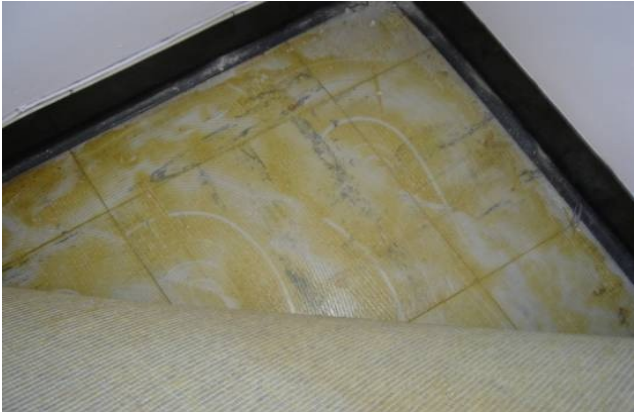
Item 4 Ref:As FP09-453-3

As FP09-453-3 – Floor tiles below carpet - Tiles removed bitumen remains
(Interview Rm 3 & 4 / Rm 0/004) (Item 4) – Very Low Risk (*Pattinsons Survey ref 21-30945-1/Interview Room 2/3*)

The floor tiles – below carpet in Interview Rooms 3 & 4 (Rm 0/004) do contain asbestos.

- Tiles removed bitumen remains

Any change in its appearance should be recorded and passed to Property Services.

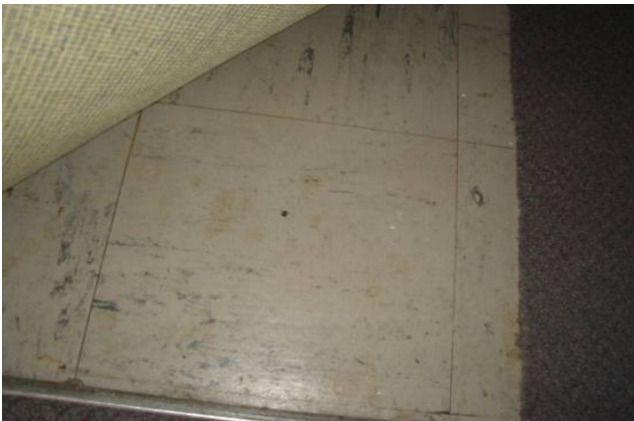
Item 5 Ref: FP09-453-5

FP09-453-5 – Floor tiles below carpet - Tiles removed bitumen remains
(Cleaners Cupboard / Rm 0/005) (Item 5) – Very Low Risk (*Pattinsons Survey ref 21-30945-1/Cleaners Cupboard*)

The floor tiles – below carpet in the Cleaners Cupboard (Rm 0/005) do contain asbestos.

- Tiles removed bitumen remains

Any change in its appearance should be recorded and passed to Property Services.

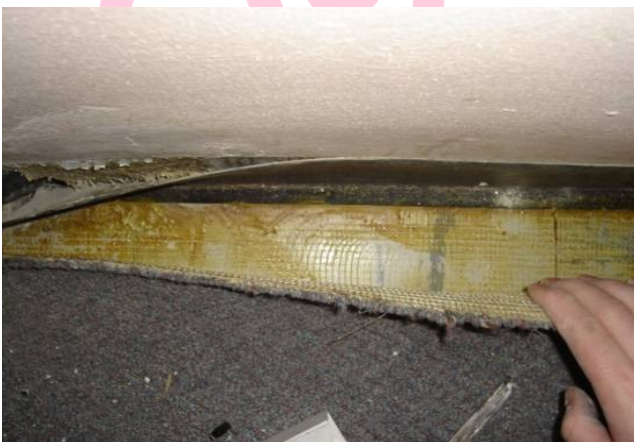
Item 6 Ref:As FP09-453-5

As FP09-453-5 – Floor tiles below carpet - Tiles removed bitumen remains (Store / Rm 0/006) (Item 6) – Very Low Risk (*Pattinsons Survey ref 21-30945-1/Server Room*)

The floor tiles – below carpet in the Store (Rm 0/006) do contain asbestos.

- Tiles removed bitumen remains

Any change in its appearance should be recorded and passed to Property Services.

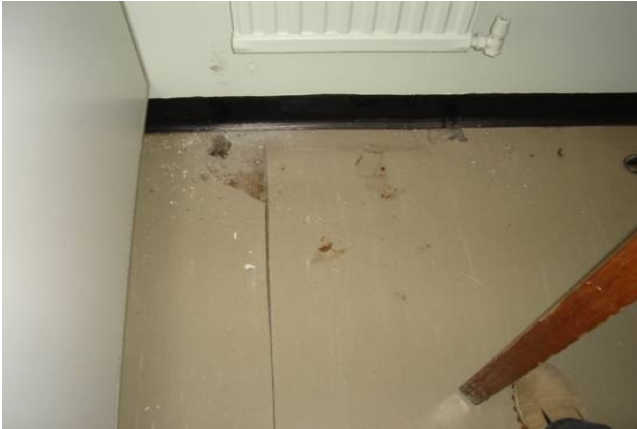
Item 7 Ref: FP09-453-7

FP09-453-7 – Floor covering (Female & Male WC / Rm 0/007) (Item 7) – Very Low Risk (*Pattinsons Survey ref 21-30945-1/Ladies and Gents Toilets*)

The floor tiles in the Female & Male WC (Rm 0/007) do contain asbestos.

Any change in its appearance should be recorded and passed to Property Services.

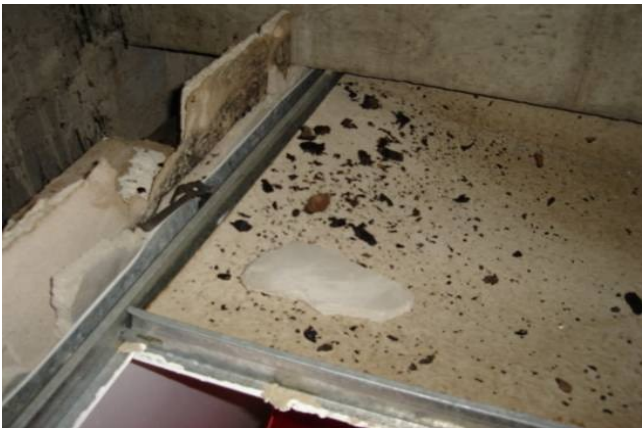
Item 8 Ref: FP09-453-1

FP09-453-1 – Debris (Interview Rms 9 & 10 – ceiling void / Rm 0/002) (Item 8) – No Risk

The roof debris in Interview Rooms 9 & 10 ceiling void (Rm 0/002) does not contain asbestos.

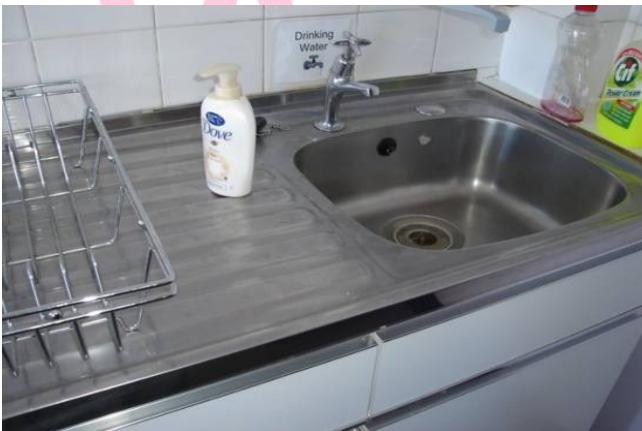
Item 9 Ref: FP09-453-2

FP09-453-2 – Sink Pad (Kitchen / Rm 0/003) (Item 9) – No Risk

The sink pad in the Kitchen (Rm 0/003) does not contain asbestos.

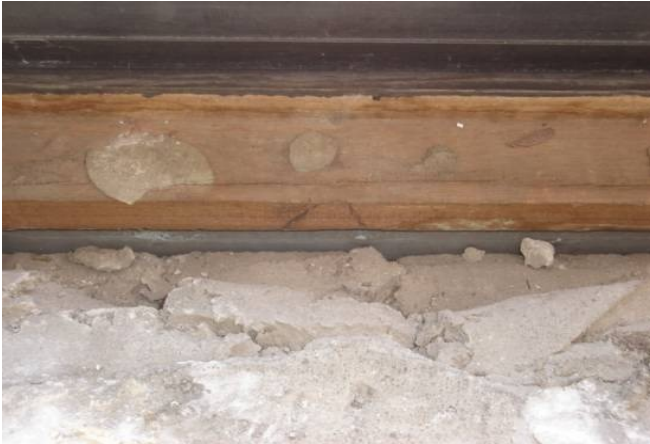
Item 10 Ref: FP09-453-4

FP09-453-4 – Panel below window – within cavity (Interview Rms 3 & 4 / Rm 0/004) (Item 10) – No Risk

The panel below window (within cavity) in the Interview Rooms 3 & 4 (Rm 0/004) does not contain asbestos.

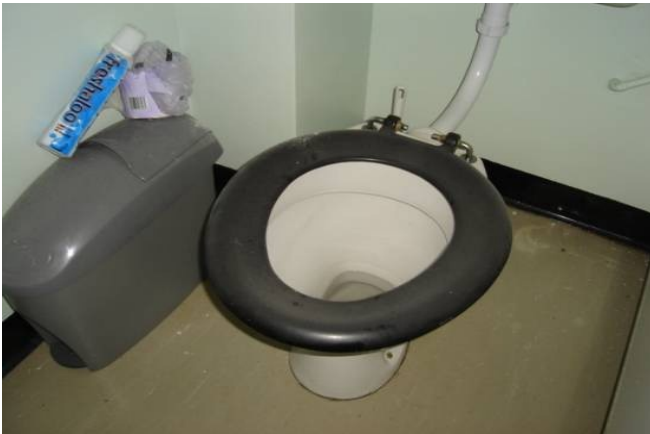
Item 11 Ref: FP09-453-6

FP09-453-6 – Toilet Seats (Female & Male WC / Rm 0/007) (Item 11) – No Risk

The toilet seats in the Female & Male WC (Rm 0/007) does not contain asbestos.

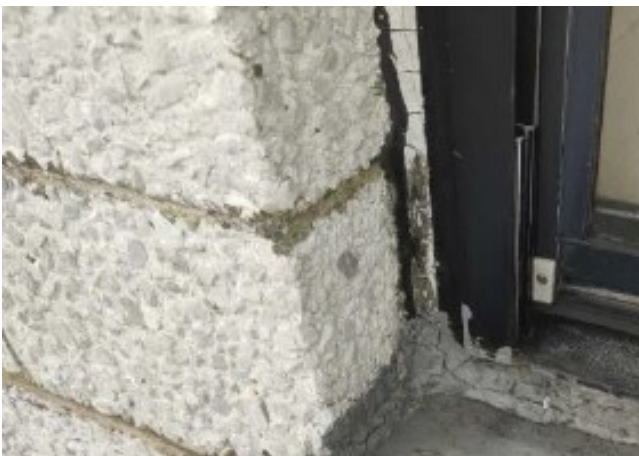
Item 12 Ref: 22-41634-3

22-41634-3 – Sealant around windows to connexions building (Area 1/External) (Item 12) – No Risk

The sealant around windows to connexions building (Area 1/External) does not contain asbestos.

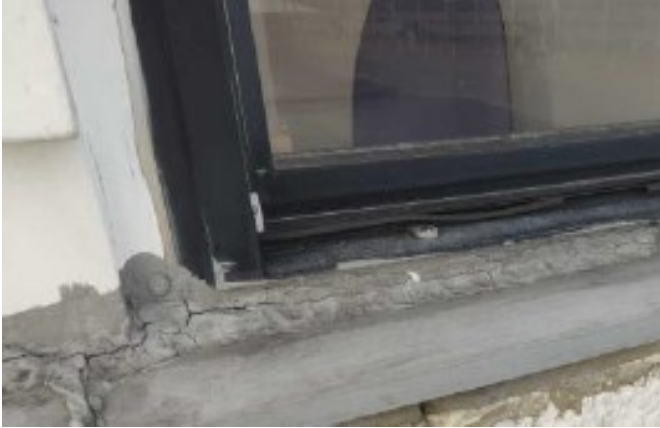
Item 13 Ref: 22-41634-4

22-41634-4 – Sills below windows to connexions building (Area 1/External) (Item 13) – No Risk

The sills below windows to connexions building (Area 1/External) does not contain asbestos.
