ASBESTOS SURVEY REPORT FOR 5 ELWIN TERRACE, SUNDERLAND, SR2 7JF

Asbestos Register for

5 Elwin Terrace, Sunderland, SR2 7JF

Date: 22 May 2025

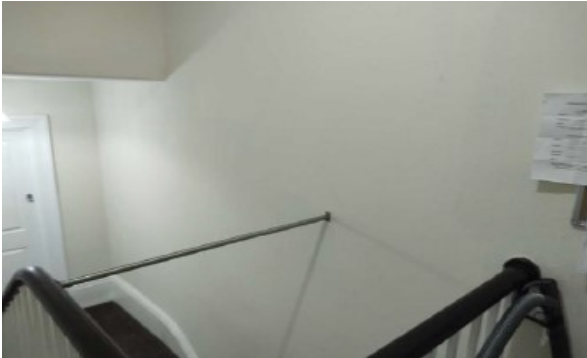
Item 1 Ref: 22-47975-1

The textured coating walls in Area 1 - Landing and Stairs does not contain asbestos.

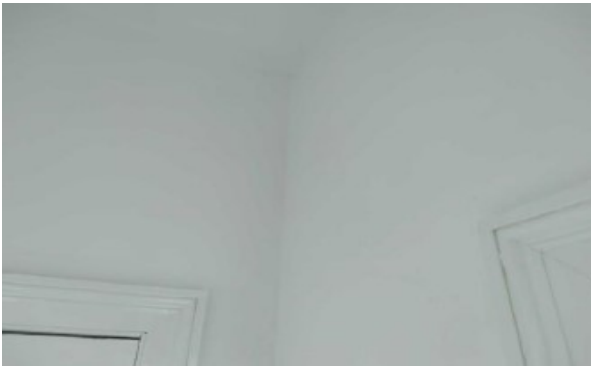
Item 2 Ref: 22-47975-1

The textured coating walls in Area 2 - Bedsit 5 does not contain asbestos.

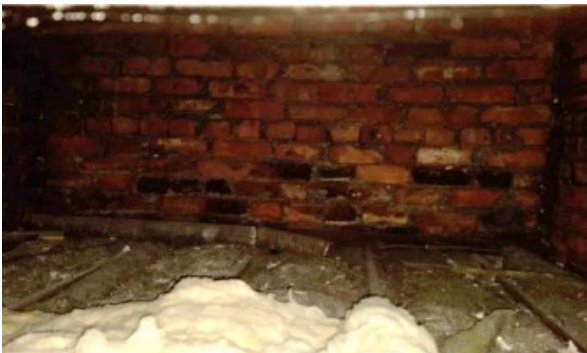
Item 3 Ref: Presumed

The redundant cement flue pipe in Area 6 – Loft 2 is strongly presumed to contain asbestos.

Any change in its appearance should be recorded and passed to Property Services.

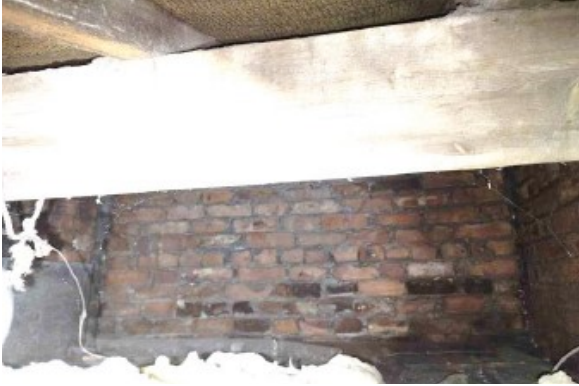
Item 4 Ref: Presumed

The redundant cement flue pipe in Area 6 – Loft 2 is strongly presumed to contain asbestos.

Any change in its appearance should be recorded and passed to Property Services.

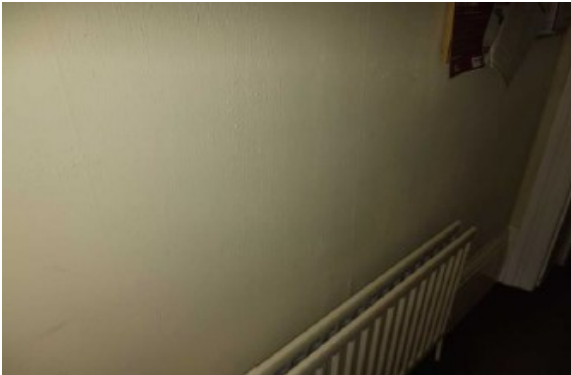
Item 5 Ref: 22-47975-1

The textured coating walls in Area 8 – Entrance Hall does not contain asbestos.

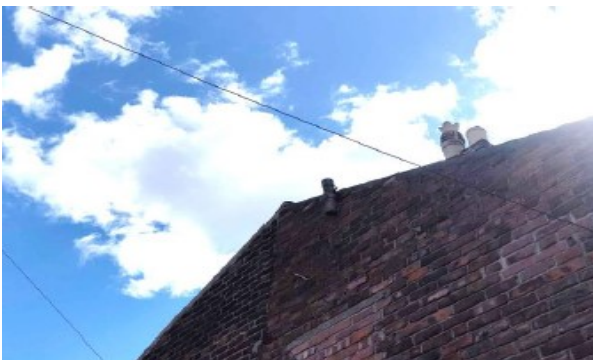
Item 6 Ref: Presumed

The redundant cement flue pipe External is strongly presumed to contain asbestos.

Any change in its appearance should be recorded and passed to Property Services.
