ASBESTOS SURVEY REPORT FOR 72-74 HIGH STREET WEST,  
SUNDERLAND, SR1 3DW.

## *Control of Asbestos Regulations 2012*

**72 – 74 High Street West, Sunderland, SR1 3DW**

**Date: 03 April 2023**

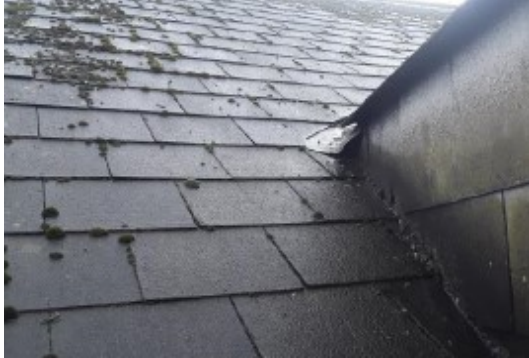
### **Item 1 Ref: 20-27002-1**

The roof tiles and upstands (External to roof /001) contain asbestos.

Any change in its appearance should be recorded and passed to Property Services.

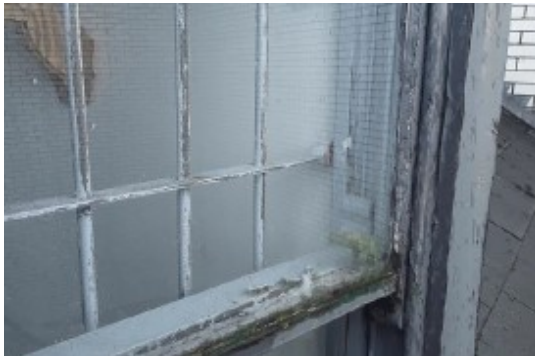
### **Item 2 Ref: 20-27002-2**

The putty to windows (External to roof /001) do not contain asbestos.

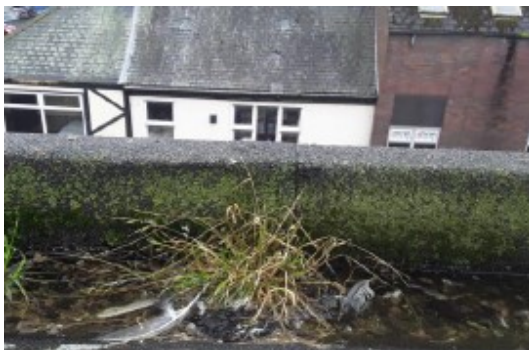
### **Item 3 Ref: 20-27002-8**

The felt gutters to front of building (External to roof /001) do not contain asbestos.

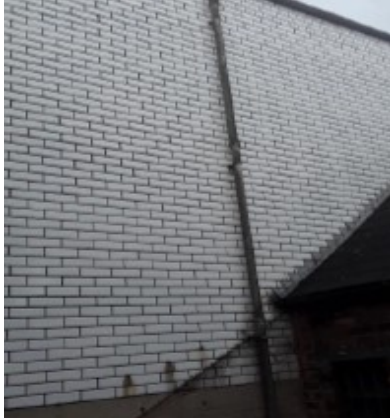
### **Item 4 Ref: Presumed**

The cement flue (External to roof /002) is presumed to contain asbestos.

Any change in its appearance should be recorded and passed to Property Services.

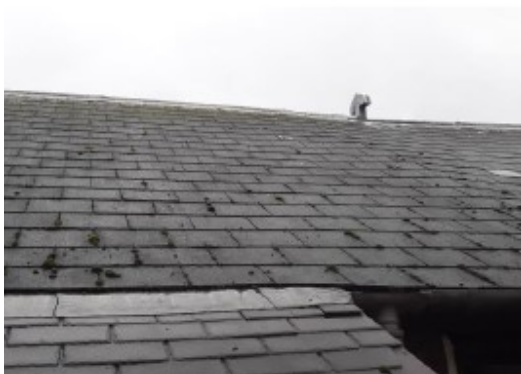
### **Item 5 Ref: 20-27002-4**

The roof tiles (External to roof /002) contain asbestos.

Any change in its appearance should be recorded and passed to Property Services.

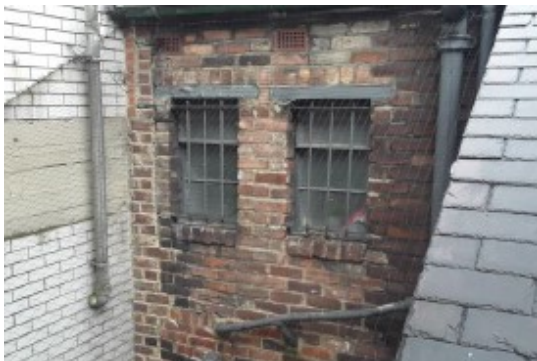
### **Item 6 Ref: 20-27002-5**

The glazing compound to metal windows (External roof /002) contain asbestos.

Any change in its appearance should be recorded and passed to Property Services.

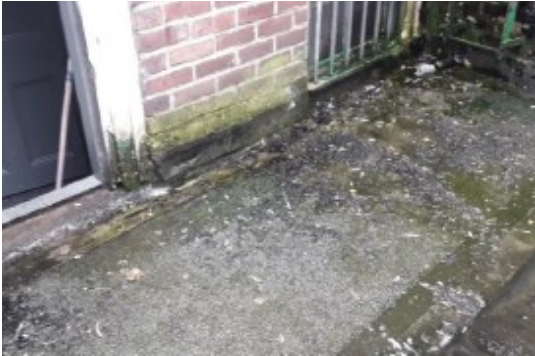
### **Item 7 Ref: 20-27002-6**

The felt and upstand (External roof/002) do not contain asbestos.

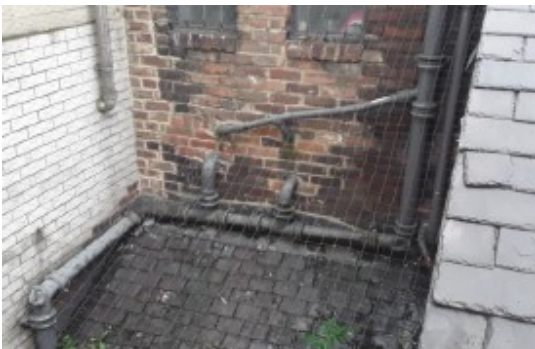
### **Item 8 Ref: Presumed**

The collars to soil pipes (External roof/002) are presumed to contain asbestos.

Any change in appearance should be recorded and passed to Property Services.

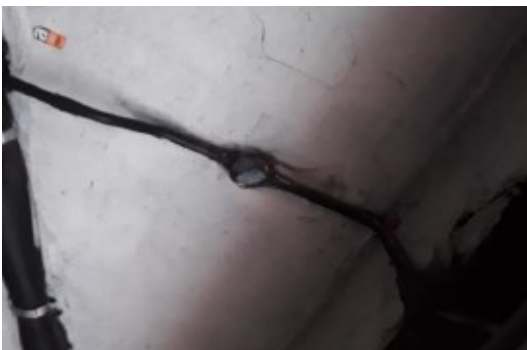
### **Item 9 Ref: 20-27002-9**

The ceiling boards and upstands in Loading Bay/003 contain asbestos.

Any change in its appearance should be recorded and passed to Property Services.
