ASBESTOS SURVEY REPORT FOR 12 GODFREY ROAD, GRINDON, SUNDERLAND

12 Godfrey Road, Grindon, Sunderland

Date: 28 April 2025

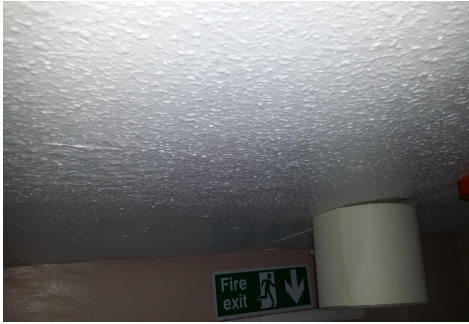
Item 1 Ref: 109589-8

The textured coating to the ceiling in the lobby (Room 0/03) contains asbestos.

Any change in its appearance should be recorded and passed to Property Services.

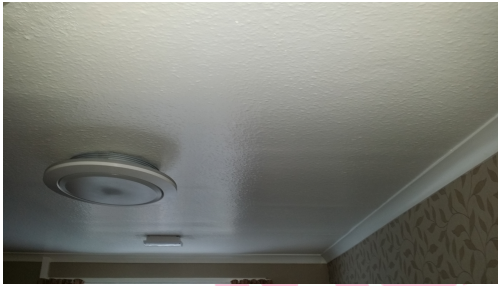
Item 2 Ref: 109589-9

The textured coating to the ceiling in the dining room (Rm 0/04) does not contain asbestos.

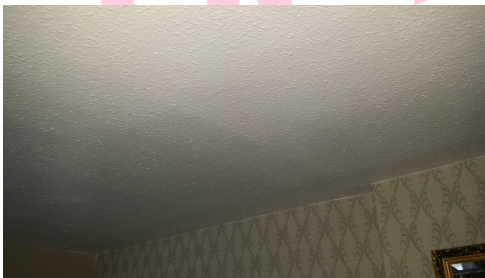
Item 3 As 109589-9

The textured coating to the ceiling in the living room (Rm 0/05) does not contain asbestos.

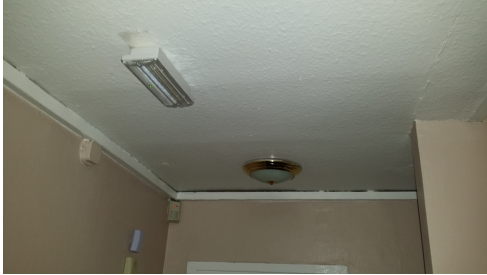
Item 4 Ref: 109589-10

The textured coating to the ceiling in the hall (Room 0/08) does not contain asbestos.

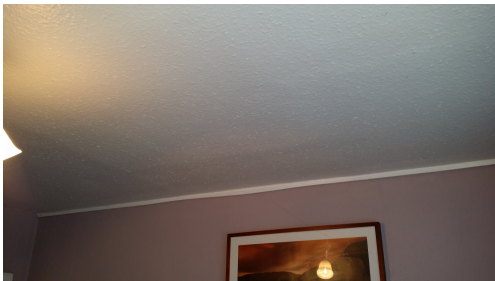
Item 5 As: 109589-10

The textured coating to the ceiling in the office (Room 0/09) does not contain asbestos.

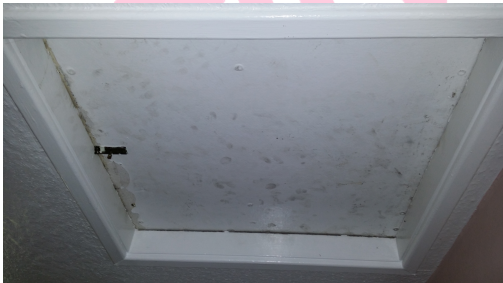
Item 6 Ref: 109589-1

The loft hatch panel to the landing (Room 1/01) does not contain asbestos.

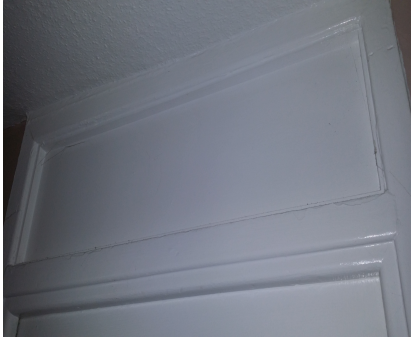
Item 7 Ref: 109589-2

The door header panels to the bedrooms on the landing (Room 1/01) do not contain

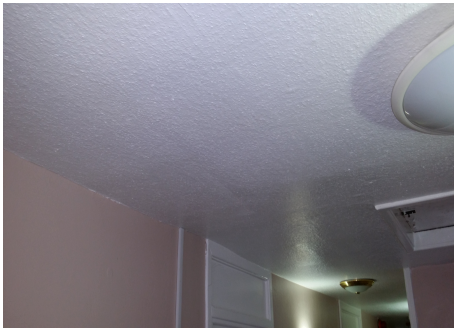
Item 8 Ref: 109589-3

The textured coating (under the woodchip) to the ceiling on the landing (Room 1/01) does not contain asbestos.

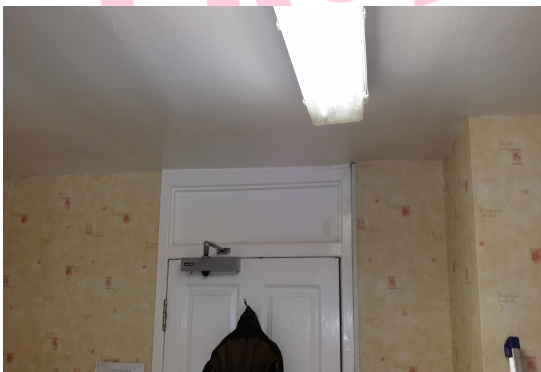
Item 9 As: 109589-2

The door header panel to the bedroom (Room 1/05) does not contain asbestos.

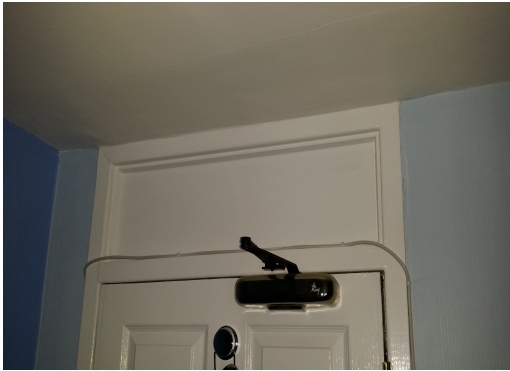
Item 10 As: 109589-2

The door header panel to the bedroom (Room 1/06) does not contain asbestos.

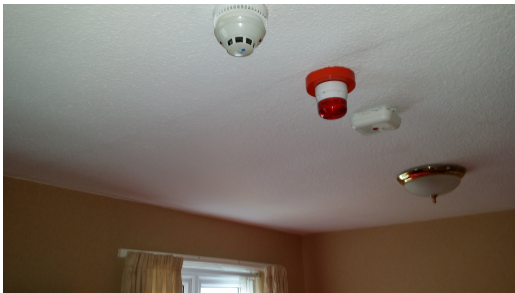
Item 11 As: 109589-3

The textured coating (under the woodchip) to the ceiling in the bedroom (Room 1/06) does not contain asbestos.

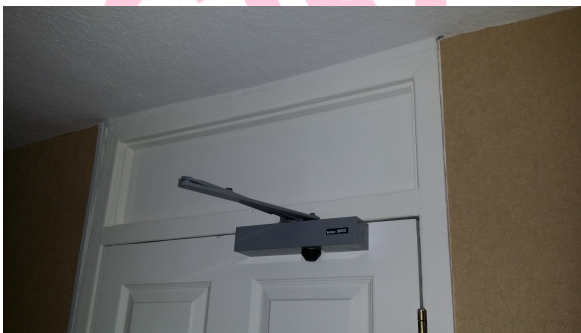
Item 12 As: 109589-2

The door header panel to the bedroom (Room 1/07) does not contain asbestos.

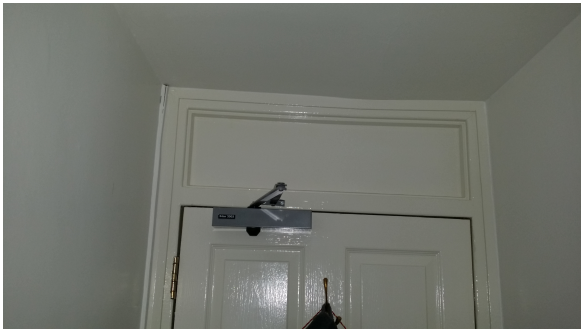
Item 13 As: 109589-2

The door header panel to the bedroom (Room 1/08) does not contain asbestos.

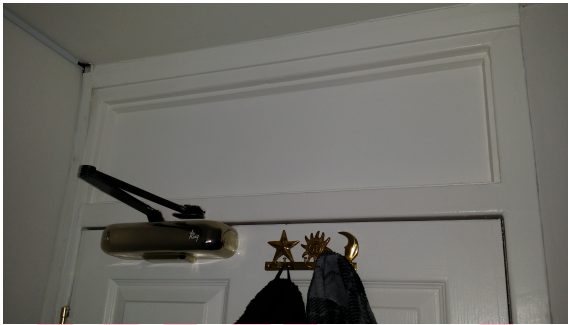
Item 14 As: 109589-2

The door header panel to the bedroom (Room 1/09) does not contain asbestos.

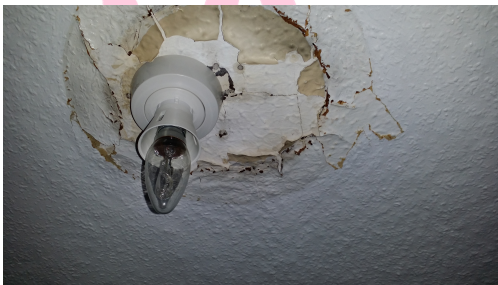
Item 15 Ref: 109589-4

The textured coating to the ceiling to the landing (Room 1/10) contains asbestos.

This has now been repaired, however, any change in its appearance should be recorded, and passed to Property Services.

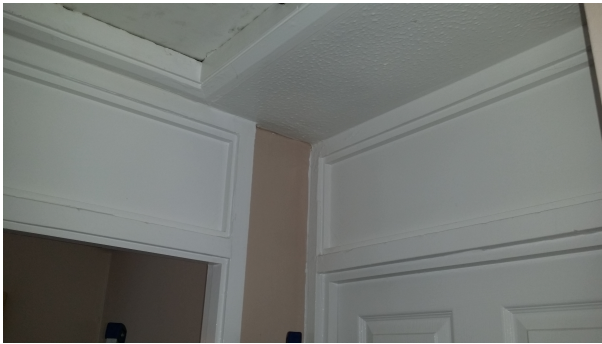
Item 16 As: 109589-2

The door header panels to the landing (Room 1/10) do not contain asbestos.

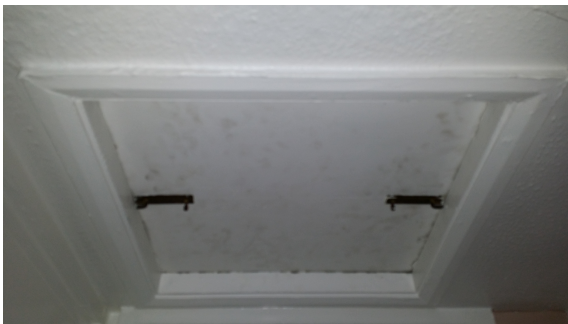
Item 17 Ref: 109589-6

The loft hatch to the landing (Room 1/10) does not contain asbestos.

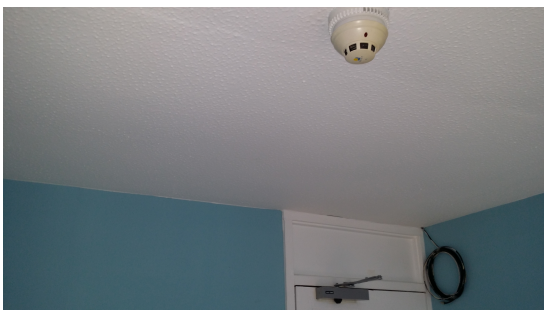
Item 18 Ref: 109589-7

The textured coating to the ceiling in the bedroom (Room 1/11) contains asbestos.

Removed on survey J066300

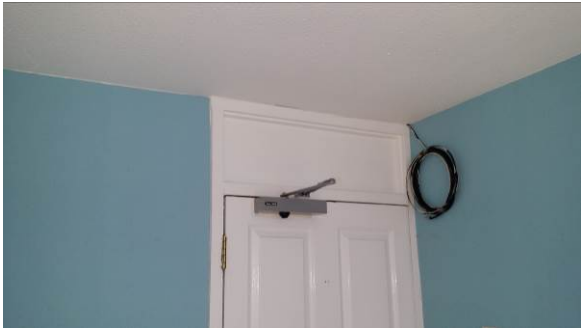
Item 19 As: 109589-5

The door header panels to the bedroom (Room 1/11) do not contain asbestos.

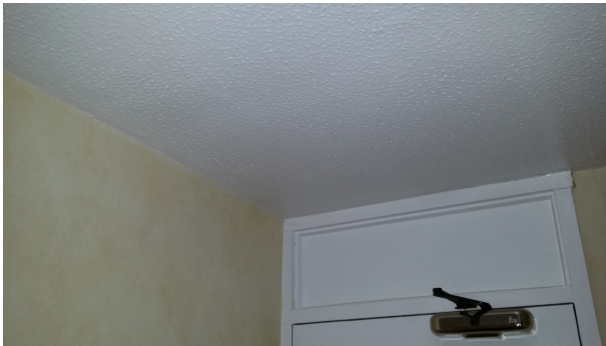
Item 20 As: 109589-7

The textured coating to the ceiling in the bedroom (Room 1/12) contains asbestos.

Removed on survey J066300

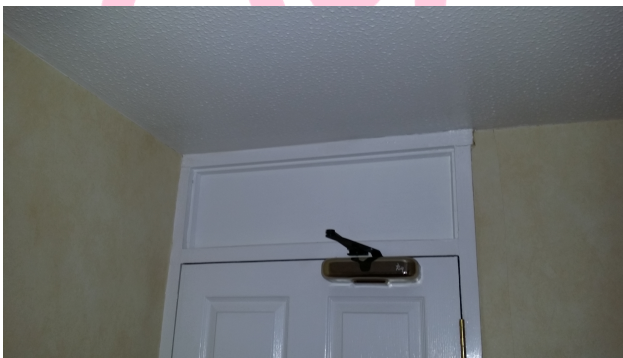
Item 21 As: 109589-5

The door header panel to the bedroom (Room 1/12) does not contain asbestos.

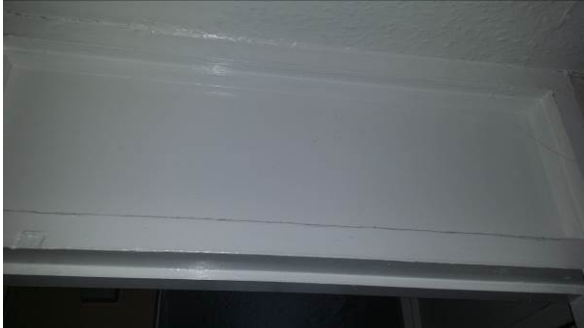
Item 22 As: 109589-5

The door header panel to the bathroom (Room 1/13) does not contain asbestos.

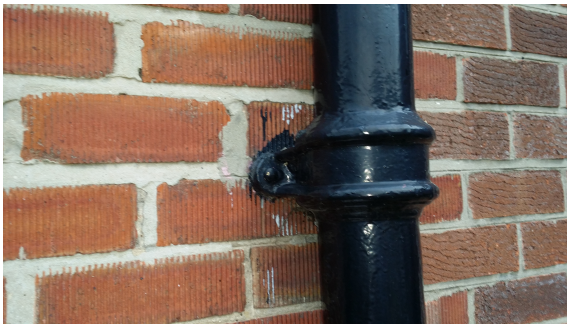
Item 23 Ref: 109589-11

The seal to the soil pipe section to the external do not contain asbestos.

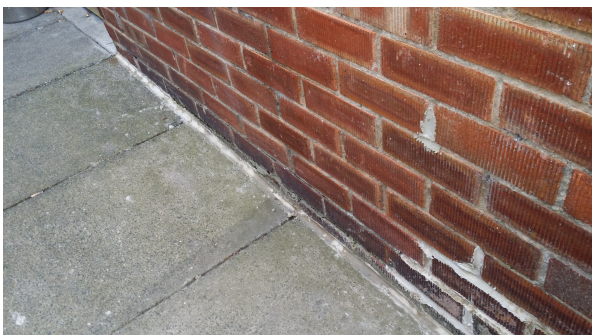
Item 24 Ref: 109589-12

The damp proof course to the external of the building does not contain asbestos.

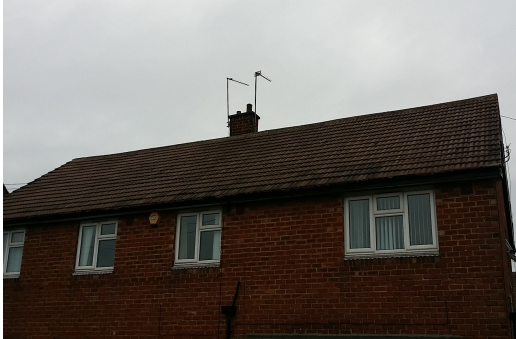
Item 25 Ref: Presumed

The cowl to the roof (External) is presumed to contain asbestos.

Any change in its appearance should be recorded and passed to Property Services.
