### ASBESTOS SURVEY REPORT FOR 12 GODFREY ROAD, GRINDON, SUNDERLAND

## **Asbestos Register for**

**12 Godfrey Road, Grindon, Sunderland**

12 Godfrey Road - Last updated 13/05/2024 - Version 2

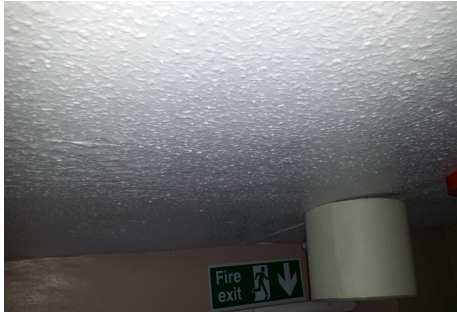
### **Item 1 Ref: 109589-8**

The textured coating to the ceiling in the lobby (Room 0/03) contains asbestos.

Any change in its appearance should be recorded and passed to Property Services.

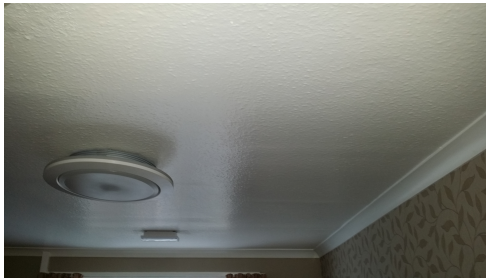
### **Item 2 Ref: 109589-9**

The textured coating to the ceiling in the dining room (Rm 0/04) does not contain asbestos.

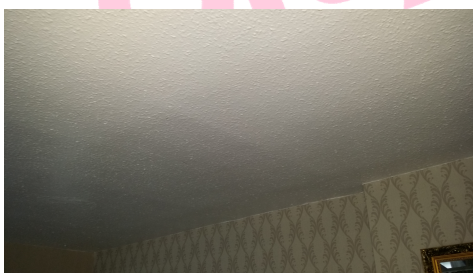
### **Item 3 As 109589-9**

The textured coating to the ceiling in the living room (Rm 0/05) does not contain asbestos.

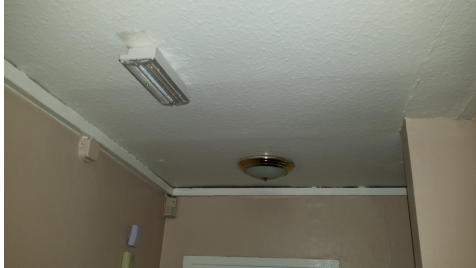
**Item 4 Ref: 109589-10**

The textured coating to the ceiling in the hall (Room 0/08) does not contain asbestos.

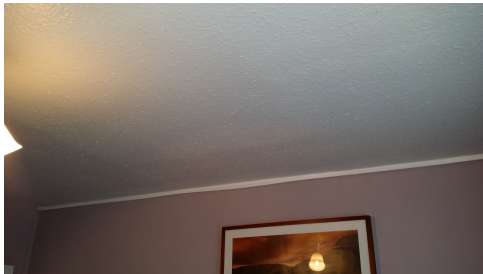
**Item 5 As: 109589-10**

The textured coating to the ceiling in the office (Room 0/09) does not contain asbestos.

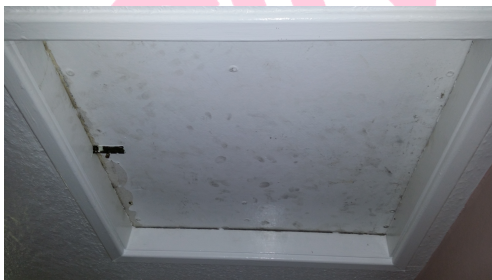
**Item 6 Ref: 109589-1**

The loft hatch panel to the landing (Room 1/01) does not contain asbestos.

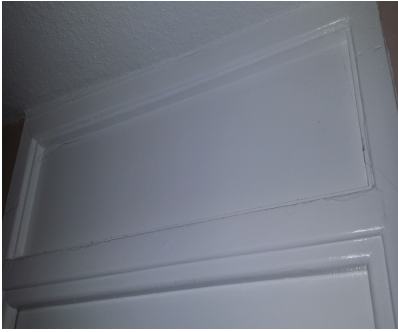
**Item 7 Ref: 109589-2**

The door header panels to the bedrooms on the landing (Room 1/01) do not contain

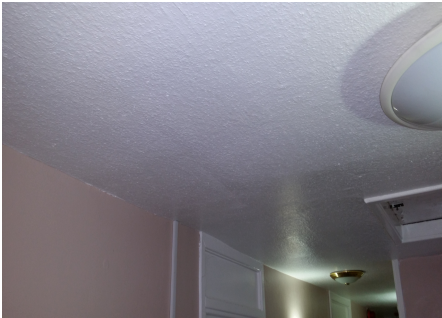
**Item 8 Ref: 109589-3**

The textured coating (under the woodchip) to the ceiling on the landing (Room 1/01) does not contain asbestos.

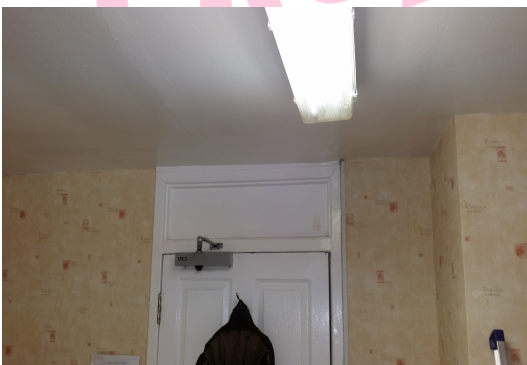
**Item 9 As: 109589-2**

The door header panel to the bedroom (Room 1/05) does not contain asbestos.

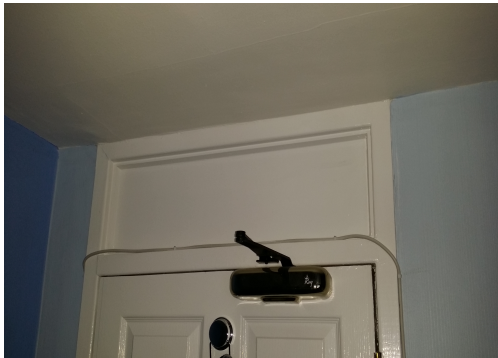
**Item 10 As: 109589-2**

The door header panel to the bedroom (Room 1/06) does not contain asbestos.

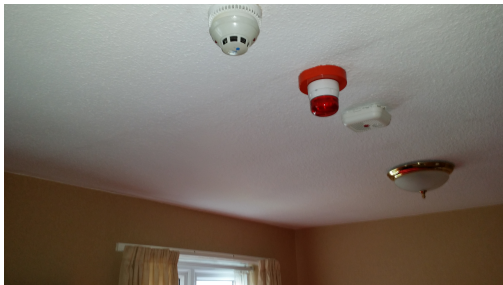
**Item 11 As: 109589-3**

The textured coating (under the woodchip) to the ceiling in the bedroom (Room 1/06) does not contain asbestos.

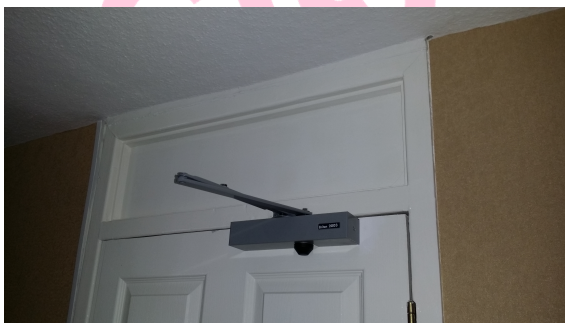
**Item 12 As: 109589-2**

The door header panel to the bedroom (Room 1/07) does not contain asbestos.

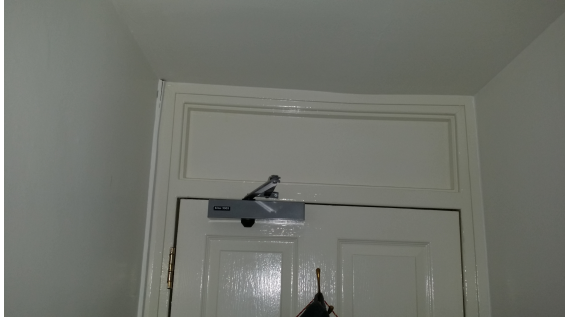
**Item 13 As: 109589-2**

The door header panel to the bedroom (Room 1/08) does not contain asbestos.

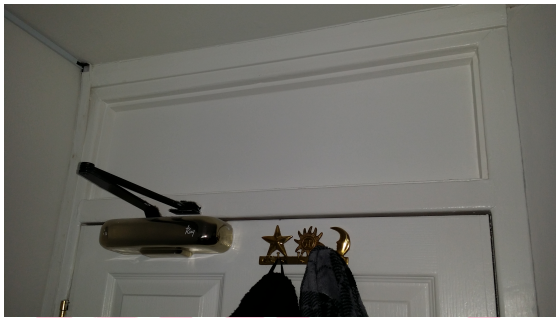
**Item 14 As: 109589-2**

The door header panel to the bedroom (Room 1/09) does not contain asbestos.

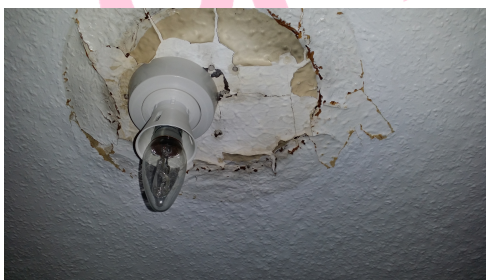
**Item 15 Ref: 109589-4**

The textured coating to the ceiling to the landing (Room 1/10) contains asbestos.

This has now been repaired, however, any change in its appearance should be recorded, and passed to Property Services.

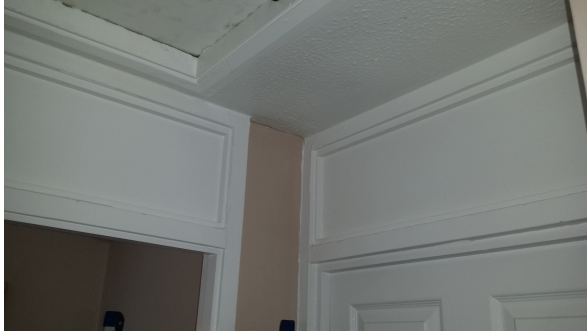
**Item 16 As: 109589-2**

The door header panels to the landing (Room 1/10) do not contain asbestos.

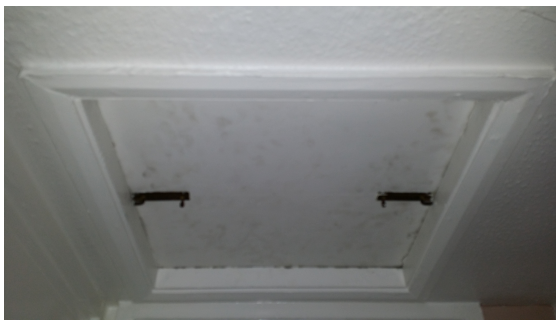
**Item 17 Ref: 109589-6**

The loft hatch to the landing (Room 1/10) does not contain asbestos.

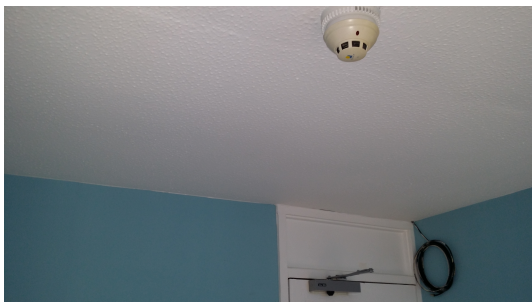
**Item 18 Ref: 109589-7**

The textured coating to the ceiling in the bedroom (Room 1/11) contains asbestos.

***Removed on survey J066300***

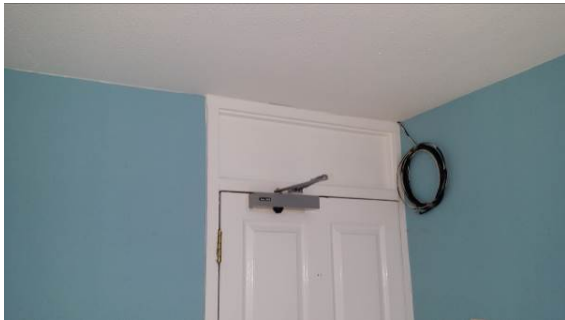
**Item 19 As: 109589-5**

The door header panels to the bedroom (Room 1/11) do not contain asbestos.

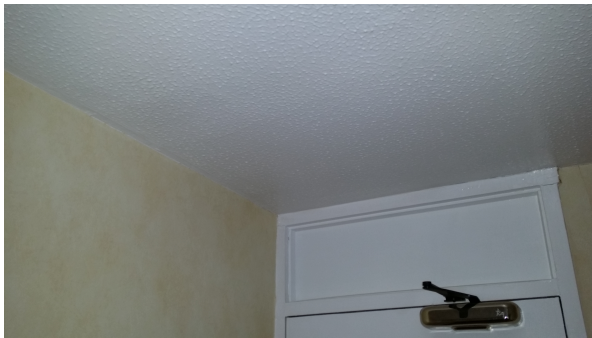
**Item 20 As: 109589-7**

The textured coating to the ceiling in the bedroom (Room 1/12) contains asbestos.

***Removed on survey J066300***

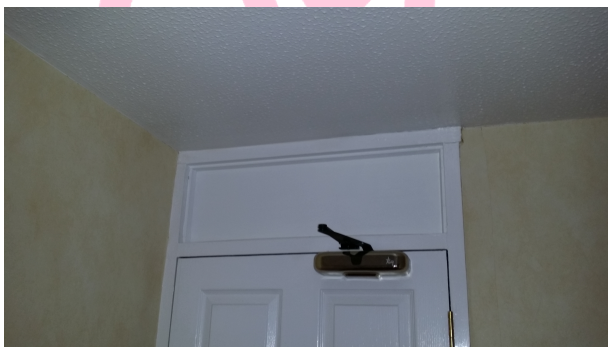
**Item 21 As: 109589-5**

The door header panel to the bedroom (Room 1/12) does not contain asbestos.

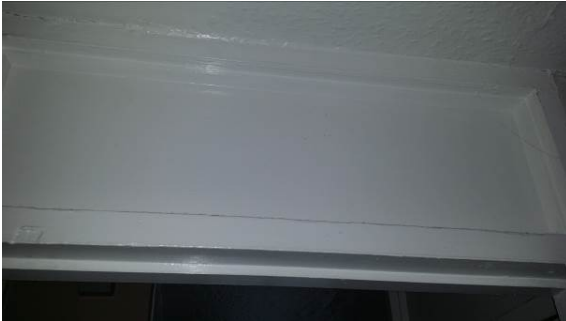
**Item 22 As: 109589-5**

The door header panel to the bathroom (Room 1/13) does not contain asbestos.

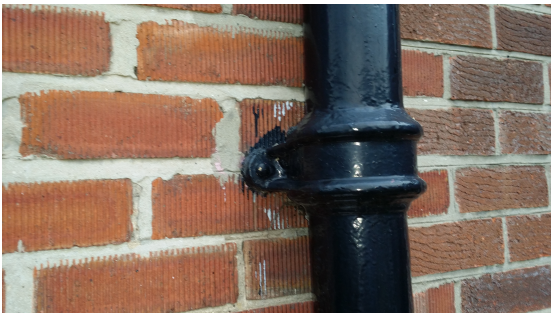
**Item 23 Ref: 109589-11**

The seal to the soil pipe section to the external do not contain asbestos.

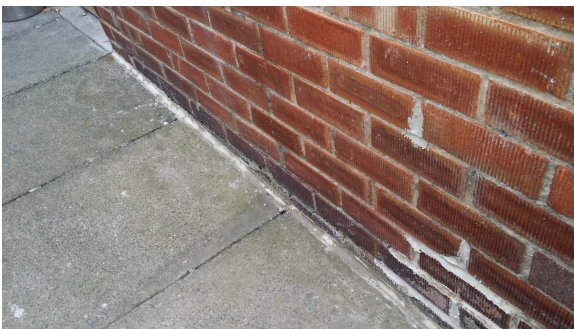
**Item 24 Ref: 109589-12**

The damp proof course to the external of the building does not contain asbestos.

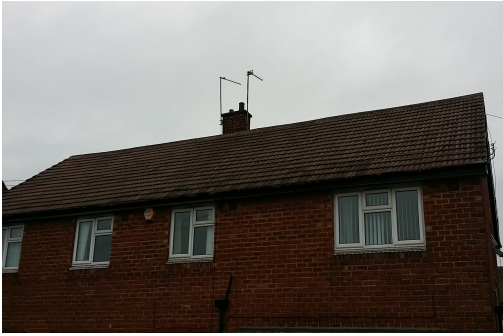
**Item 25 Ref: Presumed**

The cowl to the roof (External) is presumed to contain asbestos.

Any change in its appearance should be recorded and passed to Property Services.
