ASBESTOS SURVEY REPORT FOR 12 MERCANTILE ROAD, HOUGHTON LE SPRING, DH4 5PH.

Asbestos Register for

12 Mercantile Road (2 Phoenix Way), Houghton le Spring

Date: 02 September 2024

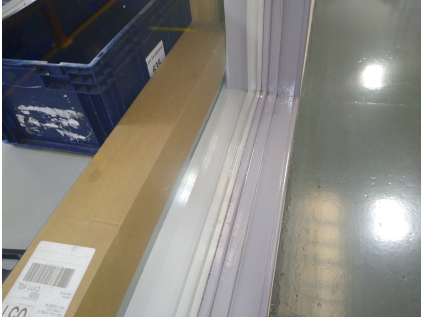
Item 1 Ref: As 419660-5

The window beading in Rm 0/006 Office does not contain asbestos.

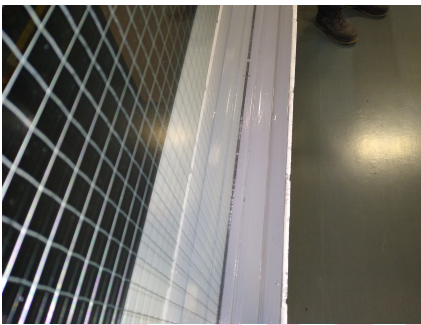
Item 2 Ref: As 419660-5

The window beading in Rm 0/015 Office does not contain asbestos.

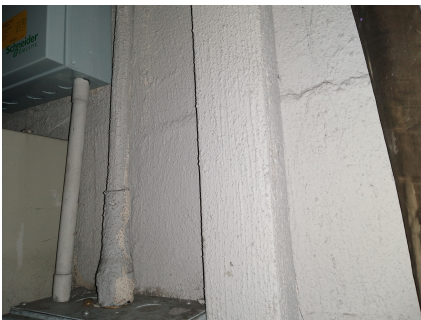
Item 3 Ref: 419660-1

The coating to walls in Rm 0/023 lift motor room does not contain asbestos.

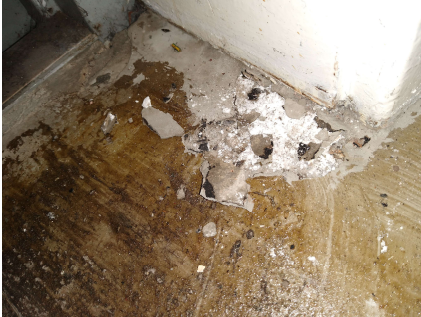
Item 4 Ref: 419660-3

The remnant adhesive to concrete floor below screed in Rm 0/038 Staircase does not contain asbestos.

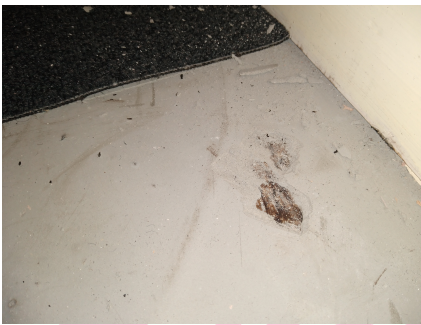
Item 5 Ref: As 419660-3

The remnant adhesive to concrete floor below screed in Rm 0/039 Under stairs cupboard does not contain asbestos.

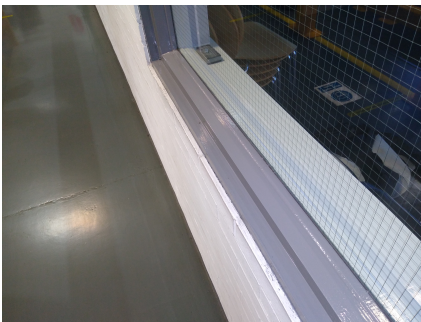
Item 6 Ref: As 419660-5

The window beading in Rm 0/040 Factory floor does not contain asbestos.

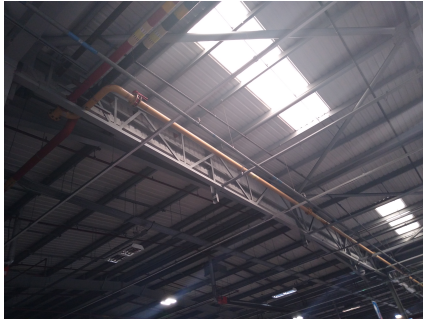
Item 7 Ref: Presumed

- (Item 6) Ref: As 419660-5 – Window beading (0/040 Factory floor) – No Risk
- (Item 7) Ref: Presumed – High level flange gasket to gas pipework (0/040 Factory floor) – Very Low Risk

The high level flange gasket to gas pipework in Rm 0/040 Factory floor is presumed to contain asbestos.

Any change in its appearance should be recorded and passed to Property Services.

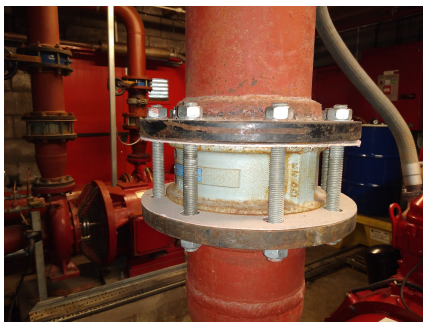
Item 8 Ref: 419960-7

- (Item 8) Ref: 419960-7 – Flange gaskets (0/044 Sprinkler house) – Very Low Risk
- (Item 9) Ref: 419960-8 – Putty to window panels (External) - No Risk

The flange gaskets in Rm 0/044 Sprinkler house contains asbestos.

Any change in its appearance should be recorded and passed to Property Services.

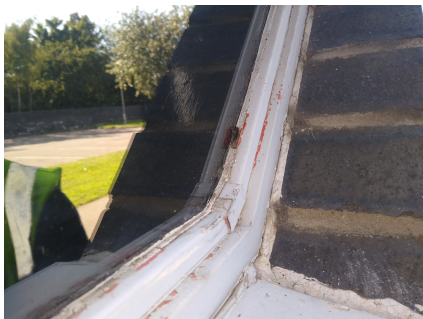
Item 9 Ref: 419660-8

The putty to window panels (External) does not contain asbestos.

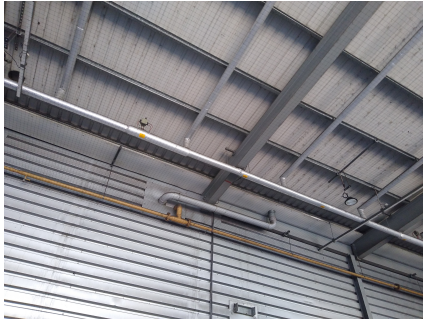
Item 10 Ref: Presumed

- (Item 10) Ref: Presumed – High level flange gasket to gas pipe (External loading bay) – Very Low Risk
- (Item 11) Ref: 419960-2 – Remnant adhesive to concrete floor below screed (1/001 Landing) – No Risk

The high level flange gasket to gas pipework (External loading bay) is presumed to contain asbestos.

Any change in its appearance should be recorded and passed to Property Services.

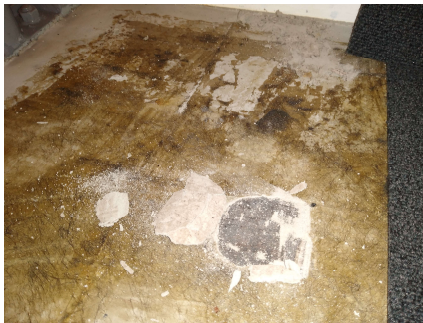
Item 11 Ref: 419960-2

The remnant adhesive to concrete floor below screed in Rm 1/001 Landing does not contain asbestos.

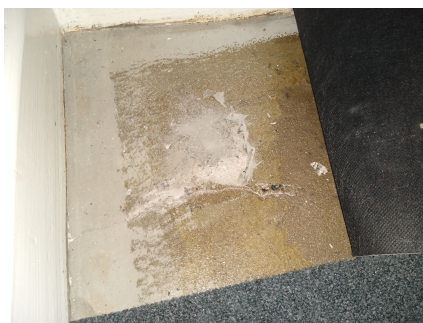
Item 12 Ref: 419660-4

The remnant adhesive to concrete floor below screed in Rm 1/002 Training Room does not contain asbestos.

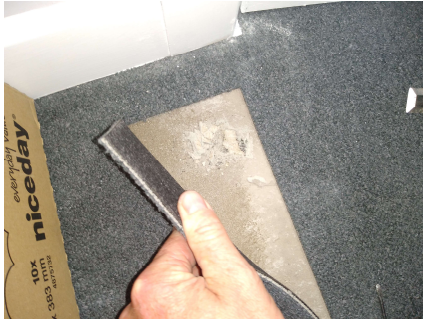
Item 13 Ref: As 419960-4

The remnant adhesive to concrete floor below screed in Rm 1/003 Store does not contain asbestos.

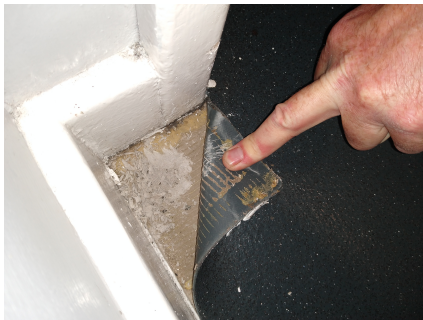
Item 14 Ref: As 419960-4

The remnant adhesive to concrete floor below screed in Rm 1/006 Corridor does not contain asbestos.

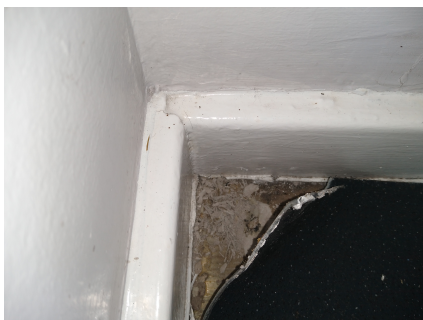
Item 15 Ref: As 419660-4

The remnant adhesive to concrete floor below screed in Rm 1/009 Corridor does not contain asbestos.

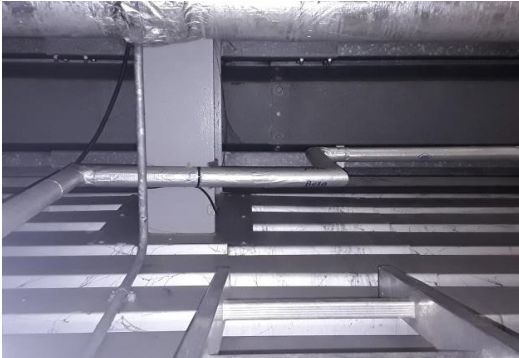
Item 16 Ref: 20-28729-1

The jointing mastic to roof gully to the factory ceiling does not contain asbestos.

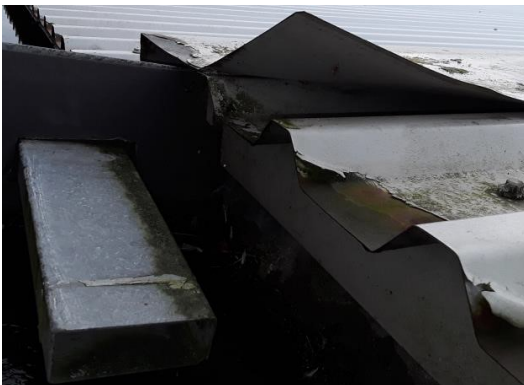
Item 17 Ref: 20-28729-2

The frame sealant beneath cladding to the roof (External) does not contain asbestos.

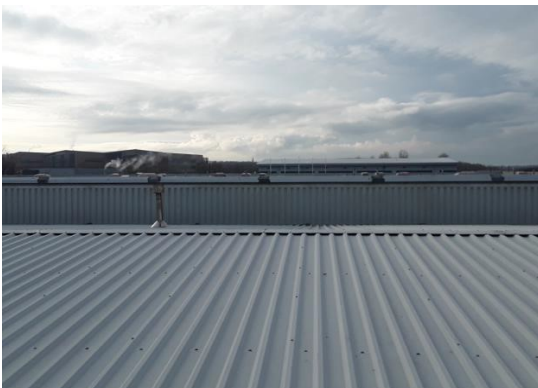
Item 18 Ref: 20-28729-3

The bitumen to the roof (External) does not contain asbestos.

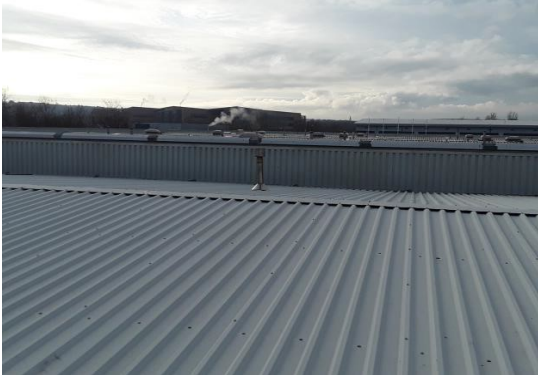
Item 19 Ref: 20-28729-4

The mastic to base around roof flue pipes (External) does not contain asbestos.

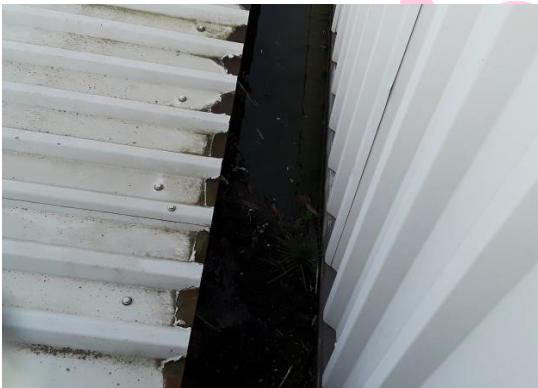
Item 20 Ref: 20-28729-5

The bitumen to metal guttering to the roof (External) does not contain asbestos.

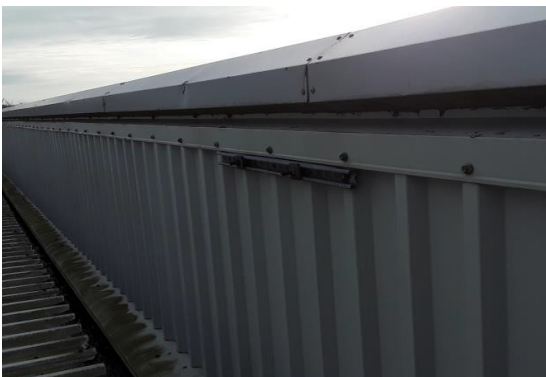
Item 21 Ref: 20-28729-6

The frame sealant to roof sheet joints (External) does not contain asbestos.
