### ASBESTOS SURVEY REPORT FOR HYLTON ROAD PLAYING FIELDS, HYLTON ROAD SUNDERLAND

### **Hylton Road Playing Fields Sunderland**

**Date: 01 April 2025**

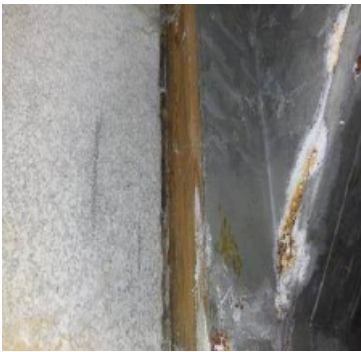
### **Item 2 – EF003175**

The mastic to the duct seal in the plant room (Room 1) does not contain asbestos.

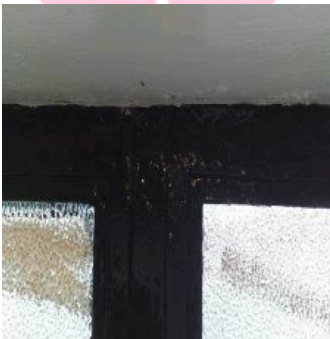
**Item 12 As EF003180**

The window mastic to changing room 2 (Room 4) does not contain asbestos. materials were found.

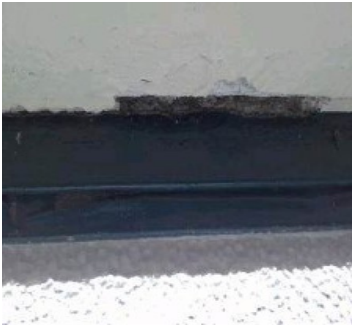
**Item 16 As EF003180**

The window mastic to the store (Room 7) does not contain asbestos.

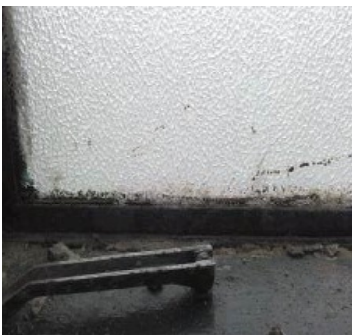
**Item 17 As EF003179**

The window putty to changing room 3 (Room 8) does not contain asbestos.

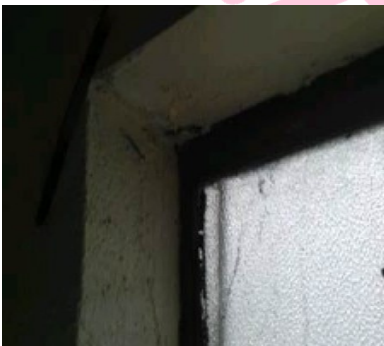
**Item 18 As EF003180**

The window mastic to changing room 3 (Room 8) does not contain asbestos.

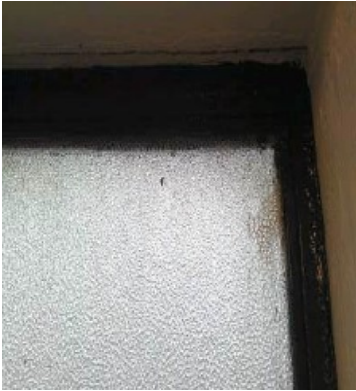
**Item 28 As EF003179**

The window putty to the shower room 2 (Room 12) does not contain asbestos.

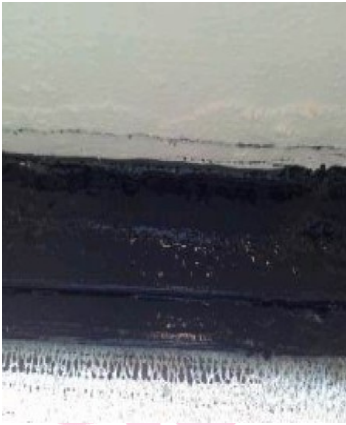
**Item 29 As EF003180**

The window mastic to the shower room 2 (Room 12) does not contain asbestos.

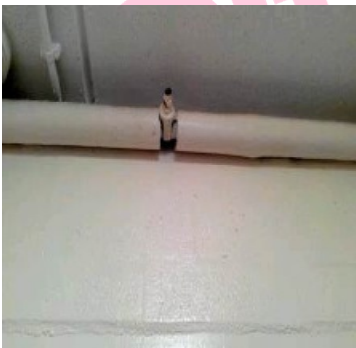
**Item 30 As EF003174**

The paper insulation to the shower room 2 (Room 12) does not contain asbestos.

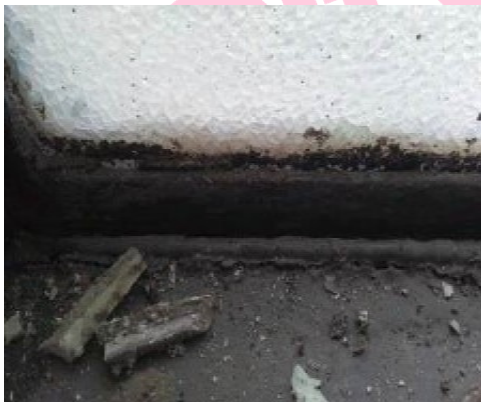
**Item 33 As EF003179**

The window putty to referee changing (Room 14) does not contain asbestos.

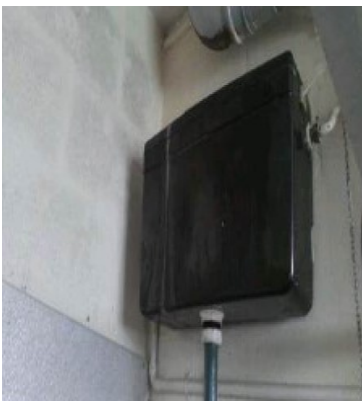
**Item 35 Ref: EF003181**

The WC cistern to the referees toilet (Room 15) contains asbestos.

***Removed 2024 – No WCN's***

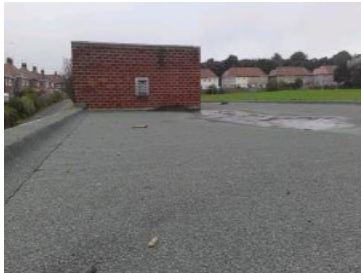
### **Item 38 Ref: EF003182**

The roofing felt to the external of the building does not contain asbestos.

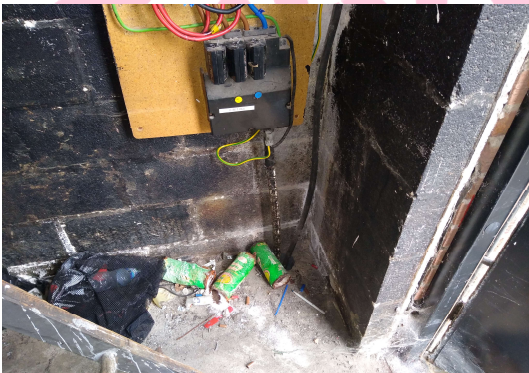
### **Item 39 Ref: 417760-01**

The cable wrap to main incomer in the Plant room (Rm 0/01) does not contain asbestos.
