### ASBESTOS SURVEY REPORT FOR HYLTON ROAD PLAYING FIELDS, HYLTON ROAD SUNDERLAND

### **Asbestos Register for**

### **Hylton Road Playing Fields Sunderland**

**Date: 07 February 2025**

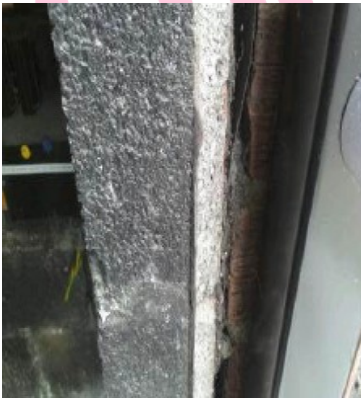
### **Item 3 – EF003176**

The mastic to the door in the plant room (Room 1) does not contain asbestos.

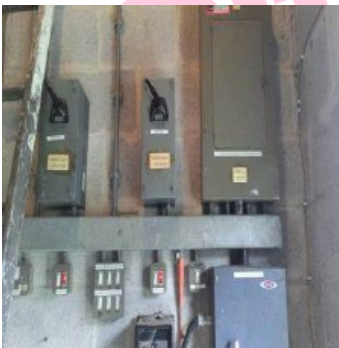
### **Item 6– Presumed**

The flash guards to the plant room (Room 1) are presumed to contain asbestos.

Item 5	No asbestos	Is present		
Item 6	<b>Flash guards to boiler room</b>	<b>Very Low</b>	<b>12 monthly</b>	<b>03.10.25</b>
Item 7	No asbestos	Is present

Any change in its appearance should be noted and passed to property services.

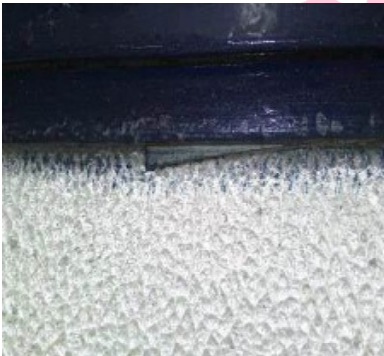
**Item 9 – EF003179**

The window putty to changing room 1 (Room 3) does not contain asbestos.

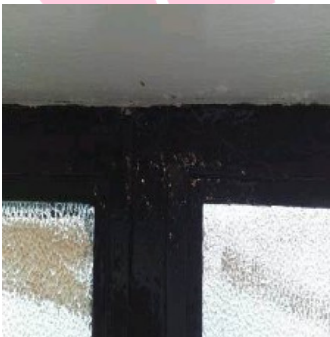
**Item 12 As EF003180**

The window mastic to changing room 2 (Room 4) does not contain asbestos. materials were found.

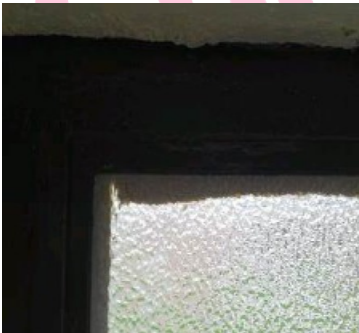
**Item 15 As EF003180**

The window putty to the store (Room 7) does not contain asbestos.

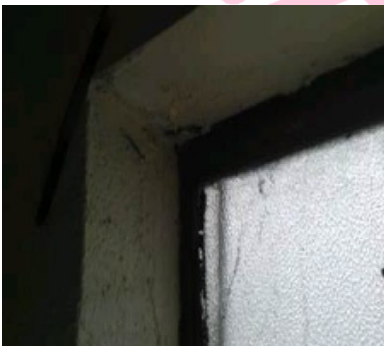
### **Item 18 As EF003180**

The window mastic to changing room 3 (Room 8) does not contain asbestos.

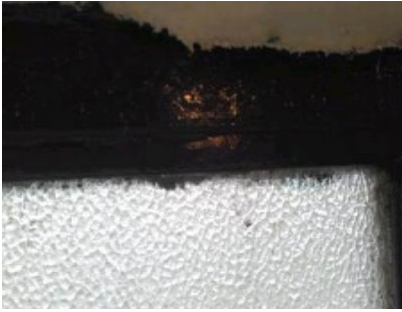
**Item 19 As EF003179**

The window putty to changing room 4 (Room 9) does not contain asbestos.

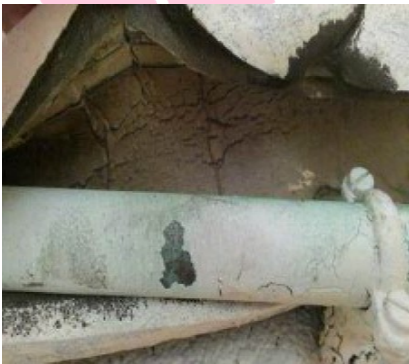
**Item 21 As EF003174**

The paper insulation to changing room 4 (Room 9) does not contain asbestos.

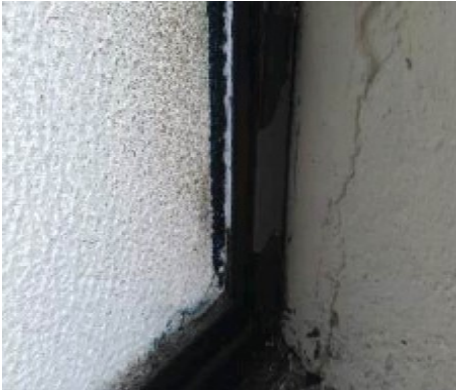
**Item 22 As EF003179**

The window putty to changing room 4 (Room 10) does not contain asbestos.

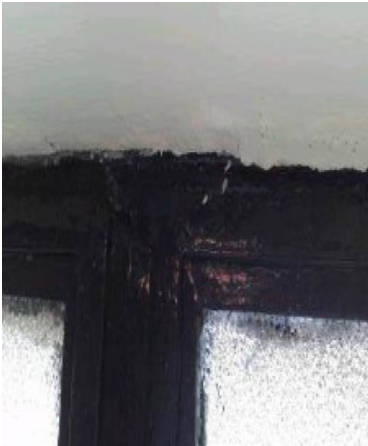
**Item 23 As EF003180**

The window mastic to changing room 4 (Room 10) does not contain asbestos.

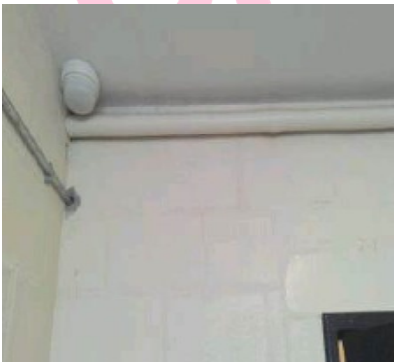
**Item 24 As EF003174**

The paper insulation to changing room 4 (Room 10) does not contain asbestos.

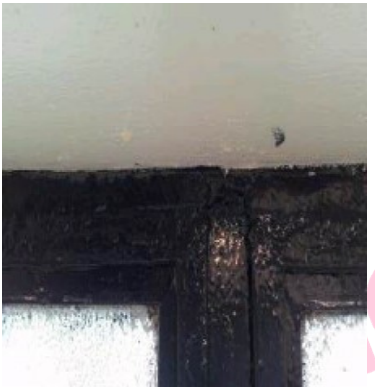
**Item 26 As EF003180**

The window mastic to the shower (Room 11) does not contain asbestos.

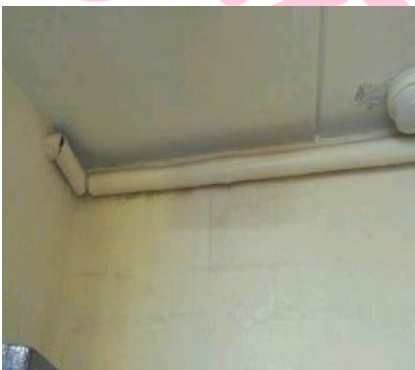
**Item 27 As EF003174**

The paper insulation to the shower (Room 11) does not contain asbestos.

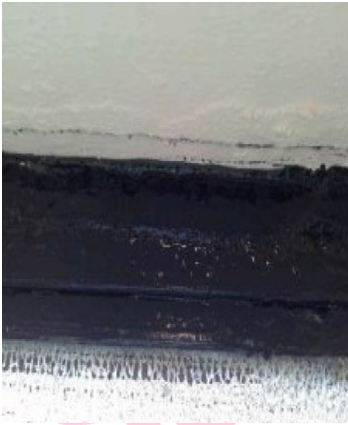
**Item 29 As EF003180**

The window mastic to the shower room 2 (Room 12) does not contain asbestos.

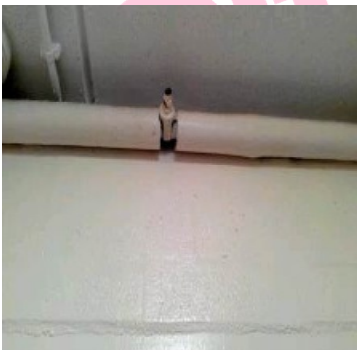
**Item 30 As EF003174**

The paper insulation to the shower room 2 (Room 12) does not contain asbestos.

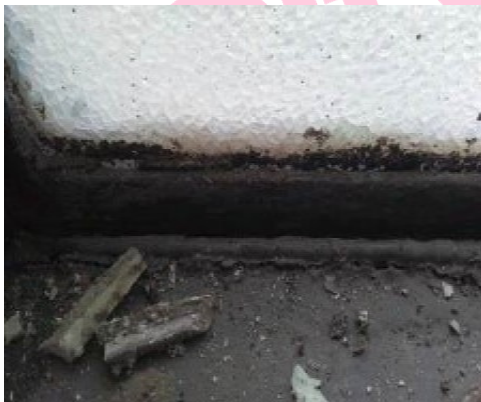
**Item 33 As EF003179**

The window putty to referee changing (Room 14) does not contain asbestos.

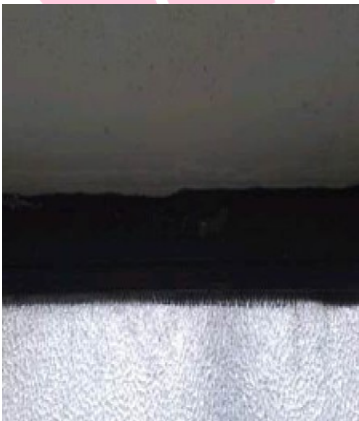
### **Item 36 As EF003179**

The window putty to referee toilet (Room 15) does not contain asbestos.

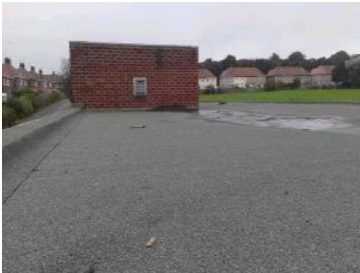
### **Item 38 Ref: EF003182**

The roofing felt to the external of the building does not contain asbestos.

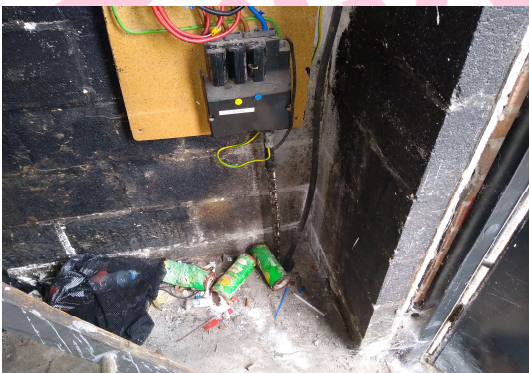
### **Item 39 Ref: 417760-01**

The cable wrap to main incomer in the Plant room (Rm 0/01) does not contain asbestos.
