ASBESTOS SURVEY REPORT FOR PLAINS FARM BOYS CLUB, PORTLAND ROAD, SUNDERLAND

Asbestos Register for Plains Farm Boys Club

Date: 04 November 2024

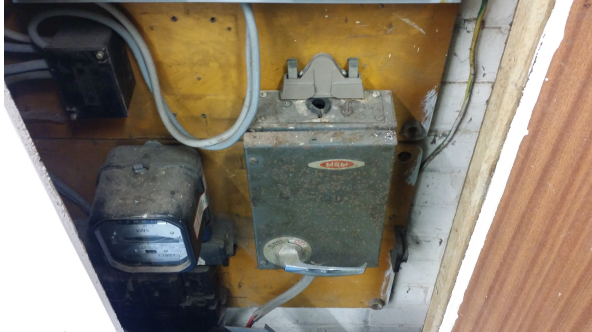
Item 1 Ref: Presumed

- (Item 1) Ref: Presumed – Electric flash guards (Room 001) – Very Low Risk
- (Item 2) Ref: Presumed – Wrap to cable (Room 001) – Very Low Risk
- (Item 3) Ref: 218429-1 – Subfloor (Room 002) – No Risk

The flash guards to the electrics in the gym (Rm 0/01) are presumed to contain asbestos.

Any change in its appearance should be recorded and passed to Property Services.

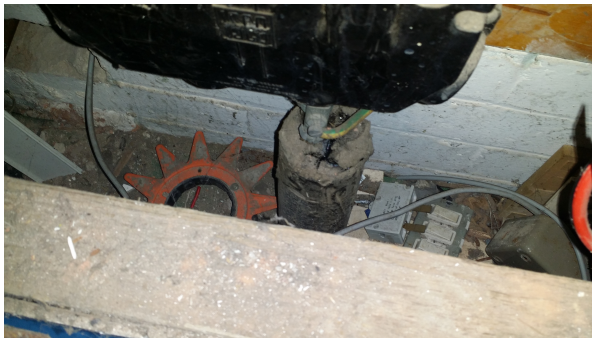
Item 2 Ref: Presumed

The wrap to cable to the electrics in the gym (Rm 0/01) are presumed to contain asbestos.

Any change in its appearance should be recorded and passed to Property Services.

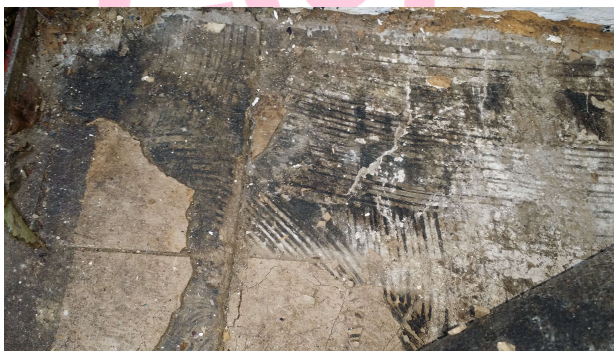
Item 3 Ref: 218429-1

The subfloor in the corridor (Room 0/02) does not contain asbestos.

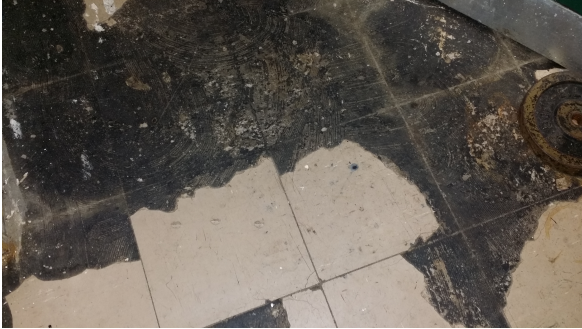
Item 4 Ref: As 218429-1

The floor covering in the toilet (Room 0/03) does not contain asbestos.

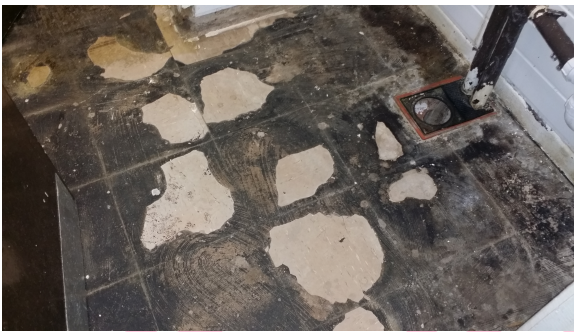
Item 5 Ref: As 218429-1

The floor covering in the toilet (Room 0/04) does not contain asbestos.

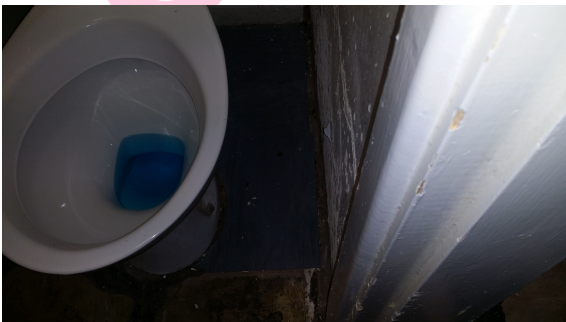
Item 6 Ref: 218429-6

The floor covering in the toilet (Room 0/04) does not contain asbestos.

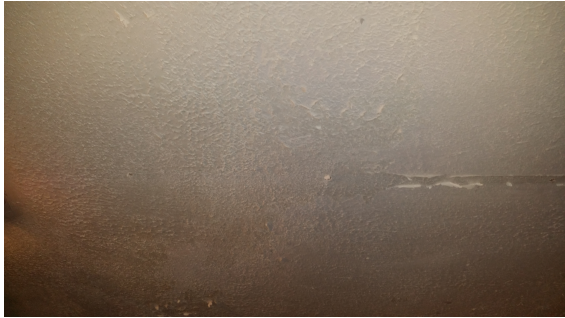
Item 7 Ref: 218429-3

The ceiling in the shower room (Room 0/05) contains asbestos.

Removed October 2020

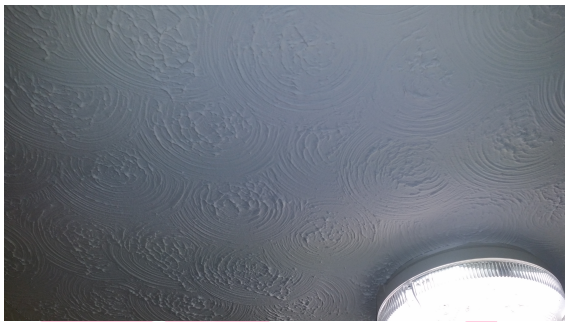
Item 8 Ref: 218429-4

The ceiling in the office (Room 0/06) does not contain asbestos.

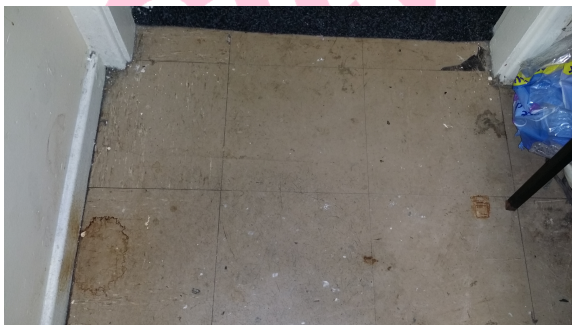
Item 9 Ref: As 218429-1

The floor covering in the office (Room 0/06) does not contain asbestos.

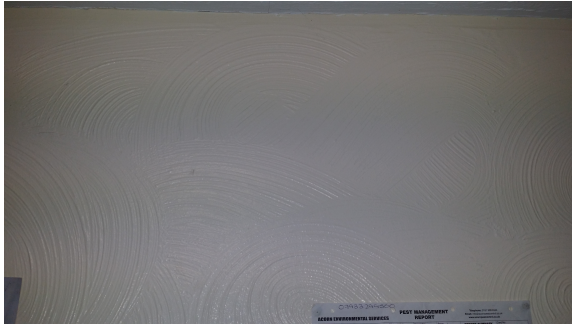
Item 10 Ref: 218429-5

The wall covering in the office (Room 0/06) does not contain asbestos.

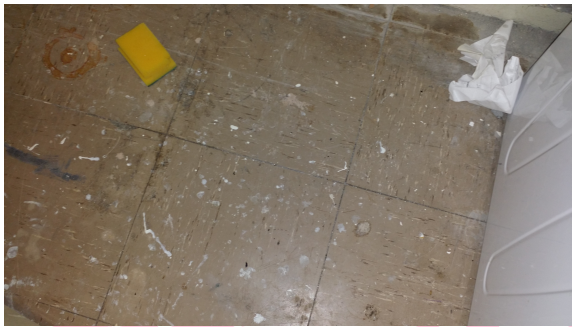
Item 11 Ref: As 218429-1

The floor covering in the reception (Room 0/07) does not contain asbestos.

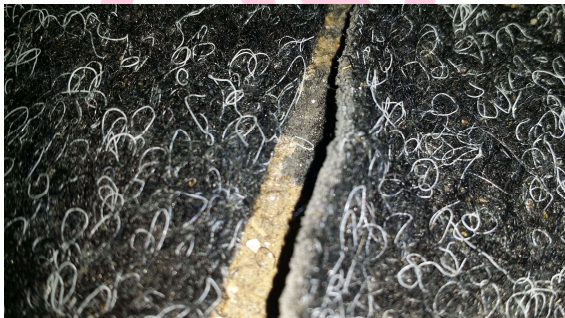
Item 12 Ref: As 218429-1

The floor covering in the gym and store (Room 0/08) does not contain asbestos.

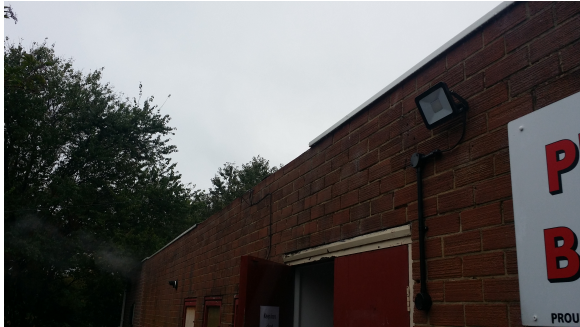
Item 13 Ref: 218429-9

The roof covering (External) does not contain asbestos.

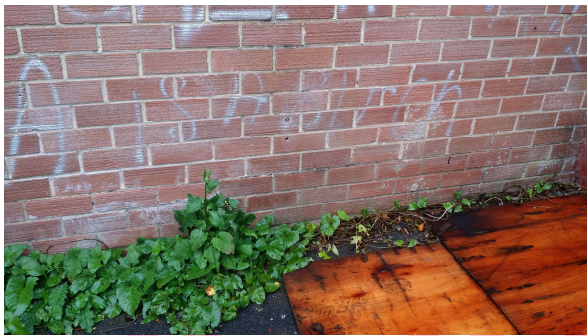
Item 14 Ref: 218429-6

The damp proof course (External) does not contain asbestos.

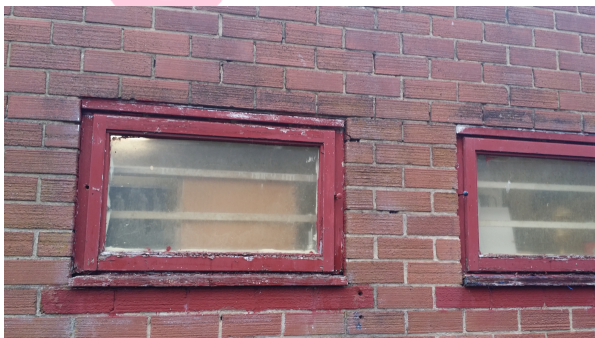
Item 15 Ref: 218429-7

The sealant to the frames (External) contains asbestos.

Any change in appearance should be reported to Property Services.

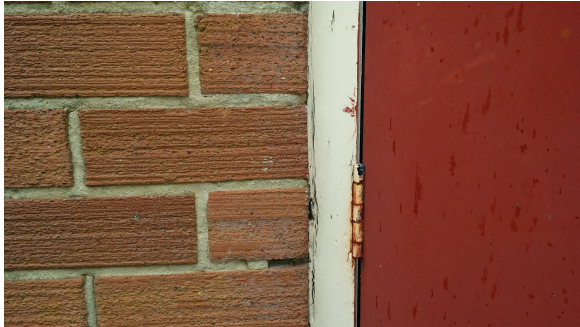
Item 16 Ref: 218429-8

The mastic to the door frames (External) does not contain asbestos.

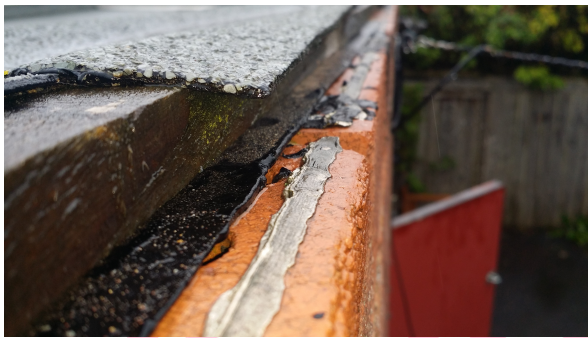
Item 17 Ref: 218429-10

The mastic to the roof edge (External) contains asbestos.

Removed December 2020

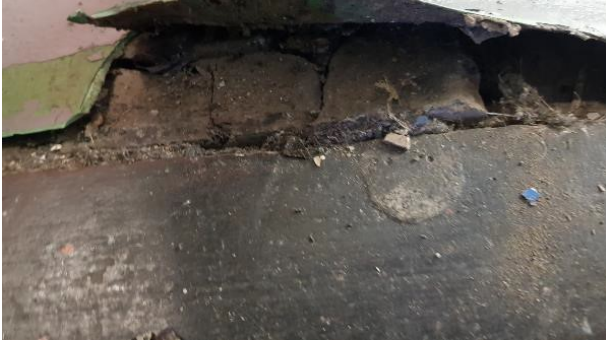
Item 19 Ref: PFB/001

The flooring composite (Gym Area) does not contain asbestos.

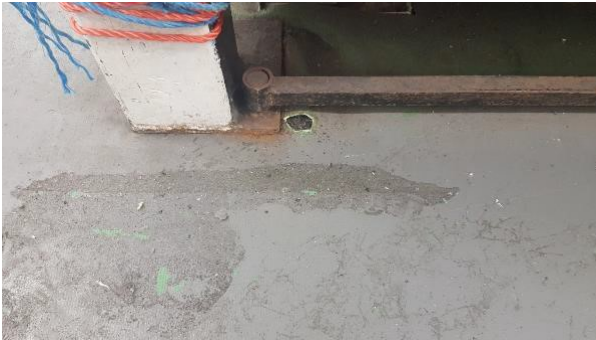
Item 20 Ref: PFB/002

The flooring composite (Gym Area) does not contain asbestos.
