ASBESTOS SURVEY REPORT FOR THORNEY CLOSE ACTION AND ENTERPRISE CENTRE, SUNDERLAND

**THORNEY CLOSE ACTION AND ENTERPRISE CENTRE
SUNDERLAND**

Date: 27 March 2024

Thorney Close Action & Ent Centre - Last updated 26/09/2024 – Version 2

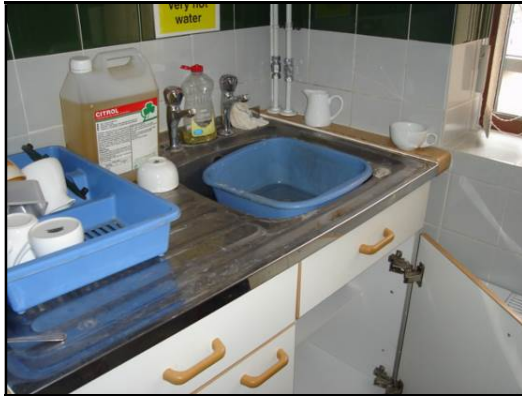
Item 1 Ref: Sample 01

The sink pad to the kitchen off the large office (Rm 005) does not contain asbestos.

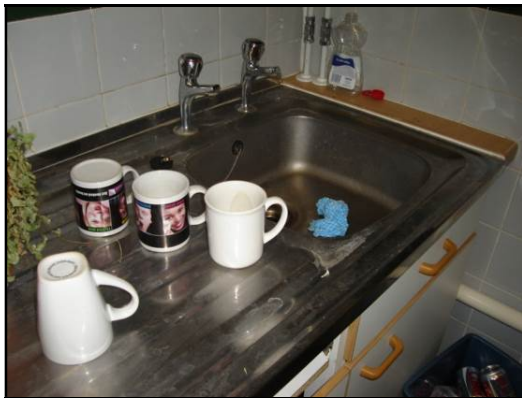
Item 2 - Ref: Sample 02

The sink pads to the offices (Rm 008) do not contain asbestos.

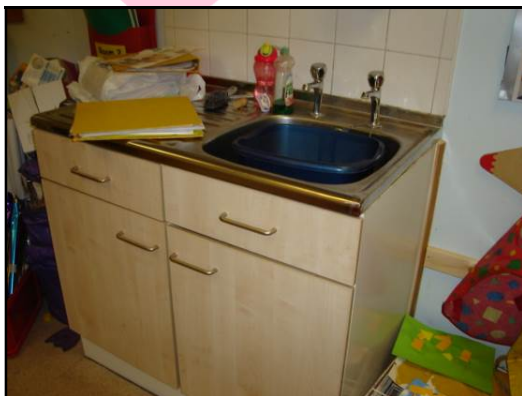
Item 3 - Ref: Sample 03

The sink pads throughout the nursery rooms (Rm 009) do not contain asbestos.

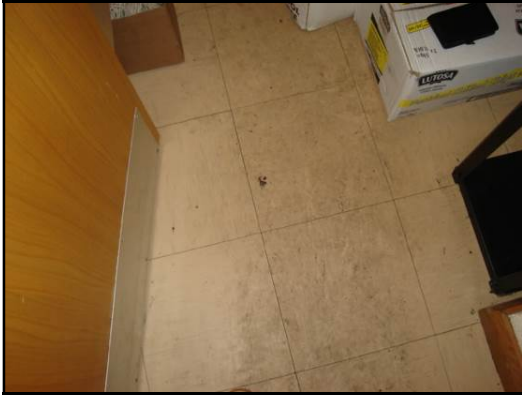
Item 4 - Ref: Sample 04

The vinyl flooring to the storerooms in the kitchen area (Rm 016) do not contain asbestos.

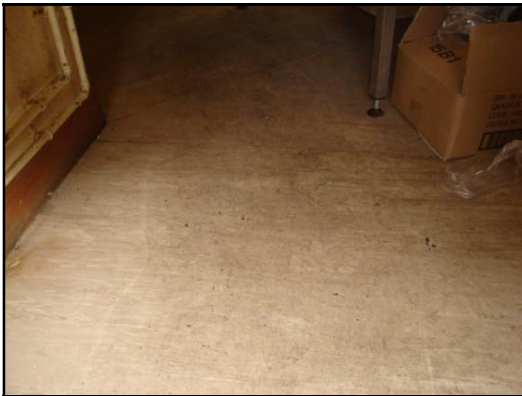
Item 5 - Ref: Sample 05

The vinyl flooring to the rear corridor floor in the kitchen area (Rm 016) does not contain asbestos.

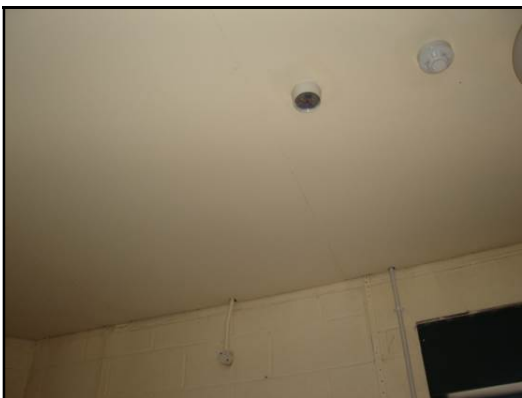
Item 6 - Ref: Sample 06 / 323690-1

The plasterboard ceiling to the bin store in the kitchen area (Rm 16) does not contain asbestos.

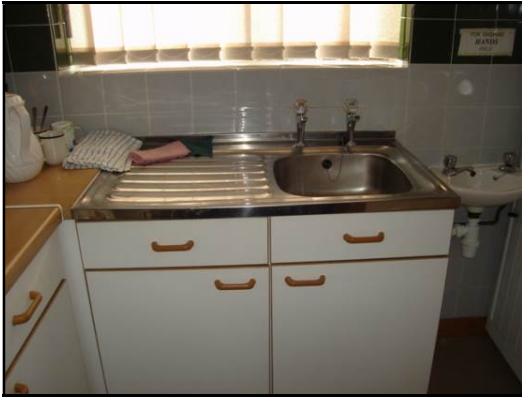
Item 7 - Ref: Sample 07

The sink pad to the kitchen (Rm 003) does not contain asbestos.

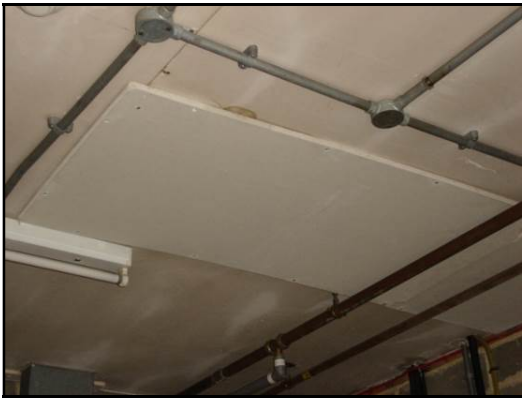
**Item 8 - Ref: Sample 08 /
As 323690-1**

The panel to the ceiling in the boiler room (Rm 029) does not contain asbestos.

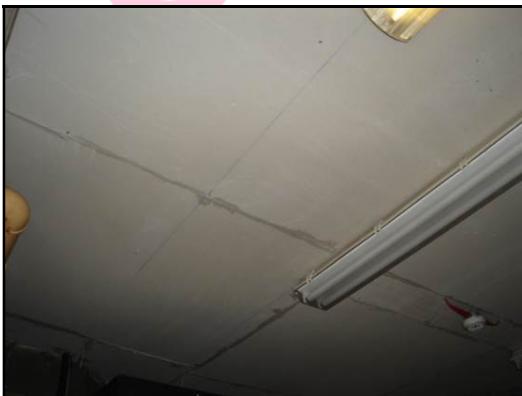
Item 9 - As Sample 08

The ceiling to the pump room (Rm 030) does not contain asbestos.

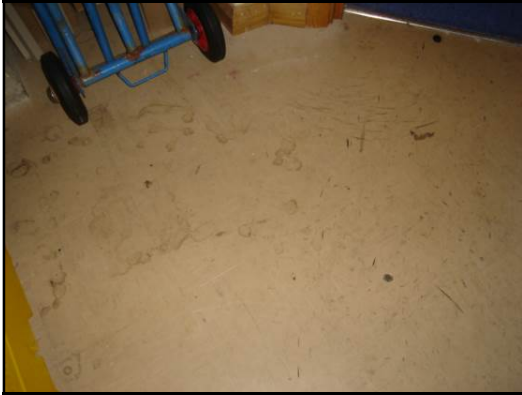
Item 10 - Ref: Sample 09

The vinyl floor tiles to the lift motor room (Rm 003) do not contain asbestos.

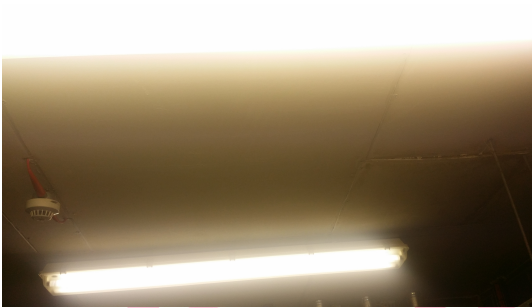
Item 11 - Ref: As 323690-1

The ceiling in room 039/boiler room does not contain asbestos.

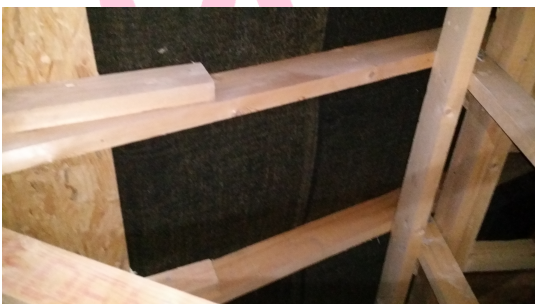
Item 12 - Ref: 241626-1

The roof sarking in room 002/general office (void above) does not contain asbestos.

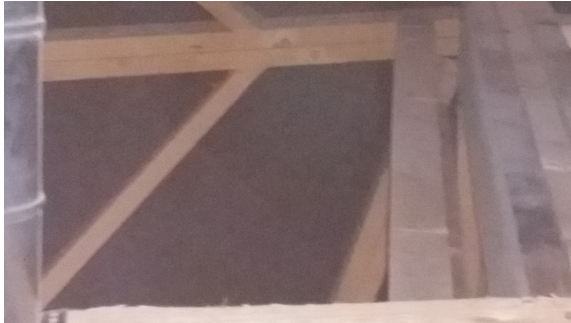
Item 13 - Ref: As 241626-1

The roof sarking in room 001/corridor (void above) does not contain asbestos.

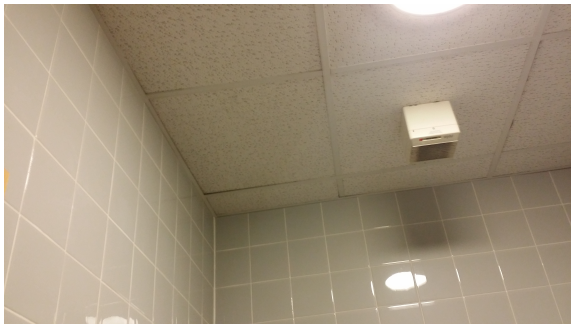
Item 14 - Ref: 241626-2

The suspended ceiling in room 003/shower does not contain asbestos.

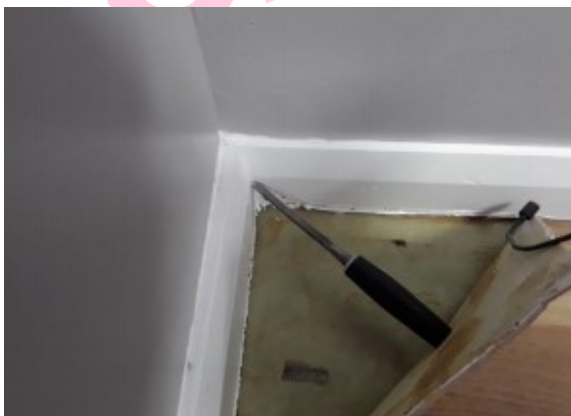
Item 15 - Ref: 2136652-1

The floor beneath new vinyl lino in Team Room 1 (Area 6) does not contain asbestos.

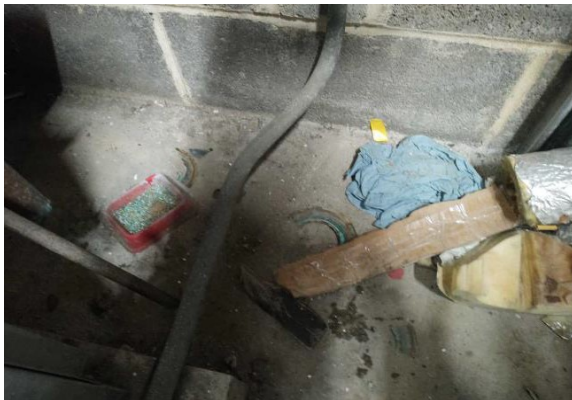
Item 17 - Ref: 21-41137-3

The debris to the floor (Gasket) (Area 1 – Boiler Room) does not contain asbestos.

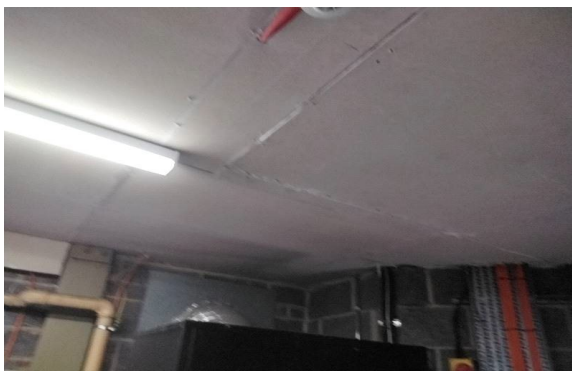
Item 18 Ref: CF005390

The ceiling (Boiler Room/G/001) does not contain asbestos.

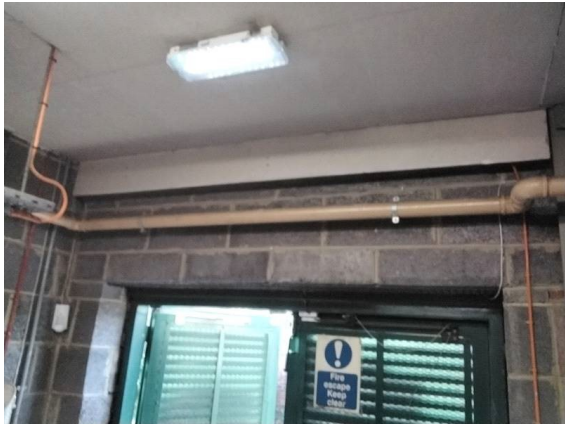
Item 19 Ref: CF005391

The pelmet above door (Boiler Room/G/001) does not contain asbestos.

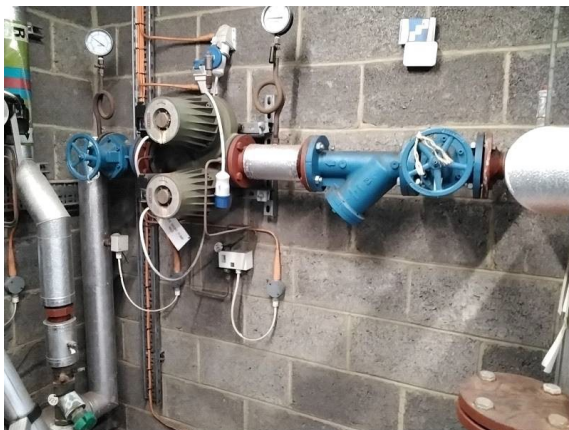
Item 20 Ref: CF005391

The pipework joint/gasket (Boiler Room/G/001) does not contain asbestos.

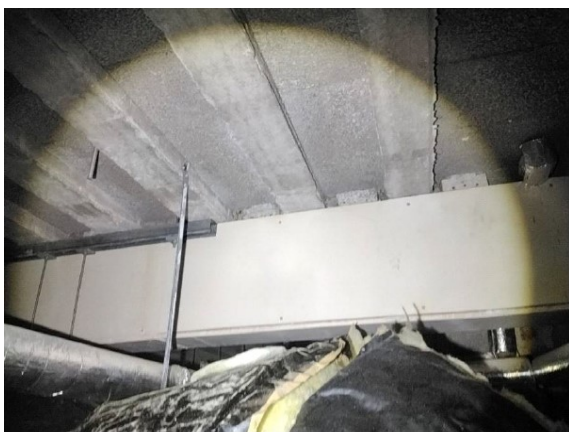
Item 21 Ref: KX001945

The ceiling void beam cladding in the Hallway/Passageway (Room G/001) does not contain asbestos.

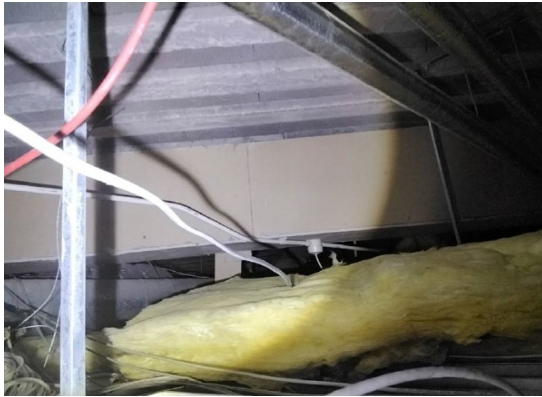
Item 22 Ref: KX001945

The ceiling void beam cladding in the reception (Room G/002) does not contain asbestos.

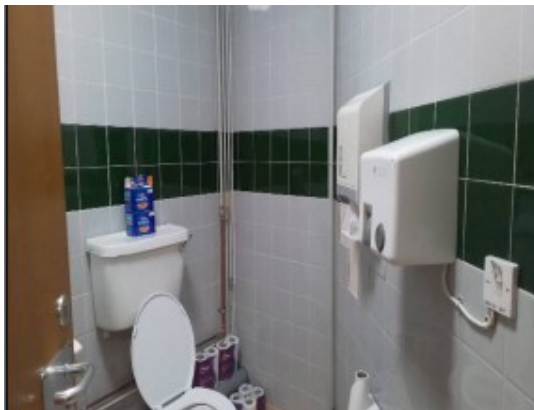
Item 23 Ref: OQ000247

The wall tile adhesive in the Staff Toilets (Room G/002) does not contain asbestos.

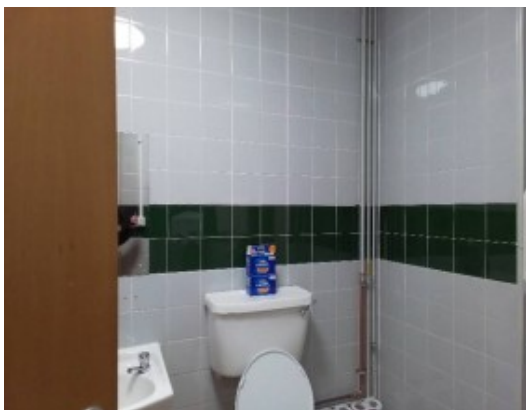
Item 24 Ref: OQ000248

The wall – designated for new opening in the Staff Toilets (Room G/002) does not contain asbestos.

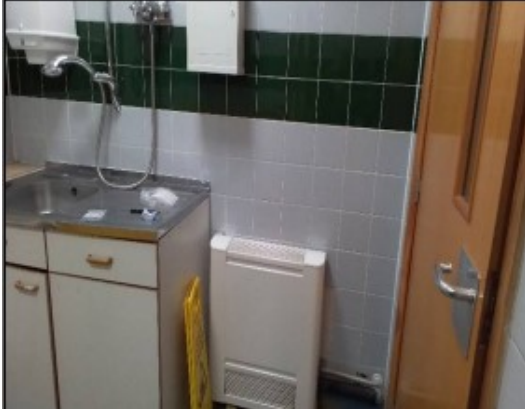
Item 25 Ref: As OQ000247

The wall tile adhesive in the Toilets (Room G/003) does not contain asbestos.

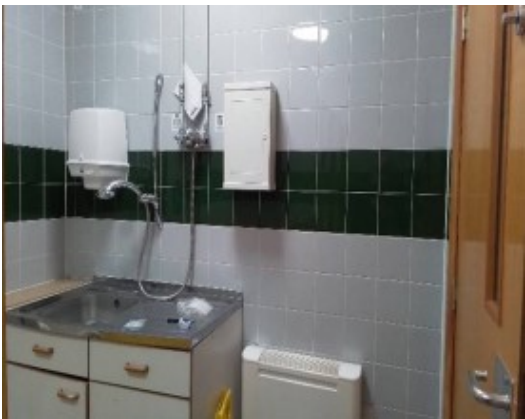
Item 26 Ref: As OQ000248

The wall – designated for new opening in the Toilets (Room G/003) does not contain asbestos.

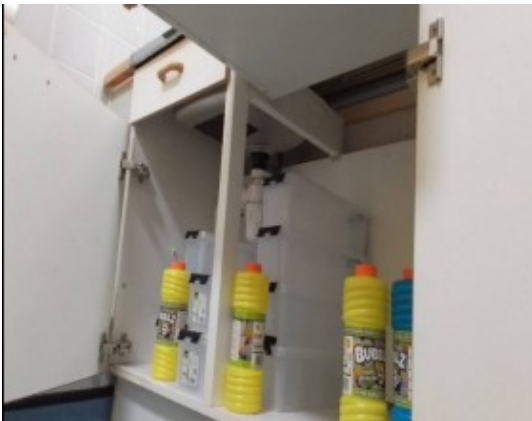
Item 27 Ref: OQ000249

The under sink mat in the Toilets (Room G/003) does not contain asbestos.

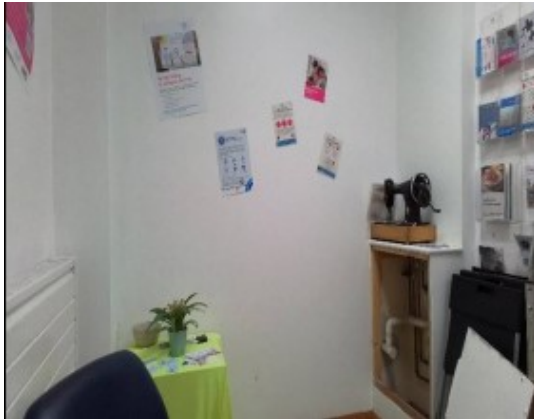
Item 28 Ref: As OQ000248

The wall – designated for new opening in the Office (Room G/004) does not contain asbestos.

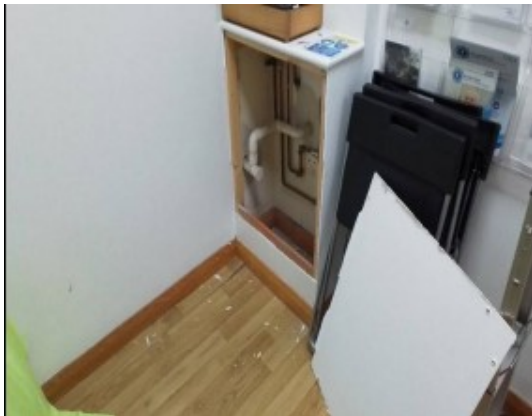
Item 29 Ref: OQ000250

The floor tile – inside boxing in the Office (Room G/004) does not contain asbestos.

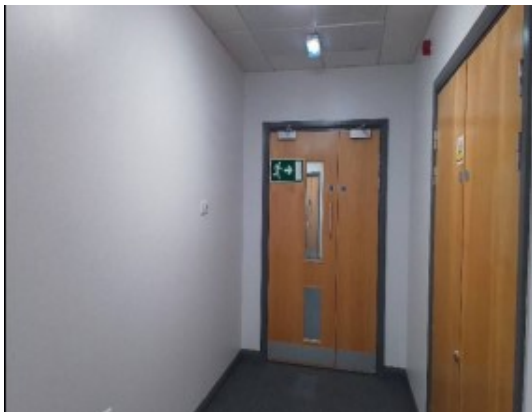
Item 30 Ref: OQ000251

The wall in the Corridor 060 (Room G/006) does not contain asbestos.

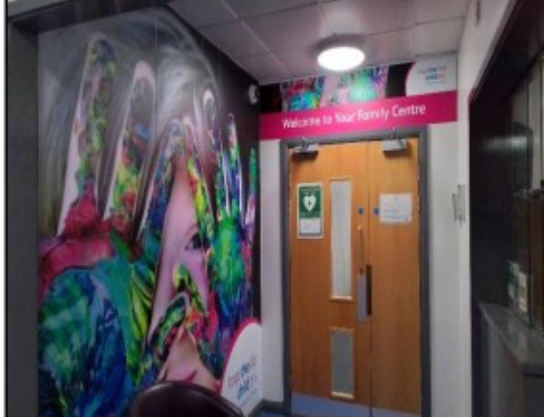
Item 31 Ref: As OQ000251

The wall in the Corridor – adj reception office (Room G/007) does not contain asbestos.

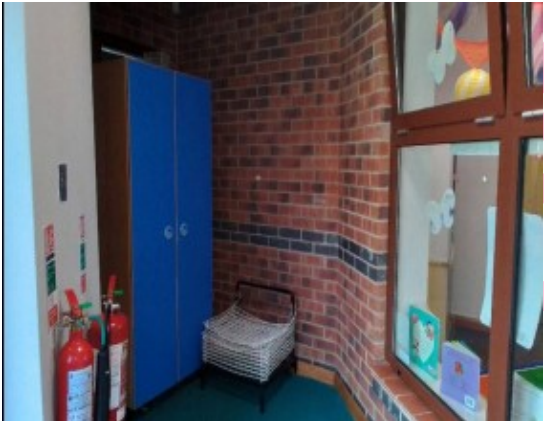
Item 32 Ref: OQ000252

The wall – new door into sensory room (Room G/009) does not contain asbestos.
