ASBESTOS SURVEY REPORT FOR 257 GLENEAGLES ROAD,  
SUNDERLAND. SR4 9QN

## **Asbestos Register for**

**257 Gleneagles Road, Sunderland. SR4 9QN**

**Date: 03 December 2024**

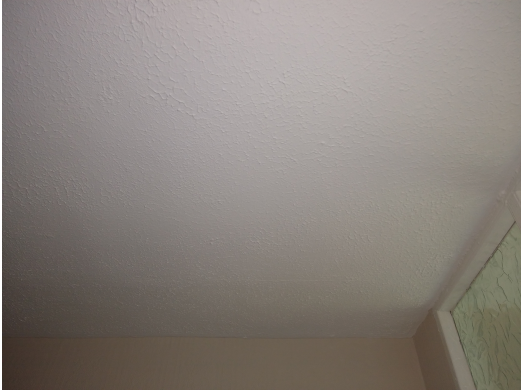
### **Item 1 Ref: 327275-4**

The textured ceiling coating in Rm 001/Hall does not contain asbestos.

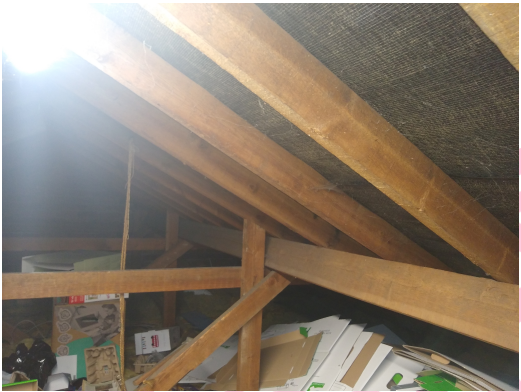
### **Item 2 Ref: 327275-1**

The Sarking bituminous felt in 001/Hall-roof void does not contain asbestos.

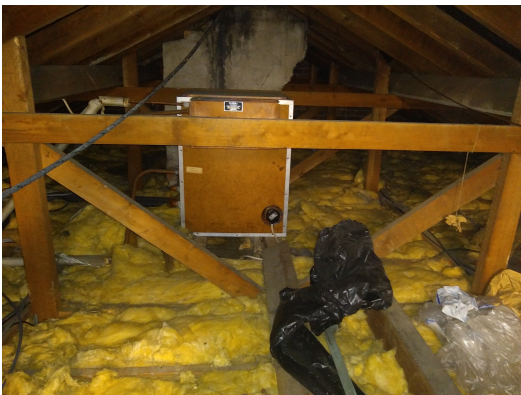
### **Item 3 Ref: 327275-2**

The Gasket to the immersion heater element in 001/Hall-roof void does not contain asbestos.

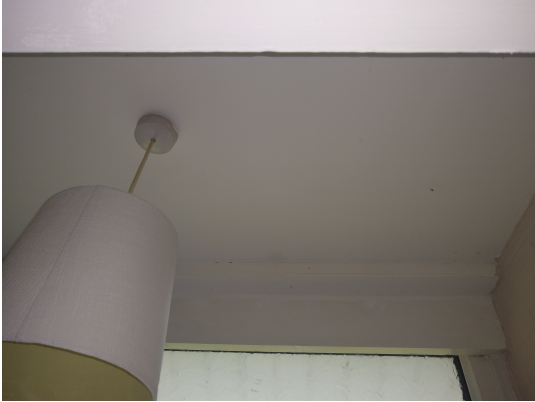
### **Item 4 Ref: 327275-5**

The Ceiling cement in 001a/Vestibule contains asbestos.

| Picture | Location | Risk | Inspection Frequency | Date of return |
|---|---|---|---|---|
| <b>Item 4</b> | <b>Ceiling<br/>(001a/Vestibule)</b> | <b>Very Low</b> | <b>12 monthly</b> | <b>10/05/2025</b> |

Any change in its appearance should be recorded and passed to Property Services.

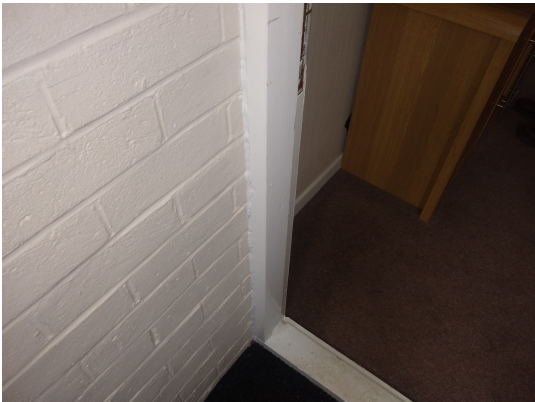
### **Item 5 Ref: 327275-6**

The Sealant to inner door frame in 001a/Vestibule contains asbestos.

| Picture | Location | Risk | Inspection Frequency | Date of return |
|---|---|---|---|---|
| <b>Item 5</b> | <b>Sealant mastic<br/>(001a/Vestibule)</b> | <b>Very Low</b> | <b>12 monthly</b> | <b>10/05/2025</b> |

Any change in its appearance should be recorded and passed to Property Services.

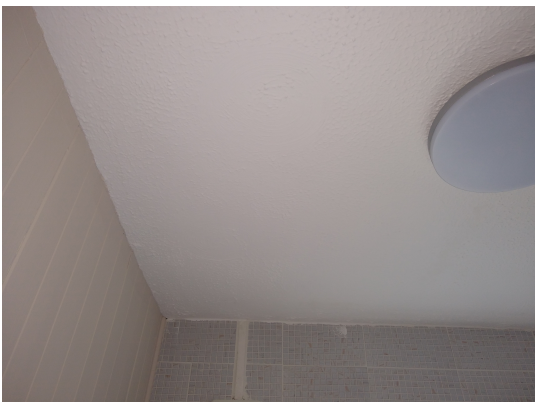
### **Item 6 Ref: 327275-3**

The Textured ceiling coating in 005/Bathroom does not contain asbestos.

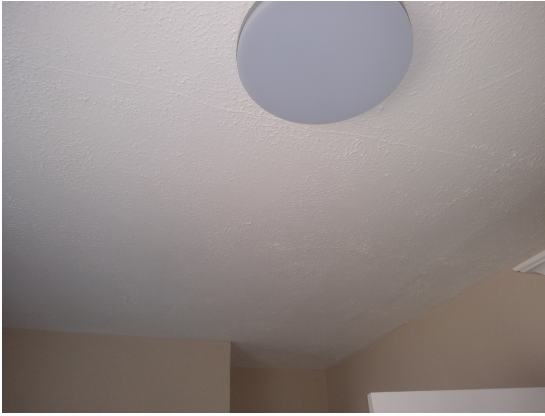
### **Item 7 Ref: KN001458**

The Textured ceiling coating in 006/Kitchen does contain asbestos.

Any change in its appearance should be recorded and passed to Property Services.

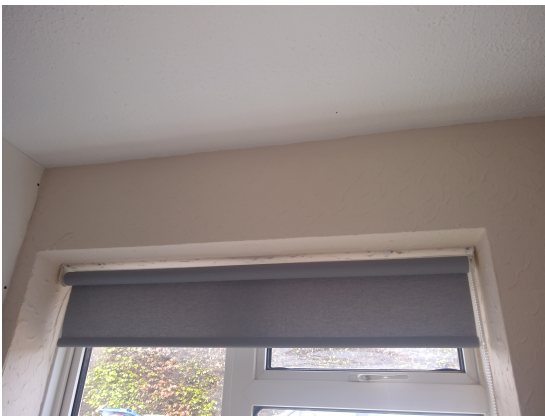
### **Item 8 Ref: 327275-7**

The Textured coating to walls in 006/Kitchen does not contain asbestos.

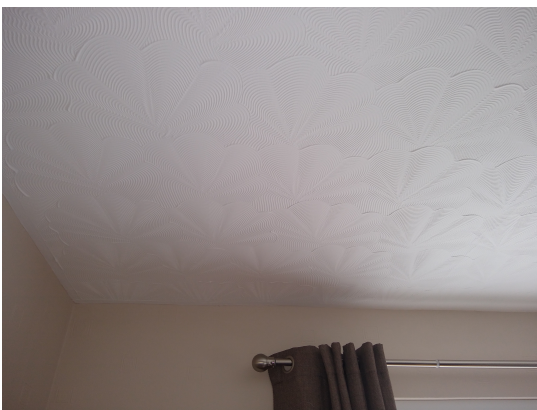
### **Item 9 Ref: 327275-8**

The Decorative finish to plasterboard ceiling in 007/Lounge does not contain asbestos.

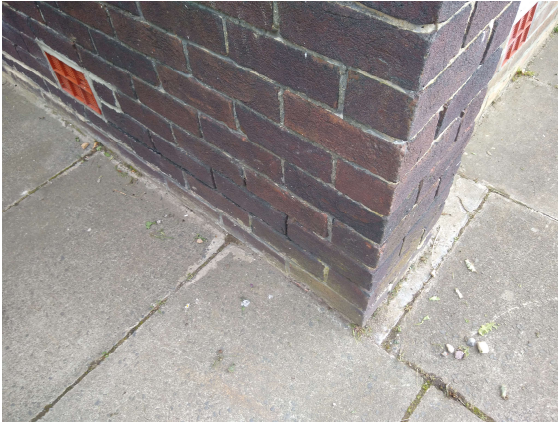
### **Item 10 Ref: 327275-9**

The Damp Proof Course (Externals) does not contain asbestos.

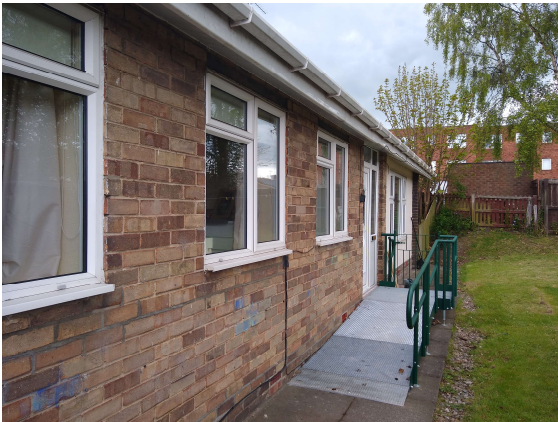
### **Item 11 Ref: 327275-10**

The Remnant Sealant to windows & door frames throughout location (Externals) contains asbestos.

| Picture | Location | Risk | Inspection Frequency | Date of return |
|---|---|---|---|---|
| <b>Item 11</b> | <b>Remnant Sealant<br/>to windows &amp; door<br/>frames throughout<br/>location<br/>(Externals)</b> | <b>Very Low</b> | <b>12 monthly</b> | <b>10/05/2025</b> |

Any change in its appearance should be recorded and passed to Property Services.

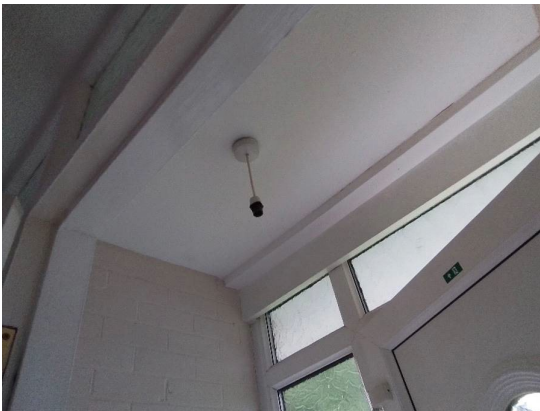
### **Item 12 Ref: KN001458/J174384/Presumed**

The ceiling (Hallway-Passageway G/002) is presumed to contain asbestos.

| Picture | Location | Risk | Inspection Frequency | Date of return |
|---|---|---|---|---|
| <b>Item 12</b> | <b>Ceiling (Hallway-<br/>Passageway<br/>G/002)</b> | <b>Low Risk</b> | <b>6 monthly</b> | <b>10/05/2025</b> |

Any change in its appearance should be recorded and passed to Property Services.

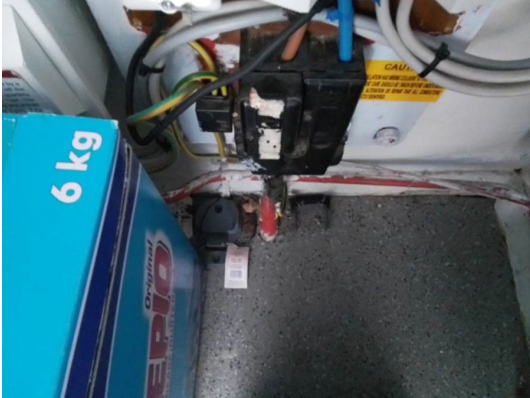
**Item 13 Ref: Presumed**

The cabling braiding/insulation (Electrical Cupboard G/009) is presumed to contain asbestos.

| Picture | Location | Risk | Inspection Frequency | Date of return |
|---|---|---|---|---|
| <b>Item 13</b> | <b>Cabling<br/>braiding/insulation<br/>(Electrical<br/>Cupboard G/009)</b> | <b>Very Low</b> | <b>12 monthly</b> | <b>10/05/2025</b> |

Any change in its appearance should be recorded and passed to Property Services.
