ASBESTOS SURVEY REPORT FOR 15 NILE STREET, SUNDERLAND, SR1 1EY.

Asbestos Register for

15 Nile Street, Sunderland, SR1 1EY

Date: 28 March 2025

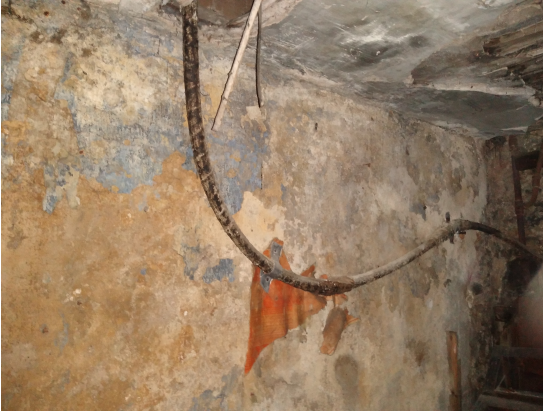
Item 1 Ref: 403295-1

The wrap to main incomer in the store (Rm -1/01) does not contain asbestos.

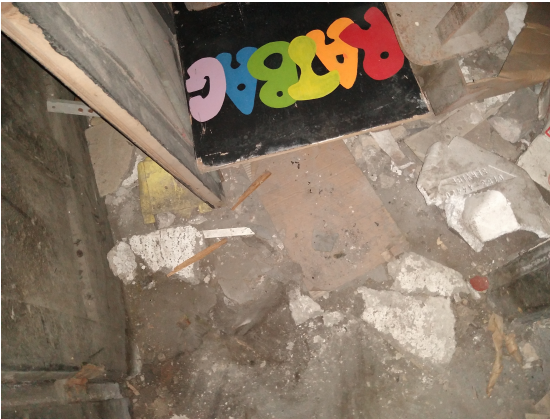
Item 2 Ref: As 403295-5

The floor covering in the store (Rm -1/01) does not contain asbestos.

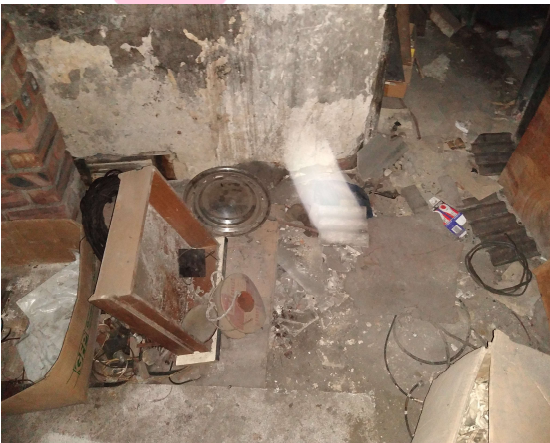
Item 3 Ref: 403295-2

The cement panel to floor in the store (Rm -1/02) contains asbestos.

| Picture | Location | Risk | Inspection Frequency | Date of return |
|---|---|---|---|---|
| Item 3 | Cement panel to floor (Store/Rm - 1/002) | Low Risk | 6 monthly | Removed May 2020 |

Removed May 2020.

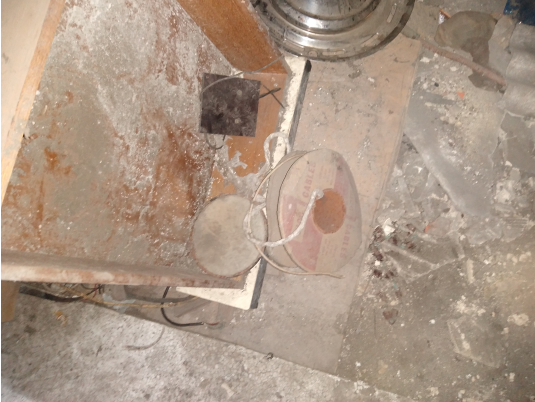
Item 4 Ref: 403295-3

The rope to cable reel in the store (Rm -1/002) does contain asbestos.

| Picture | Location | Risk | Inspection Frequency | Date of return |
|---|---|---|---|---|
| Item 4 | Rope to cable reel (Store/Rm - 1/002) | Low Risk | 6 monthly | Removed May 2020 |

Removed May 2020

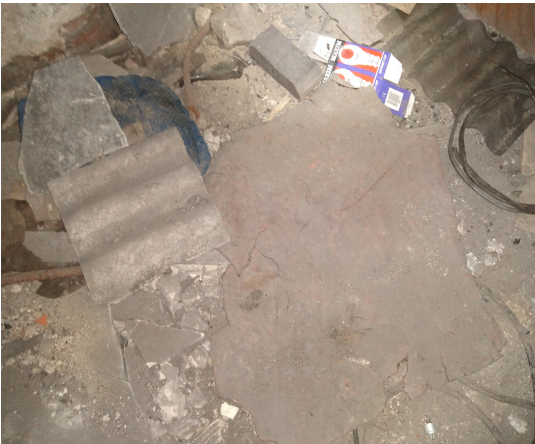
Item 5 Ref: 403295-4

The floor covering in the store (Rm -1/002) does not contain asbestos.

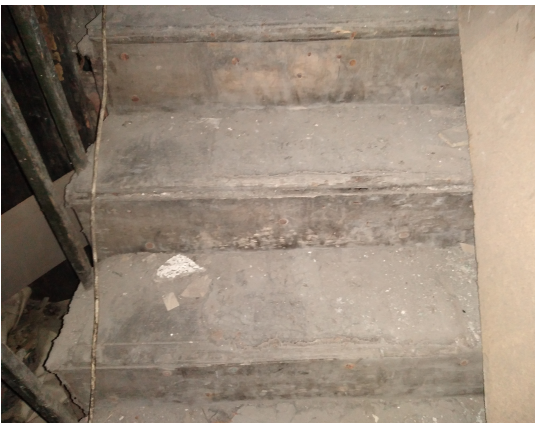
Item 6 Ref: 403295-5

The floor covering to stairs in the stairwell (Rm -1/004) does not contain asbestos.

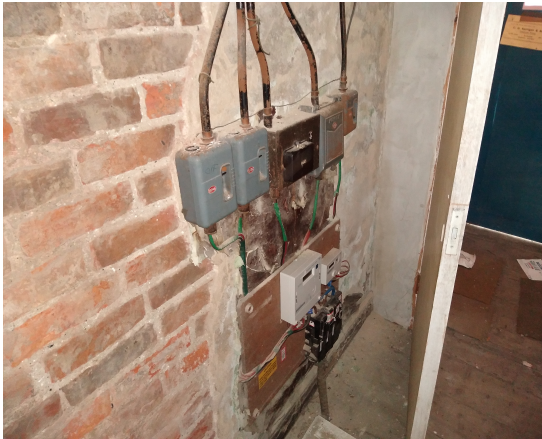
Item 7 Ref: Presumed

The Electrics in the entrance hallway (Rm 0/02) is presumed to contain asbestos.

| Picture | Location | Risk | Inspection Frequency | Date of return |
|---|---|---|---|---|
| Item 7 | Electrics flash protection (Entrance hallway/Rm 0/002) | Low Risk | 6 monthly | 11/09/2025 |

Further investigation is required before any works can commence.

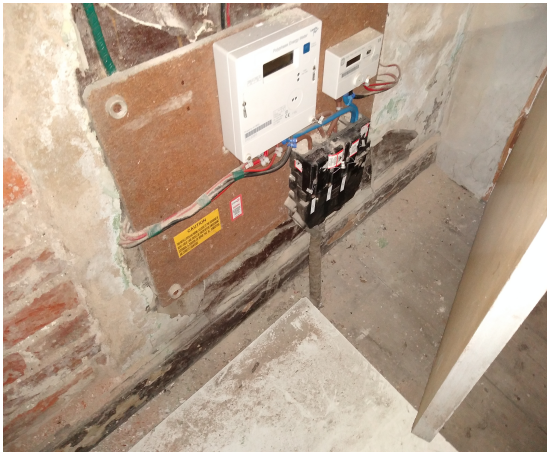
Item 8 Ref: As 403295-1

The wrap to main incomer in the entrance hallway (Rm 0/002) does not contain asbestos.

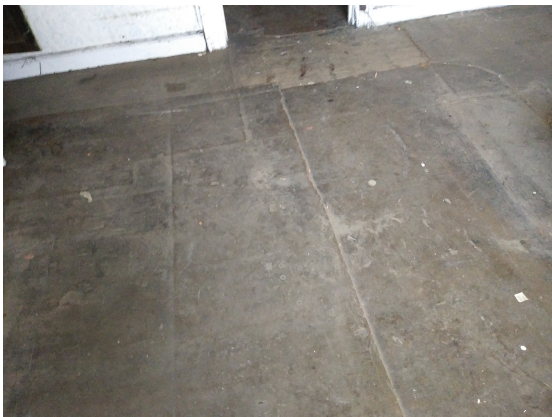
Item 9 Ref: 403295-6

The floor covering in the living room (Rm 0/003) does not contain asbestos.

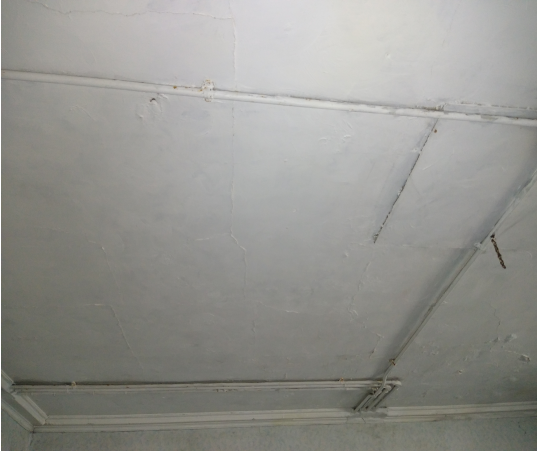
Item 10 Ref: 403295-7

The decorative finish to lath and plaster ceiling in the living room (Rm 0/003) does not contain asbestos.

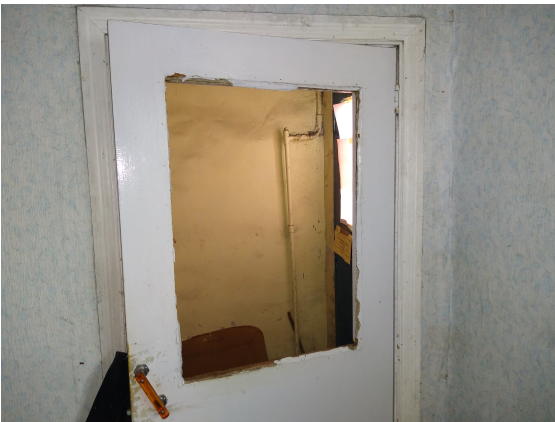
Item 11 Ref: 403295-11

The putty to door in the living room (Rm 0/003) does not contain asbestos.

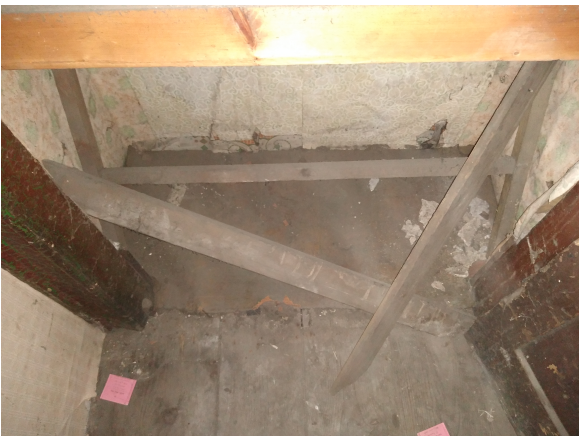
Item 12 Ref: 403295-8

The floor covering in the cupboard (Rm 0/004) does not contain asbestos.

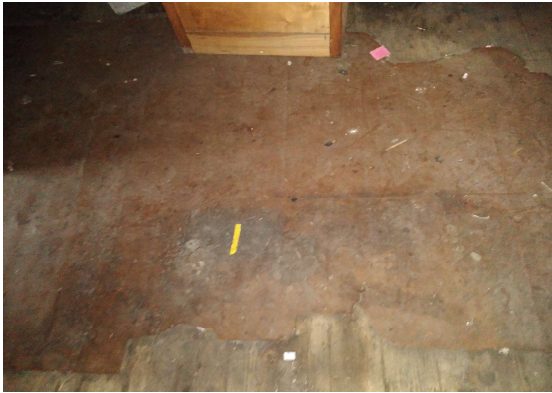
Item 13 Ref: As 403295-6

The floor covering to the workshop (Rm 0/005) does not contain asbestos.

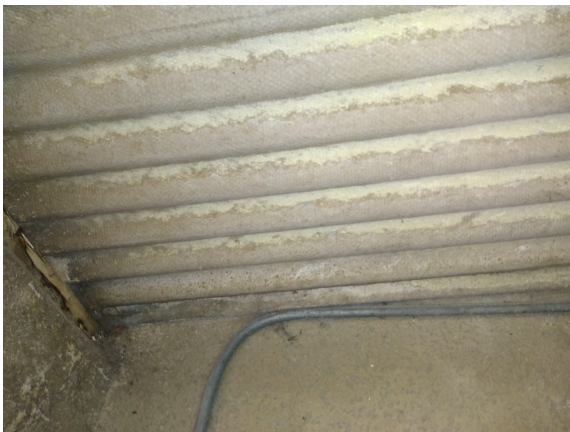
Item 14 Ref: 403295-9

The roof covering in the external wc (Rm 0/006) does contain asbestos.

| Picture | Location | Risk | Inspection Frequency | Date of return |
|---|---|---|---|---|
| Item 14 | Roof covering (External WC/Rm 0/006) | Very Low Risk | 12 monthly | Removed May 2020 |

Removed May 2020

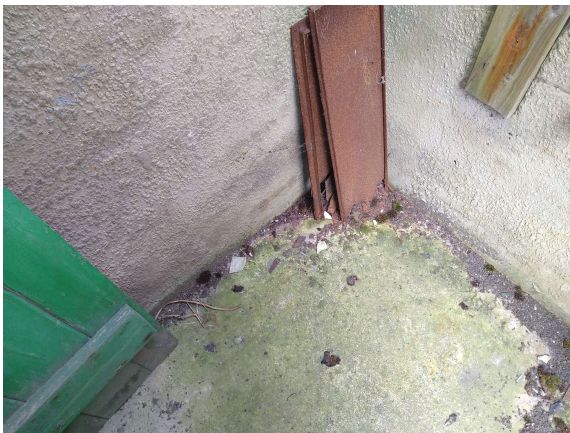
Item 15 Ref: As 403295-9

The cement debris to floor in the external wc (Rm 0/006) does contain asbestos.

| Picture | Location | Risk | Inspection Frequency | Date of return |
|---|---|---|---|---|
| Item 15 | Cement debris to floor (External WC/Rm 0/006) | Low Risk | 6 monthly | Removed May 2020 |

Removed May 2020

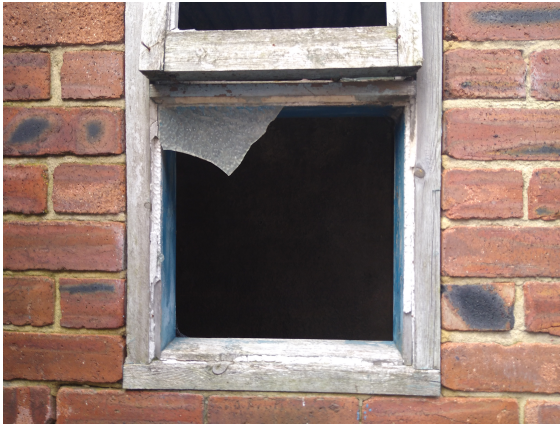
Item 16 Ref: 403295-10

The putty to the windows in the external wc (Rm 0/006) does not contain asbestos.

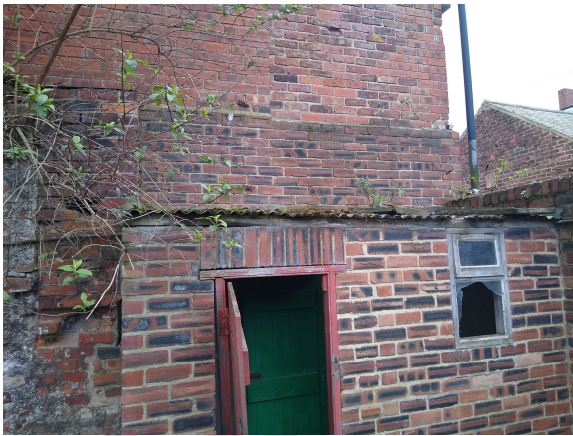
Item 17 Ref: As 403295-9

The roof covering in the external wc (Rm 0/007) does contain asbestos.

| Picture | Location | Risk | Inspection Frequency | Date of return |
|---|---|---|---|---|
| Item 17 | Roof covering (External WC/Rm 0/007) | Very Low Risk | 12 monthly | Removed May 2020 |

Removed May 2020

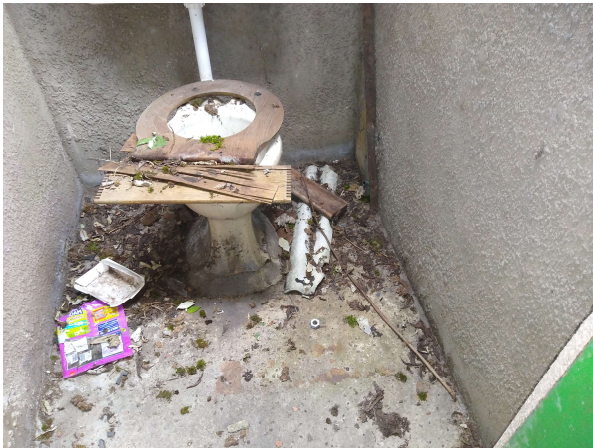
Item 18 Ref: As 403295-9

The cement debris to floor in the external wc (Rm 0/007) does contain asbestos.

| Picture | Location | Risk | Inspection Frequency | Date of return |
|---|---|---|---|---|
| Item 18 | Cement debris to floor (External WC/Rm 0/007) | Low Risk | 6 monthly | Removed May 2020 |

Removed May 2020.

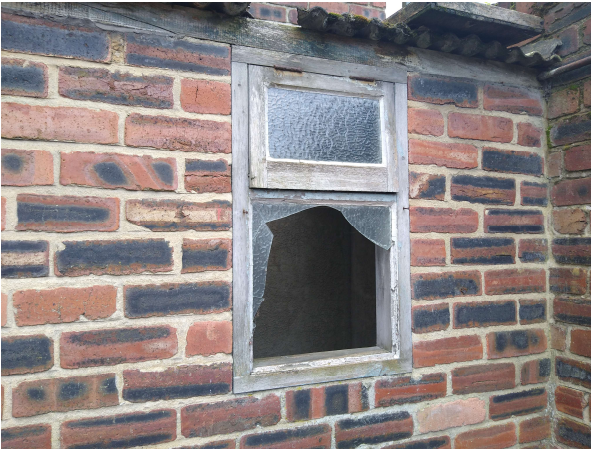
Item 19 Ref: As 403295-10

The putty to the windows in the external wc (Rm 0/007) does not contain asbestos.

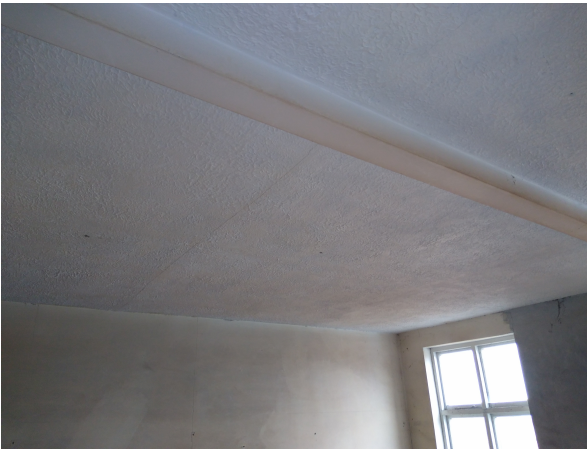
Item 20 Ref: 403295-12

The decorative finish to lath and plasterboard in the living area (Rm 1/001) does not contain asbestos.

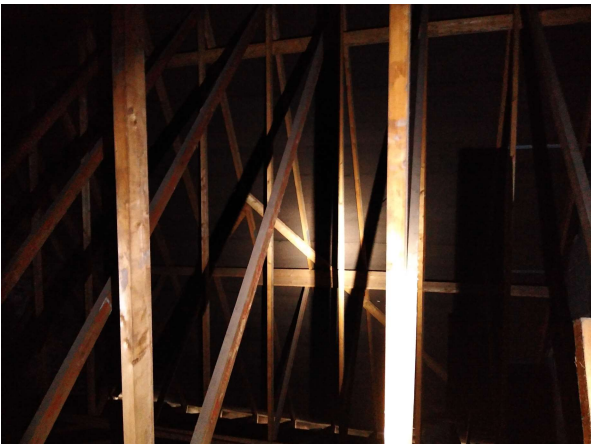
Item 21 Ref: 403295-13

The sarking in the loft void (Rm 2/001) does not contain asbestos.

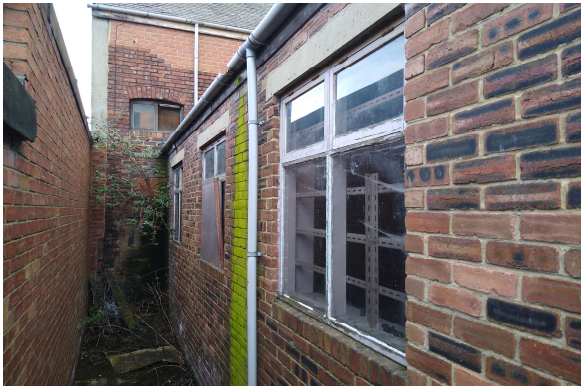
Item 22 Ref: 403295-14

The putty to the windows in the external does not contain asbestos.

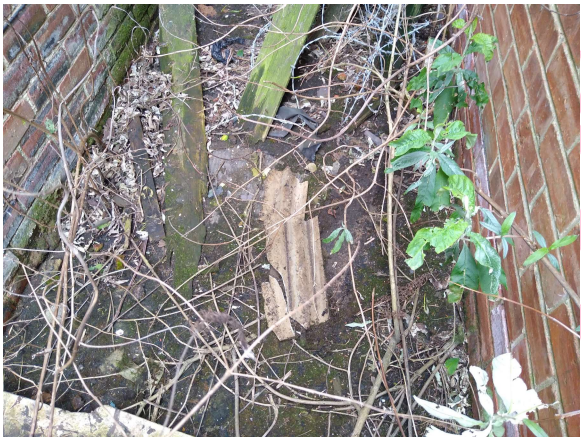
Item 23 Ref: 403295-15

The cement panels to path adjacent to workshop externally does contain asbestos.

| Picture | Location | Risk | Inspection Frequency | Date of return |
|---|---|---|---|---|
| Item 23 | Cement panels to path adjacent | Low Risk | 6 monthly | Removed May 2020 |

Removed May 2020
