ASBESTOS SURVEY REPORT FOR FULWELL QUARRY RECREATION AREA, SUNDERLAND

**Fulwell Quarry Recreation Area,
Sunderland**

UPRN: - J549544

Premises Manager / Samo: - Tenant Date: 14 February 2025

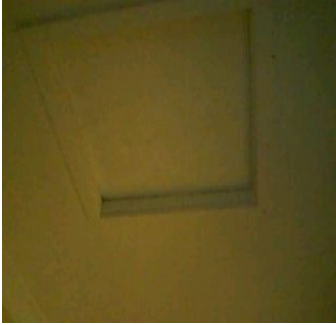
Item 1 Ref – BB005465

The textured coating to the ceiling in the hall (room 1) does not contain asbestos.

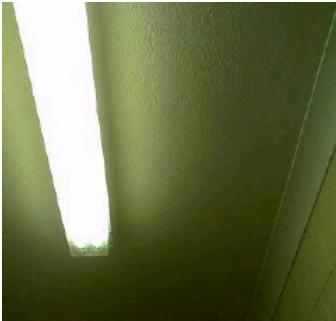
Item 2 As BB005465

The textured coating to the officials room (Room 2) does not contain asbestos.

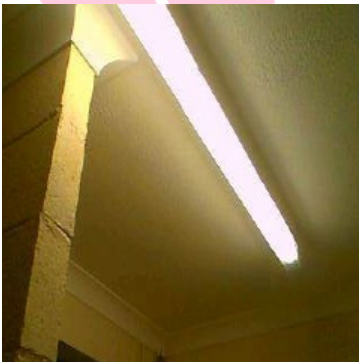
Item 3 As BB005465

The textured coating to the ceiling in the officials bathroom (Room 4) does not contain asbestos.

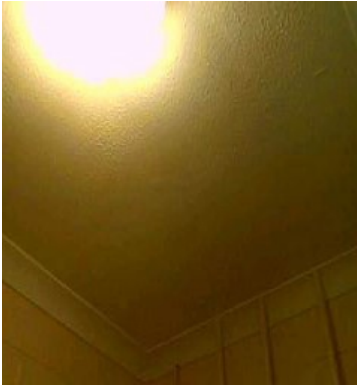
Item 4 As BB005465

The textured coating to the ceiling in the pump cupboard (Room 5) does not contain asbestos.

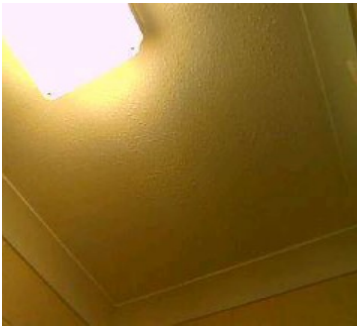
Item 5 As BB005465

The textured coating to the ceiling in the male bathroom lobby (Room 6) does not contain asbestos.

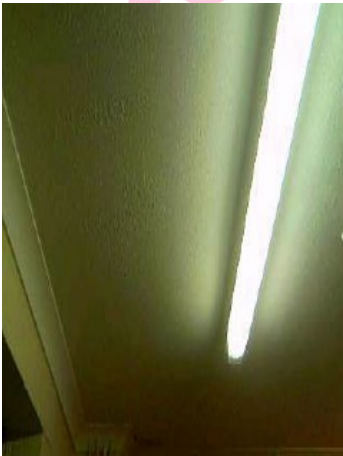
Item 6 As BB005465

The textured coating to the ceiling in the male bathroom (Room 7) does not contain asbestos.

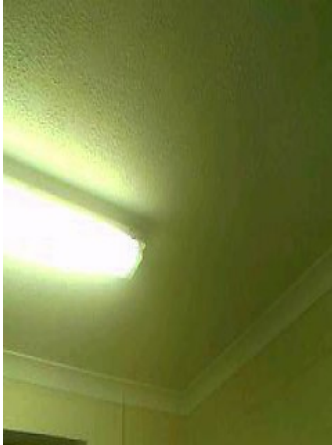
Item 7 As BB005465

The textured coating to the ceiling in changing room 2 (Room 8) does not contain asbestos.

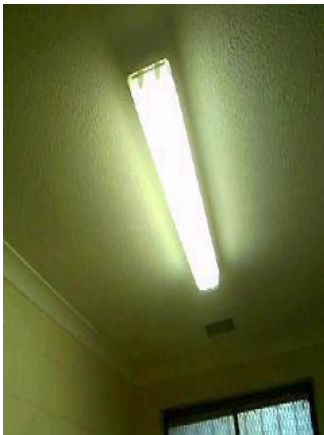
Item 8 As BB005465

The textured coating to the ceiling in the showers (Room 9) does not contain asbestos.

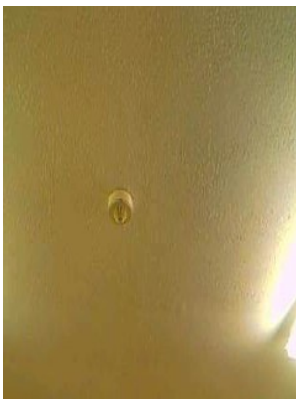
Item 9 As BB005465

The textured coating to the ceiling in changing room 1 (Room 10) does not contain asbestos.

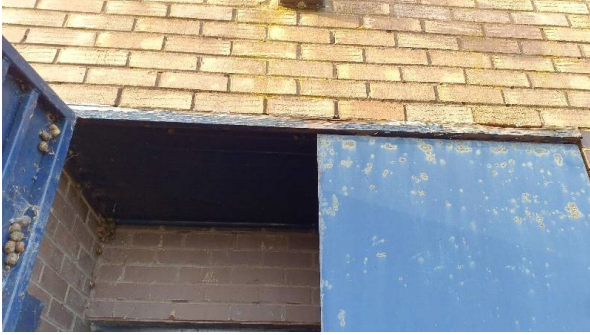
Item 10 Ref: OU001158

- OU001158 - Residual frame sealant - Around metal doors (External) (Item 10) – Very Low Risk
- OU001159 - Frame sealant - Around windows (External) (Item 11) – Very Low Risk

The residual frame sealant - Around metal doors (External) contains asbestos.

Any change in appearance should be noted and passed to Property Services.

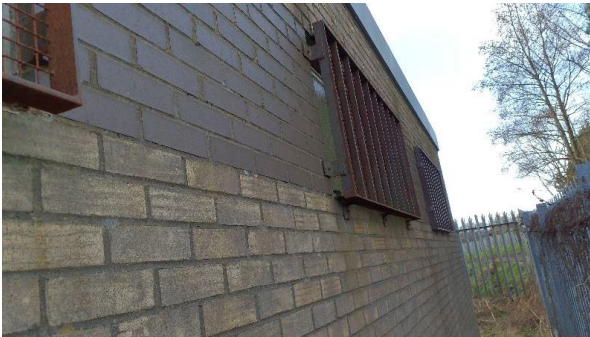
Item 11 Ref: OU001159

The frame sealant - Around windows (External) contains asbestos.

Any change in appearance should be noted and passed to Property Services.

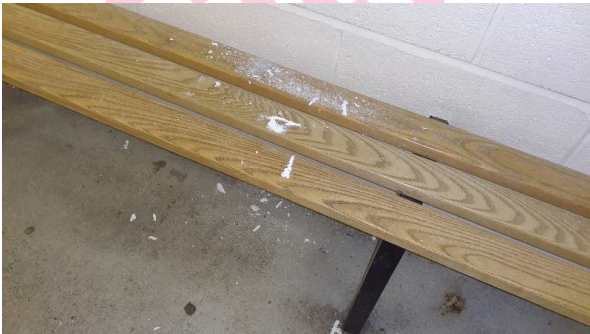
Item 12 Ref: As OU001152

The textured coating - Debris on floor (Changing room 2 G/01) does not contain asbestos.

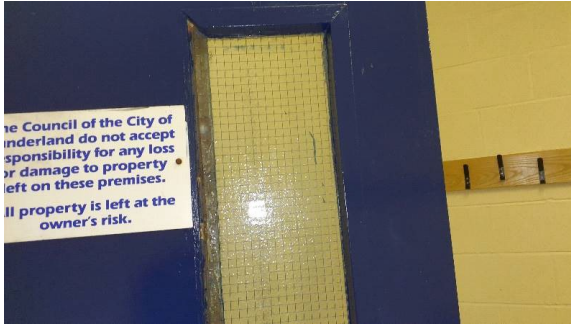
Item 13 Ref: OU001153

The sealant - Around glass in door (Changing room 2 G/01) does not contain asbestos.

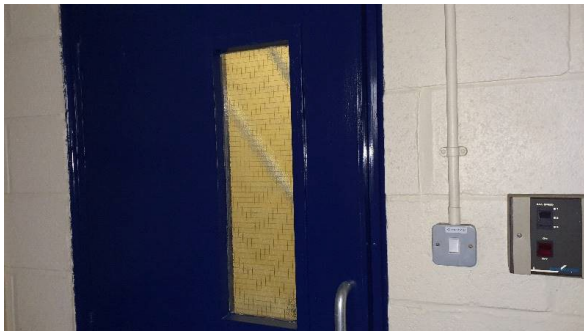
Item 14 Ref: As OU001153

The sealant - Around glass in door (Changing room 1 G/10) does not contain asbestos.

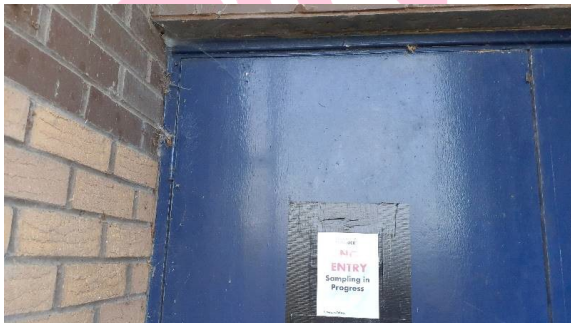
Item 15 Ref: OU001157

The frame sealant - Around timber doors (Front entrance G/11) does not contain asbestos.

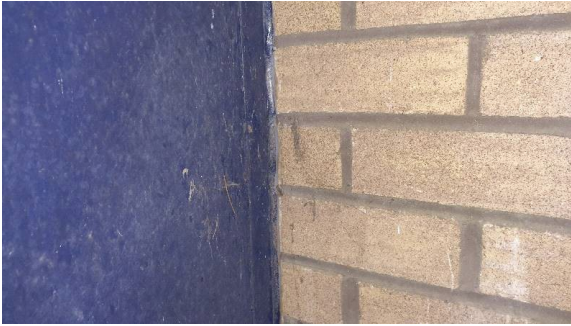
Item 16 Ref: As OU001157

The frame sealant - Around timber doors (Rear entrance G/12) does not contain asbestos.

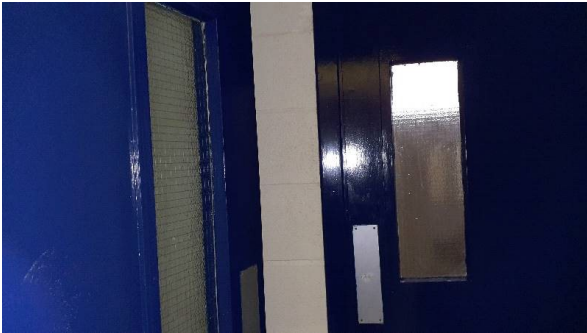
Item 17 Ref: As OU001153

The sealant - Around glass in door (Men's WC entrance G/07) does not contain asbestos.

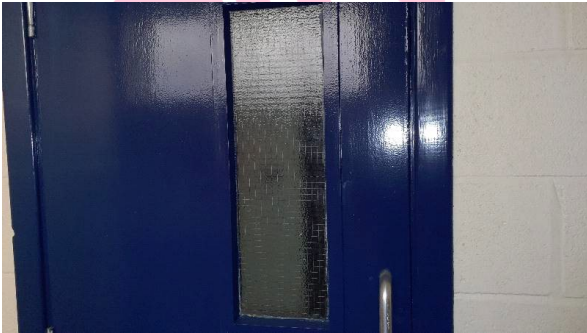
Item 18 Ref: As OU001153

The sealant - Around glass in door (Men's WC G/08) does not contain asbestos.

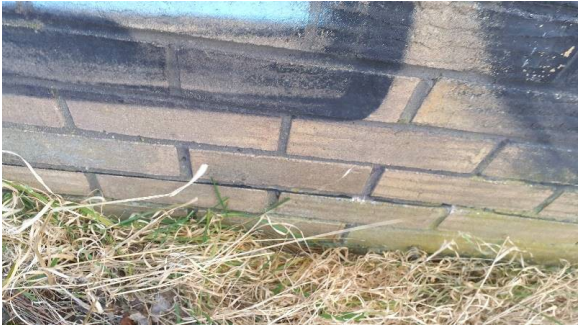
Item 19 Ref: OU001160

The bitumen - Damp proof course (External) does not contain asbestos.

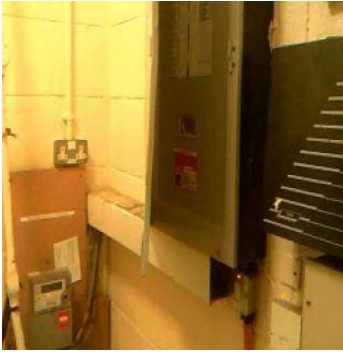
The old boiler cupboard (Room 3) was accessed and no suspect materials were found.

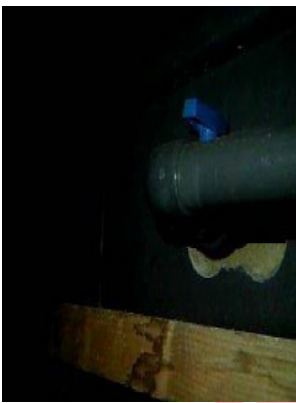
There was limited access to the loft due to height, accessed from hatch only.

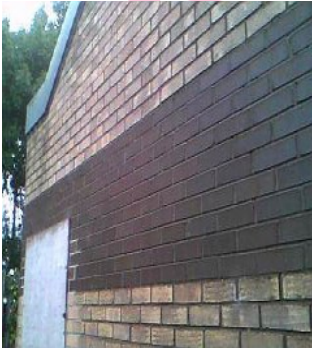
The external to the building was accessed and no suspect materials were found.
