ASBESTOS SURVEY REPORT FOR BARNES PARK, SUNDERLAND SR4 7PY

Barnes Park, Sunderland, SR4 7PY

Date: 23 July 2025

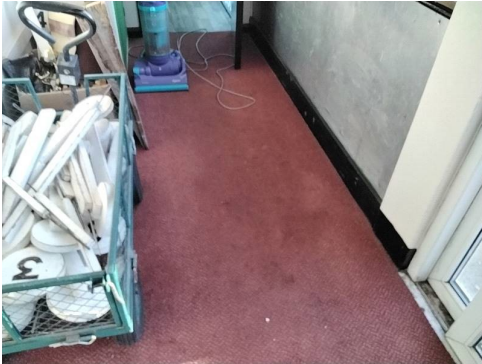
Item 1 Ref: KX000456/001

The Floor - Tile (Under floor covering) - beige, painted green in Bowling Pavilion G/001 - Entrance Hall/Foyer/Lobby does not contain asbestos.

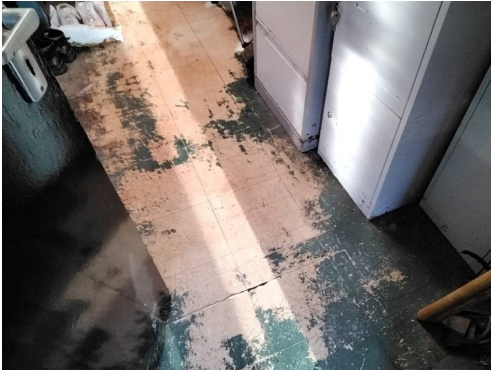
Item 2 Ref: As KX000456

The Floor - Tile (Under floor covering) - beige, painted green in Bowling Pavilion G/006 – Staffroom does not contain asbestos.

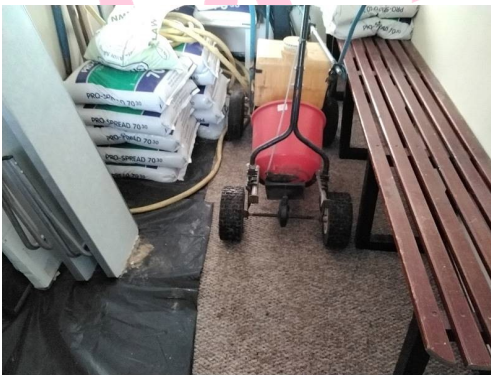
Item 3 Ref: KX000458/003

The Floor - Tile (Under floor covering) - Red in Bowling Pavilion G/007 – Staff Room/Storeroom does not contain asbestos.

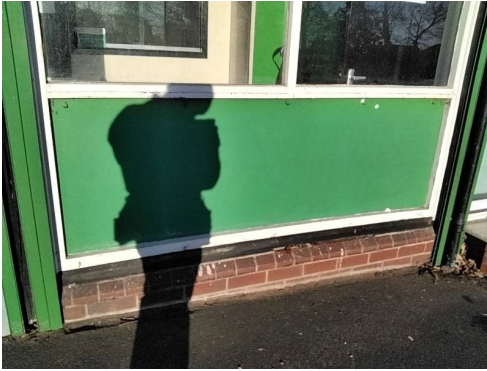
Item 4 Ref: KX000459/004

The Window - Infill Panel in Bowling Pavilion E/001 – External does not contain asbestos.

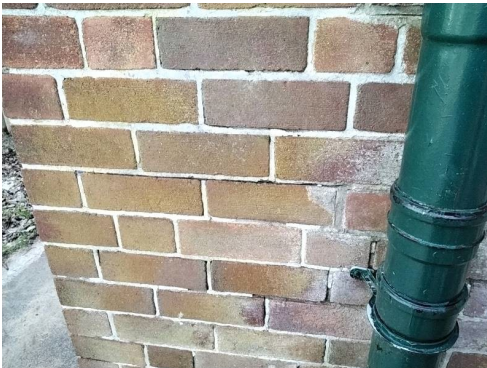
Item 5 Ref: KX000461/007

The Damp Proof Course in Bowling Pavilion E/001 – External does not contain asbestos.

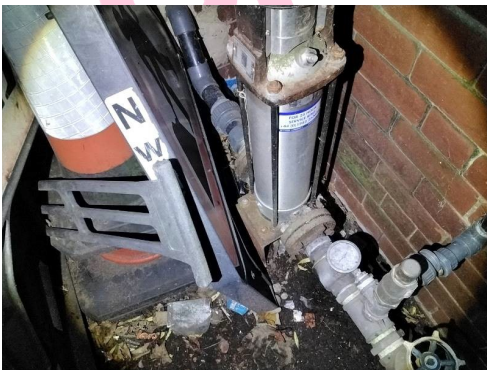
Item 6 Ref: Presumed

6.	Presumed	Pipework Gasket	Bowling Pavilion E/001 – External	Very Low Risk
7.	KX000460/006	Door - frame sealant to wall	Bowling Pavilion E/002 – External	No Risk

The Pipework Gasket in Rm Bowling Pavilion E/001 – External is presumed to contain asbestos.

Any change in its appearance should be recorded and passed to Property Services.

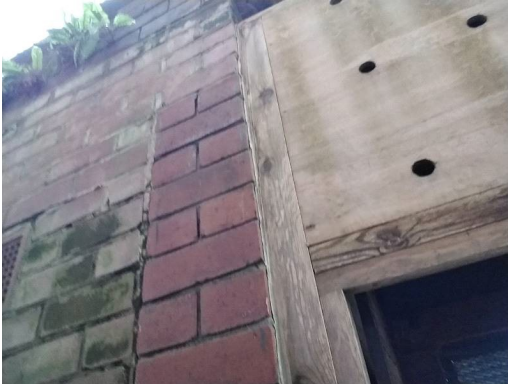
Item 7 Ref: KX000460/006

The Door - frame sealant to wall in Bowling Pavilion E/002 – External does not contain asbestos.

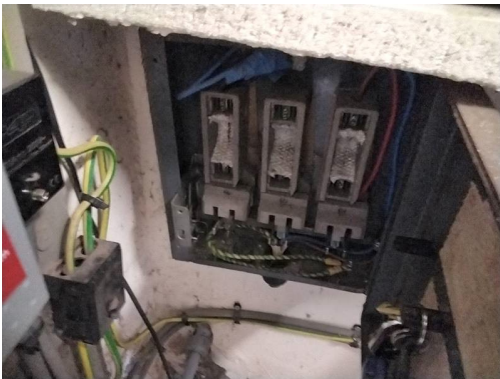
Item 8 Ref: KX000464/014

8.	KX000464/014	Electrical Services - Fuses/Flashguards	Barnes West End Men's Pavilion G/006 - Staffroom	Low Risk
9.	KX000465/015	Under Sink Mat - to old sink discarded in loft	Pavilion – Roof Void R/001 Loft Space	No Risk

The Electrical Services - Fuses/Flashguards in Barnes West End Men's Pavilion G/006 - Staffroom contains asbestos.

Any change in its appearance should be recorded and passed to Property Services.

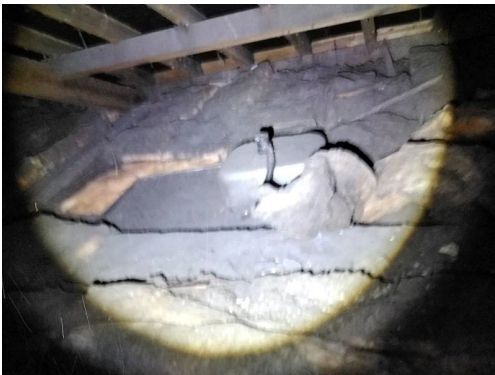
Item 9 Ref: KX000465/015

The Under Sink Mat - to old sink discarded in loft in Pavilion – Roof Void R/001 Loft Space does not contain asbestos.

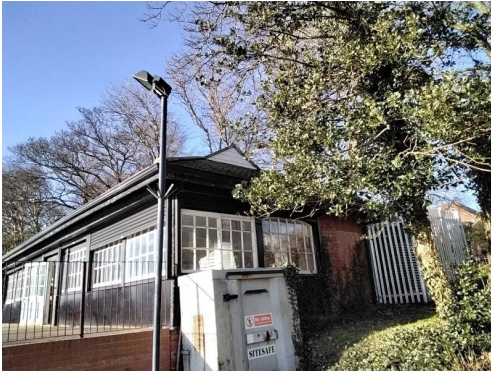
Item 10 Ref: As KX000466

The Undercloak - to peak in Barnes West End Men's Pavilion – External E/001 does not contain asbestos.

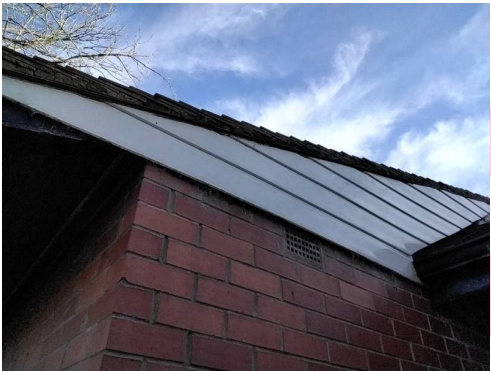
Item 11 Ref: KX000466/017

The Undercloak - to toilet block in Barnes West End Men's Pavilion – External E/001 does not contain asbestos.
