ASBESTOS SURVEY REPORT FOR LEYBURN GROVE RECREATION GROUND, HOUGHTON LE SPRING

LEYBURN GROVE RECREATION GROUND

Premises Manager / Samo: - Tenant Date: 3rd June 2023

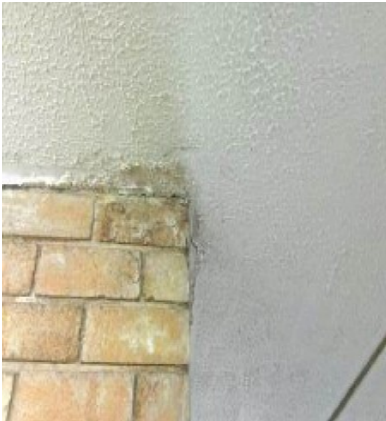
Item 1 Ref: EA003009

The textured coating to the ceiling in the Corridor (Room 1) does not contain asbestos.

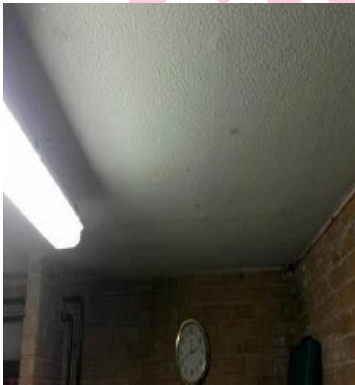
Item 3 - Ref: EA003009

The textured coating to the ceiling in the staff room (Room 2) do not contain asbestos.

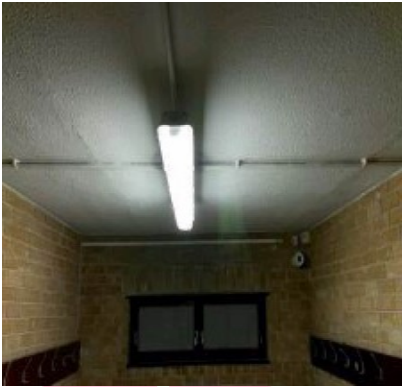
Item 5 - Ref: EA003009

The textured coating to the ceiling in changing room 5 (Room 4) does not contain asbestos.

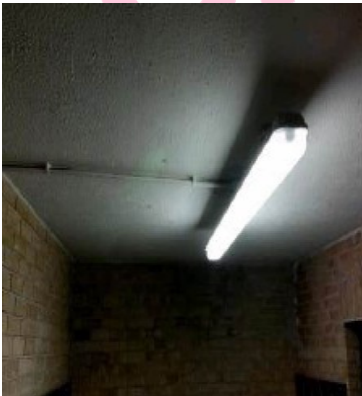
Item 6 - Ref: EA003009

The textured coating to the ceiling in changing room 6 (Room 5) does not contain asbestos.

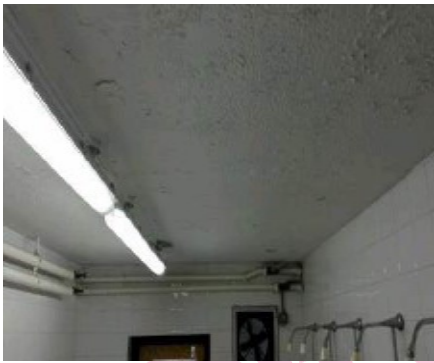
Item 8 - Ref: EA003009

The textured coating to the ceiling in the shower room (Room 7) does not contain asbestos.

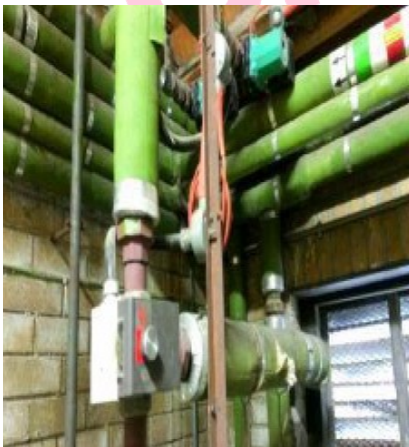
Item 9 - Ref: EA003011

The pipe lagging to the boiler room (Room 8) does not contain asbestos.

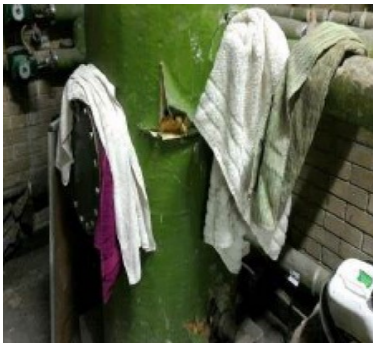
Item 11 - Ref: EA003013

The lagging to the calorifiers in the boiler room (Room 8) do not contain asbestos.

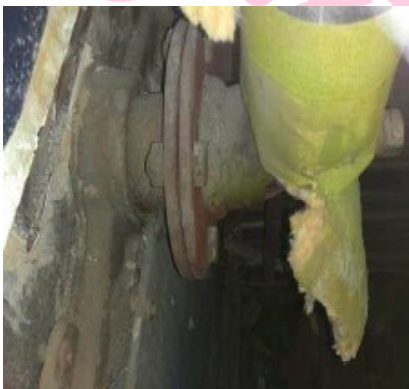
Item 12 – 21-30813-3

The gaskets to the pipework in the boiler room (Room 8) does not contain asbestos.

No Risk – resampled, report J278817 confirms this

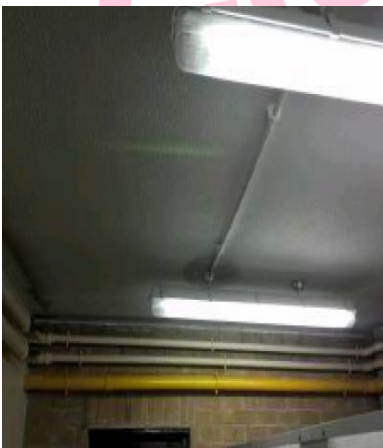
Item 15 - As EA003015

The textured coating to the ceiling in the Female WC (Room 11) does not contain asbestos.

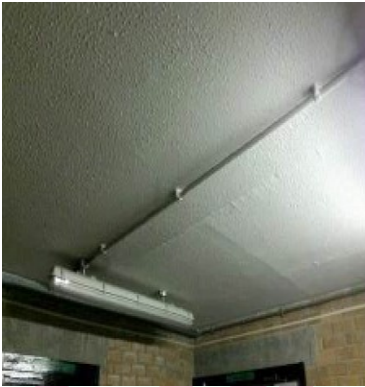
Item 17 - As EA003015

The textured coating to the ceiling in the lobby (Room 12) does not contain asbestos.

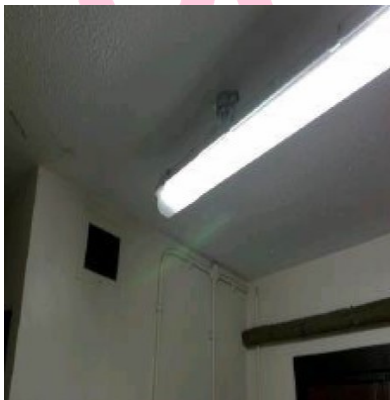
Item 18 - As EA003015

The textured coating to the ceiling in the kitchen (Room 13) does not contain asbestos.

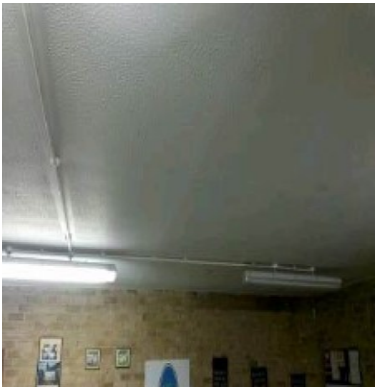
Item 22 - As EA003015

The textured coating to the ceiling in the team room (Room 15) does not contain asbestos.

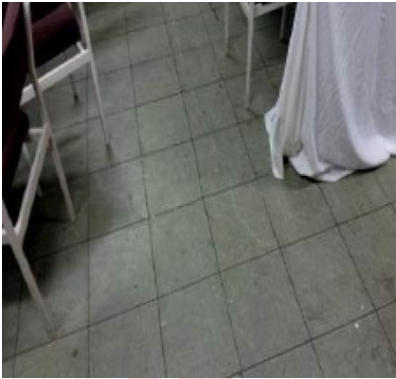
Item 23 - As EA003017

The green floor tiles to the tea room (Room 15) do not contain asbestos.

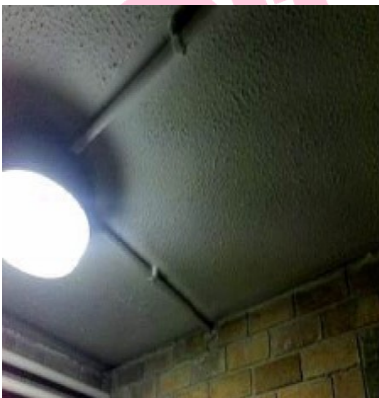
Item 24 - As EA003015

The textured coating to the ceiling in the disabled WC (Room 16) does not contain asbestos.

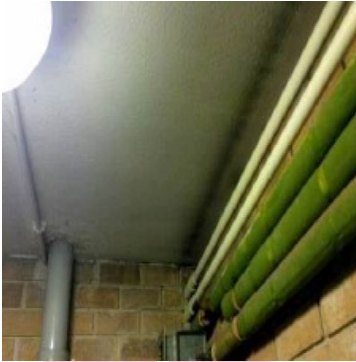
Item 26 - As EA003015

The textured coating to the ceiling in the WC (Room 17) does not contain asbestos.

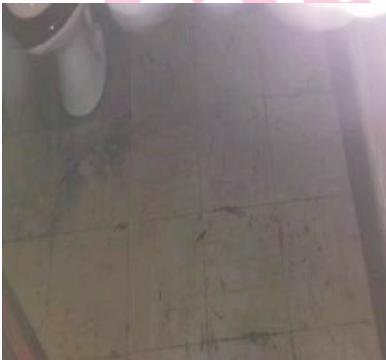
Item 27 - As EA003017

The green floor tiles to the WC (Room 17) do not contain asbestos.

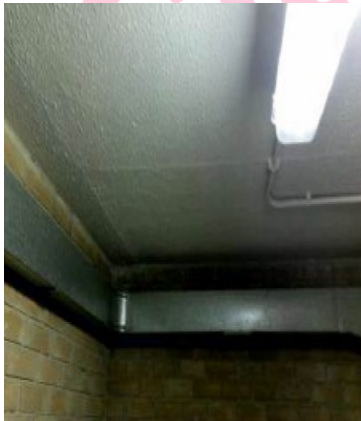
Item 30 - As EA003018

The textured coating to the ceiling in the officials Room (Room 20) does not contain asbestos.

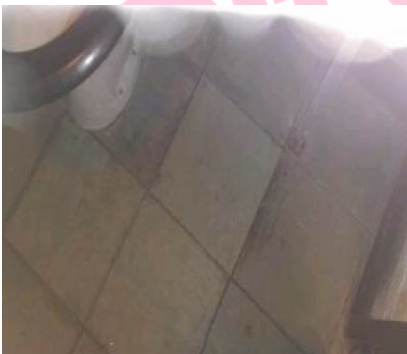
Item 33 - As EA003017

The green floor tiles to the officials WC (Room 22) do not contain asbestos.

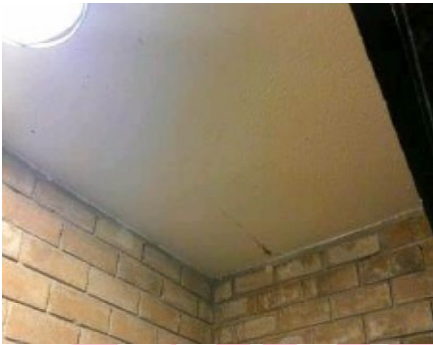
Item 35 - As EA003018

The textured coating to the ceiling in the store (Room 24) does not contain asbestos.

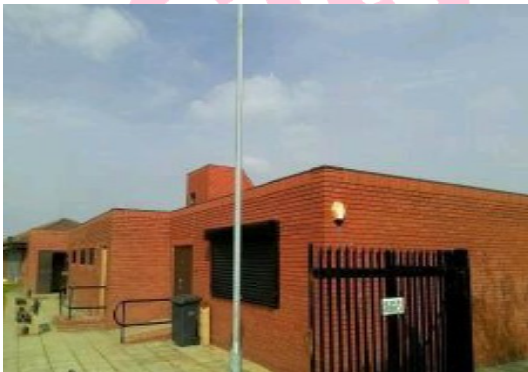
Item 36 – Presumed

The bitumen to the flat roof (External) was presumed to contain asbestos.

Any change in its appearance should be noted and passed to Property Services.

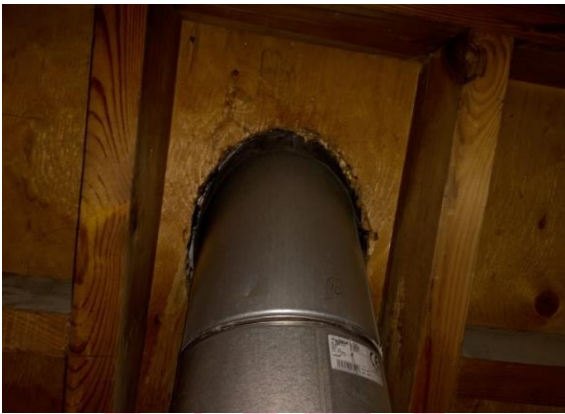
Item 41 Ref: 21-30813-7

The ceiling flue penetration Area 1/Boiler Room does not contain asbestos.

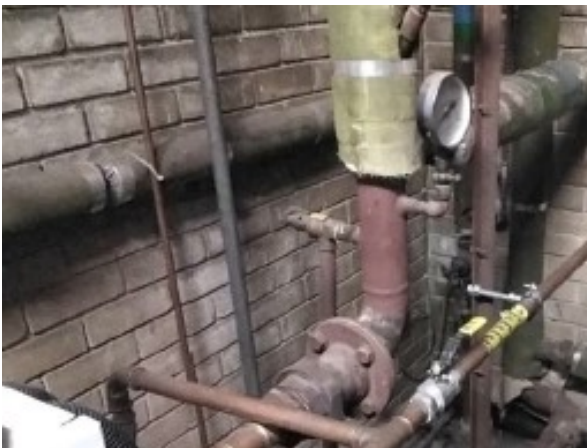
Item 45 Ref: NG001281

The pipework gasket to elbow joint off new vessel Area 1/Boiler Room does not contain asbestos.
