ASBESTOS SURVEY REPORT FOR FARMBOROUGH COURT, BRENTFORD AVENUE, SUNDERLAND, SR5 4EU.

Asbestos Register for Farmborough Court, Brentford Avenue, Sunderland

Date: 26 June 2025

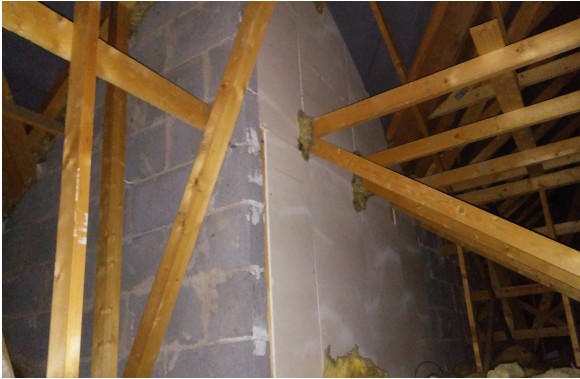
Item 1 Ref: As 416204-2

The walls in Rm 2/001 Loft do not contain asbestos.

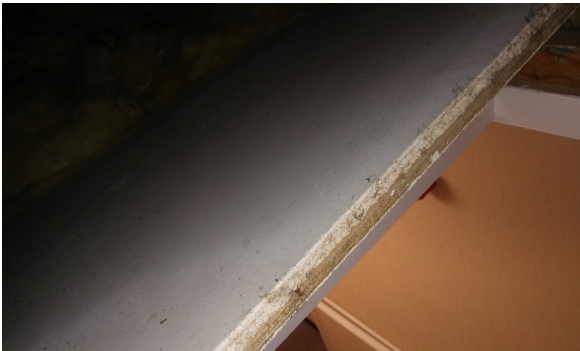
Item 2 Ref: As 416204-3

The rear of loft hatch in Rm 2/001 Loft does not contain asbestos.

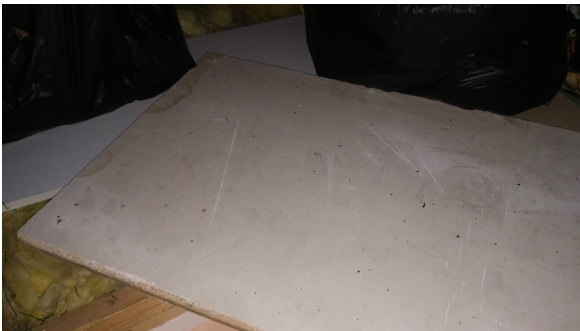
Item 3 Ref: As 416204-3

The rear of loft hatch in Rm 2/002 Loft does not contain asbestos.

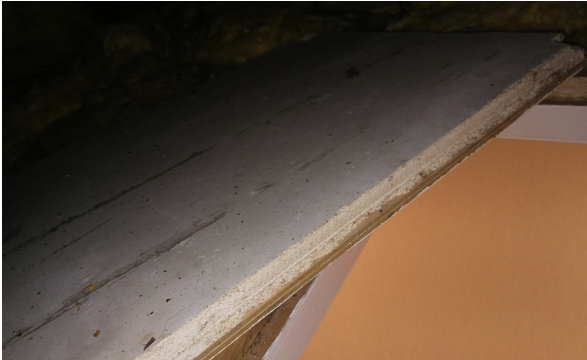
Item 4 Ref: As 416204-3

The rear of loft hatch in Rm 2/003 Loft does not contain asbestos.

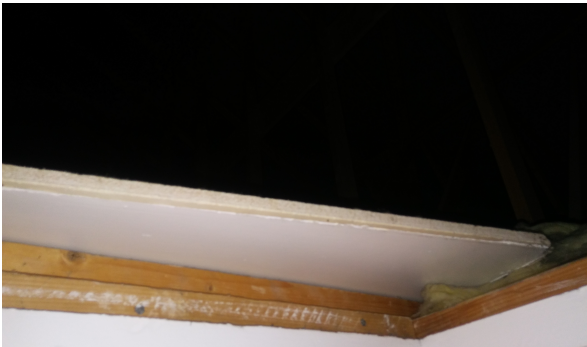
Item 5 Ref: As 416204-3

The loft hatch in Rm 2/004 Loft does not contain asbestos.

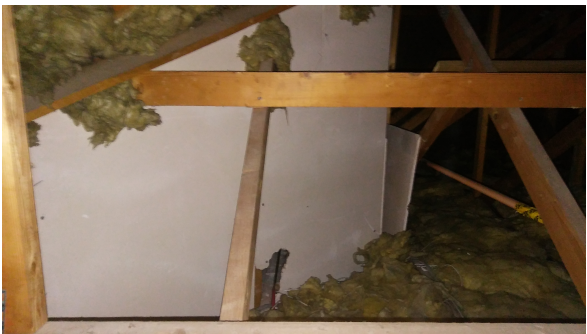
Item 6 Ref: 416204-2

The walls in Rm 2/005 Loft do not contain asbestos.

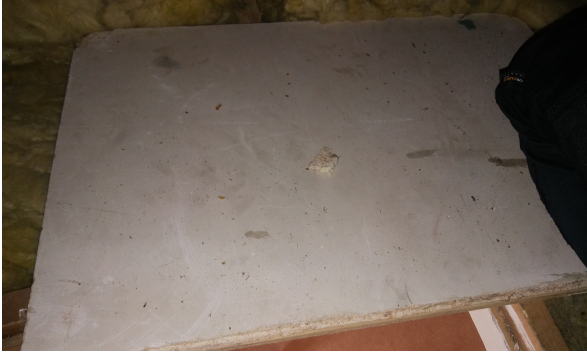
Item 7 Ref: 416204-3

The rear of loft hatch in Rm 2/005 Loft does not contain asbestos.

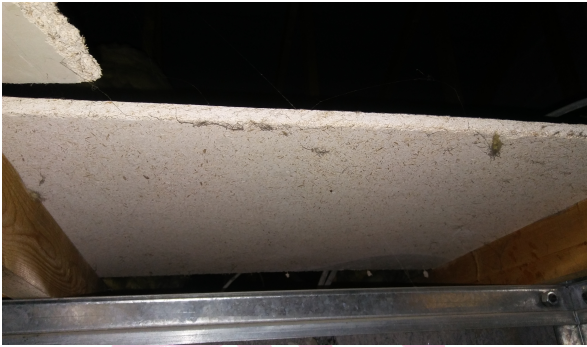
Item 8 Ref: As 416204-4

The ceiling to dumb waiter below in Rm 2/006 Loft does not contain asbestos.

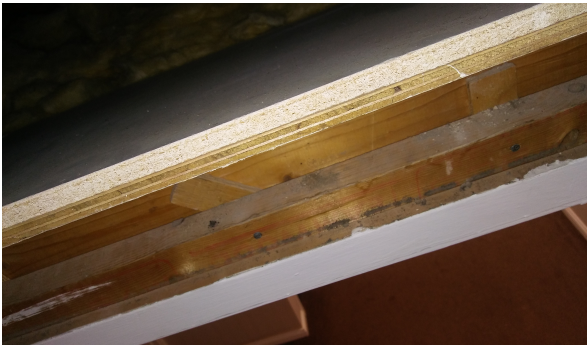
Item 9 Ref: As 416204-3

The rear of loft hatch in Rm 2/007 Loft does not contain asbestos.

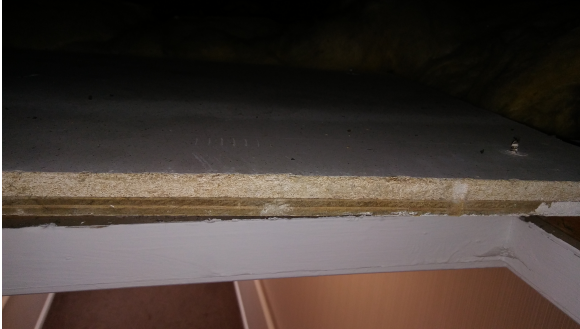
Item 10 Ref: 416204-3

The rear of loft hatch in Rm 2/008 Loft does not contain asbestos.

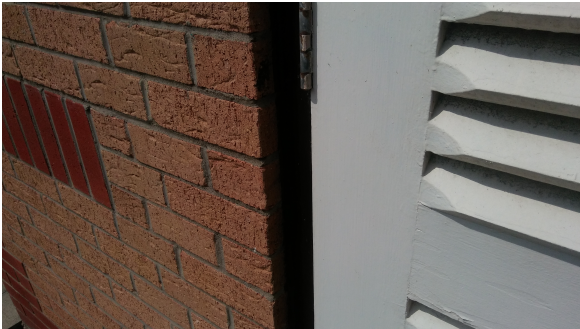
Item 11 Ref: 416204-11

The sealant to door frames (External) does not contain asbestos.

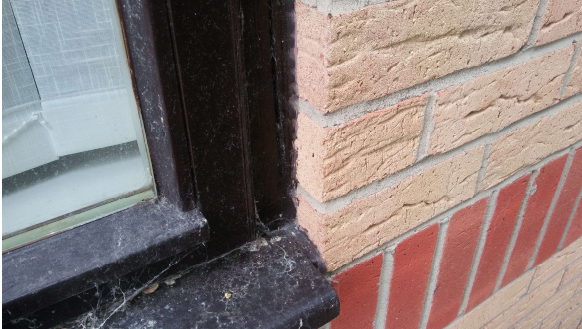
Item 13 Ref: 416204-13

The sealant to window frames (External) does not contain asbestos.

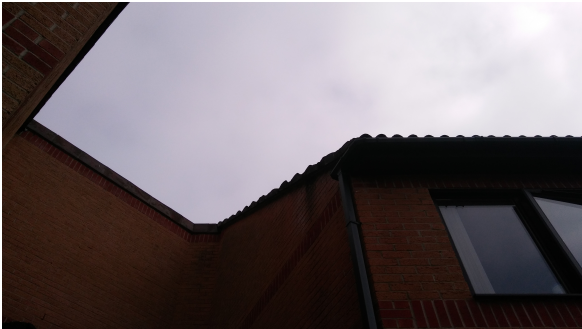
Item 14 Ref: 416204-14

The undercloak high level (above link 2 area/External) does not contain asbestos.

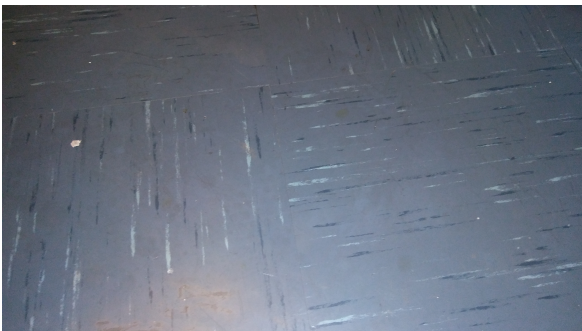
Item 15 Ref: As 416204-9

The floor covering in Rm 0/68 Store Balmoral Unit does not contain asbestos.

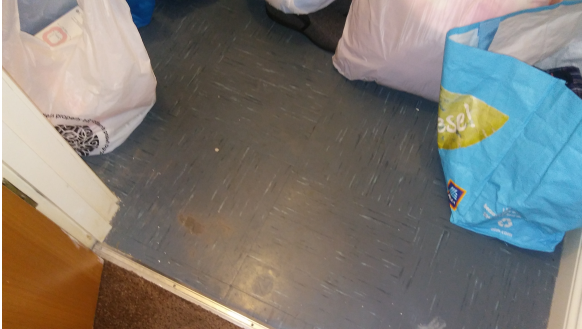
Item 16 Ref: 416204-9

The floor covering in Rm 0/69 Store Balmoral Unit does not contain asbestos.

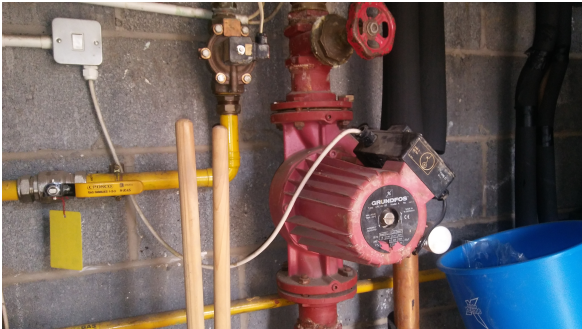
Item 17 Ref: 416204-10

The pipework flange gasket in Rm 0/79 Boiler house does not contain asbestos.

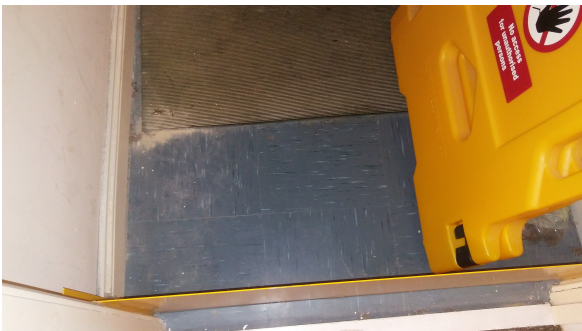
Item 18 Ref: As 416204-5

The floor covering in Rm 1/043 Lift machinery room Buckingham unit does not contain asbestos.

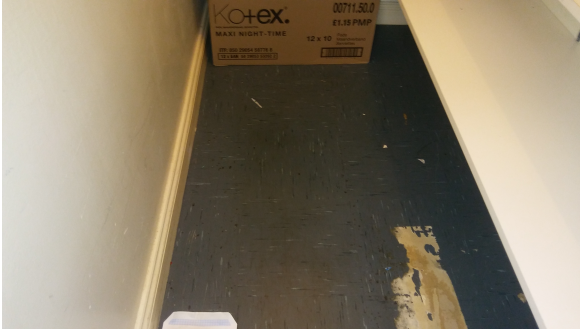
Item 19 Ref: As 416204-5

The floor covering in Rm 1/044 Store Buckingham unit does not contain asbestos.

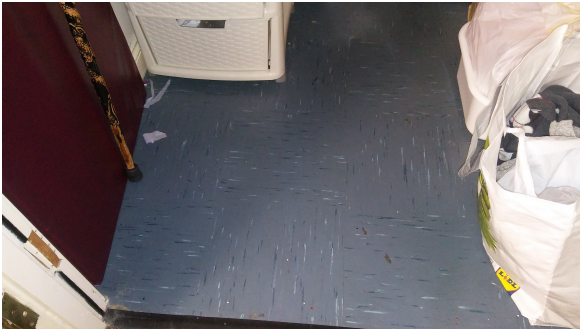
Item 20 Ref: 416204-5

The floor covering in Rm 1/048 Store Buckingham unit does not contain asbestos.

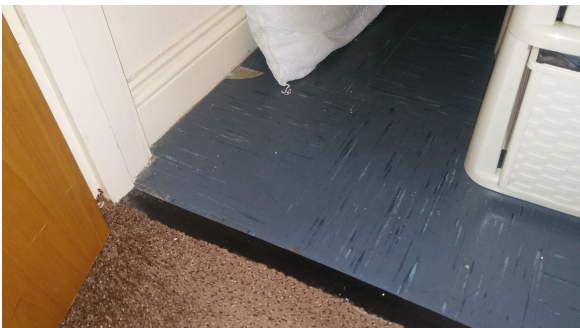
Item 21 Ref: 416204-1

The floor covering in Rm 1/014 Store Clarence unit does not contain asbestos.

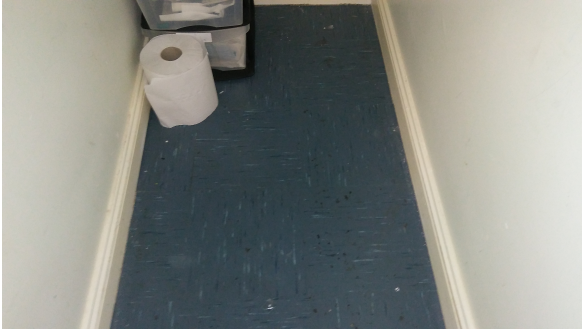
Item 22 Ref: As 416204-1

The floor covering in Rm 1/016 Store Clarence unit does not contain asbestos.

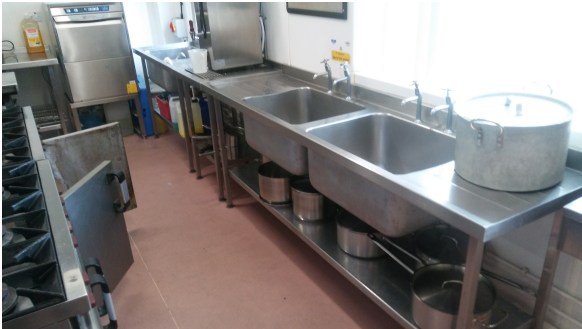
Item 23 Ref: 416204-7

The sink paint in Rm 0/043 kitchen Link 1 does not contain asbestos.

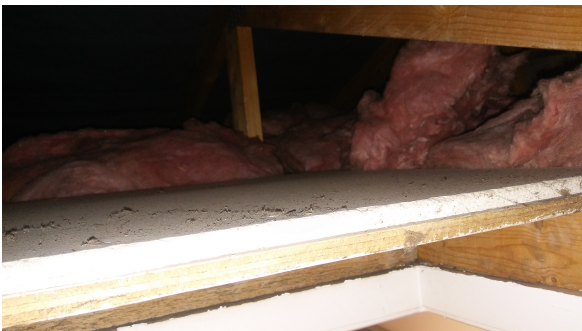
Item 24 Ref: 416204-8

The rear of access hatch in Rm 0/034a Cold store void above Link 1 does not contain asbestos.

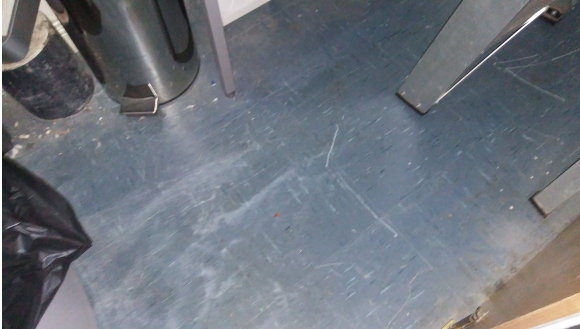
Item 25 Ref: As 416204-1

The floor covering in Rm 0/037 Switchroom Link 1 does not contain asbestos.

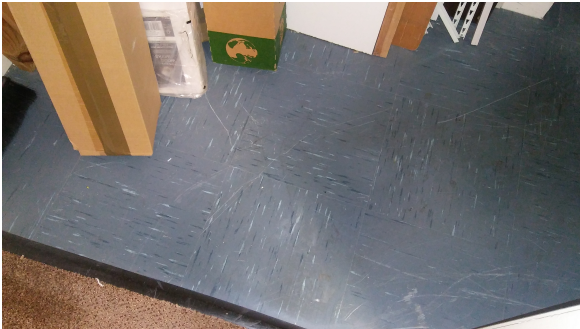
Item 26 Ref: As 416204-1

The floor covering in Rm 1/028 Office Link 2 does not contain asbestos.

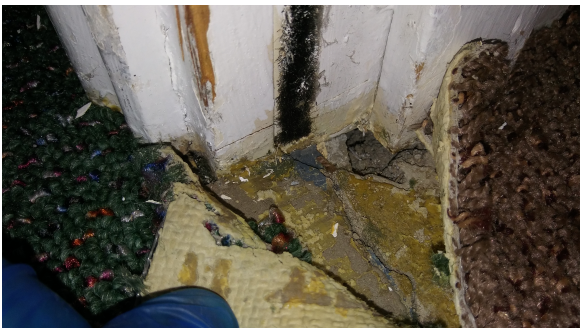
Item 27 Ref: As 416204-1

The floor covering in Rm 1/033 Store Link 2 does not contain asbestos.

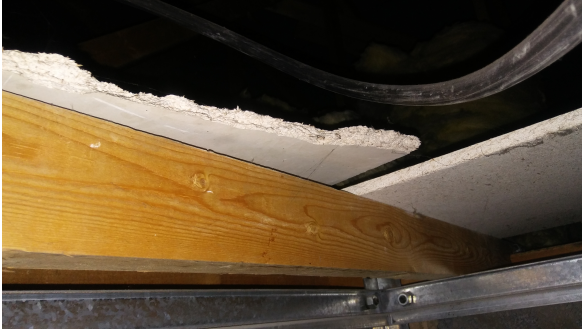
Item 28 Ref: 416204-4

The ceiling in Rm 1/068
Corridor dub waiter Link 2
does not contain asbestos.

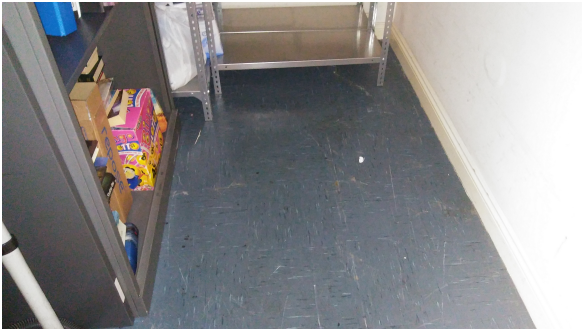
Item 29 Ref: As 416204-6

The floor covering in Rm
0/066 Store Windsor unit does
not contain asbestos.

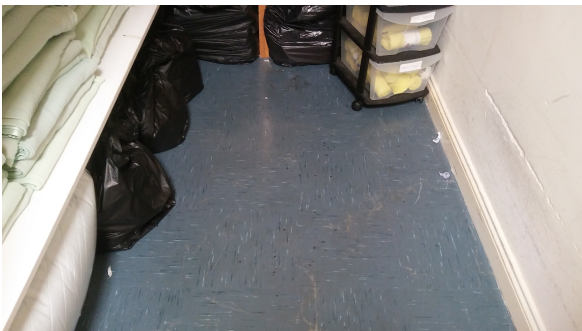
Item 30 Ref: 416204-6

The floor covering in Rm
0/007 Store Windsor unit does
not contain asbestos.

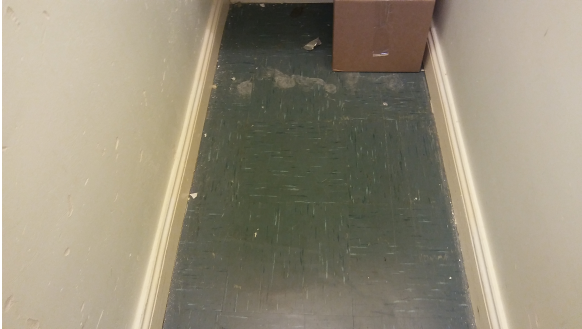
Item 31 Ref: As 416204-6

The floor covering in Rm 0/13b Store Windsor unit does not contain asbestos.

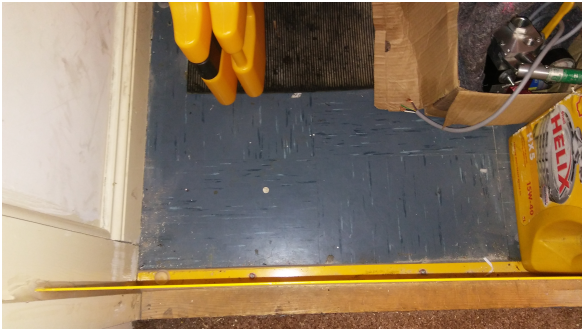
Item 32 Ref: As 416204-6

The floor covering in Rm 0/016 Lift machinery room Windsor unit does not contain asbestos.

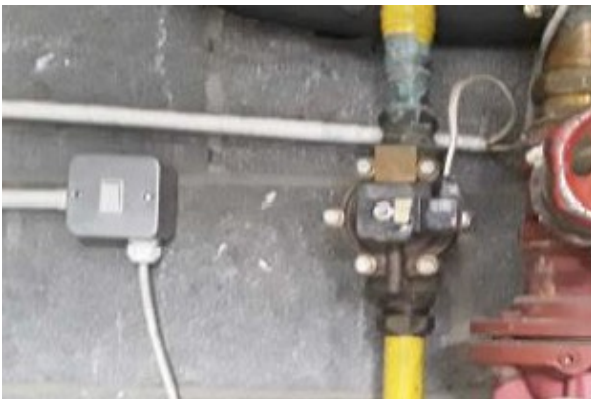
Item 33 Ref: 21-41127-1

The flange gaskets to the pipes in the Plant Room (Area 1) does not contain asbestos.

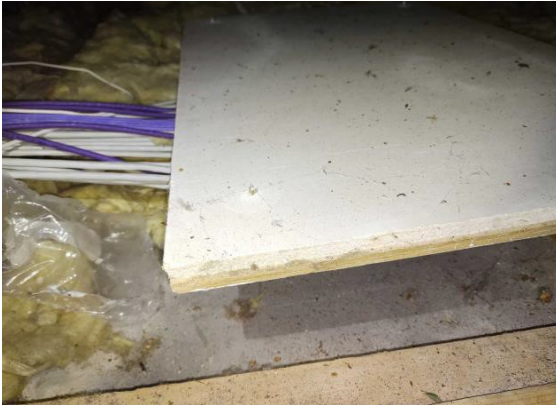
Item 34 Ref: 22-46328-1

The insulating board to access hatch (Loft Space 1/Area 2.001) does not contain asbestos.

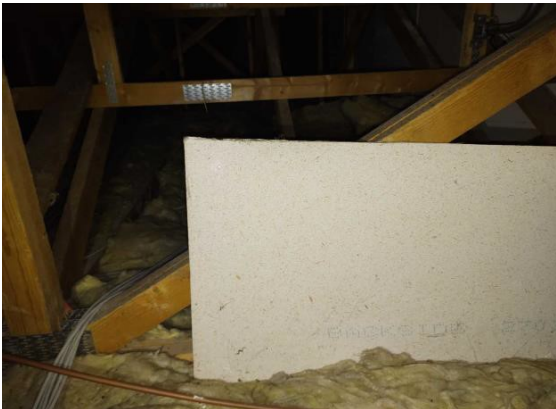
Item 35 Ref: 22-46328-1

The loose panel (Loft Space 1/Area 2.001) does not contain asbestos.

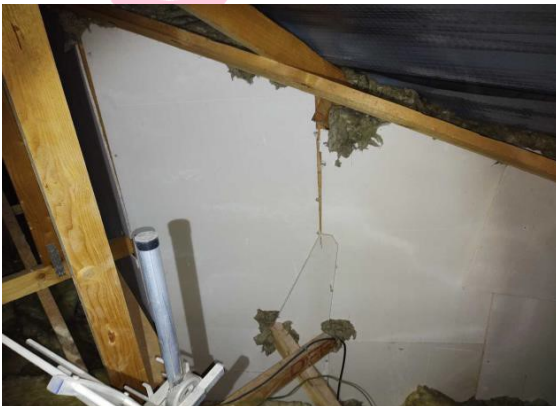
Item 36 Ref: 22-46328-1

The partition wall (Loft Space 1/Area 2.001) does not contain asbestos.

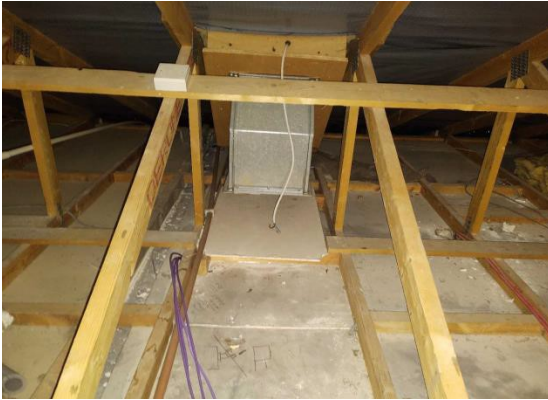
Item 37 Ref: 22-46328-1

The floor panel beneath duct work to roof (Loft Space 2/Area 2.002) does not contain asbestos.

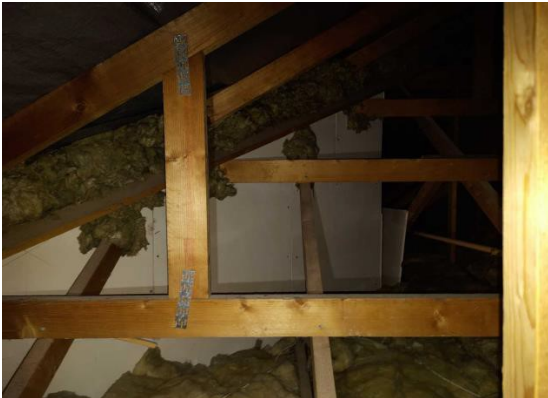
Item 38 Ref: 22-46328-1

The partition wall (Loft Space 3/Area 2.003) does not contain asbestos.

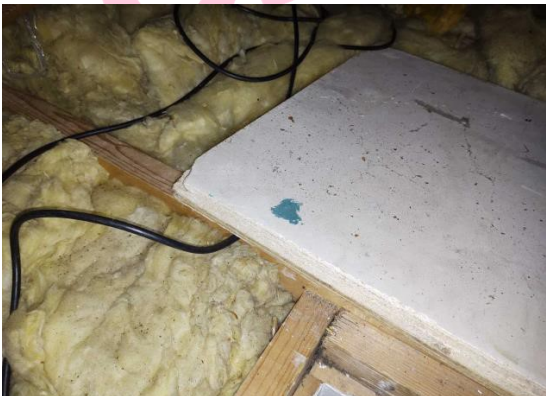
Item 39 Ref: 22-46328-1

The door (Loft Space 3/Area 2.003) does not contain asbestos.

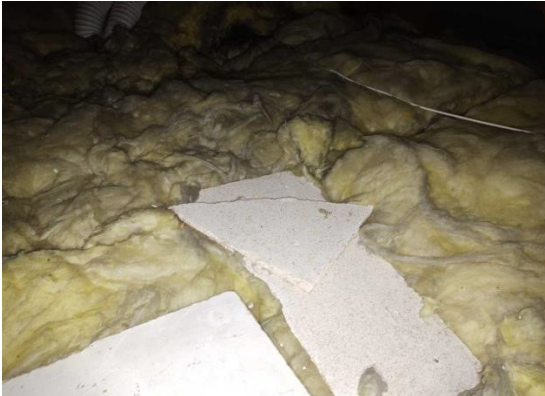
Item 40 Ref: 22-46328-1

The loose lying panels surrounding hatch (Loft Space 3/Area 2.003) does not contain asbestos.

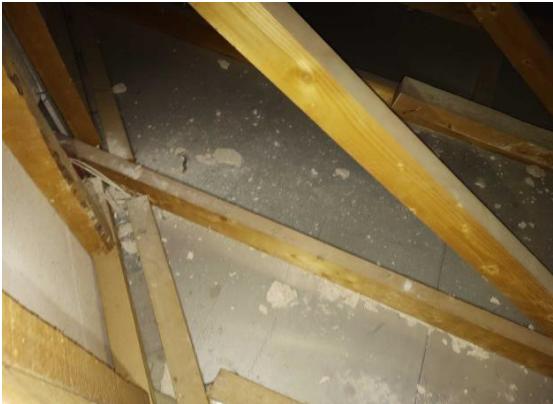
Item 41 Ref: 22-46328-2

The Insulating board debris to top side of ceiling (Stairwell/ Area 1.024a) does not contain asbestos.

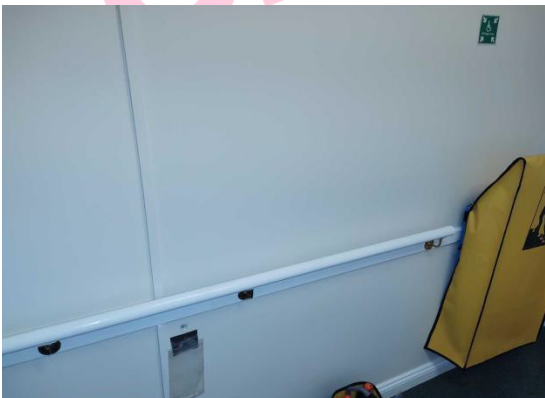
Item 42 Ref: 22-46328-3

The walls (Stairwell/Area 1.024a) does not contain asbestos.

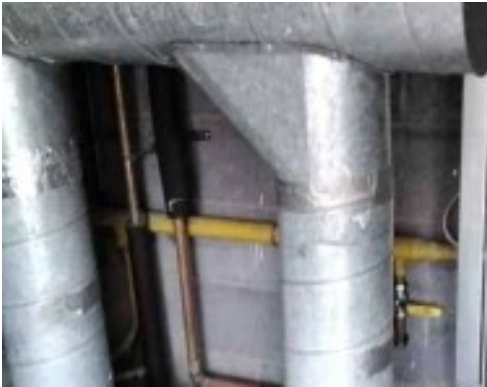
Item 43 Ref: SY000007

The flue pipe – sealant to flue/boiler in the boiler house (E/001) does not contain asbestos.

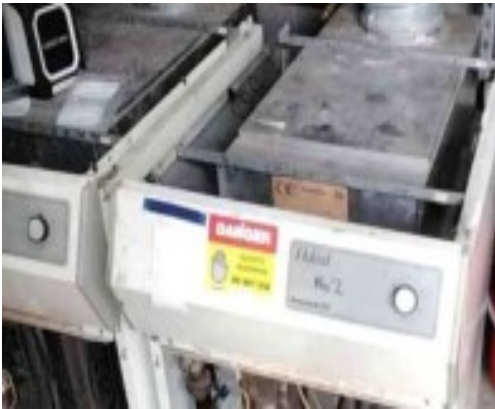
Item 44 Ref: SY000008

The boiler -seal gasket in the boiler house (E/001) does not contain asbestos.

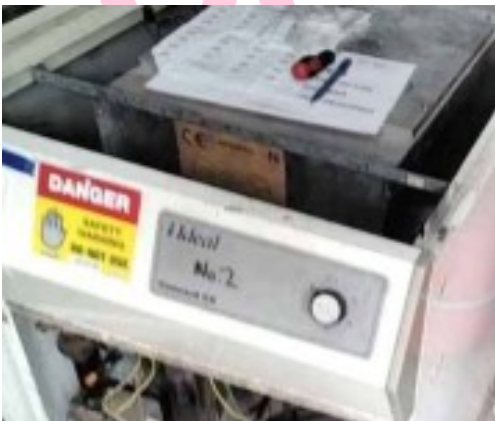
Item 45 Ref: SY000010

The boiler – lining/casing in the boiler house (E/001) does not contain asbestos.

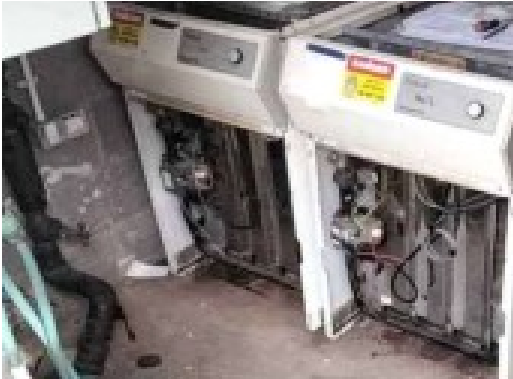
Item 46 Ref: SY000011

The debris/residue to the floor in the boiler house (E/001) does not contain asbestos.

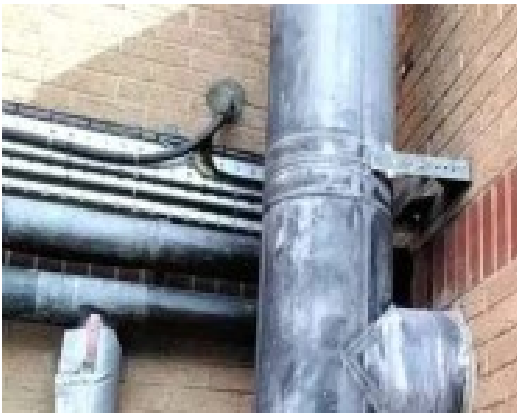
Item 47 Ref: SY000012

The flue pipe – sealant to flue/wall in the boiler house (E/001) does not contain asbestos.
