ASBESTOS SURVEY REPORT FOR FARMBOROUGH COURT, BRENTFORD AVENUE, SUNDERLAND, SR5 4EU.

Asbestos Register for

Farmborough Court, Brentford Avenue, Sunderland

Date: 01 July 2026

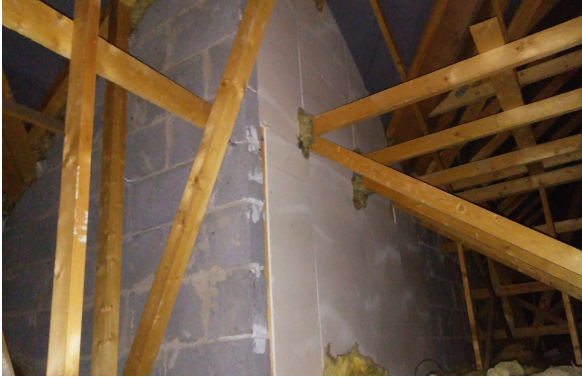
Item 1 Ref: As 416204-2

- (Item 1) Ref: As 416204-2 – Walls (2/001 Loft) – No Risk
- (Item 2) Ref: As 416204-3 – Rear of loft hatch (2/001 Loft) – No Risk
- (Item 3) Ref: As 416204-3 – Rear of loft hatch (2/002 Loft) – No Risk

The walls in Rm 2/001 Loft do not contain asbestos.

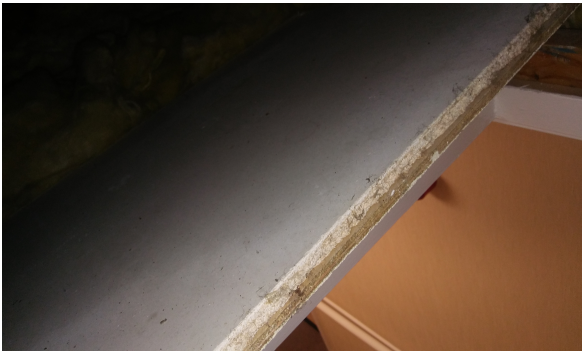
Item 2 Ref: As 416204-3

The rear of loft hatch in Rm 2/001 Loft does not contain asbestos.

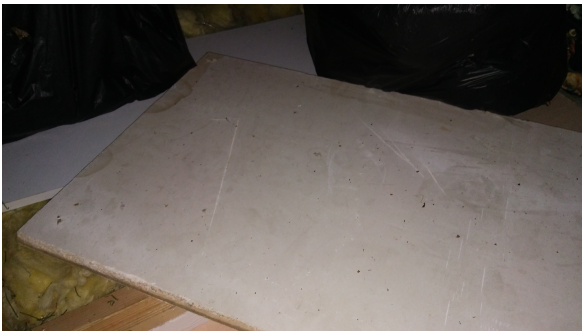
Item 3 Ref: As 416204-3

The rear of loft hatch in Rm 2/002 Loft does not contain asbestos.

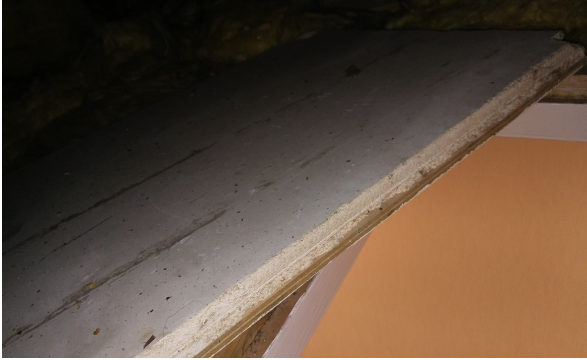
Item 4 Ref: As 416204-3

The rear of loft hatch in Rm 2/003 Loft does not contain asbestos.

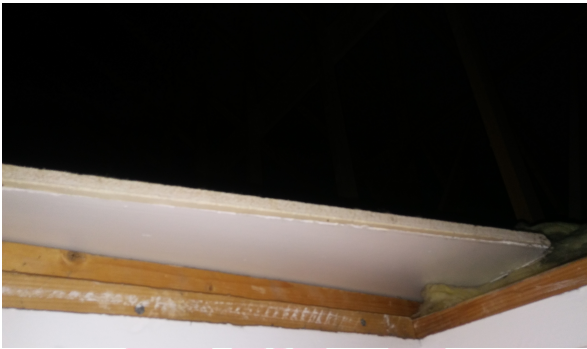
Item 5 Ref: As 416204-3

The loft hatch in Rm 2/004 Loft does not contain asbestos.

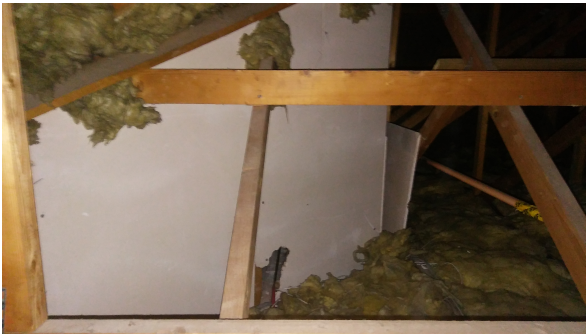
Item 6 Ref: 416204-2

The walls in Rm 2/005 Loft do not contain asbestos.

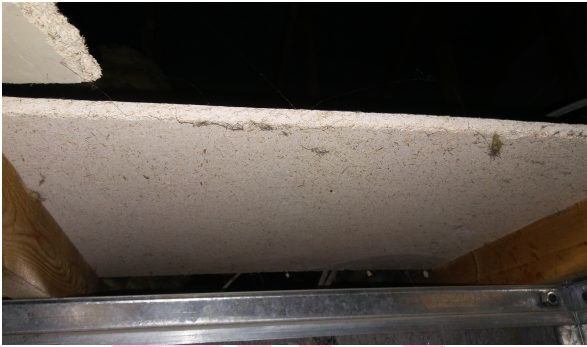
Item 8 Ref: As 416204-4

The ceiling to dumb waiter below in Rm 2/006 Loft does not contain asbestos.

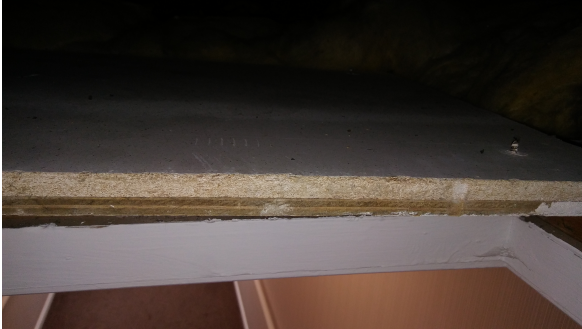
Item 10 Ref: 416204-3

The rear of loft hatch in Rm 2/008 Loft does not contain asbestos.

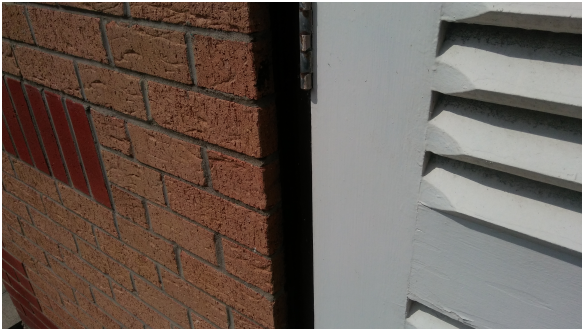
Item 11 Ref: 416204-11

The sealant to door frames (External) does not contain asbestos.

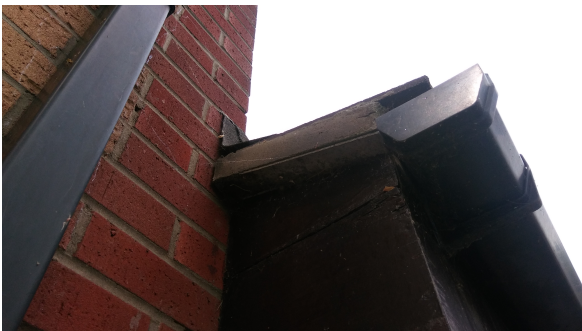
Item 12 Ref: As 416204-3

- (Item 10) Ref: As 416204-3 – Rear of loft hatch (2/008 Loft) – No Risk
- (Item 11) Ref: 416204-11 – Sealant to door frames (External) – No Risk
- (Item 12) Ref: 51416204-12 – Undercloak to lower level roofs (External) – Very Low Risk

The undercloak to lower level roofs (External) contain asbestos.

Item 10	No asbestos	Is present		
Item 11	No asbestos	Is present		
Item 12	Undercloak to lower level roofs (External)	Very Low Risk	12 monthly	03/07/2027
Item 13	No asbestos	Is present

Any change in its appearance should be recorded and passed to Property Services.

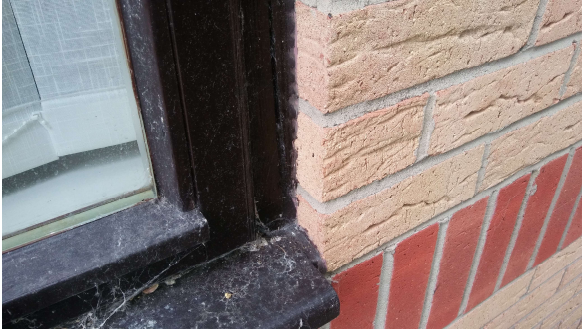
Item 13 Ref: 416204-13

The sealant to window frames (External) does not contain asbestos.

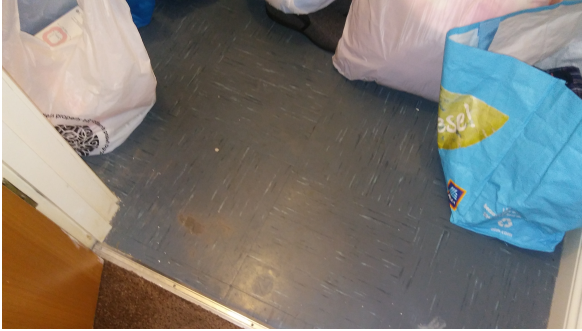
Item 16 Ref: 416204-9

The floor covering in Rm 0/69 Store Balmoral Unit does not contain asbestos.

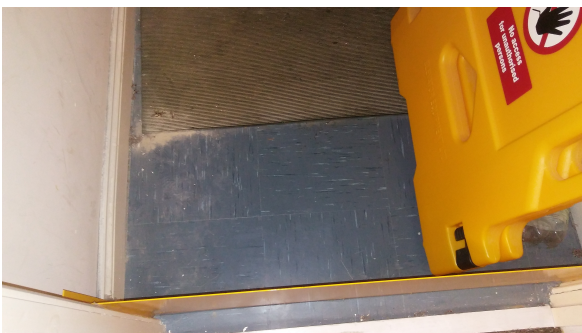
Item 18 Ref: As 416204-5

The floor covering in Rm 1/043 Lift machinery room Buckingham unit does not contain asbestos.

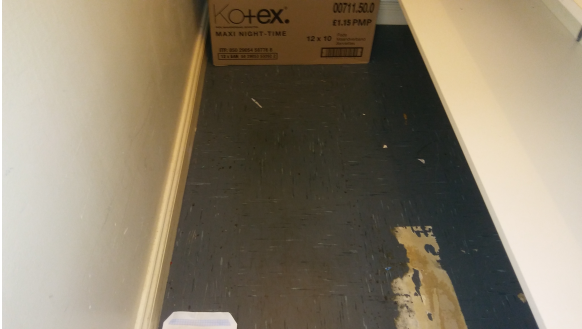
Item 19 Ref: As 416204-5

The floor covering in Rm 1/044 Store Buckingham unit does not contain asbestos.

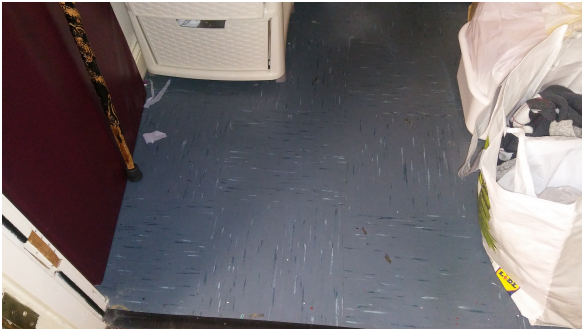
Item 20 Ref: 416204-5

The floor covering in Rm 1/048 Store Buckingham unit does not contain asbestos.

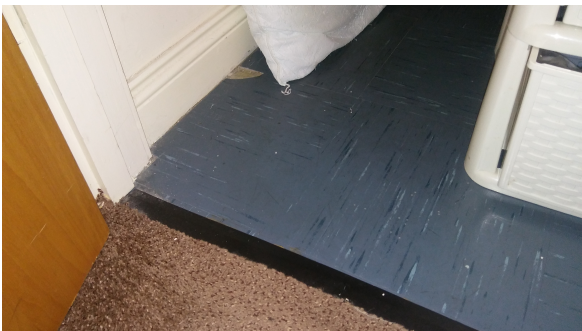
Item 21 Ref: 416204-1

The floor covering in Rm 1/014 Store Clarence unit does not contain asbestos.

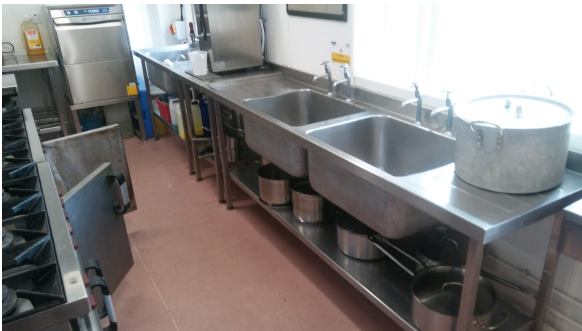
Item 23 Ref: 416204-7

The sink paint in Rm 0/043 kitchen Link 1 does not contain asbestos.

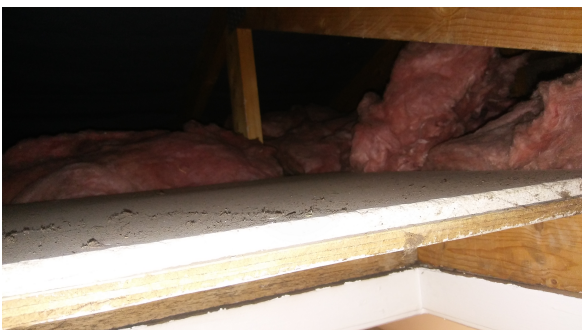
Item 24 Ref: 416204-8

The rear of access hatch in Rm 0/034a Cold store void above Link 1 does not contain asbestos.

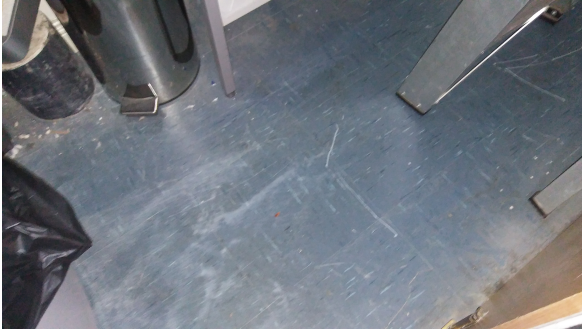
Item 25 Ref: As 416204-1

The floor covering in Rm 0/037 Switchroom Link 1 does not contain asbestos.

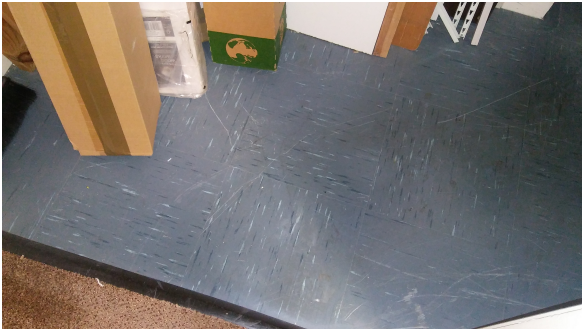
Item 26 Ref: As 416204-1

The floor covering in Rm 1/028 Office Link 2 does not contain asbestos.

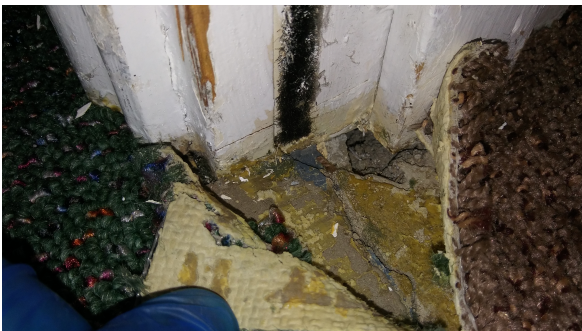
Item 27 Ref: As 416204-1

The floor covering in Rm 1/033 Store Link 2 does not contain asbestos.

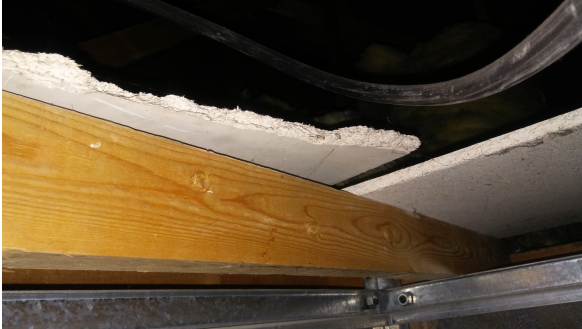
Item 28 Ref: 416204-4

The ceiling in Rm 1/068
Corridor dub waiter Link 2
does not contain asbestos.

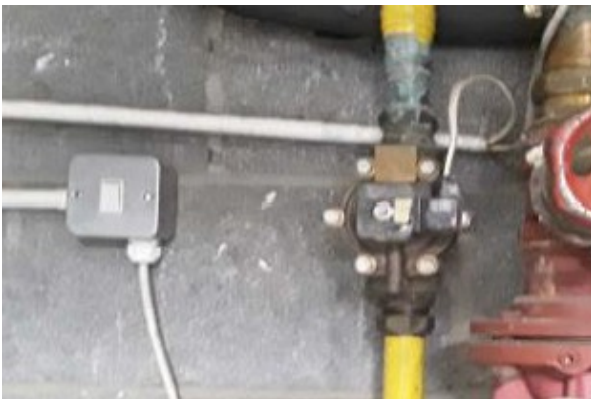
Item 33 Ref: 21-41127-1

The flange gaskets to the pipes in the Plant Room (Area 1) does not contain asbestos.

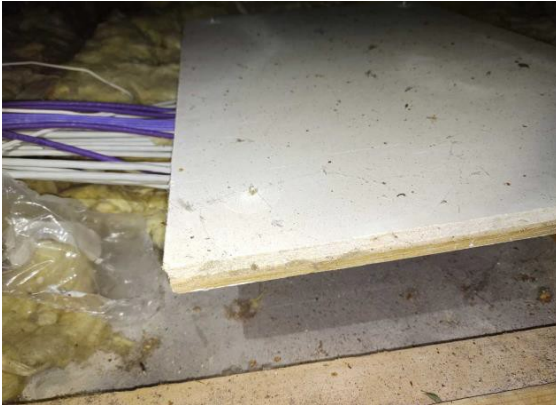
Item 34 Ref: 22-46328-1

The insulating board to access hatch (Loft Space 1/Area 2.001) does not contain asbestos.

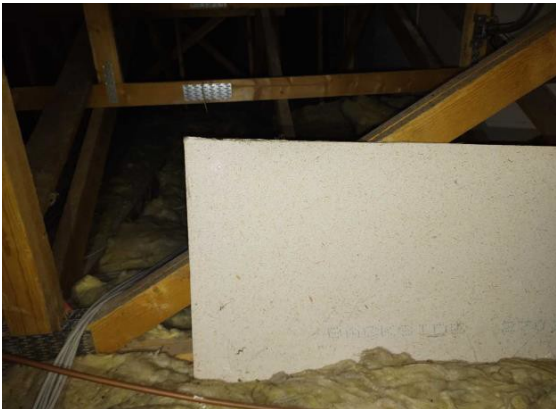
Item 35 Ref: 22-46328-1

The loose panel (Loft Space 1/Area 2.001) does not contain asbestos.

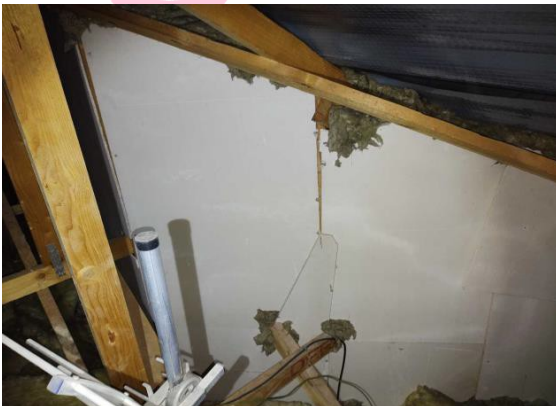
Item 36 Ref: 22-46328-1

The partition wall (Loft Space 1/Area 2.001) does not contain asbestos.

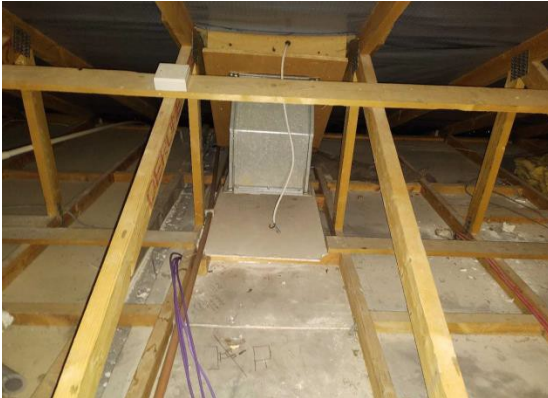
Item 37 Ref: 22-46328-1

The floor panel beneath duct work to roof (Loft Space 2/Area 2.002) does not contain asbestos.

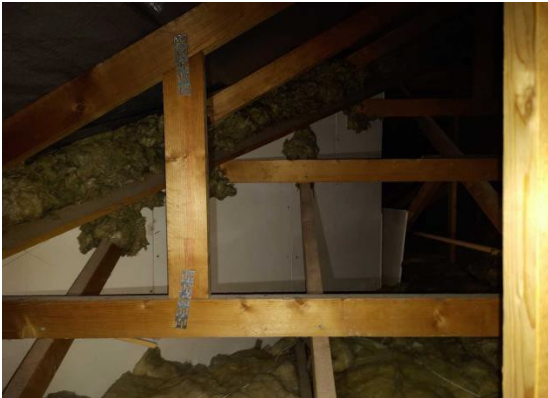
Item 38 Ref: 22-46328-1

The partition wall (Loft Space 3/Area 2.003) does not contain asbestos.

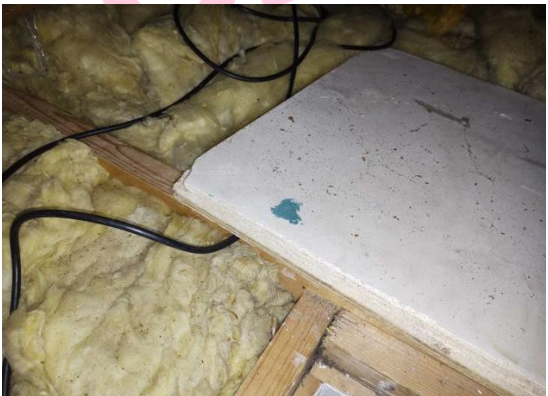
Item 39 Ref: 22-46328-1

The door (Loft Space 3/Area 2.003) does not contain asbestos.

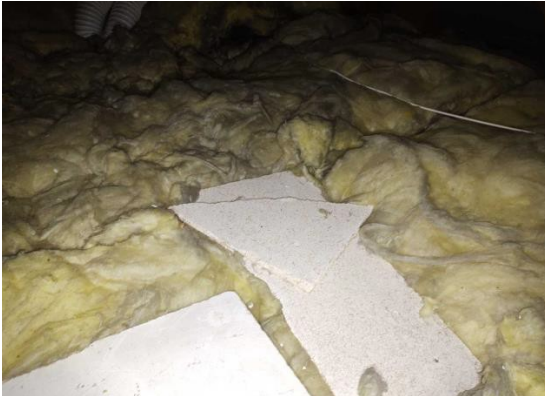
Item 40 Ref: 22-46328-1

The loose lying panels surrounding hatch (Loft Space 3/Area 2.003) does not contain asbestos.

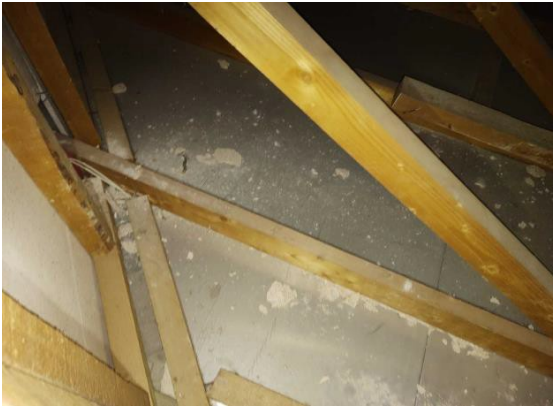
Item 41 Ref: 22-46328-2

The Insulating board debris to top side of ceiling (Stairwell/ Area 1.024a) does not contain asbestos.

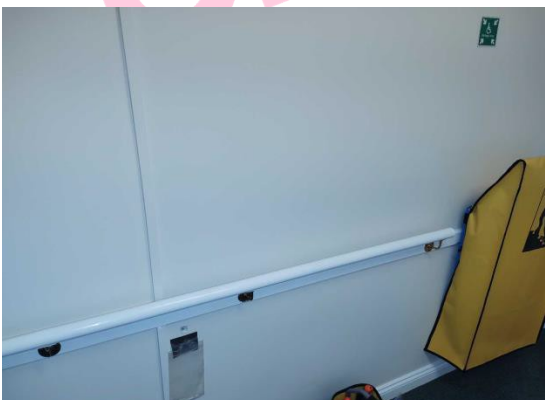
Item 42 Ref: 22-46328-3

The walls (Stairwell/Area 1.024a) does not contain asbestos.

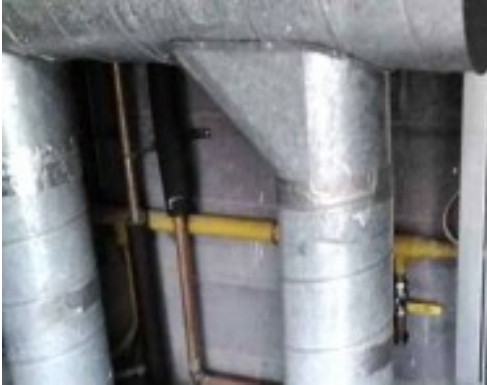
Item 43 Ref: SY000007

The flue pipe – sealant to flue/boiler in the boiler house (E/001) does not contain asbestos.

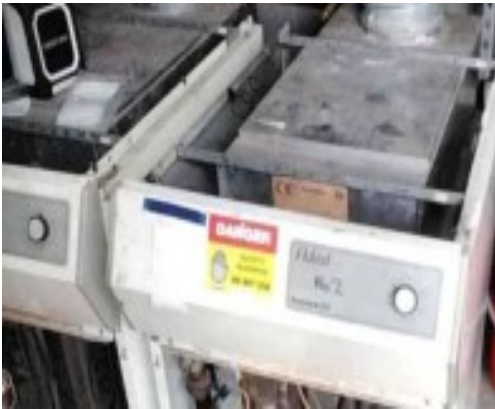
Item 44 Ref: SY000008

The boiler -seal gasket in the boiler house (E/001) does not contain asbestos.

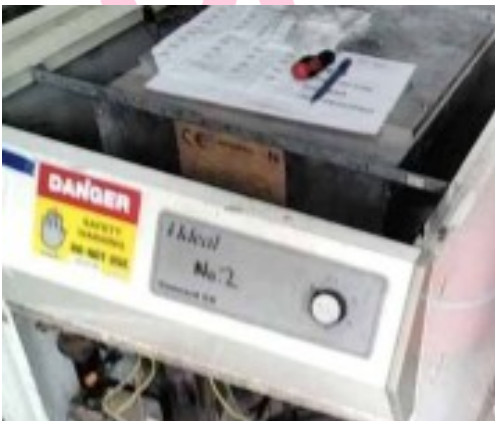
Item 45 Ref: SY000010

The boiler – lining/casing in the boiler house (E/001) does not contain asbestos.

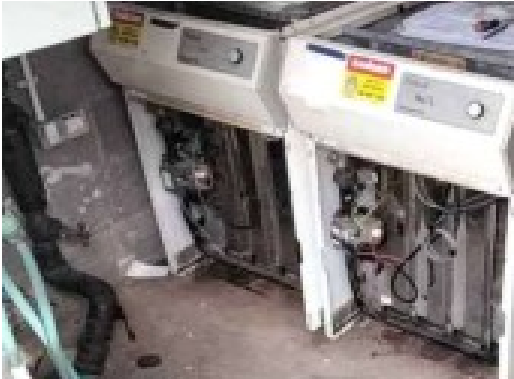
Item 46 Ref: SY000011

The debris/residue to the floor in the boiler house (E/001) does not contain asbestos.

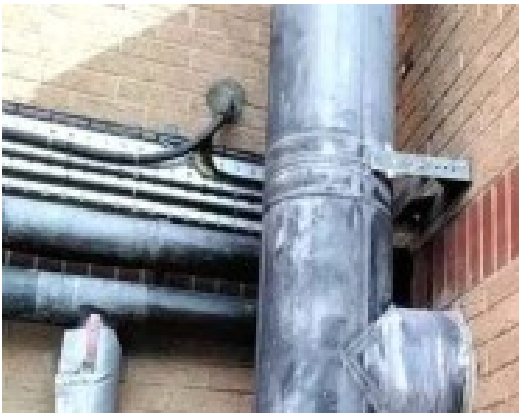
Item 47 Ref: SY000012

The flue pipe – sealant to flue/wall in the boiler house (E/001) does not contain asbestos.
