ASBESTOS SURVEY REPORT FOR WOODBINE TERRACE (SALT STORE),  
PALLION, SUNDERLAND, SR4 6TY.

## **Asbestos Register for Woodbine Terrace (Salt Store) Pallion, SR4 6TY**

**Date: 24 November 2022**

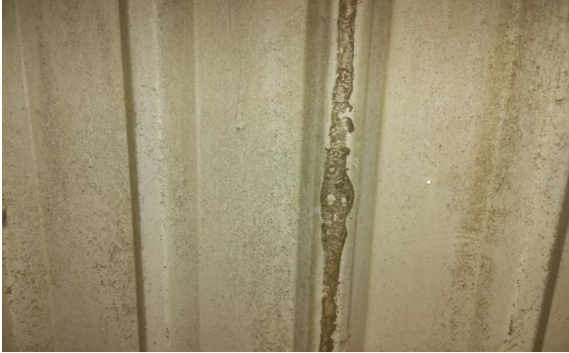
### **Item 1 Ref: 21-33486-1**

The residue to various metal sheet walls (mastic) in the warehouse does not contain asbestos.

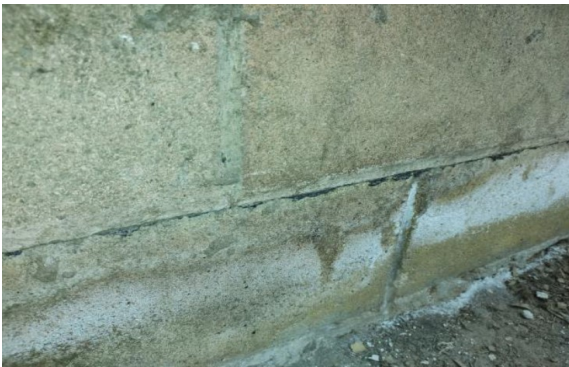
### **Item 2 Ref: 21-33486-2**

The damp proof course (bitumen) in the warehouse does not contain asbestos.

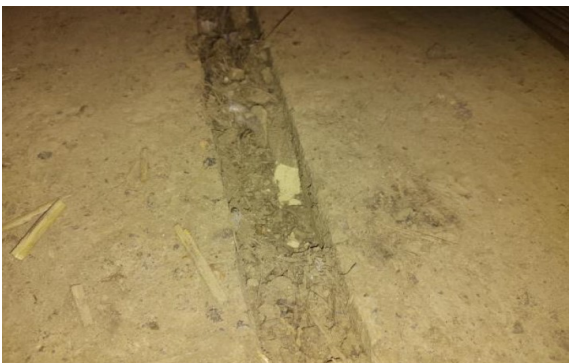
### **Item 3 Ref: 21-33486-3**

The compound between joints to the floor (cement) in the warehouse does not contain asbestos.

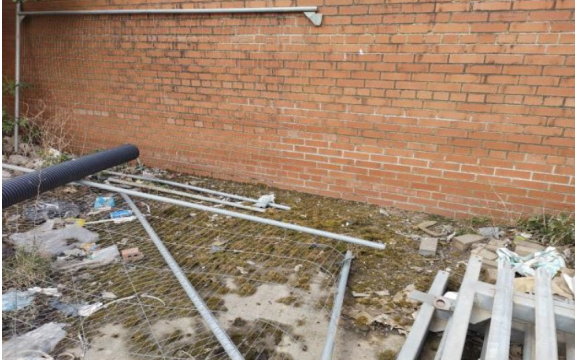
**Item 4 Ref: 21-33486-8**

The bitumen debris to floor along the wall (External) does not contain asbestos.

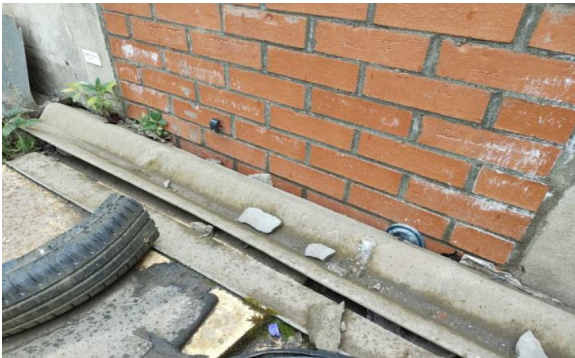
**Item 5 Ref: 21-33486-4**

The debris to floor (External) does not contain asbestos.

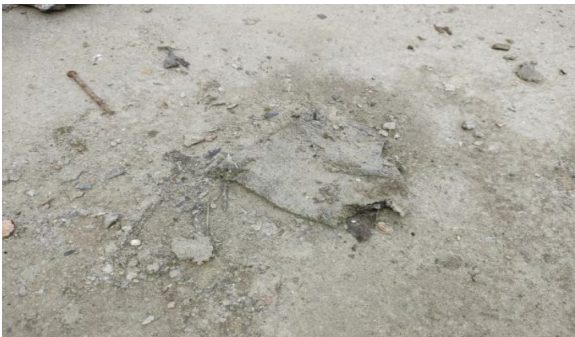
**Item 6 Ref: 21-33486-5**

The bitumen felt debris to the floor in the external store does not contain asbestos.

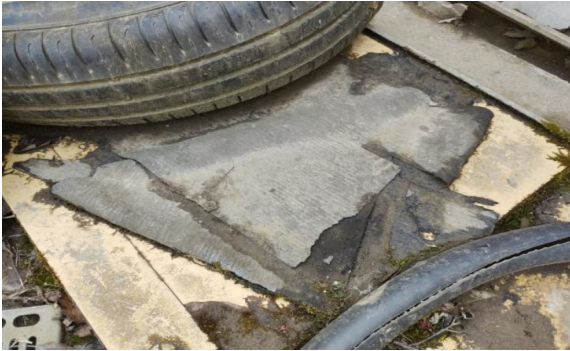
**Item 7 Ref: 21-33486-6**

The bitumen felt debris to the floor in the external store does not contain asbestos.

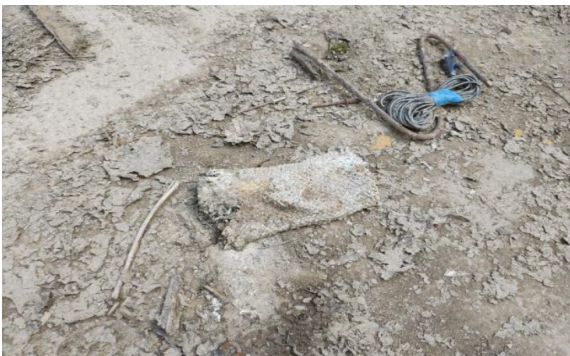
**Item 8 Ref: 21-33486-7**

The textile debris to the floor in the external store does contain asbestos.

Any change in its appearance should be recorded and passed to Property Services.

*Removed June 2021*
