ASBESTOS SURVEY REPORT FOR FORMER WARD BROS STEEL SITE, HAY STREET, SUNDERLAND

Asbestos Register for Former Ward Bros Steel Site, Hay Street, Sunderland

Premises Manager / Samo: - Tenant Date: 15 February 2023

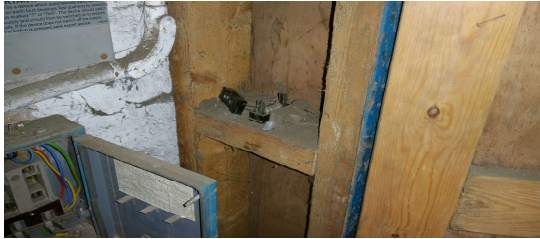
Item 1 Ref: 146686-1

The millboard to the work factory (Room 0/01) does not contain asbestos.

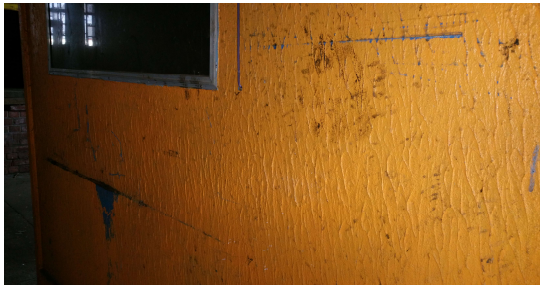
Item 2 Ref: 146686-2

The textured coating (Room 0/01) to the office and male WC does not contain asbestos

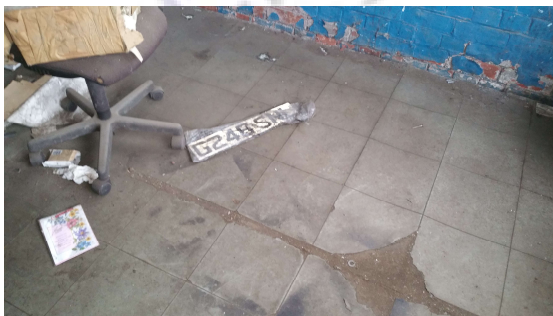
Item 3 Ref: 146686-3

The floor tile without bitumen adhesive in the Kitchen (Room 0/05) does not contain asbestos.

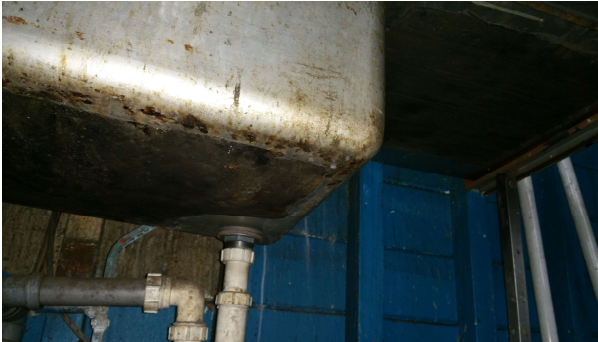
Item 4 Ref: 146686-4

The Sink Paint in the kitchen (Room 0/05) does not contain asbestos.

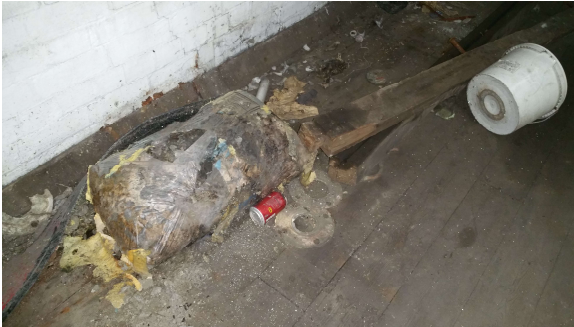
Item 5 Ref: 146686-5

Redundant gaskets to floor in Factory (Room 1/01) contained asbestos.

Removed January 2017.

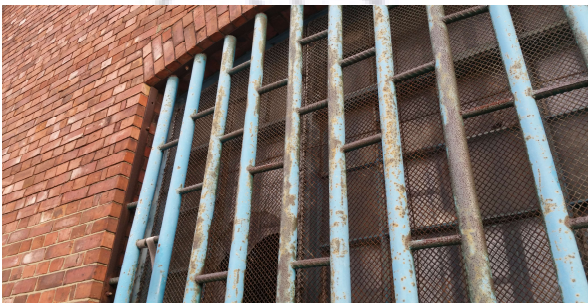
Item 6 Ref: 146686-6

The putty to windows - External (Room 9/999) do not contain asbestos.

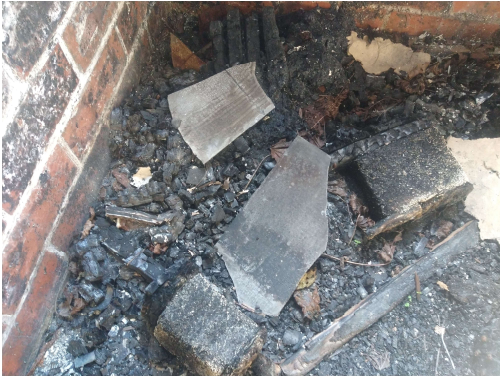
Item 7 Ref: As 481881-2

The debris to the floor in the outbuildings (Room 006) does not contain asbestos.

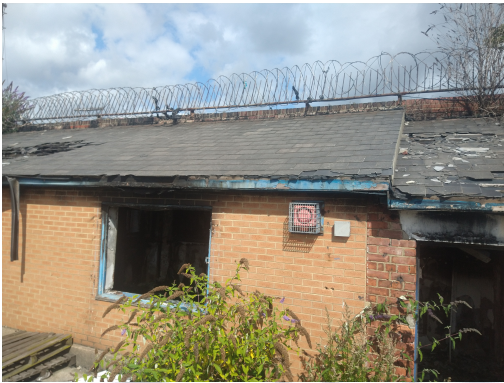
Item 8 Ref: As 481881-2

The roof tile to the outbuildings (External) do not contain asbestos.

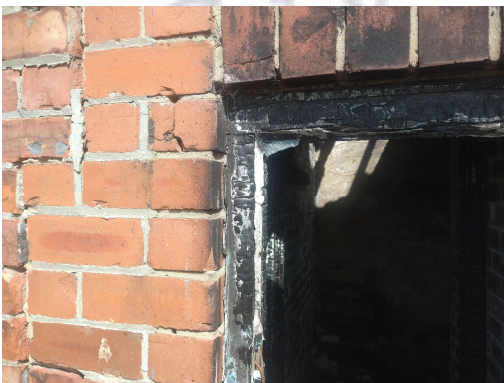
Item 9 Ref: 481881-3

The sealant to windows to the outbuildings (External) does contain asbestos.

Any change in appearance should be reported to Property Services.

Item 9	Sealant to windows (External/Outbuildings)	Very Low Risk	12 monthly	15/2/2024
Item 10	Pipe lagging (Room 0/001 Main Warehouse Space Shed)	Very Low Risk	12 monthly	15/2/2024
<i>Item 11</i>	<i>No asbestos</i>	<i>Is present</i>		
<i>Item 12</i>	<i>No asbestos</i>	<i>Is present</i>		
<i>Item 13</i>	<i>No asbestos</i>	<i>Is present</i>		
<i>Item 14</i>	<i>No asbestos</i>	<i>Is present</i>		
<i>Item 15</i>	<i>No asbestos</i>	<i>Is present</i>		
<i>Item 16</i>	<i>No asbestos</i>	<i>Is present</i>		
<i>Item 17</i>	<i>No asbestos</i>	<i>Is present</i>		
<i>Item 18</i>	<i>No asbestos</i>	<i>Is present</i>		
<i>Item 19</i>	<i>No asbestos</i>	<i>Is present</i>		
<i>Item 20</i>	<i>No asbestos</i>	<i>Is present</i>		
<i>Item 21</i>	<i>No asbestos</i>	<i>Is present</i>

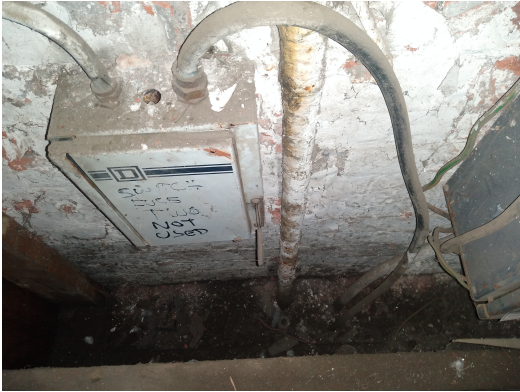
Item 10 Ref: Presumed

The pipe lagging in the main warehouse space (Shed) does contain asbestos.

Any change in appearance should be reported to Property Services.

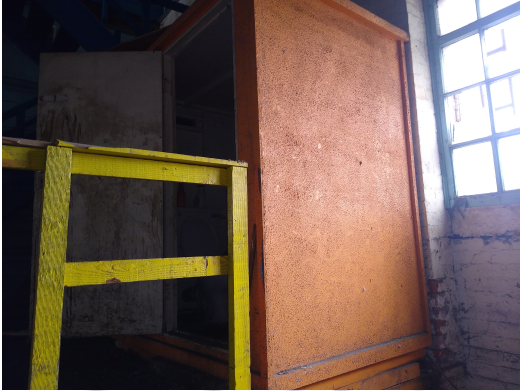
Item 11 Ref: 481881-8

The walls to cabin (toilet) in the main warehouse space (Shed) do not contain asbestos.

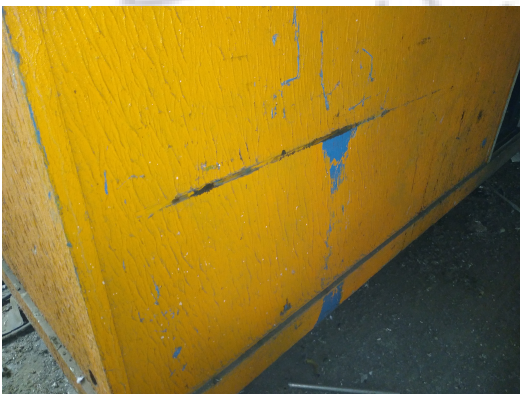
Item 12 Ref: 481881-9

The walls to cabin (toilet) in the main warehouse space (Shed) do not contain asbestos.

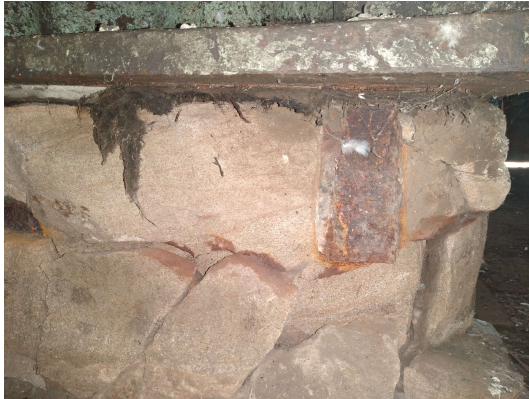
Item 13 Ref: 481881-10

The damp proof course to columns base in the main warehouse space (Shed) do not contain asbestos.

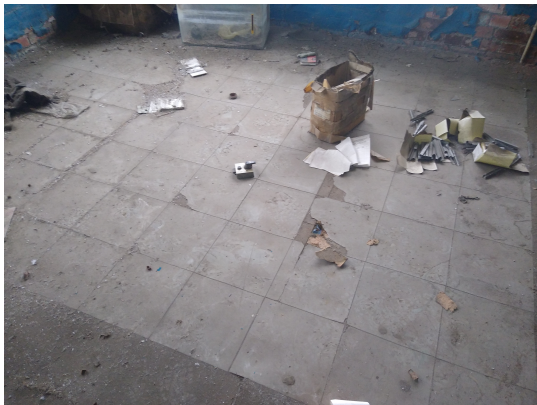
Item 14 Ref: 481881-5

The floor covering in the office (Shed) does not contain asbestos.

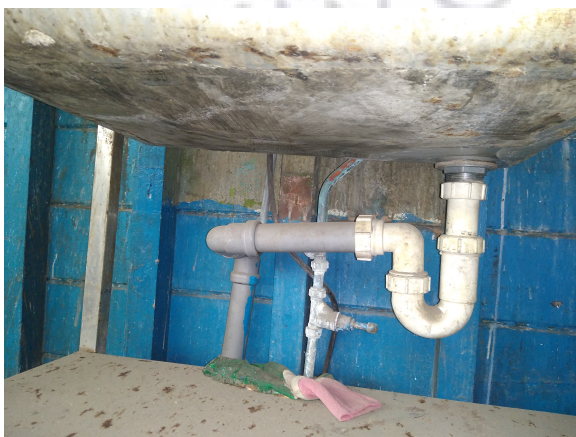
Item 15 Ref: 481881-6

The sink paint in the office (Shed) does not contain asbestos.

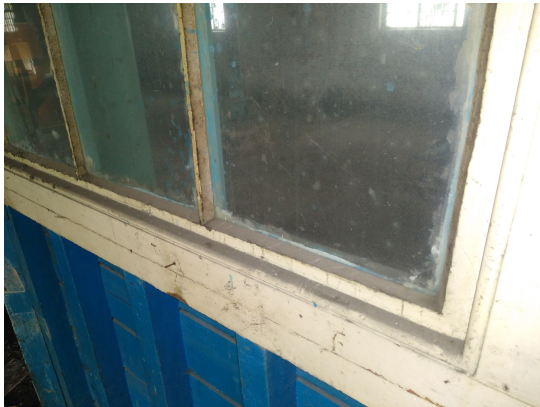
Item 16 Ref: As 481881-4

The window frame in the office (Shed) does not contain asbestos.

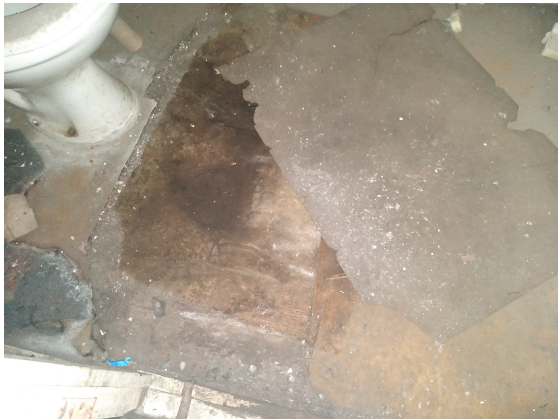
Item 17 Ref: 481881-7

The floor covering in the toilet (Shed) does not contain asbestos.

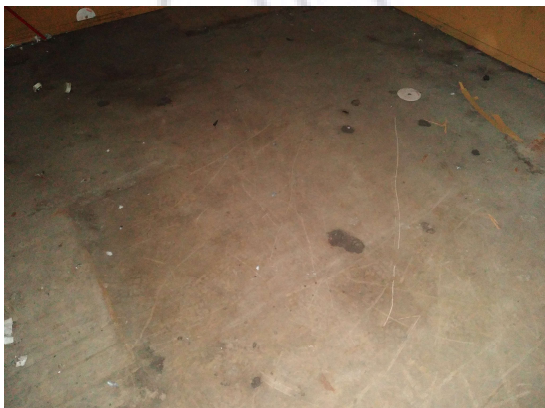
Item 18 Ref: As 481881-7

The floor covering in the toilet (Shed) does not contain asbestos.

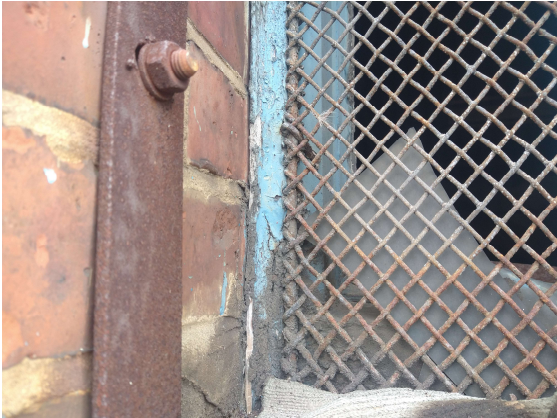
Item 19 Ref: 481881-4

The sealant to windows frames to the shed (External) does not contain asbestos.

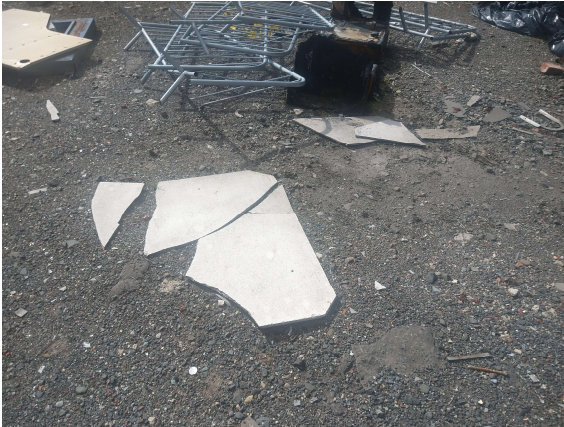
Item 20 Ref: 481881-1

The debris to the floor (external) does not contain asbestos.

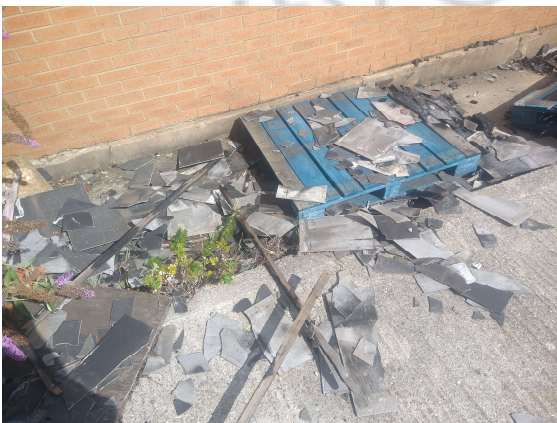
Item 21 Ref: 481881-2

The debris to the floor adjacent to outbuildings (External) does not contain asbestos.
