ASBESTOS SURVEY REPORT FOR CABLE HOUSE (EVENT STORE) GREENWELLS QUAY, SUNDERLAND

Asbestos Register for

**CABLE HOUSE (EVENT STORE) GREENWELLS QUAY,
SUNDERLAND**

Date: 08 May 2025

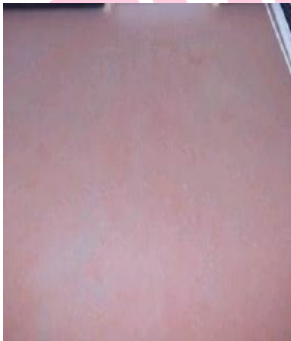
Item 1 - Ref: VP002062

The red vinyl flooring in the corridor on the 1st Floor (Room 1) does not contain asbestos.

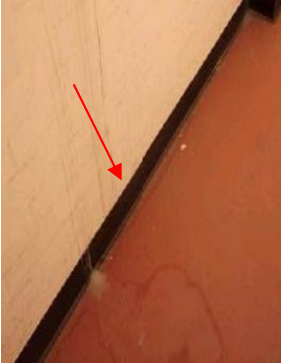
Item 5 – As VP002063

The black skirting to the base of the wall to the corridor on the 1st floor (Room 2) does not contain asbestos.

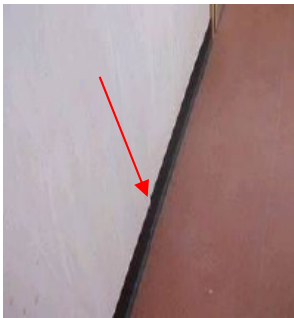
Item 8 – As VP002063

The black skirting to the base of the wall in the WC on the 1st Floor (Room 3) does not contain asbestos.

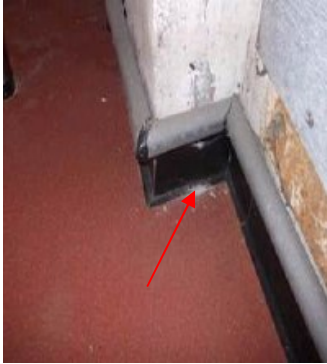
Item 12 – As VP002063

The black skirting to the base of the wall in the kitchen on the 1st Floor (Room 4) does not contain asbestos.

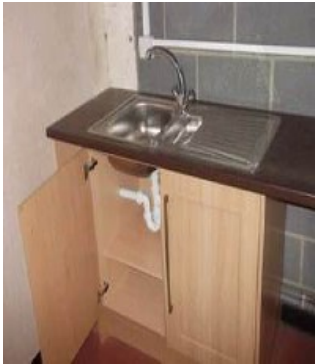
Item 13 – Ref: VP002066

The sink pads to the kitchen on the 1st Floor (Room 4) do not contain asbestos.

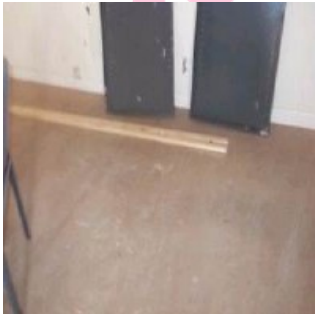
Item 14 – Ref: VP002067

The tan vinyl flooring to the office on the 1st Floor (Room 5) do not contain asbestos.

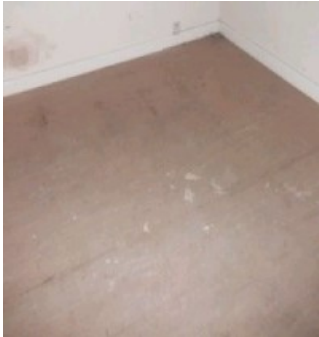
Item 15 – As VP002067

The tan vinyl flooring to the office on the 1st Floor (Room 6) does not contain asbestos.

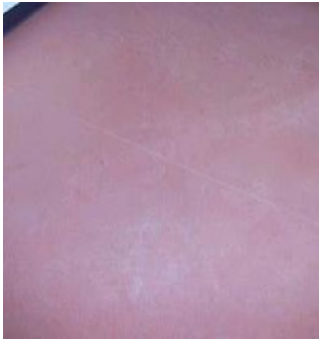
Item 16 – As VP002062

The red vinyl flooring to the office on the 1st Floor (Room 7) does not contain asbestos.

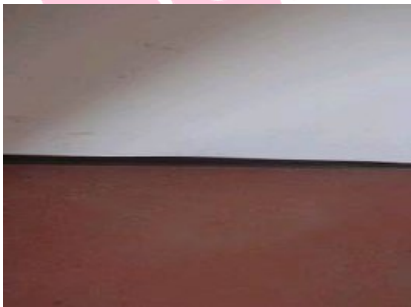
Item 17 – As VP002063

The black skirting to the base of the wall in the office on the 1st Floor (Room 7) does not contain asbestos.

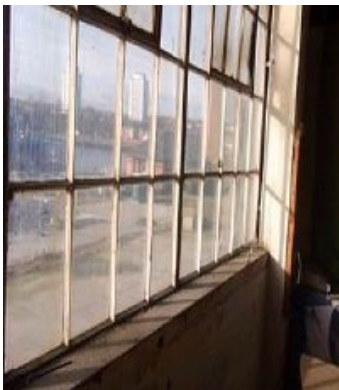
Item 18 – As VP002067

The window putty to the window in the store (Room 8) does not contain asbestos.

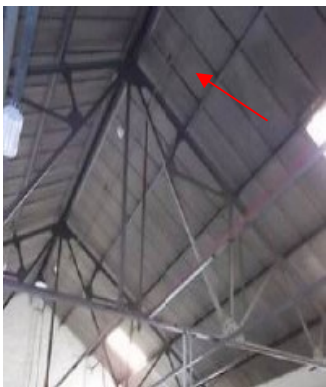
Item 19 – Ref: VP002069

The profiled cement sheets to the underside of the roof of the store on the 1st Floor contain asbestos. Any change in its appearance needs to be noted and details sent to Property Services.

<i>Item 18</i>	<i>No asbestos</i>	<i>Is present</i>		
Item 19	Roof (Internal)	Very Low	12 Monthly	03.10.2025
Item 20	Damp Proof course (External)	Very Low	12 Monthly	03.10.2025
<i>Item 21</i>	<i>No asbestos</i>	<i>Is present</i>		
<i>Item 22</i>	<i>No asbestos</i>	<i>Is present</i>		
<i>Item 23</i>	<i>No asbestos</i>	<i>Is present</i>

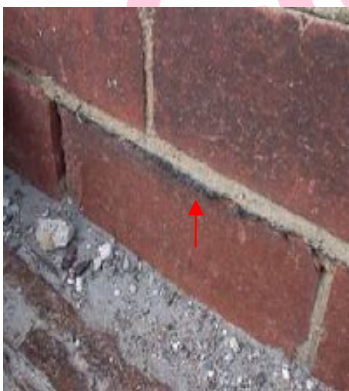
Item 20 – Ref: VP002070

The damp proof course to the external of the building contains asbestos. Any change in its appearance needs to be noted and details sent to Property Services.

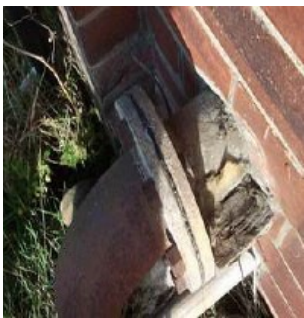
Item 22 – Ref: VP002072

The gasket to the pipe to the external does not contain asbestos.

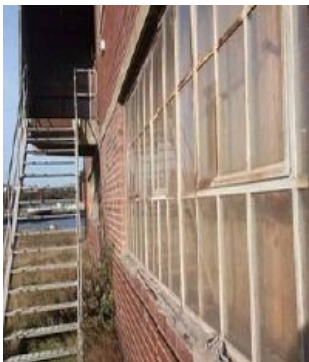
Item 23 – Ref: VP002073

The window putty to the external windows does not contain asbestos.

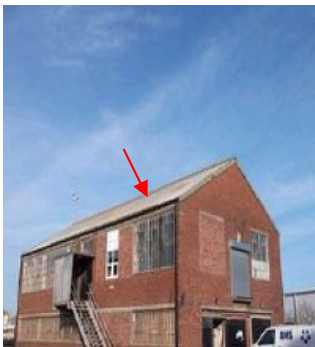
Item 24 – Ref: VP002073

The cement roof to the external of the building contains asbestos. Any change in its appearance needs to be noted and details passed to Property Services.

Item 24	Cement roof - (External)	Very Low	12 Monthly	03.10.2025
<i>Item 25</i>	<i>Windows Frame sealant (External)</i>	<i>Very Low</i>	<i>Removed</i>	<i>July 2021</i>

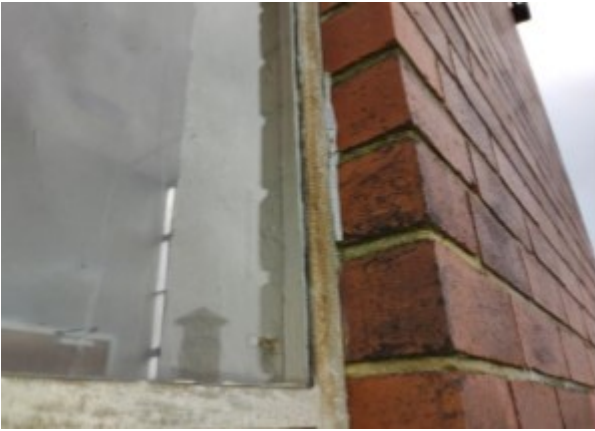
Item 25 – Ref: 21-29965-10

The brickwork to the windows has frame sealant (External) which contain asbestos.

Removed July 2021

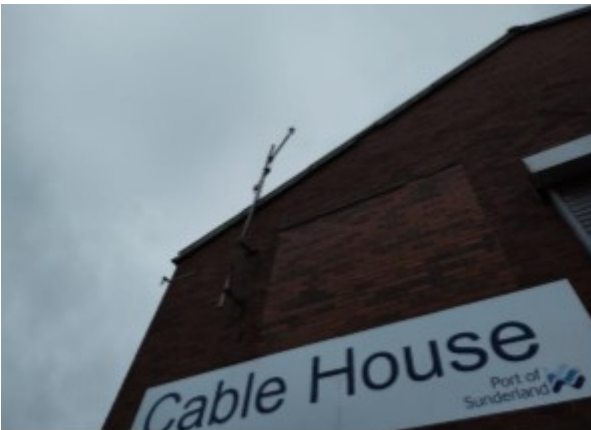
Item 26 – Ref: 21-29965-6

The barge boards to gables (External) contain asbestos.

Item 26	Barge boards to gable (External)	Very Low	12 Monthly	12.02.2025

Any change in its appearance needs to be noted and details sent to Property Services.
