### **ASBESTOS SURVEY REPORT FOR CABLE HOUSE (EVENT STORE) GREENWELLS QUAY, SUNDERLAND**

**Asbestos Register for  
CABLE HOUSE (EVENT STORE) GREENWELLS QUAY,  
SUNDERLAND**

**Premises Manager / Samo: - Tenant      Date: 02 February 2023**

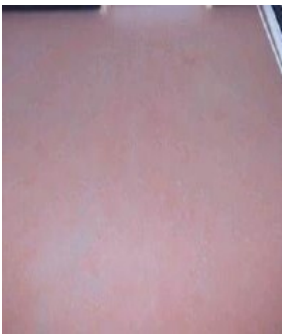
### **Item 1 - Ref: VP002062**

The red vinyl flooring to the corridor on the 1<sup>st</sup> Floor (Room 1) does not contain asbestos.

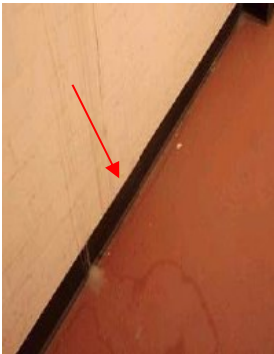
**Item 5 – As VP002063**

The black skirting to the base of the wall to the corridor on the 1<sup>st</sup> floor (Room 2) does not contain asbestos.

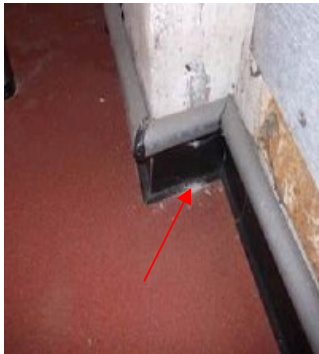
**Item 12 – As VP002063**

The black skirting to the base of the wall in the kitchen on the 1<sup>st</sup> Floor (Room 4) does not contain asbestos.

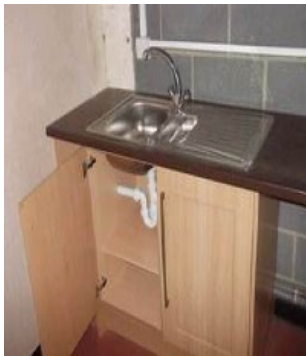
**Item 13 – Ref: VP002066**

The sink pads to the kitchen on the 1<sup>st</sup> Floor (Room 4) do not contain asbestos.

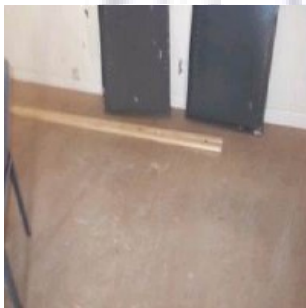
**Item 14 – Ref: VP002067**

The tan vinyl flooring to the office on the 1<sup>st</sup> Floor (Room 5) do not contain asbestos.

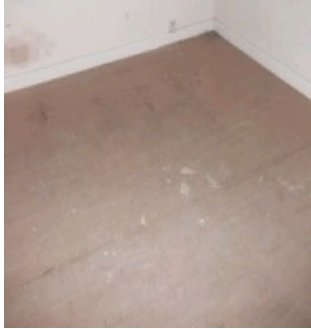
**Item 15 – As VP002067**

The tan vinyl flooring to the office on the 1<sup>st</sup> Floor (Room 6) does not contain asbestos.

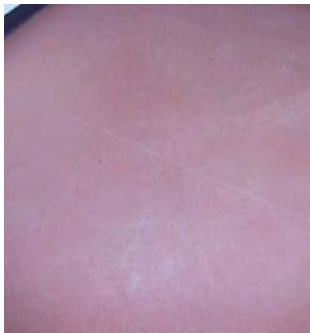
**Item 16 – As VP002062**

The red vinyl flooring to the office on the 1<sup>st</sup> Floor (Room 7) does not contain asbestos.

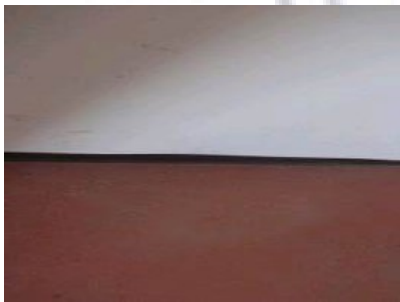
**Item 17 – As VP002063**

The black skirting to the base of the wall in the office on the 1<sup>st</sup> Floor (Room 7) does not contain asbestos.

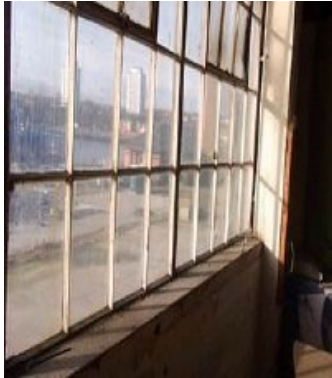
#### **Item 18 – As VP002067**

The window putty to the window in the store (Room 8) does not contain asbestos.

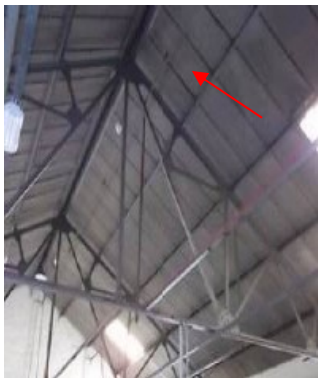
#### **Item 19 – Ref: VP002069**

The profiled cement sheets to the underside of the roof of the store on the 1<sup>st</sup> Floor contain asbestos. Any change in its appearance needs to be noted and details sent to Property Services.

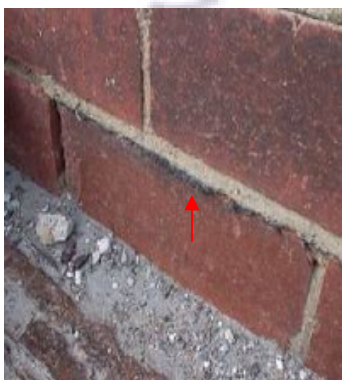
#### **Item 20 – Ref: VP002070**

The damp proof course to the external of the building contains asbestos. Any change in its appearance needs to be noted and details sent to Property Services.

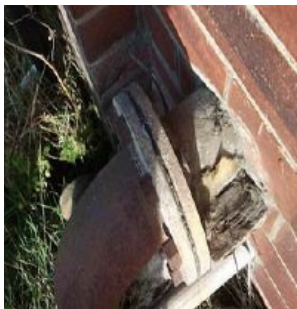
**Item 22 – Ref: VP002072**

The gasket to the pipe to the external does not contain asbestos.

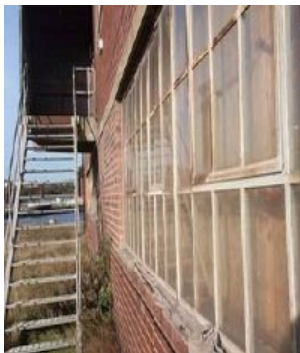
**Item 23 – Ref: VP002073**

The window putty to the external windows does not contain asbestos.

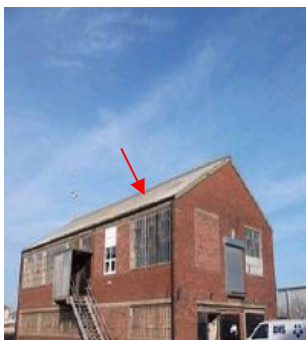
**Item 24 – Ref: VP002073**

The cement roof to the external of the building contains asbestos. Any change in its appearance needs to be noted and details passed to Property Services.

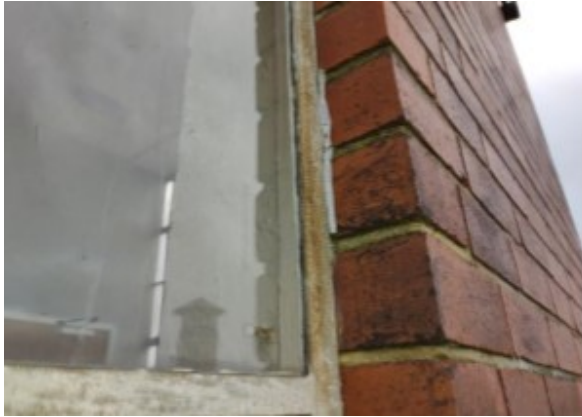
**Item 25 – Ref: 21-29965-10**

The brickwork to the windows has frame sealant (External) which contain asbestos.

*Removed July 2021*

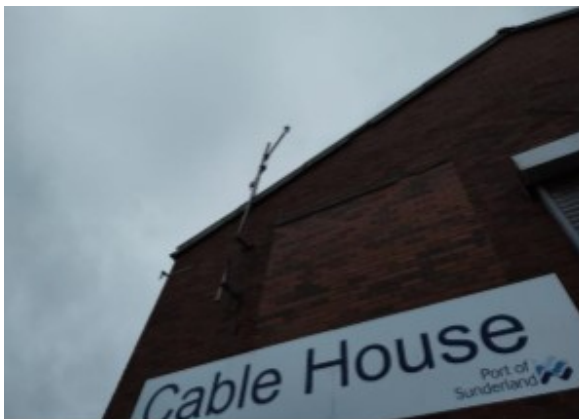
**Item 26 – Ref: 21-29965-6**

The barge boards to gables (External) contain asbestos.

Any change in its appearance needs to be noted and details sent to Property Services.
