ASBESTOS SURVEY REPORT FOR ENDURANCE WAREHOUSE, NORTH MOOR STREET, SUNDERLAND, SR1 2BQ

Asbestos Register for

**ENDURANCE HOUSE AND WAREHOUSE, NORTH
MOOR STREET,
SUNDERLAND, SR1 2BQ**

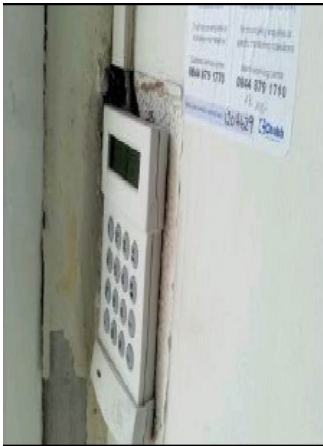
Item 4 - Ref: EA001526

The textured coating to walls to the entrance lobby (Room 1) does not contain asbestos.

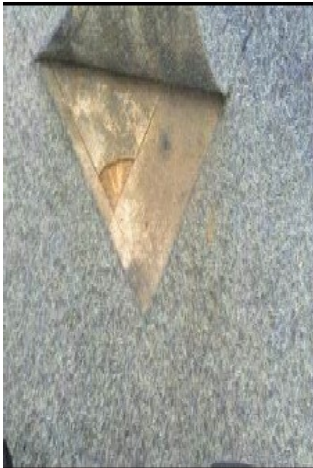
Item 5 - Ref: EA001487

The vinyl floor tiles to office 1 (Room 2) do not contain asbestos.

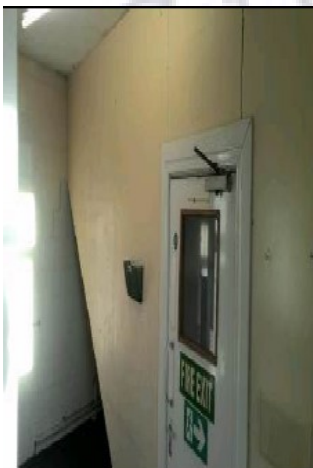
Item 6 - Ref: EA001488

The cladding boards to staircase and wall in office (Room 2) do not contain asbestos.

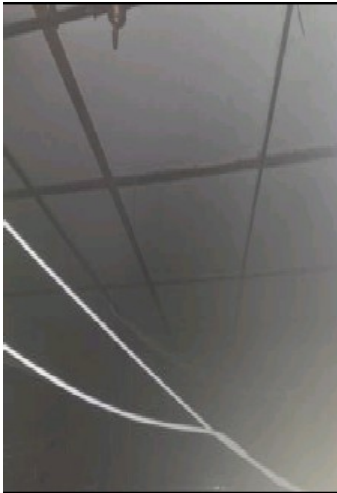
Item 7 - Ref: EA001489

The Paper lined fibreboard ceiling to office 1 (Room 2) contains asbestos.

Any change in its appearance should be recorded, and passed to Property Services.

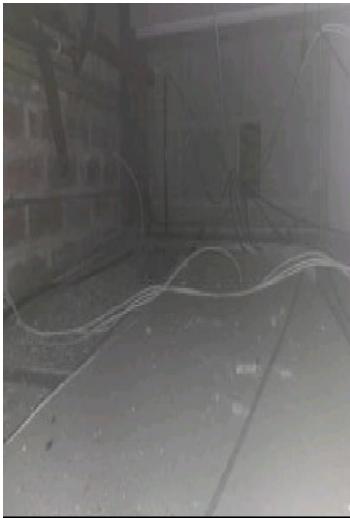
Item 8 - Ref: EA001490

The debris to ceiling tiles tops - Office 1 (Room 2) does not contain asbestos.

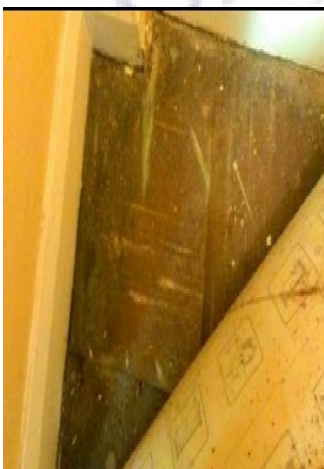
Item 9 - Ref: EA001491

The vinyl floor tiles to the Lobby /stairs (Room 3) do not contain asbestos.

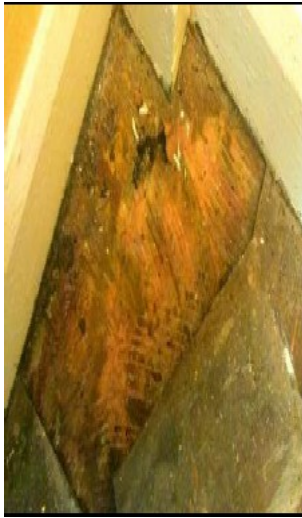
Item 10 - Ref: EA001492

The bitumen adhesive below cement skim to the lobby /stairs (Room 3) does not contain asbestos.

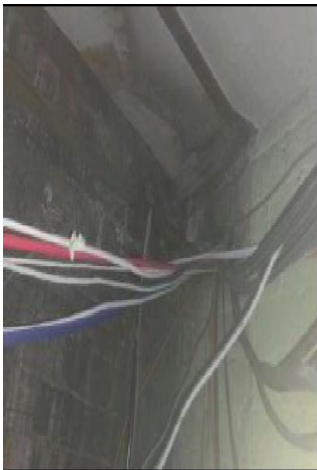
Item 11 - Ref: As EA001489

The Paper lined fibreboard ceiling to the lobby/stairs (Room 3) contains asbestos.

Any change in its appearance should be recorded, and passed to Property Services.

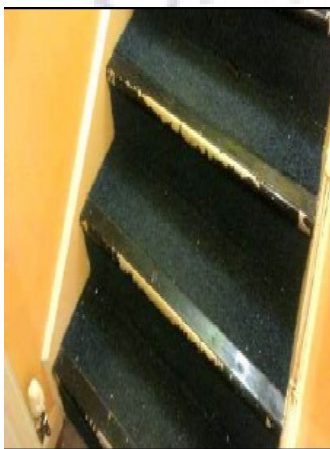
Item 12 - Ref: EA001493

The stair nosing to the lobby/stairs (Room 3) does not contain asbestos.

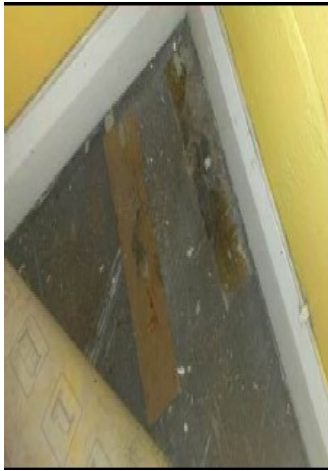
Item 13 - Ref: As EA001491

The vinyl floor tiles to the circulation area (Room 4) do not contain asbestos.

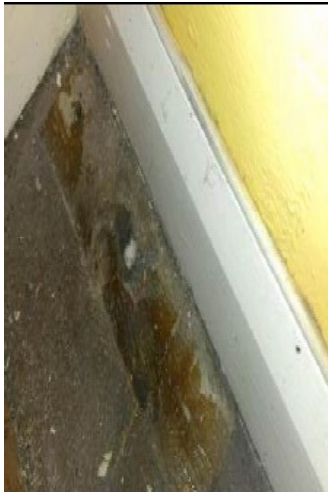
Item 14 - Ref: As EA001492

The bitumen adhesive below cement skim to the circulation area (Room 4) does not contain asbestos.

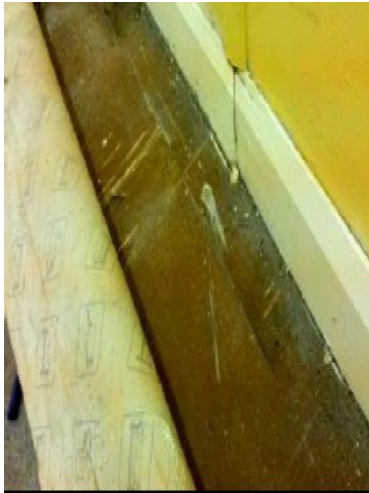
Item 16 - Ref: As EA001491

The vinyl floor tiles to the corridor (Room 5) do not contain asbestos.

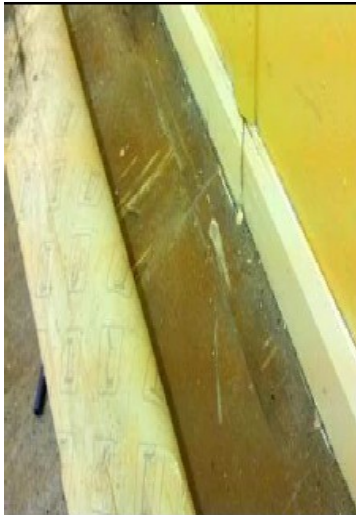
Item 17 - Ref: As EA001492

The bitumen adhesive below cement skim to the corridor (Room 5) does not contain asbestos.

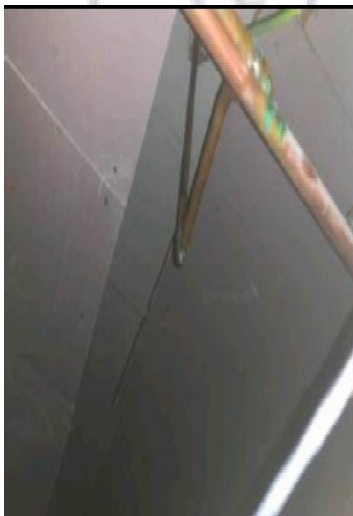
Item 18 - Ref: As EA001489

The Paper lined fibreboard ceiling to the corridor (Room 5) contains asbestos.

Any change in its appearance should be recorded, and passed to Property Services.

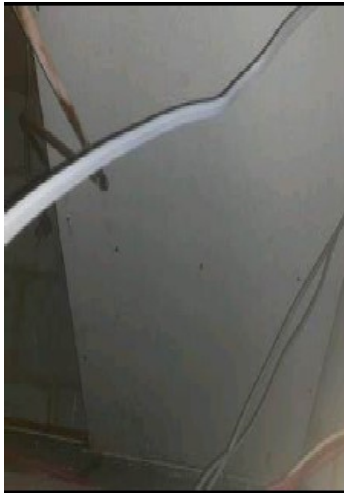
Item 19 - Ref: EA001494

The panels to the bottom on staircase of the corridor (Room 5) do not contain asbestos.

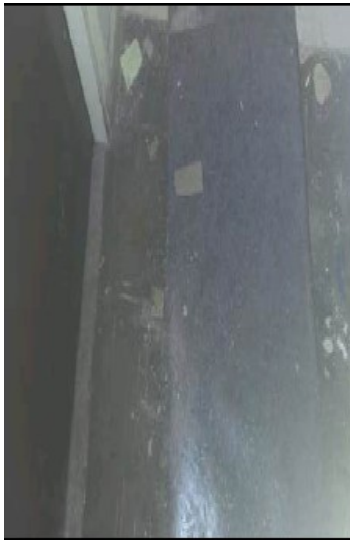
Item 20 - Ref: As EA001491

The vinyl floor tiles to the upstairs cupboard (Room 6) do not contain asbestos.

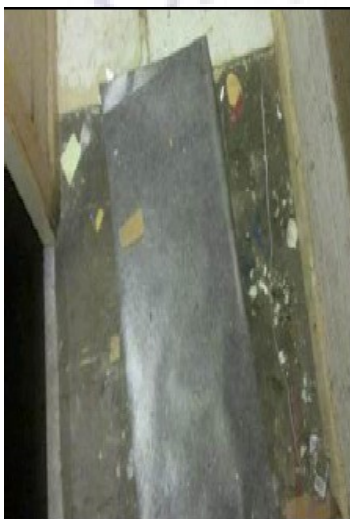
Item 21 - Ref: As EA001492

The bitumen adhesive below cement skim to the upstairs cupboard (Room 6) does not contain asbestos.

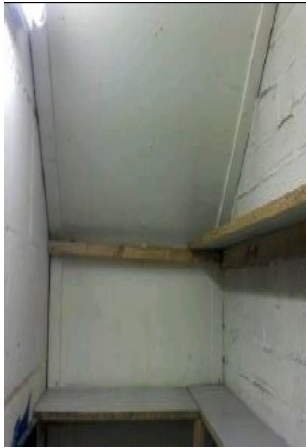
Item 22 - Ref: As EA001494

The cladding to the underside of stairs of the upstairs cupboard (Room 6) does not contain asbestos.

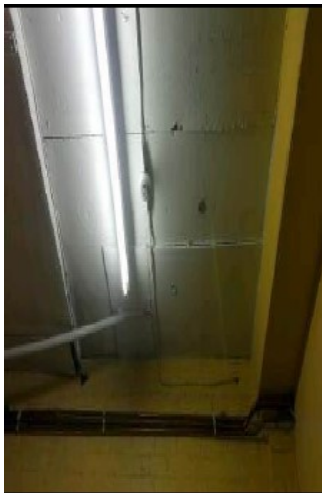
Item 23 - Ref: EA001495

The paper lined fibreboard ceiling panels in the circulation area (Room 7) contain asbestos.

Any change in its appearance should be recorded, and passed to Property Services.

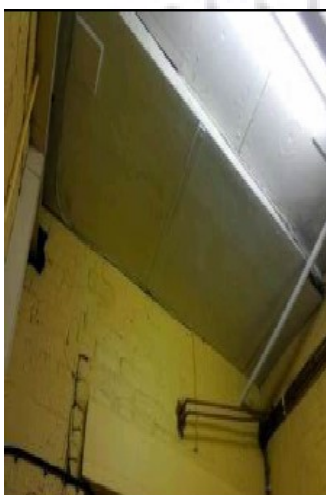
Item 24 - Ref: EA001496

The boards to lower level ceiling in the circulation area (Room 7) does not contain asbestos.

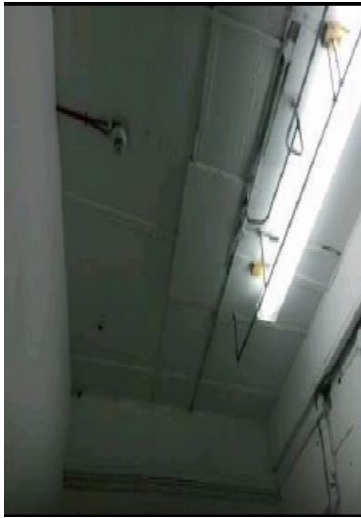
Item 25 - Ref: As EA001495

The paper lined fibreboard ceiling panels to the circulation area (Room 8) contain asbestos.

Any change in its appearance should be recorded, and passed to Property Services.

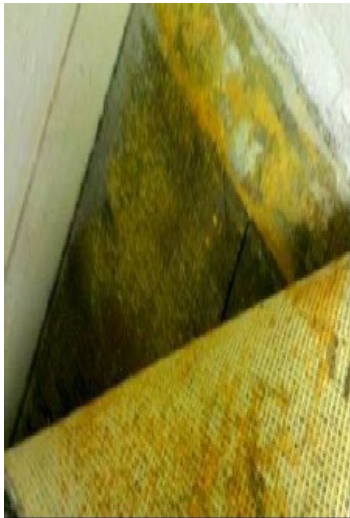
Item 26 - Ref: As EA001487

The vinyl floor tiles to the circulation area (Room 8) do not contain asbestos.

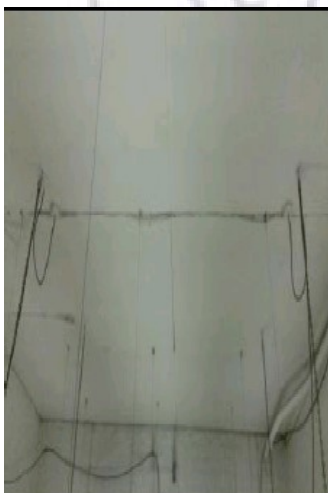
Item 27 - Ref: EA001497

The Ceiling panels above the suspended ceiling to Office 2 (Room 9) do contain asbestos.

Any change in its appearance should be recorded, and passed to Property Services.

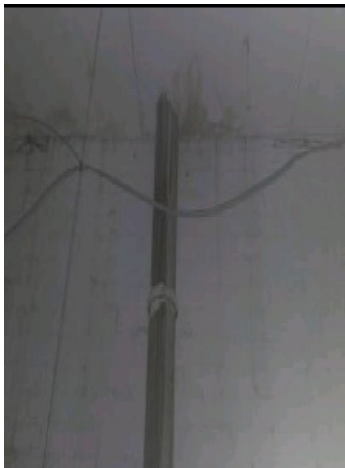
Item 29 - Ref: EA001498

Redundant flue pipe within ceiling void to office 3 (Room 10) does contain asbestos.

Any change in its appearance should be recorded, and passed to Property Services.

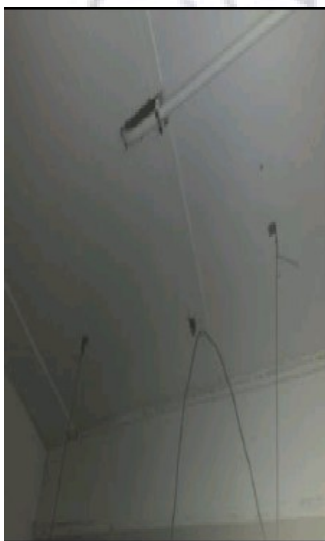
Item 30 - Ref: As EA001495

The paper lined fibreboard ceiling panels to the kitchen (Room 11) contain asbestos.

Any change in its appearance should be recorded, and passed to Property Services.

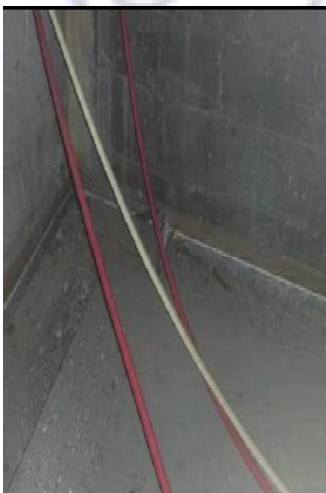
Item 33 - Ref: EA001500

The board debris to suspended ceiling tops to the toilets (Room 12) does contain asbestos.

Any change in its appearance should be recorded, and passed to Property Services.

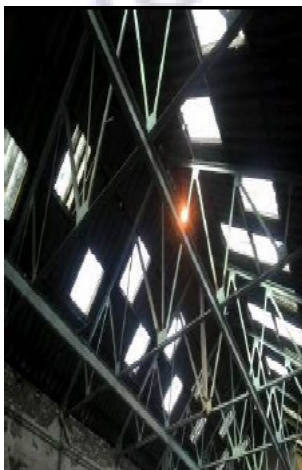
Item 36 - Ref: EA001508

The corrugated roof sheets to warehouse 1 (Room 14) does contain asbestos.

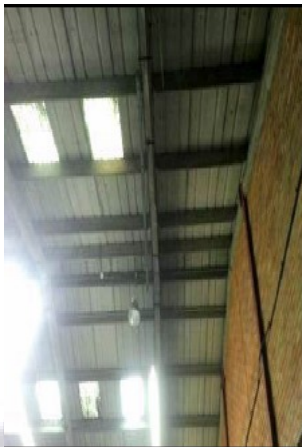
Item 38 - Ref: EA001509

The corrugated roof sheets to warehouse 4 (Room 16) does contain asbestos.

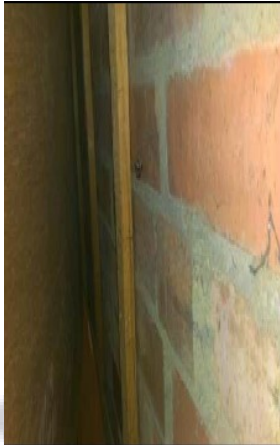
Inspection point-behind timber Panel. No suspect materials Found in the store (Room 15).

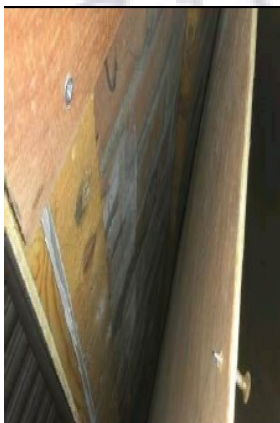
Inspection point-behind timber Panel. No suspect materials found to store (Room 15).

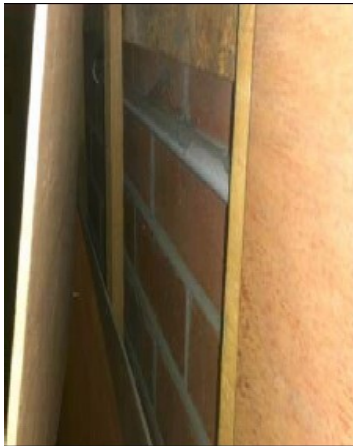
Inspection point-behind timber Panel. No suspect materials found to the store (Room 15).

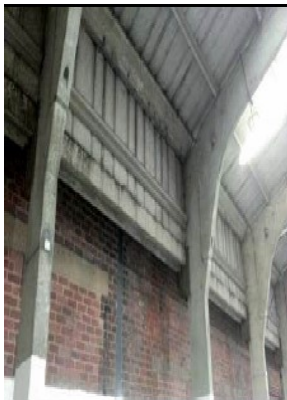
Item 40 - Ref: EA001512

The corrugated wall sheets to warehouse 4 (Room 16) contain asbestos.

Any change in its appearance should be recorded, and passed to Property Services.

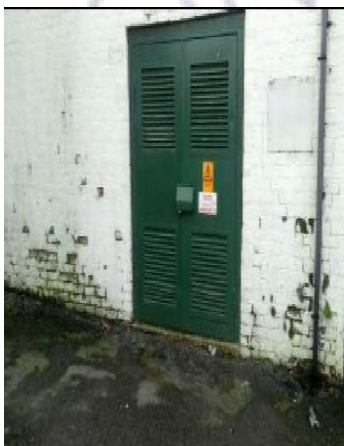
The Sub-Station (Room 17) was inaccessible as a Northern Powergrid Property.

Further investigation required.

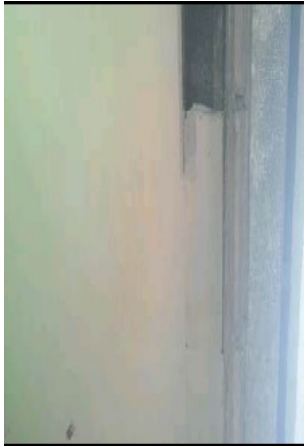
Item 41 - Ref: EA001513

The ceiling boards to boiler room 2 (Room 18) contain asbestos.

Any change in its appearance should be recorded, and passed to Property Services.

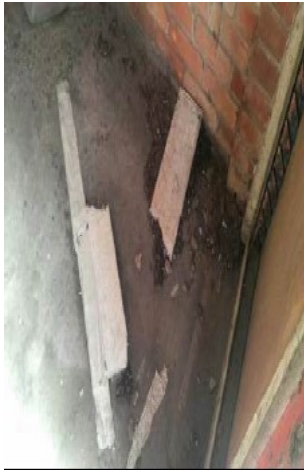
Item 42 - Ref: EA001514

The debris to floor to boiler room 2 (Room 18) contains asbestos.

There should be no access to the area until an environmental clean has been carried out.

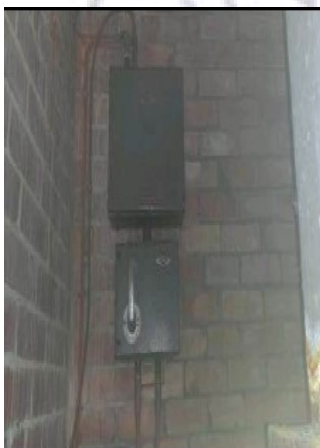
Item 43 - Presumed

It was presumed asbestos was present in the flash guards within fuse box to boiler room 2 (Room 18).

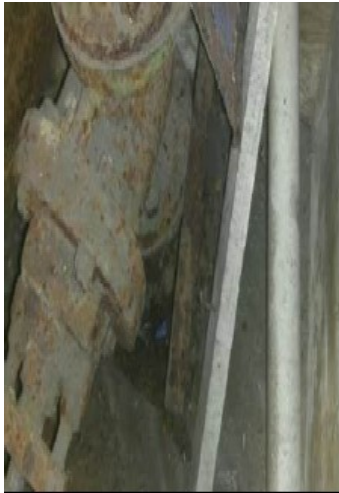
Item 44 - Ref: EA001515

The gasket to the pipe flange to Boiler Room 2 (Room 18) does contain asbestos.

Any change in its appearance should be recorded, and passed to Property Services.

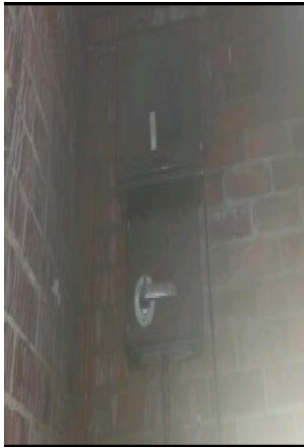
Item 47 - Presumed

It was presumed asbestos was present in the flash guards within fuse box to boiler room 1 (Room 19).

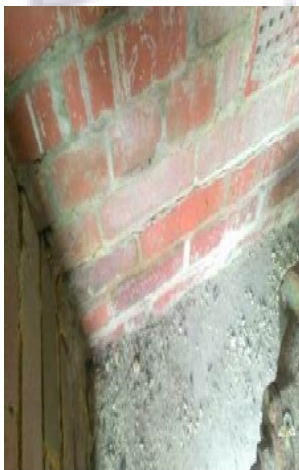
Item 52 Ref: EA001524

The damp proof course to the gas intake room (Room 20) contains asbestos.

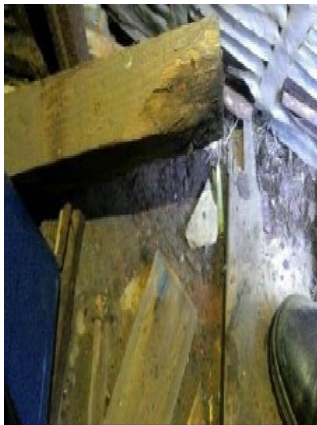
Item 54 - Ref: EA001530

The debris to the floor of Boiler Room 3 (Room 21) does not contain asbestos.

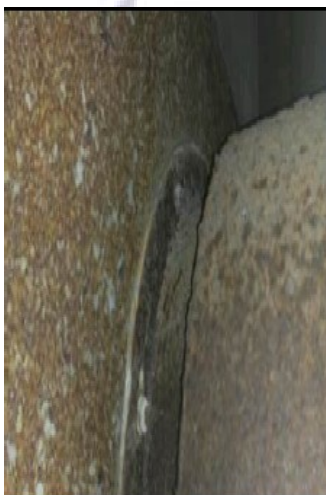
Item 55 - Ref: EA001531

The gaskets to air pump boiler room 3 (Room 21) contains asbestos.

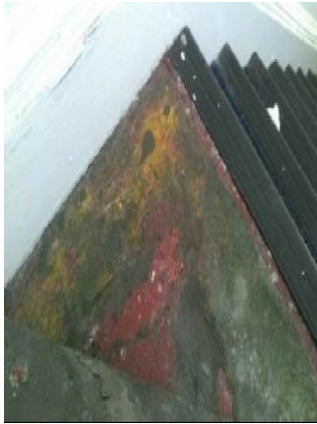
Item 56 - Ref: EA001502

The red screed to floor (First floor landing) (Room 1) does not contain asbestos.

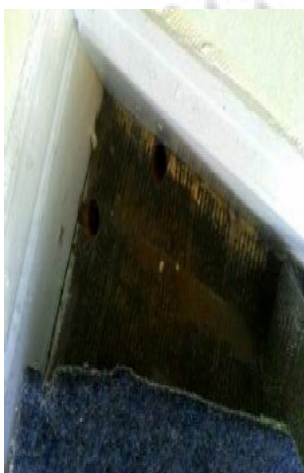
Item 58 - Ref: EA001504

The vinyl floor covering to office 3 (First floor Room 2) does not contain asbestos.

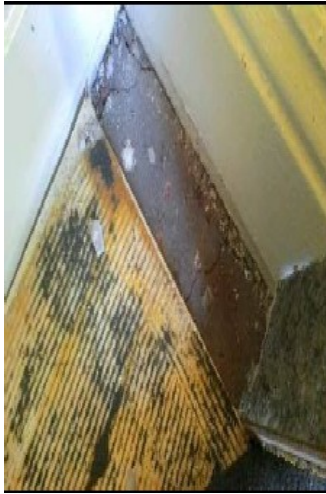
Item 59 - Ref: As EA001502

The red screed to floor of office 4 (First floor Room 3) does not contain asbestos.

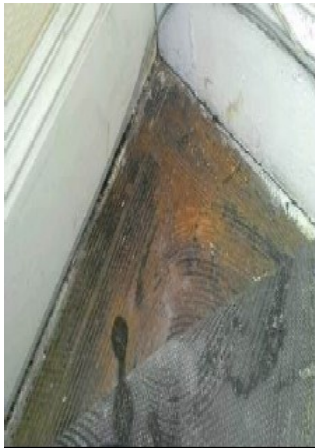
Item 60 - Ref: As EA001504

The vinyl floor covering to Office 4 (First floor Room 3) does not contain asbestos.

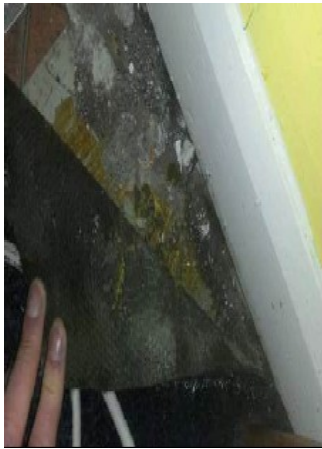
Item 62 - Ref: EA001505

The vinyl floor covering to the landing (First floor - Room 6) does not contain asbestos.

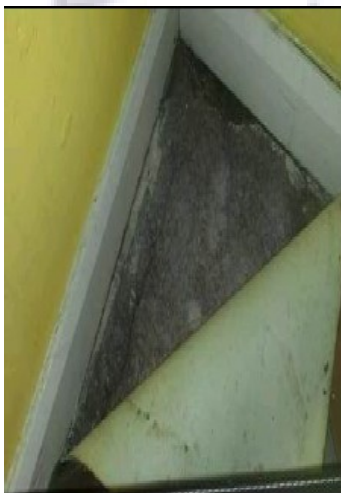
Item 64 - Ref: As EA001502

The red screed to the female wc (First floor - Room 8) does not contain asbestos.

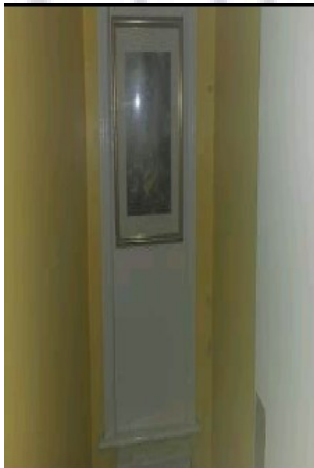
Item 67 - Ref: As EA001506

The panel to the window of the female wc (First Floor Room 8) does not contain asbestos.

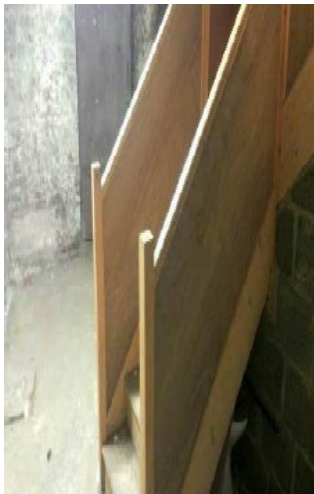
The Stairwell to sub level Room 1 was accessed and no suspect materials were found.

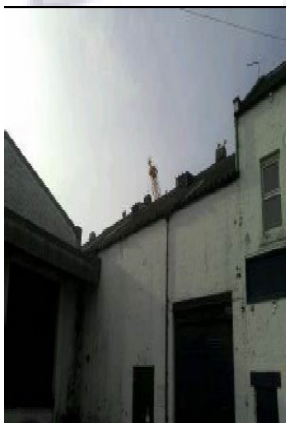
Item 72 - Ref: As EA001508

The corrugated roof /apex/cowl sheet to warehouse 1 (External) contains asbestos.

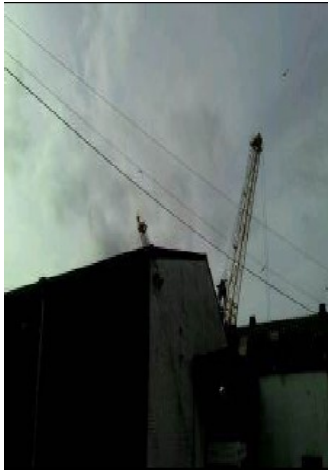
Item 73 - Ref: As EA001509

The corrugated roof /apex/cowl sheet to warehouse 4 (External) contains asbestos.

Any change in its appearance should be recorded, and passed to Property Services.

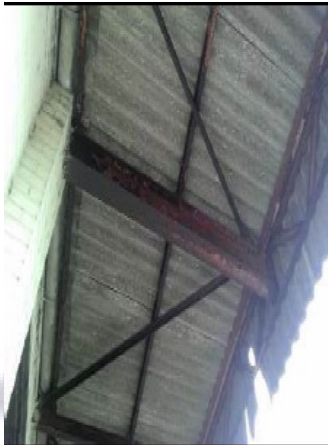
Item 74 - Ref: EA001519

The corrugated sheet canopy to warehouse 4 (External) contains asbestos.

Any change in its appearance should be recorded and passed to Property Services.

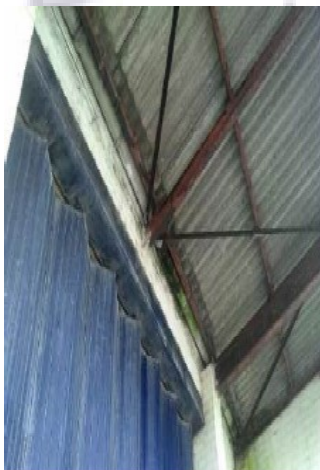
Item 75 - Ref: EA001520

The guttering to Warehouse 4 (External) contains asbestos.

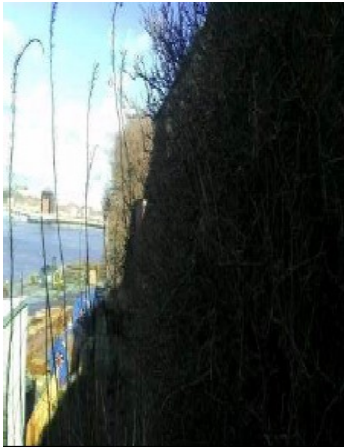
No access to area at high level wall (Room 1) (External).
Further investigation required.

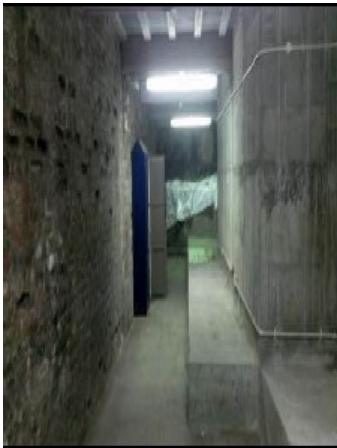
Room 2 (Sub level) was accessed and no suspect materials were found.

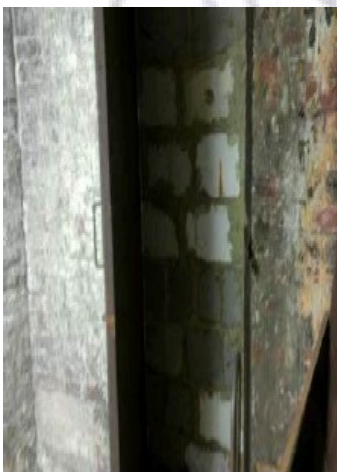
Room 3 (Space behind blocked doorway) to the sub level was inaccessible.
Further inspection required.

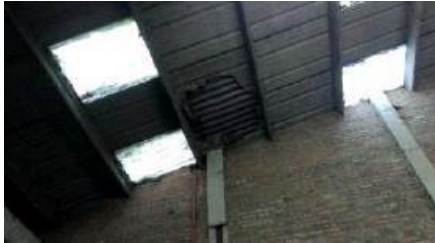
Item 88 - Ref: EC001137

The cement ceiling panels to room 1 of warehouse 3 contain asbestos.

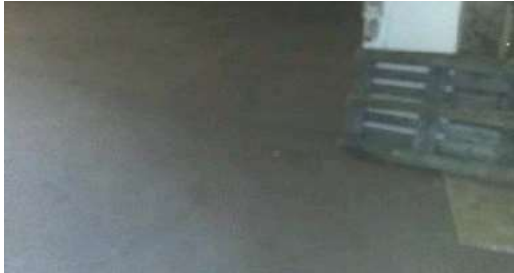
Item 97 - Ref: EC001146

The cement pipe to the external of warehouse 3 contains asbestos.

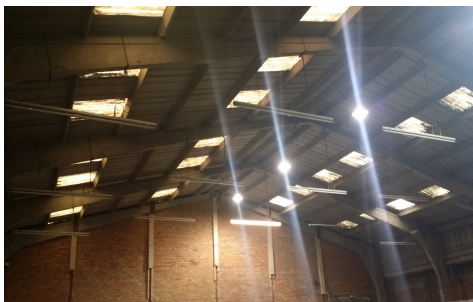
Item 101 - Ref: Presumed

The underside of the roof in Warehouse 4 (Room 002) does contain asbestos.

Any change in its appearance should be recorded and passed to Property Services.

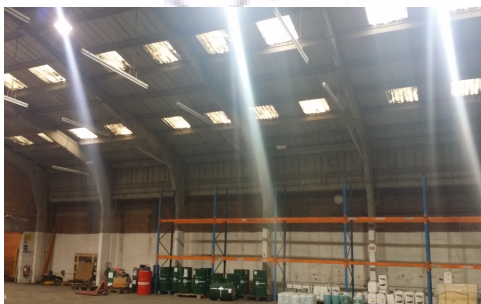
Item 102 - Ref: Presumed

The wall cladding at high level west in Warehouse 4 (Room 002) does contain asbestos.

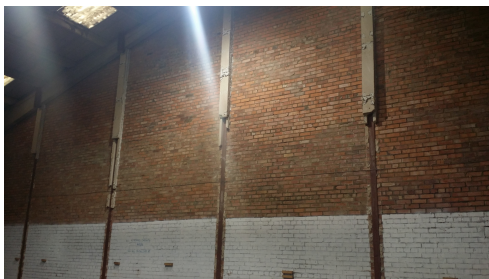
Item 104 - Ref: As 279740-2

The remnant boxing to columns south in Warehouse 4 (Room 002) does not contain asbestos.

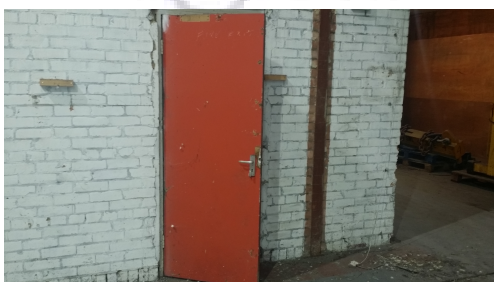
Item 105 - Ref: 279740-3

The lining to fire door south (damaged) in Warehouse 4 (Room 002) does contain asbestos.
