ASBESTOS SURVEY REPORT FOR PARK LANE MARKET (PREVIOUSLY HIDDEN), SUNDERLAND, SR1 3NX

*Control of Asbestos
Regulations 2012*

Park Lane Market (Previously Hidden)

Date: 11 October 2024

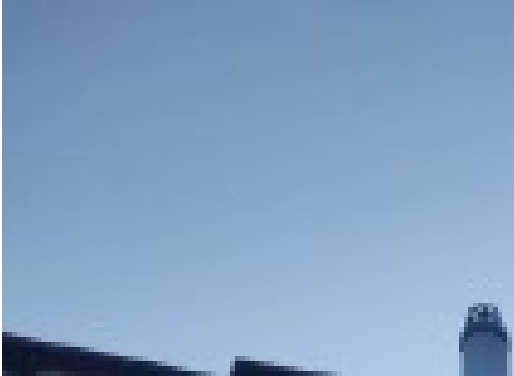
Item 1 Ref: 21-38141-1

- (Item 1) Ref: 21-38141-1 – Undercloak to gable end (area 1/Storage Units) – Removed September 2021 (A Watson to forward ppw)
- (Item 2) Ref: 21-38141-1 – Undercloak and tile fillets (area 1/Storage Units) – Removed September 2021 (A Watson to forward ppw)

The roof undercloak to the gable end (Storage units/Area1) contains asbestos.

These were removed September 2021.

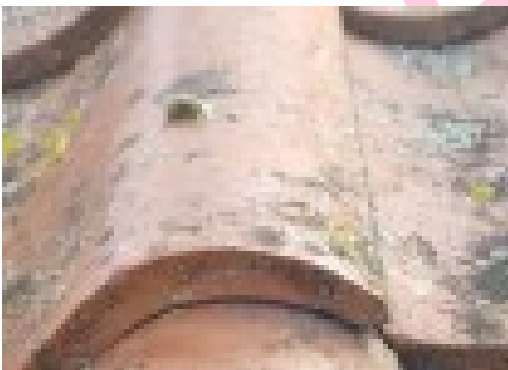
Item 2 Ref: 21-38141-1

The roof undercloak and tile fillets (Storage units/Area1) contains asbestos.

These were removed September 2021.

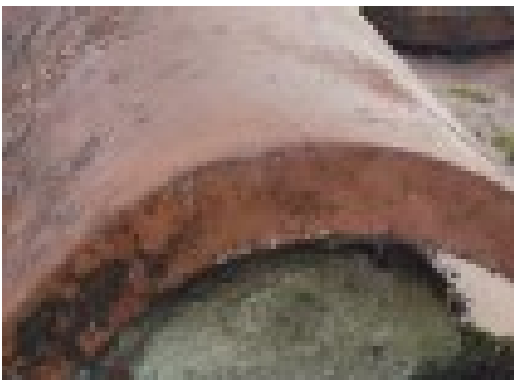
Item 3 Ref: 21-38141-1

The roof undercloak and tile fillets (Storage units/Area1) contains asbestos.

These were removed September 2021.

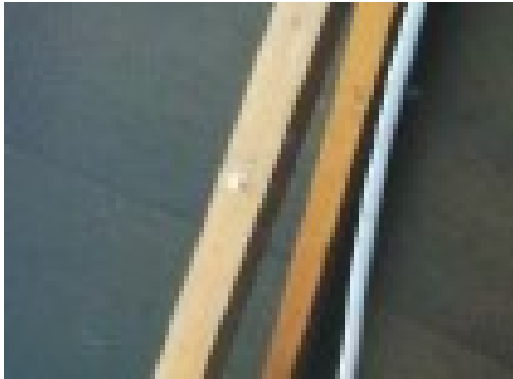
Item 4 Ref: 21-38141-2

The bitumen to the roof (Storage units/Area 1) do not contain asbestos.

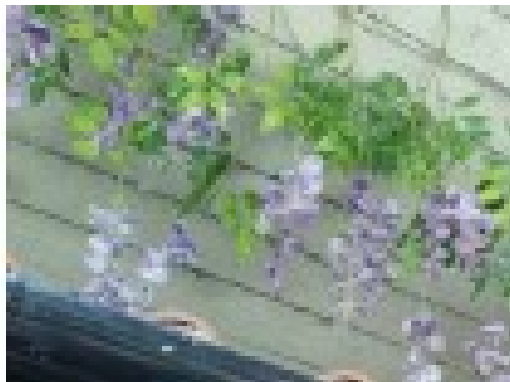
Item 5 Ref: 21-38141-10

- (Item 5) Ref: 21-38141-10 – Undercloak and tile fillets (Area 2/Open Air Hidden Pub Area) – Very Low Risk
- (Item 6) Ref: 21-38141-11 – Sarking felt left roof (Area 2/Open Air Hidden Pub Area) – No Risk

The roof undercloak and tile fillets (Storage units/Area1) contains asbestos.

Any change in appearance should be reported to Property Services.

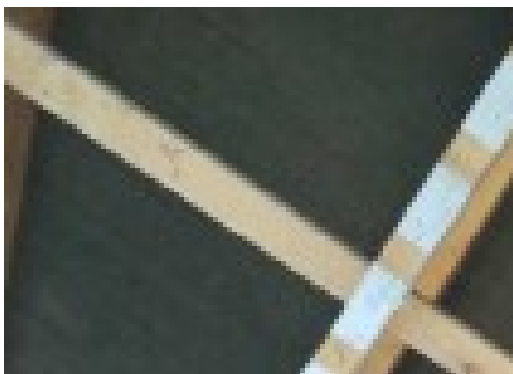
Item 6 Ref: 21-38141-11

The roof sarking felt to the left roof (Open air Hidden Pub Area/Area 2) does not contain asbestos.

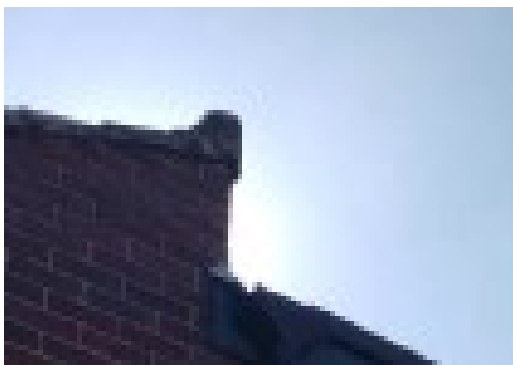
Item 9 Ref: 21-38141-14

The flat roof felt (Open air Hidden Pub Area/Area 2) does not contain asbestos.

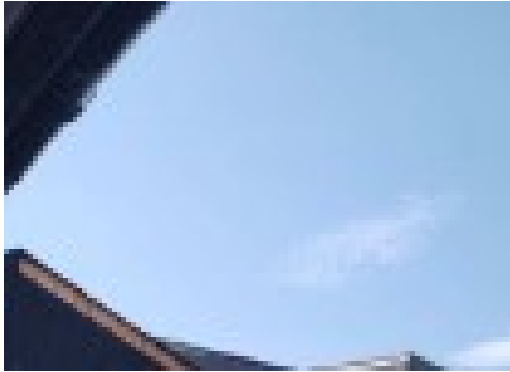
Item 10 Ref: 21-38141-15

The felt over roof pitches (Open air Hidden Pub Area/Area 2) does not contain asbestos.

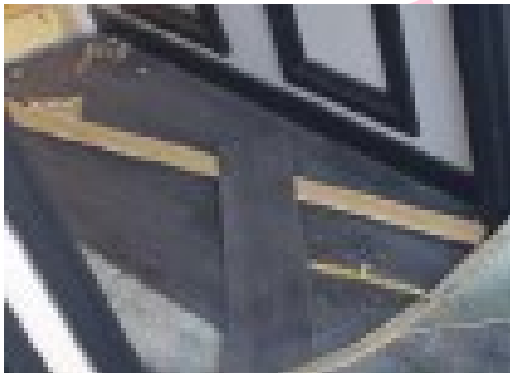
Item 11 Ref: 21-38141-3

The flooring to WC area (Open air Hidden Pub Area/Area 2) does not contain asbestos.

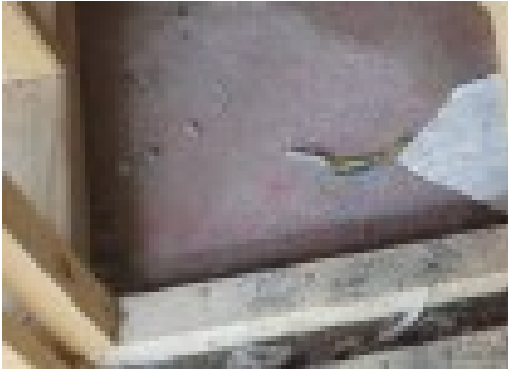
Item 13 Ref: 21-38141-5

The vinyl flooring (Open air Hidden Pub Area/Area 2) does not contain asbestos.

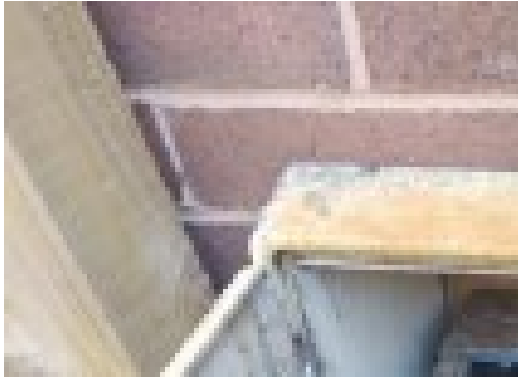
Item 16 Ref: 21-38141-8

The cartridge fuses to electrics at rear (Open air Hidden Pub Area/Area 2) do not contain asbestos.

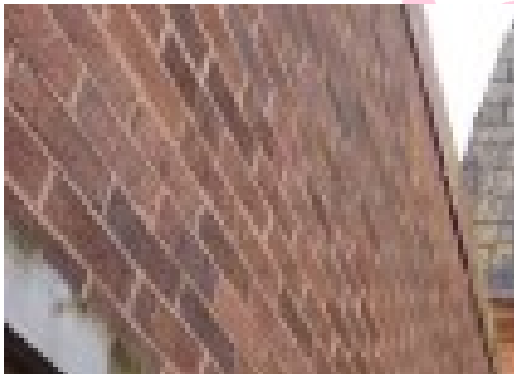
Item 17 Ref: 21-38141-9

The tiles to adjacent building fire exit roof (Open air Hidden Pub Area/Area 2) do not contain asbestos.
